Building and Pest Report

5 Morton Way Skennars Head

Pest And Building Inspection

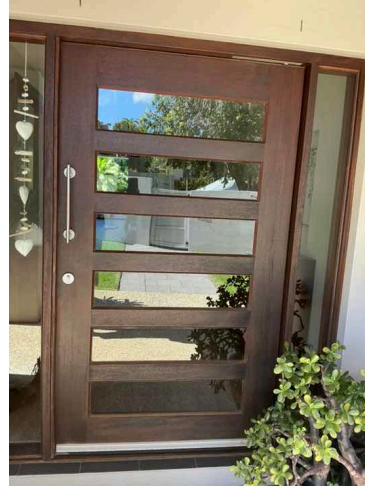
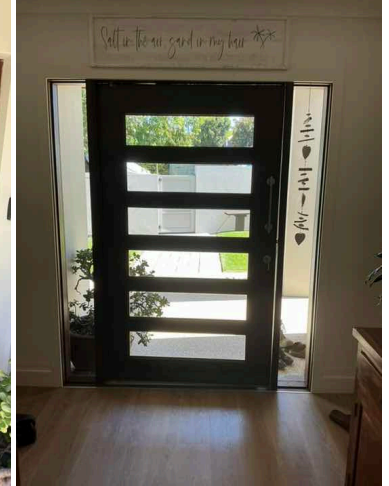
Front Entry Doors

The doors are in serviceable condition with no notable defects observed.

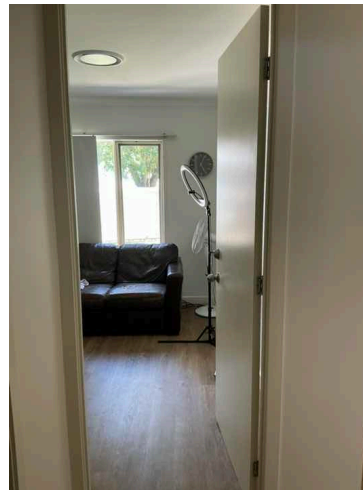
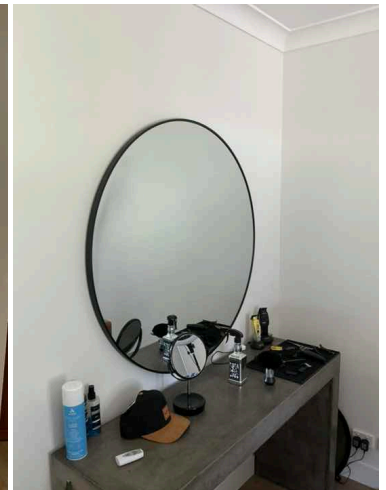
Study

From the visible and accessible areas, this room appears to be in a serviceable condition for the age of the property with no notable structural defects sighted.

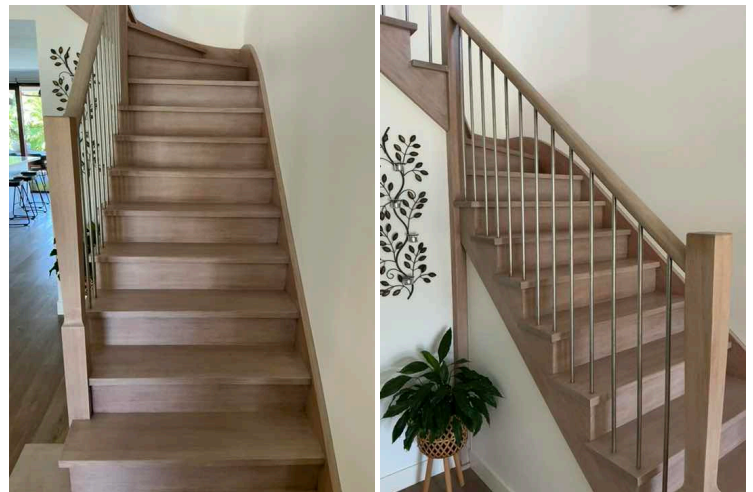
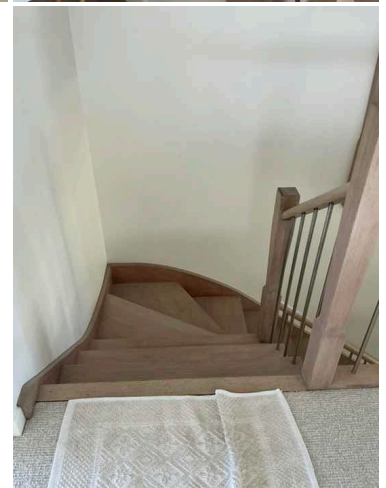
The internal staircase and components appear to be in a serviceable condition for the age with no notable defects sighted.

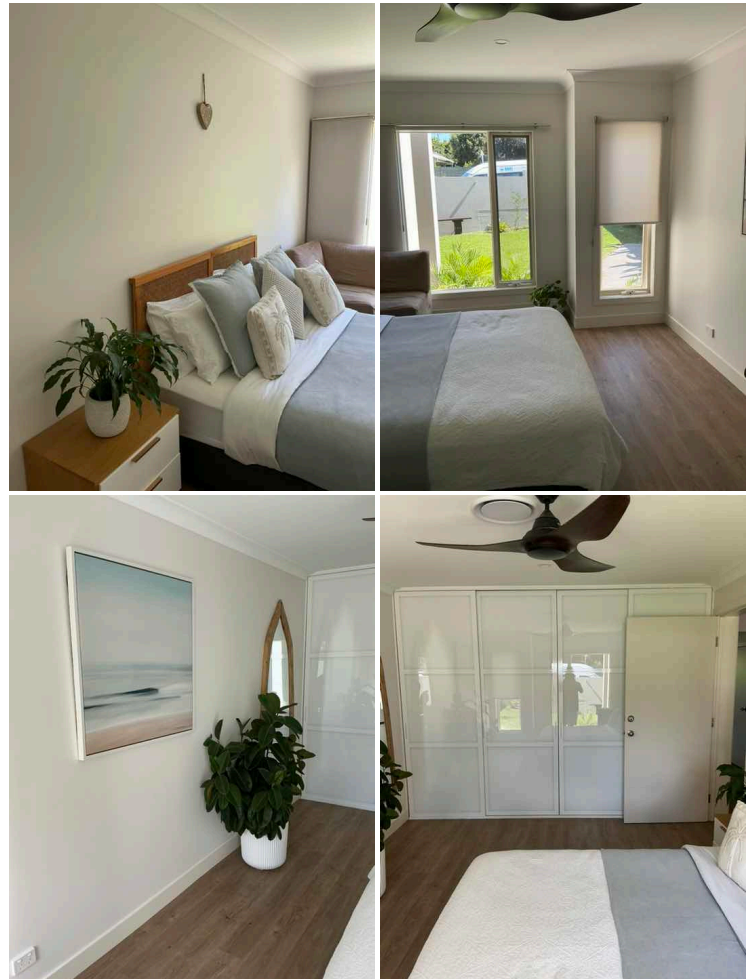
Bedroom 2

From the visible and accessible areas, this bedroom appears to be in a serviceable condition for the age of the property with no notable structural defects sighted.

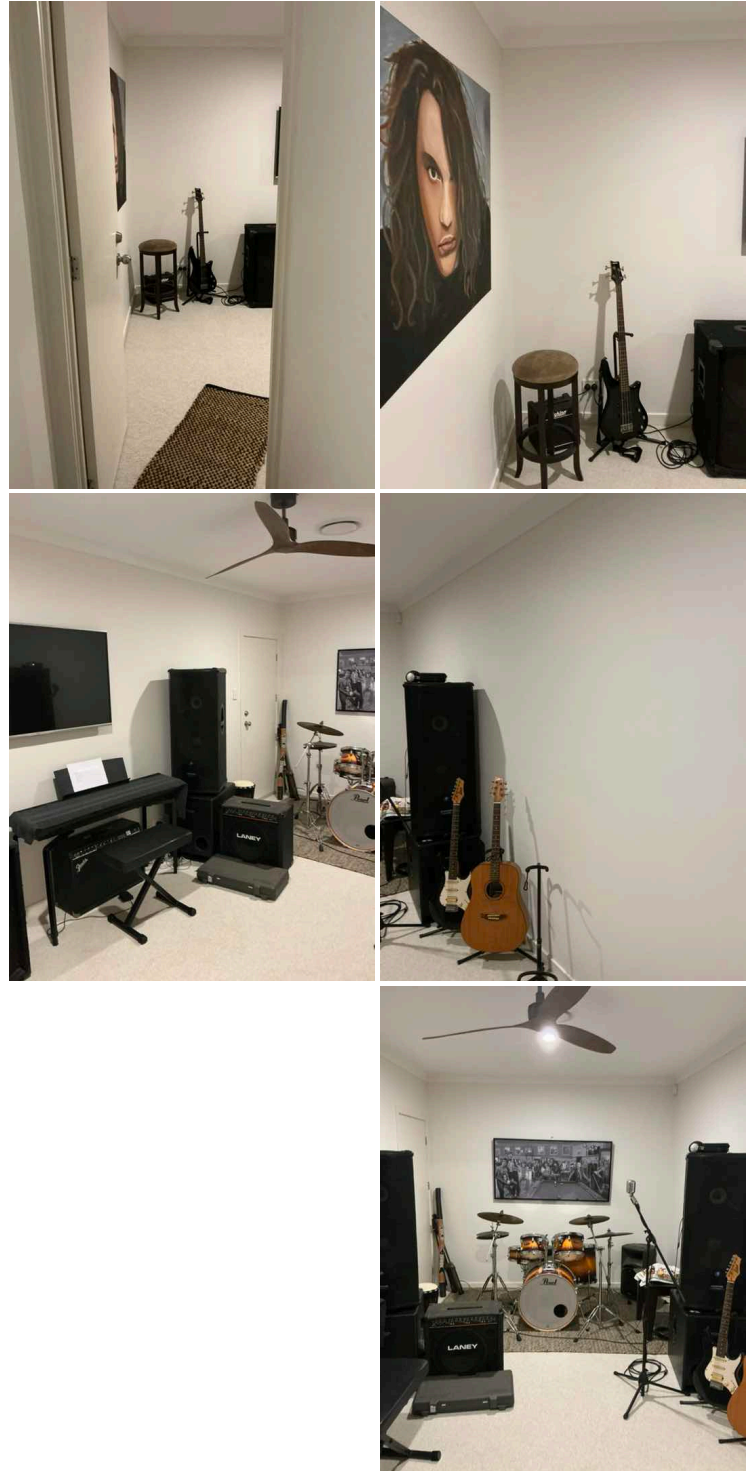
Bedroom 3

From the visible and accessible areas, this bedroom appears to be in a serviceable condition for the age of the property with no notable structural defects sighted.

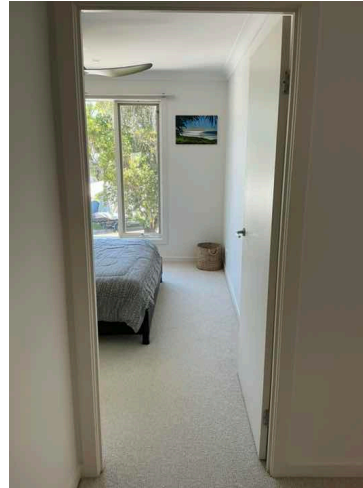
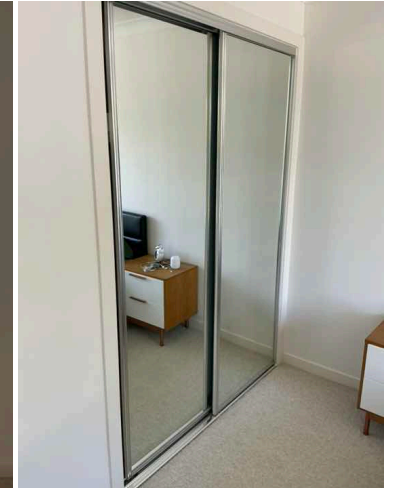
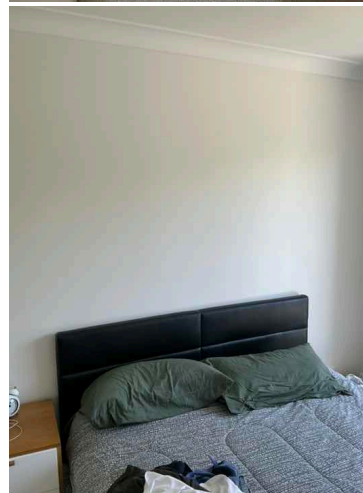
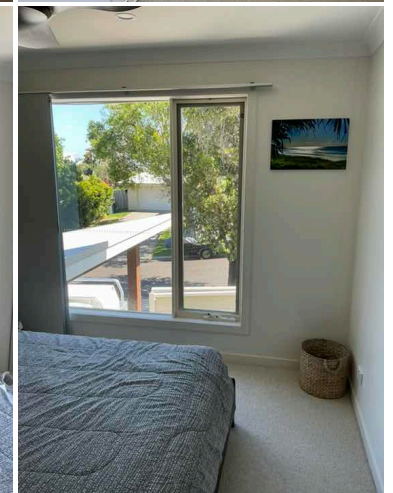
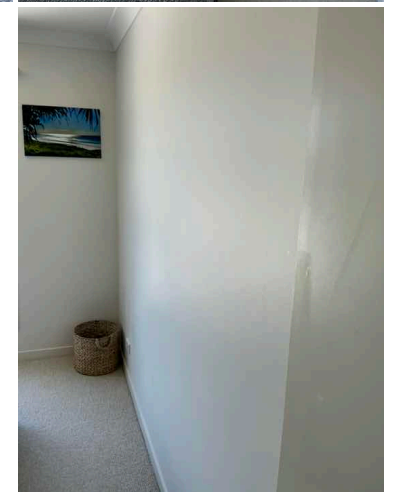
Bedroom 4

From the visible and accessible areas, this bedroom appears to be in a serviceable condition for the age of the property with no notable structural defects sighted.

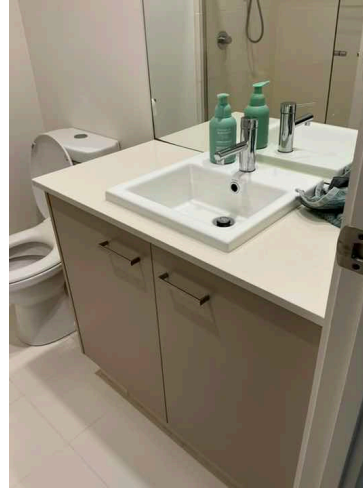
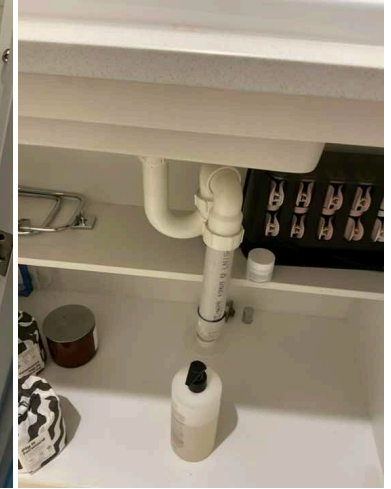
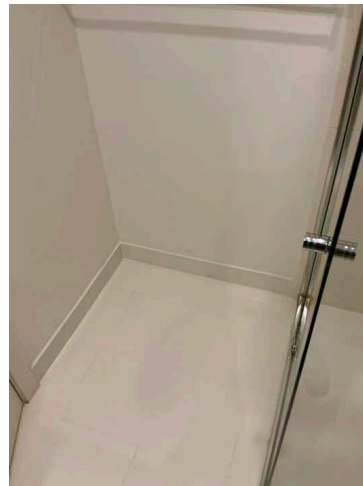
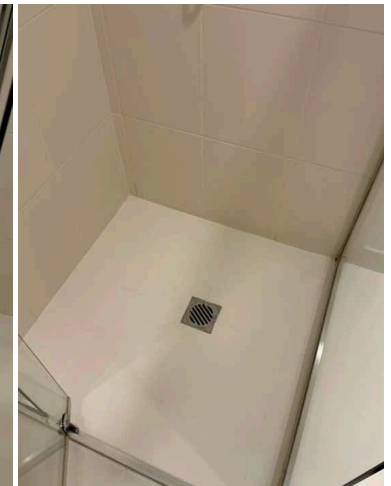
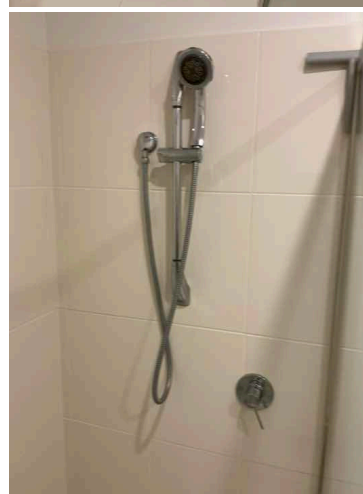
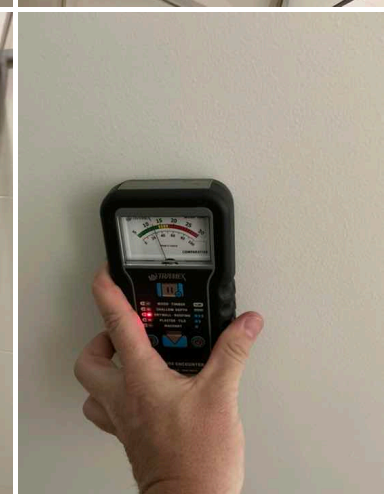
Of the visible areas, the general condition of this bathroom is serviceable or in reasonable condition for age of dwelling.

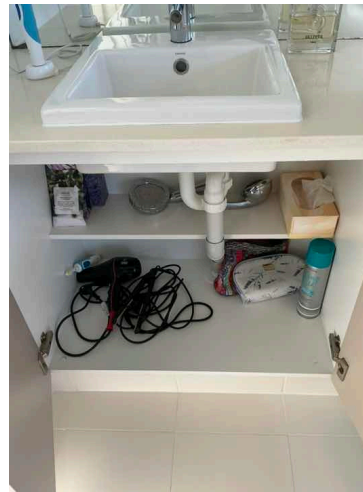
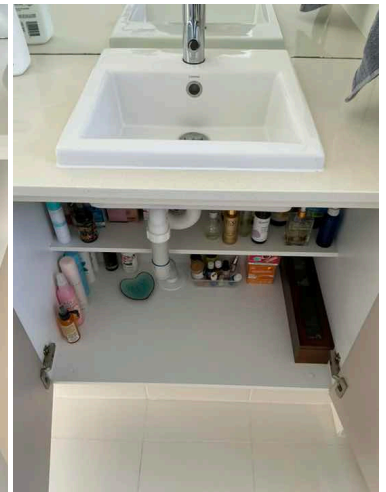
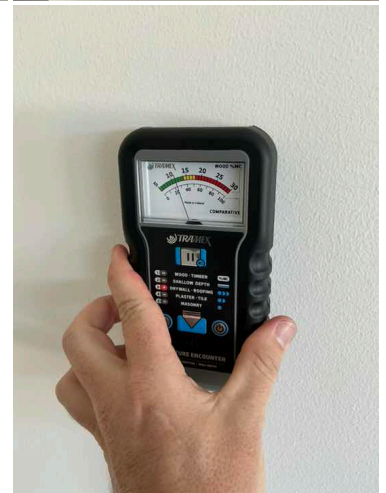
Bathroom 3

Of the visible areas, the general condition of this bathroom is serviceable or in reasonable condition for age of dwelling.

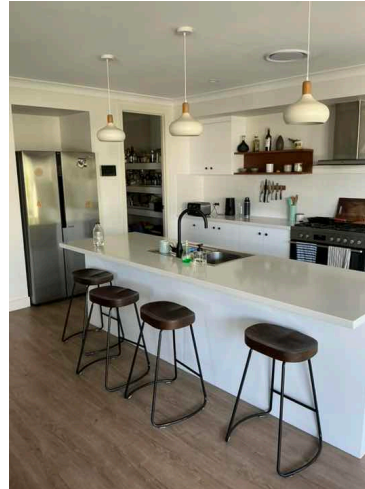
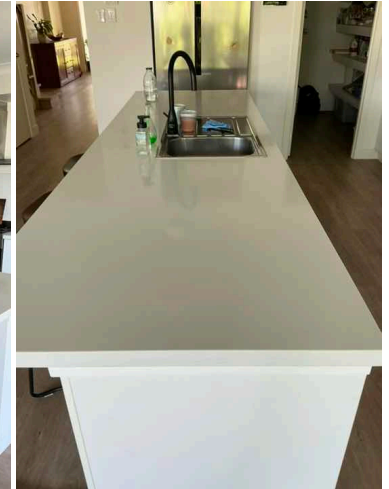
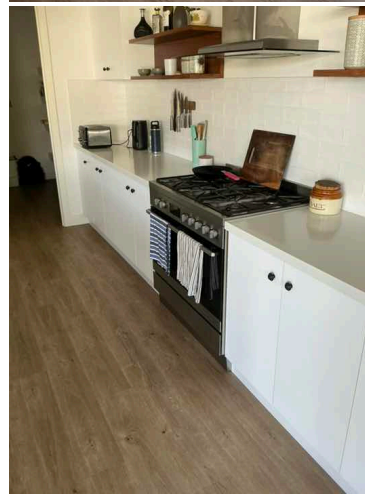
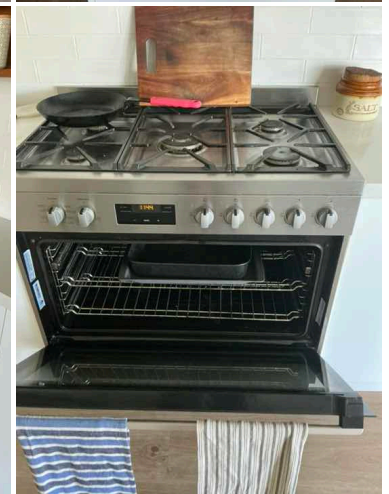
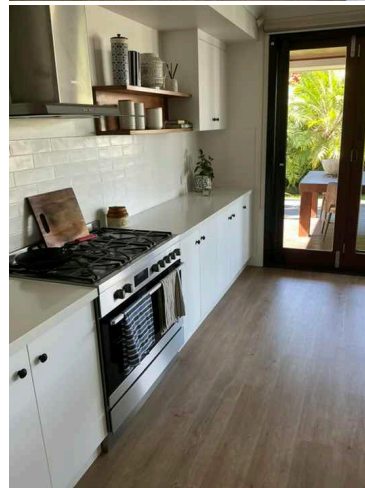
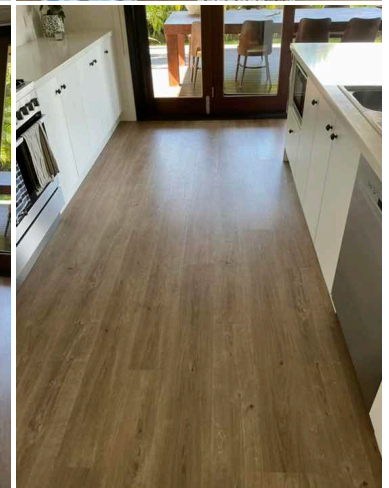
KITCHEN & LAUNDRY

Of the visible areas, the general condition of the kitchen and pantry is serviceable or in reasonable condition for age of dwelling.

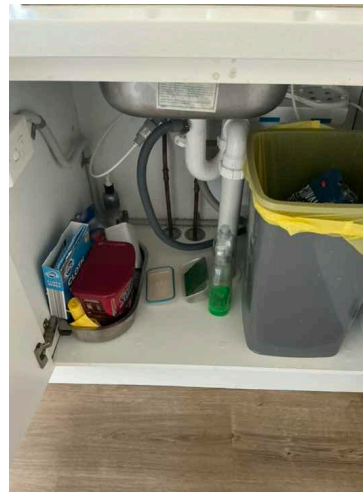
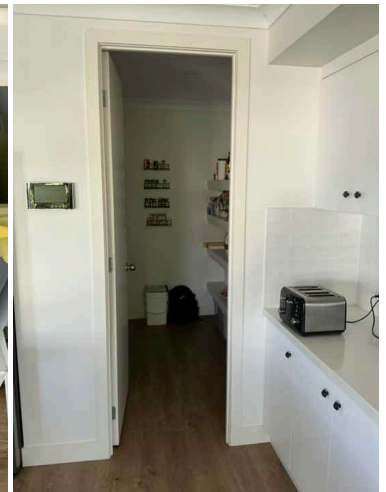
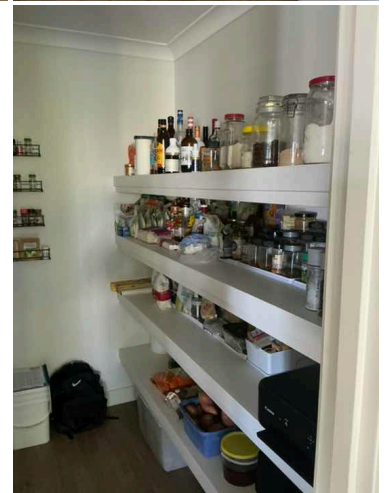
These components appear to be in a serviceable condition

Of the visible areas, the general condition of the laundry is serviceable or in reasonable condition for age of dwelling.

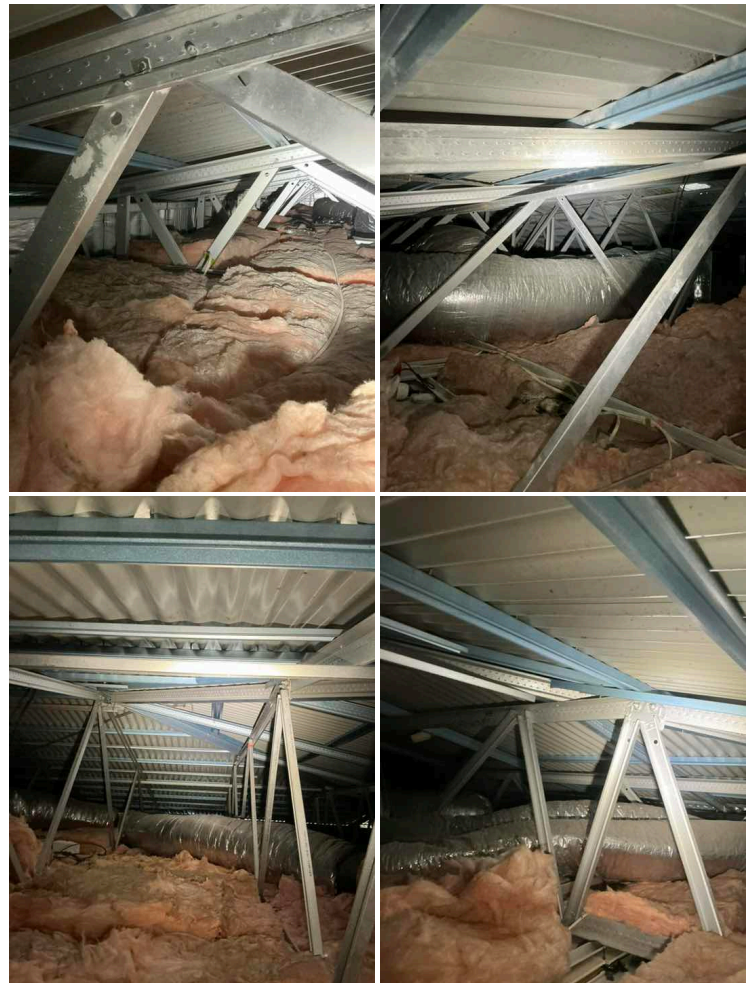
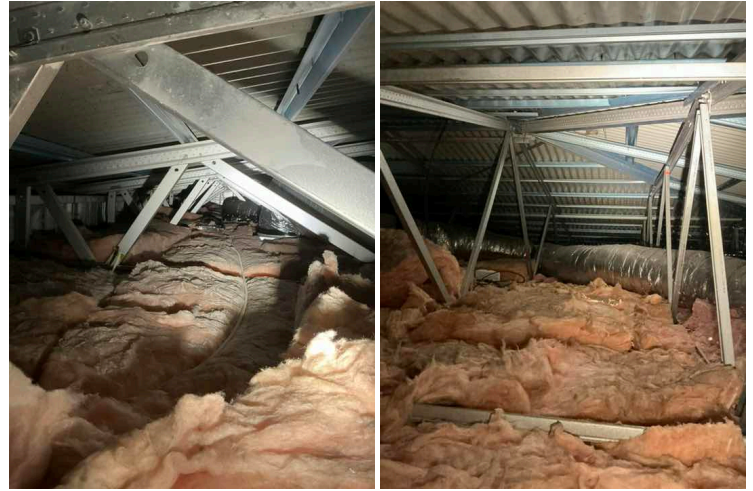
Insulation

Where visible and accessible, the insulation appears to be in a serviceable condition.

sarking is not Installed.
