# Building and Pest Report

## 55B Habitat Way Lennox Head

Report/Agreement #	240425085605395
Inspection Date:	24 Apr 2025
Inspection Time:	08:56 am

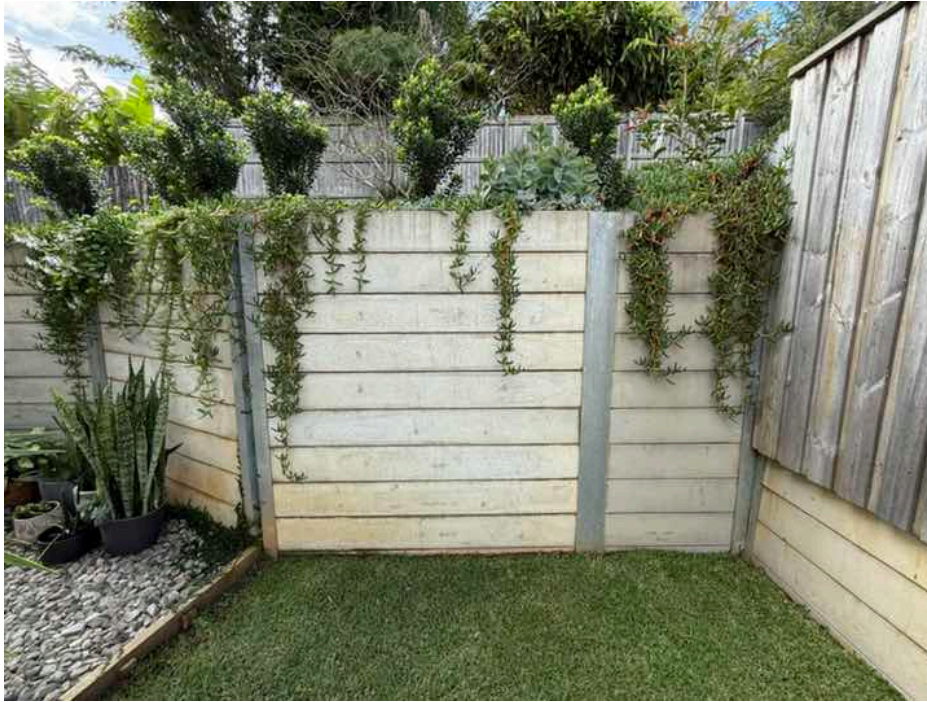
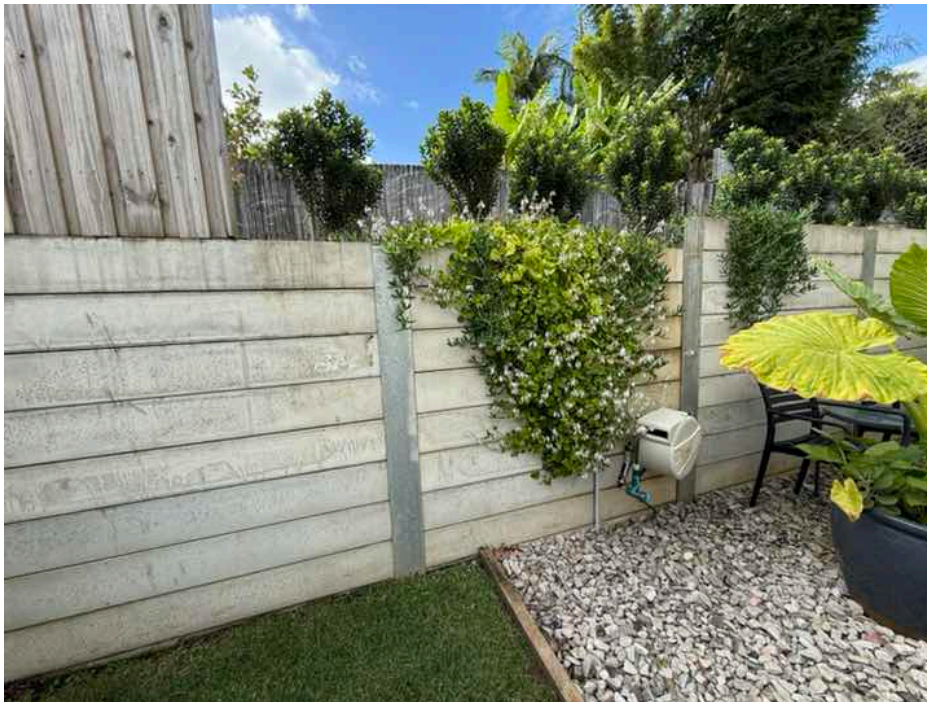
There was no visible evidence of excess ponding or fall towards the property walls at the time of the inspection. Regardless, it is difficult to ascertain in dry conditions and it is therefore recommended that you assess same after a rainfall period to be able to sufficiently ascertain if any problems exist in this regard. If water is ponding around perimeter walls and paths or appears to be flowing into the footings/foundations you must have assessed by a qualified plumber or landscaper.

Recommend installing a drainage point under the tap to assist with drainage.

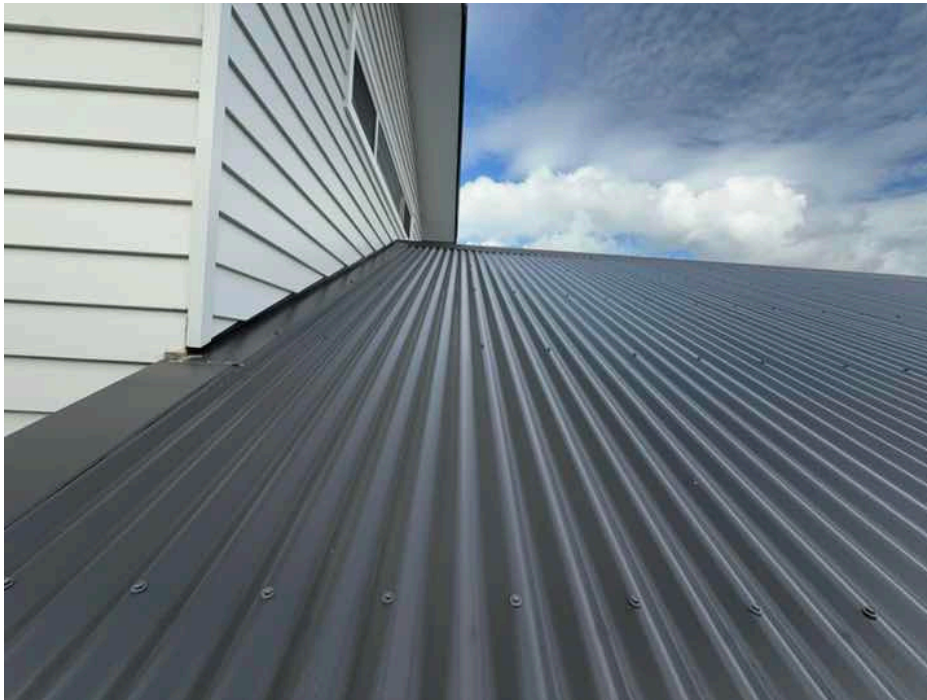
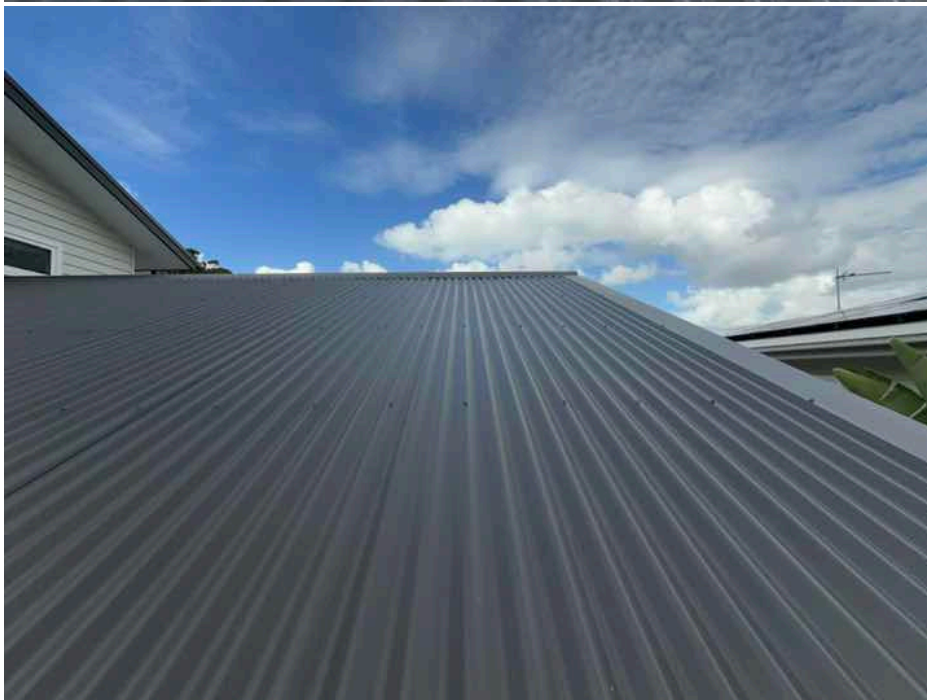
Of the visible areas, the general condition of the roof is in serviceable condition for the age.  
Note: In the absence of rainfall there is no guarantee that the roof won't leak.

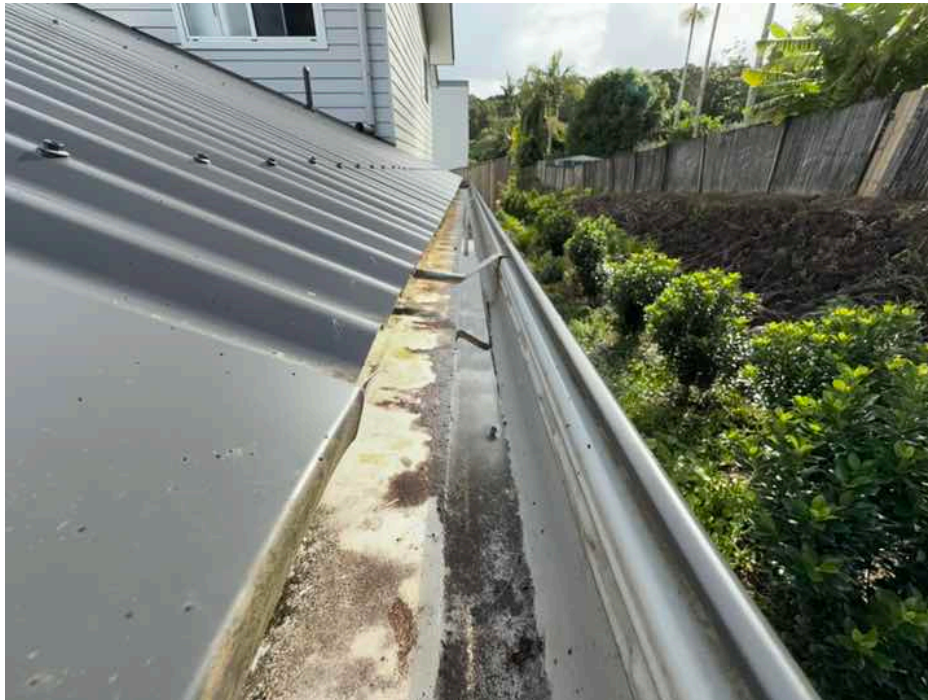
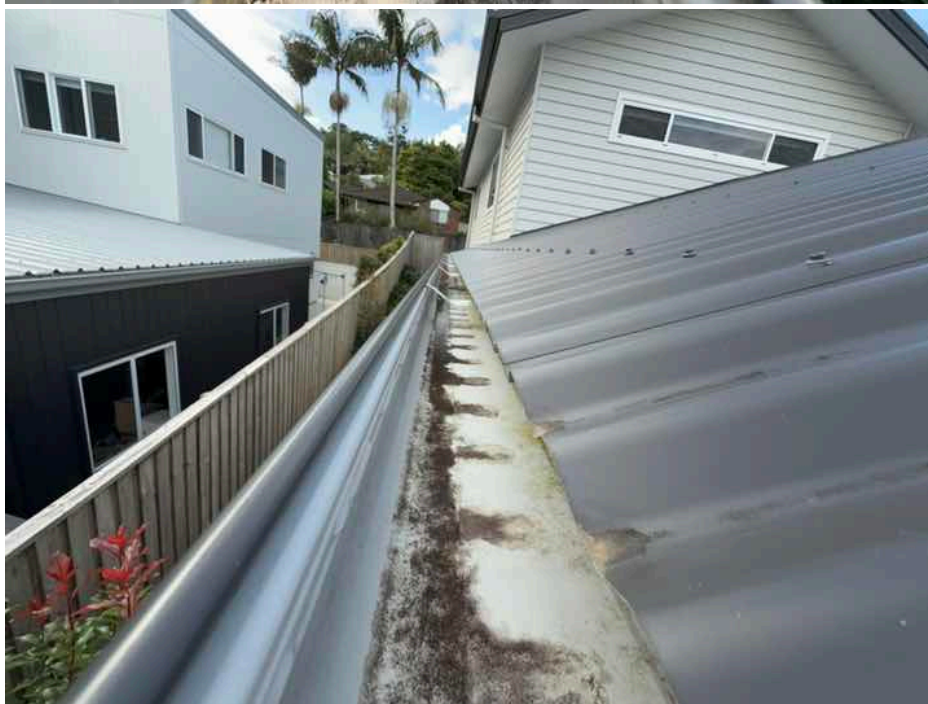
All visible and accessible of the physical nature of the guttering system appears to be in a serviceable condition with no apparent defects at the time of inspection. In the absence of prolonged rain fall efficiency of the guttering can not be assessed and you may find that further investigation or repairs maybe required. Note: Periodic maintenance checks should be carried out for rust penetrations and leaks.

Gutter ponding - This can relate to poor fall, inadequate down pipes, gutter or debris build up. If debris presence has been noted above clean same out and re-assess for any ponding. If clean guttering is ponding it can be a blocked down pipe or the guttering fall is inadequate. A qualified roof plumber should be engaged for advice and recommendations.

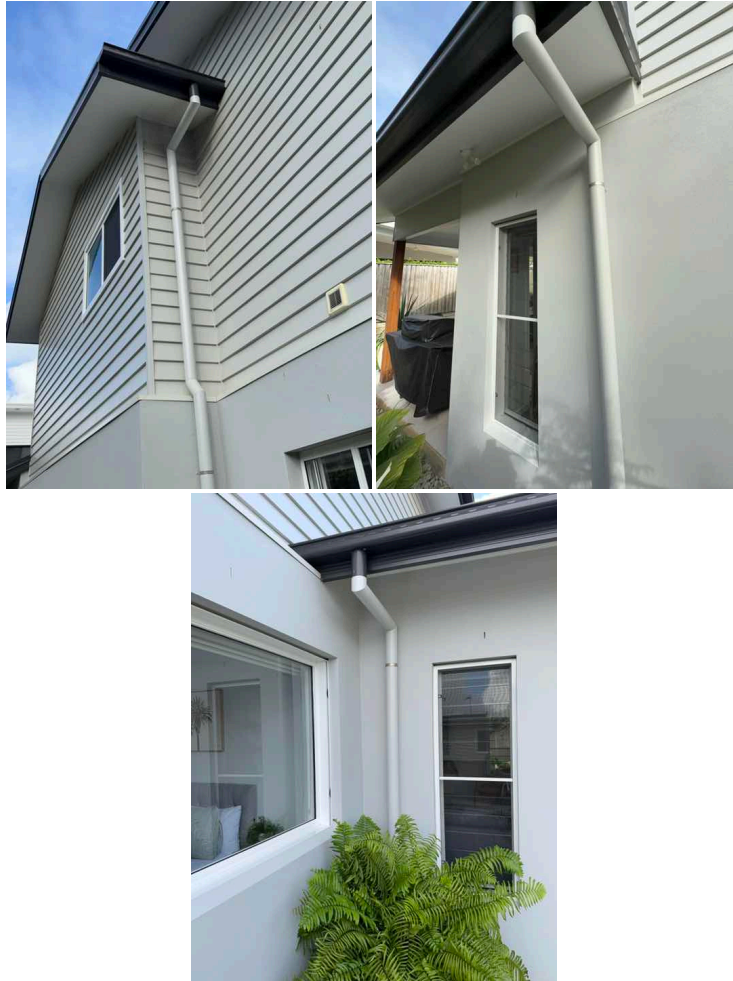
On visual inspection no apparent defects were noted to the down pipes and are considered serviceable, however no comment can be made with regard to blockages or connections to stormwater or functionality in the absence of rain. Note: Periodic maintenance checks should be carried out for rust penetrations and leaks.

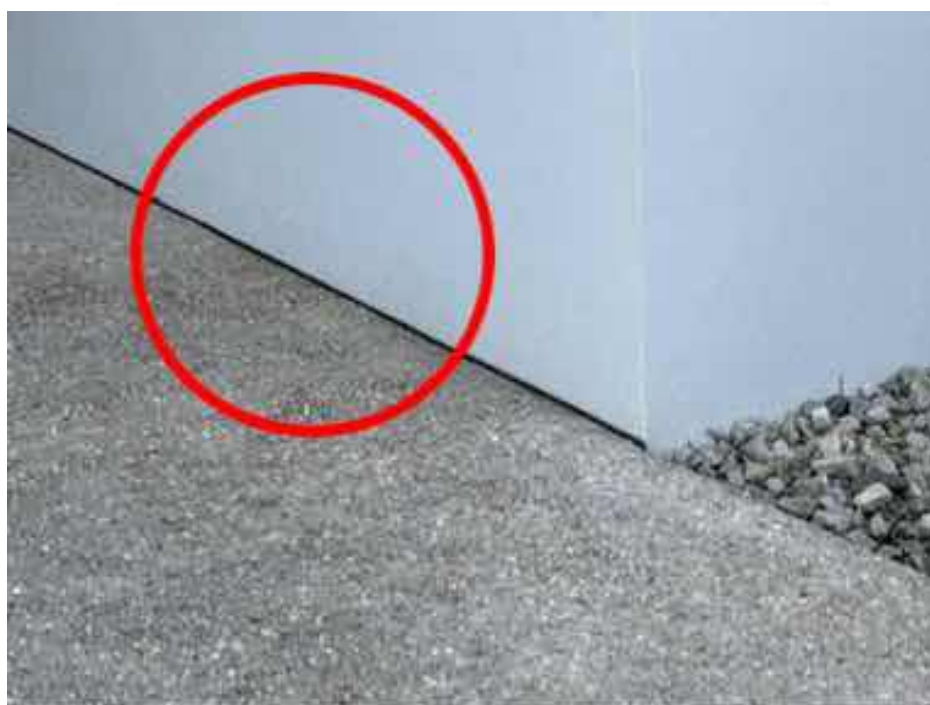
Some weep holes partially are covered - Recommendations: Lower finished ground levels to fully expose all weep holes on the lower brick courses around the dwelling.

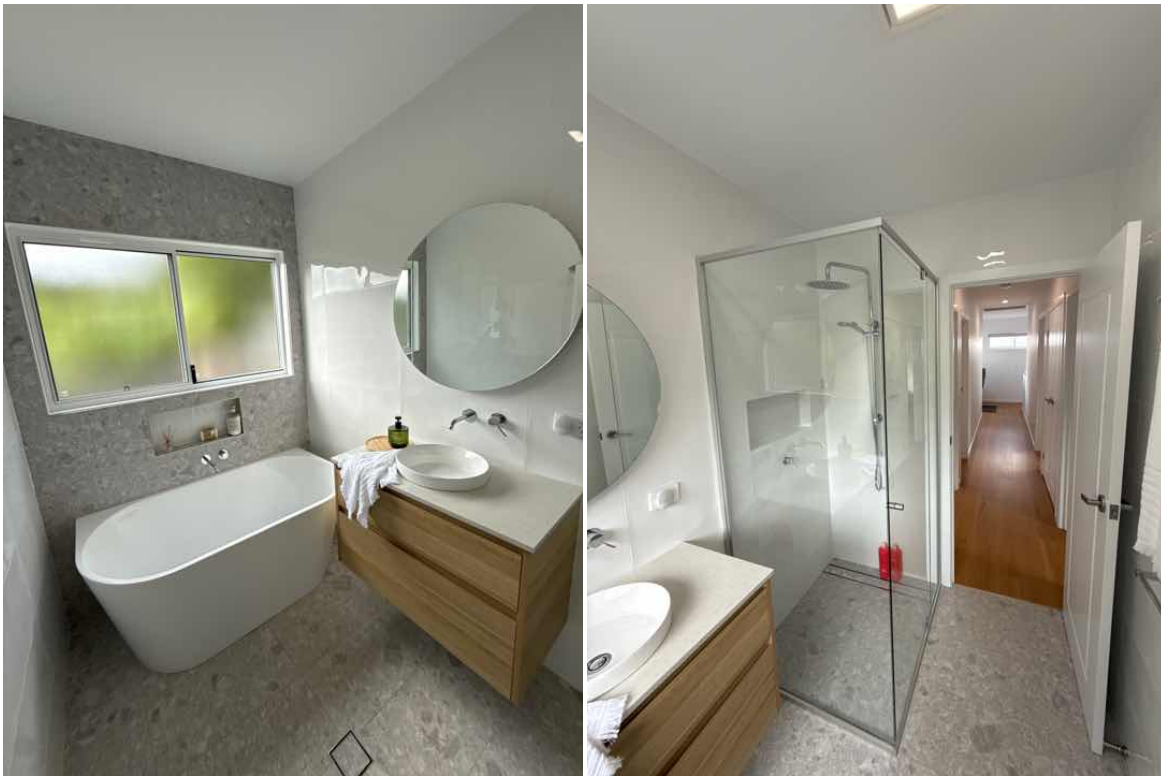
### **Shower And Bath**

Bath spout is loose

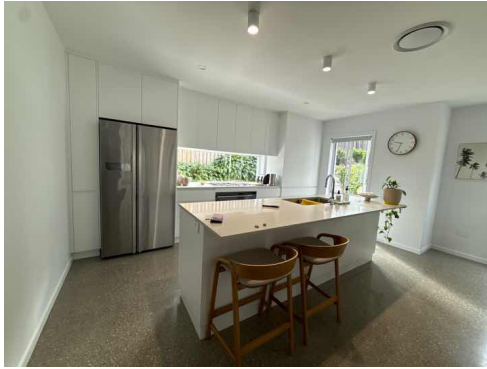
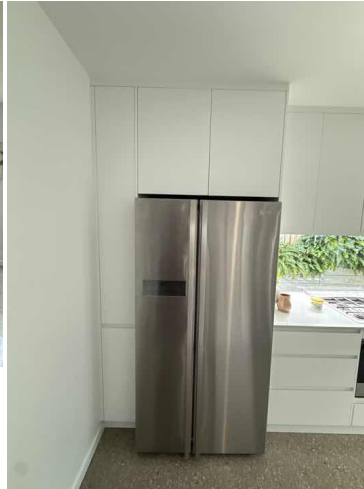
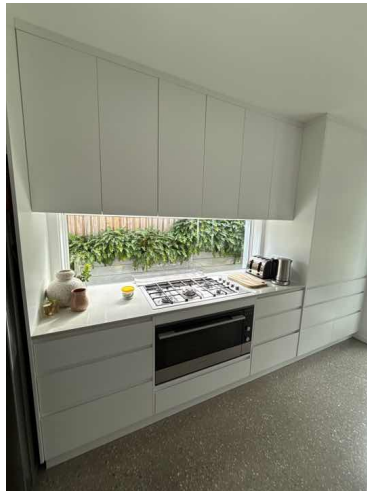
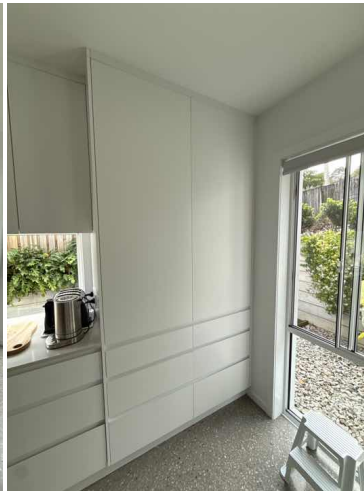
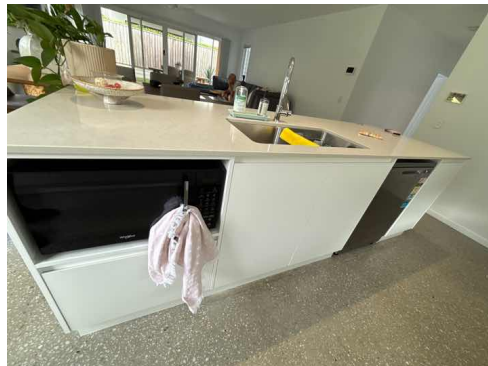
These components appear to be in a serviceable condition

Adjustment to cabinet doors required, in some instance hinges may need to be replaced.

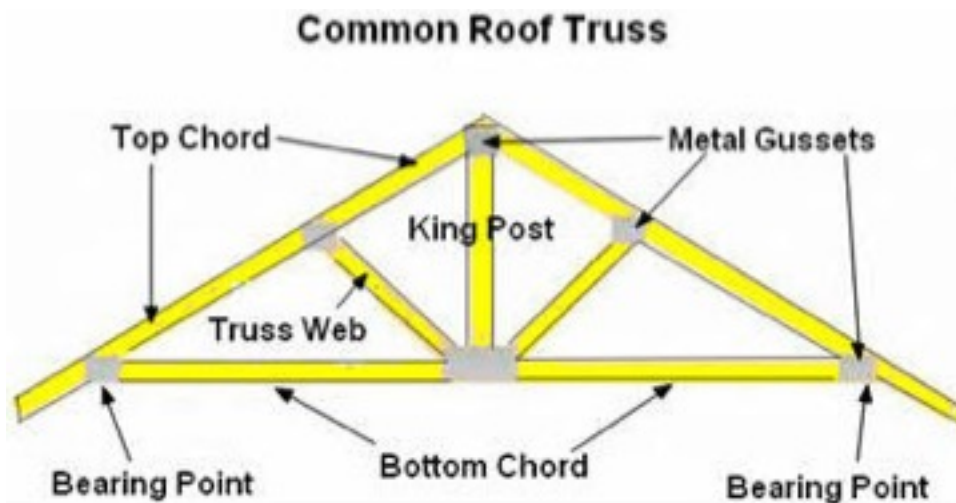
#### Roof Frame Type

The roof frame is a truss timber frame.

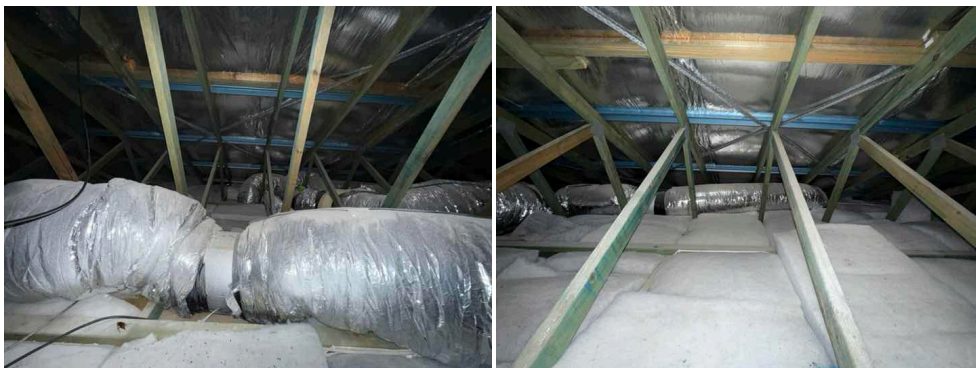
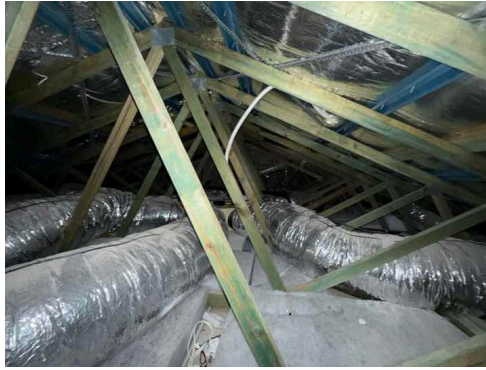
#### Overall Condition

Visible sections of the roof void is in a serviceable condition for age of this dwelling.

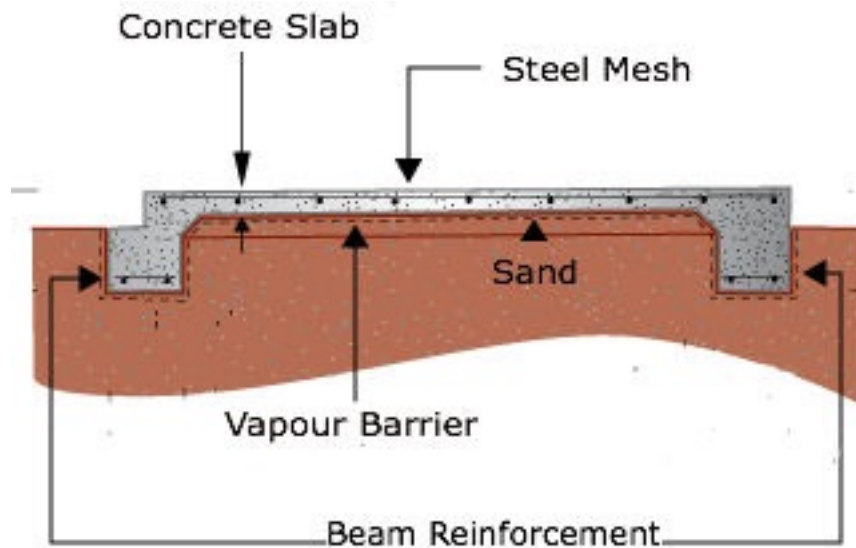
#### **Footings Type**

Slab on ground construction.
