# Building and Pest Report

## 5 Castle Drive Lennox Head

# Inspection Report

**5 Castle Drive , Lennox Head , NSW, 2478**

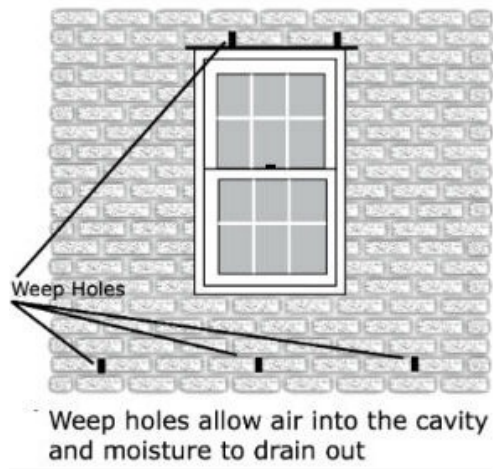
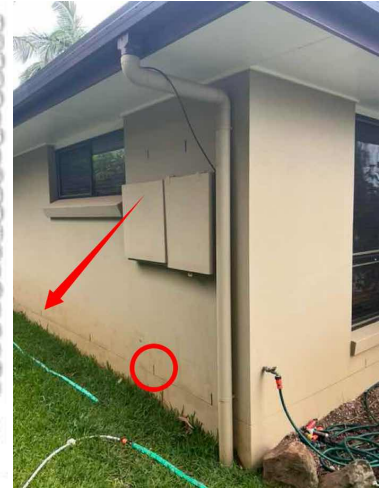
The weep holes are unobstructed .

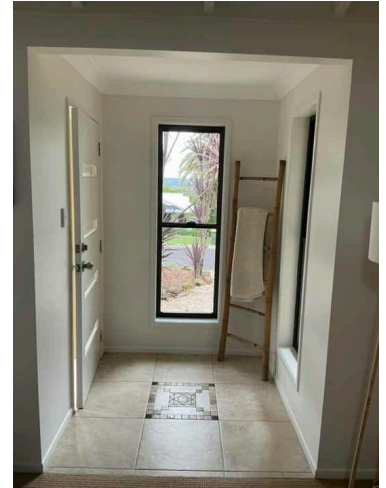
From the visible and accessible areas, this area appears to be in a serviceable condition for the age of the property with no notable structural defects sighted.

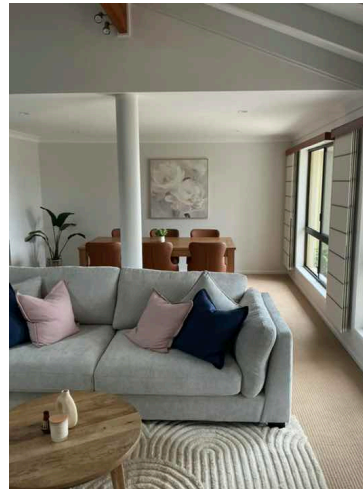
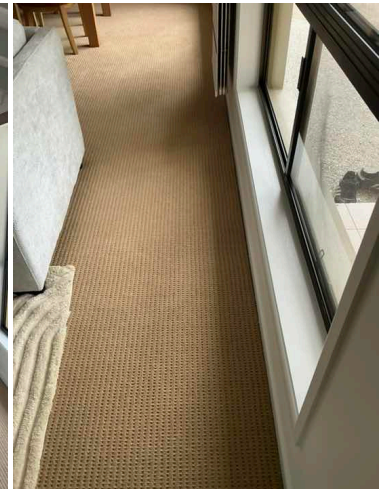
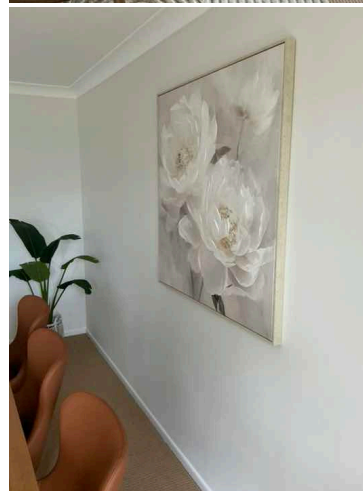
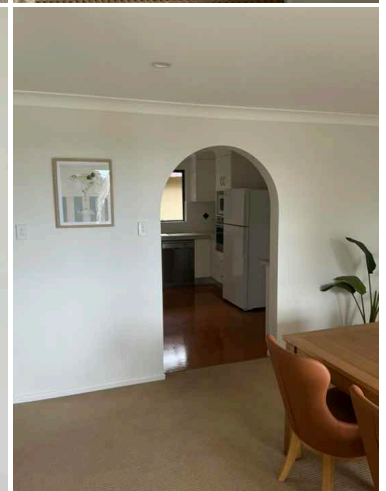
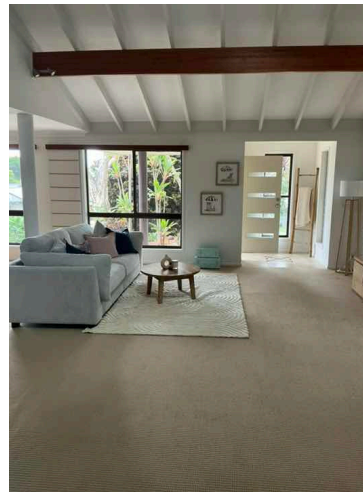
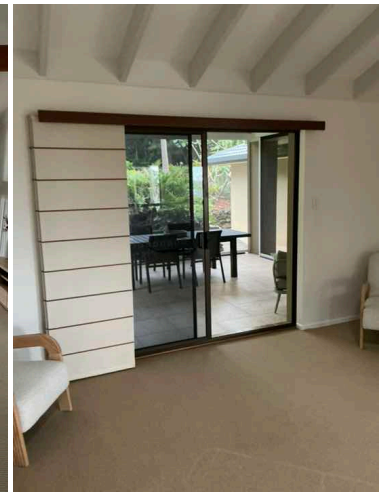
## Combined Living & Dining

From the visible and accessible areas, this room appears to be in a serviceable condition for the age of the property with no notable structural defects sighted.

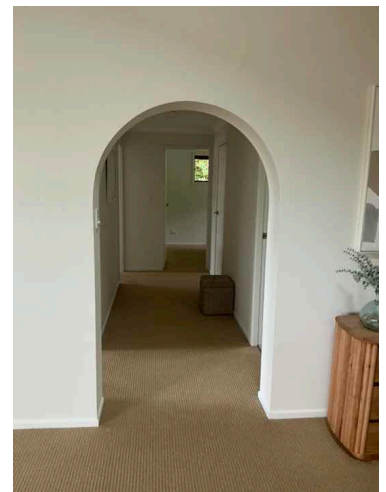
## Hallway/s

From the visible and accessible areas, the hallways/ appears to be in a serviceable condition for the age of the property with no notable structural defects sighted.

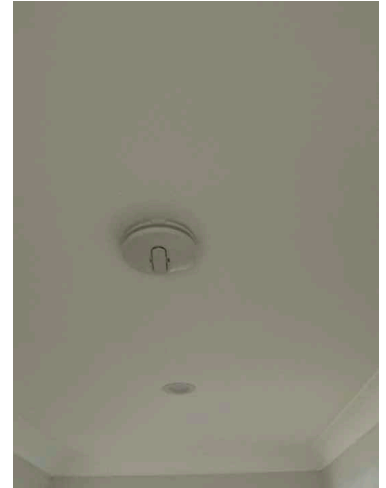
Yes a smoke alarm was sighted but not tested.

Legislation requires smoke Alarms to be installed. Check with your local council regarding type, locations and other related requirements.

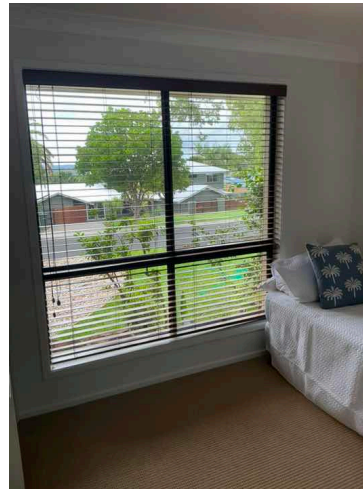
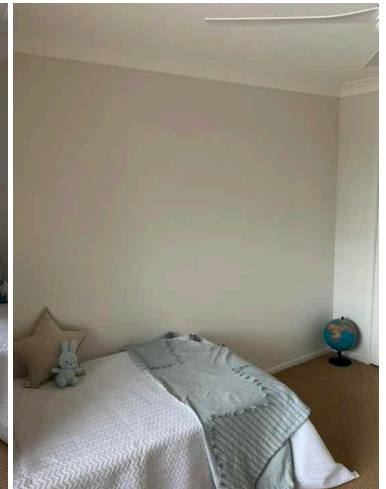
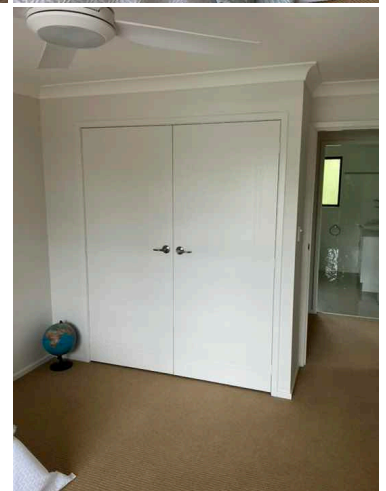
## **Bedroom 1**

From the visible and accessible areas, this bedroom appears to be in a serviceable condition for the age of the property with no notable structural defects sighted.

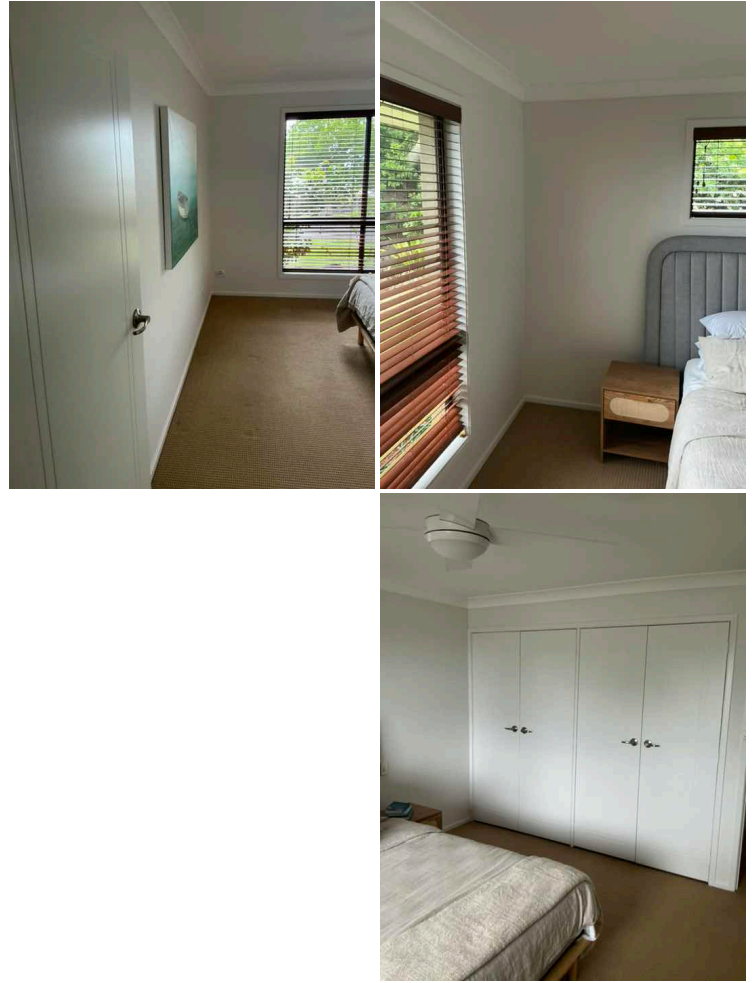
## **Bedroom 2**

From the visible and accessible areas, this bedroom appears to be in a serviceable condition for the age of the property with no notable structural defects sighted.

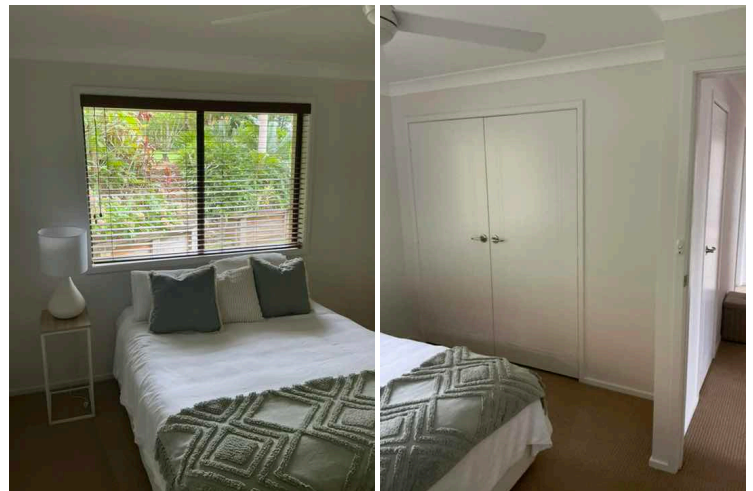
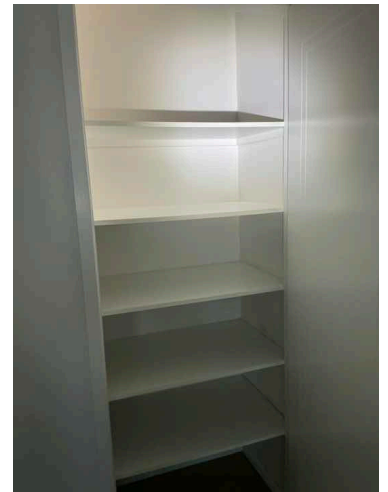
## **Bedroom 3**

From the visible and accessible areas, this bedroom appears to be in a serviceable condition for the age of the property with no notable structural defects sighted.

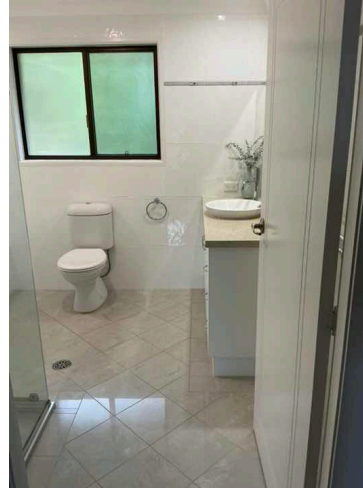
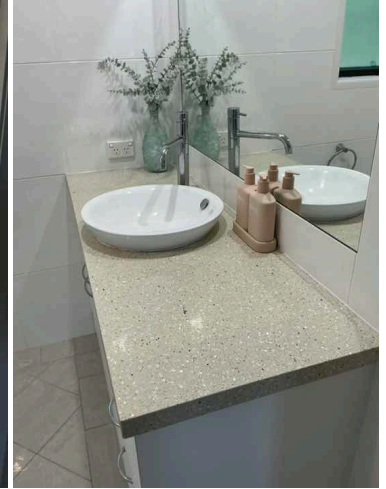
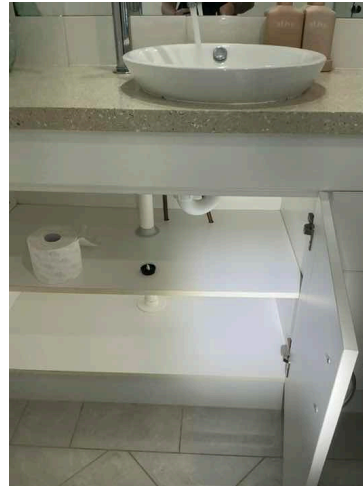
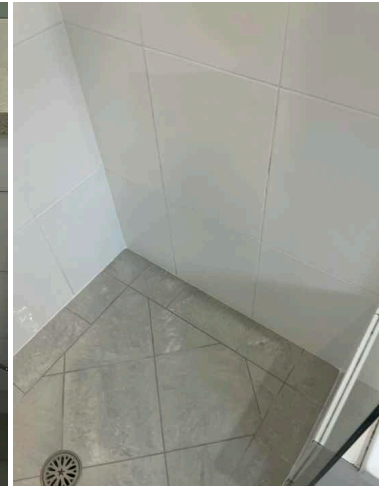
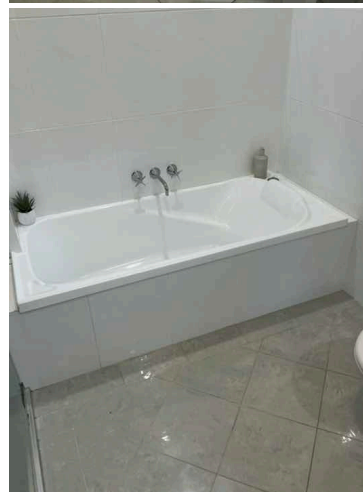
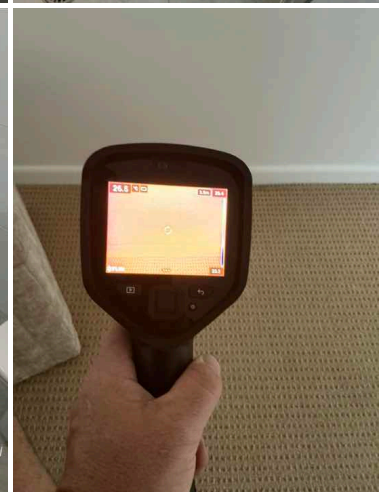
Of the visible areas, the general condition of this bathroom is serviceable or in reasonable condition for age of dwelling.

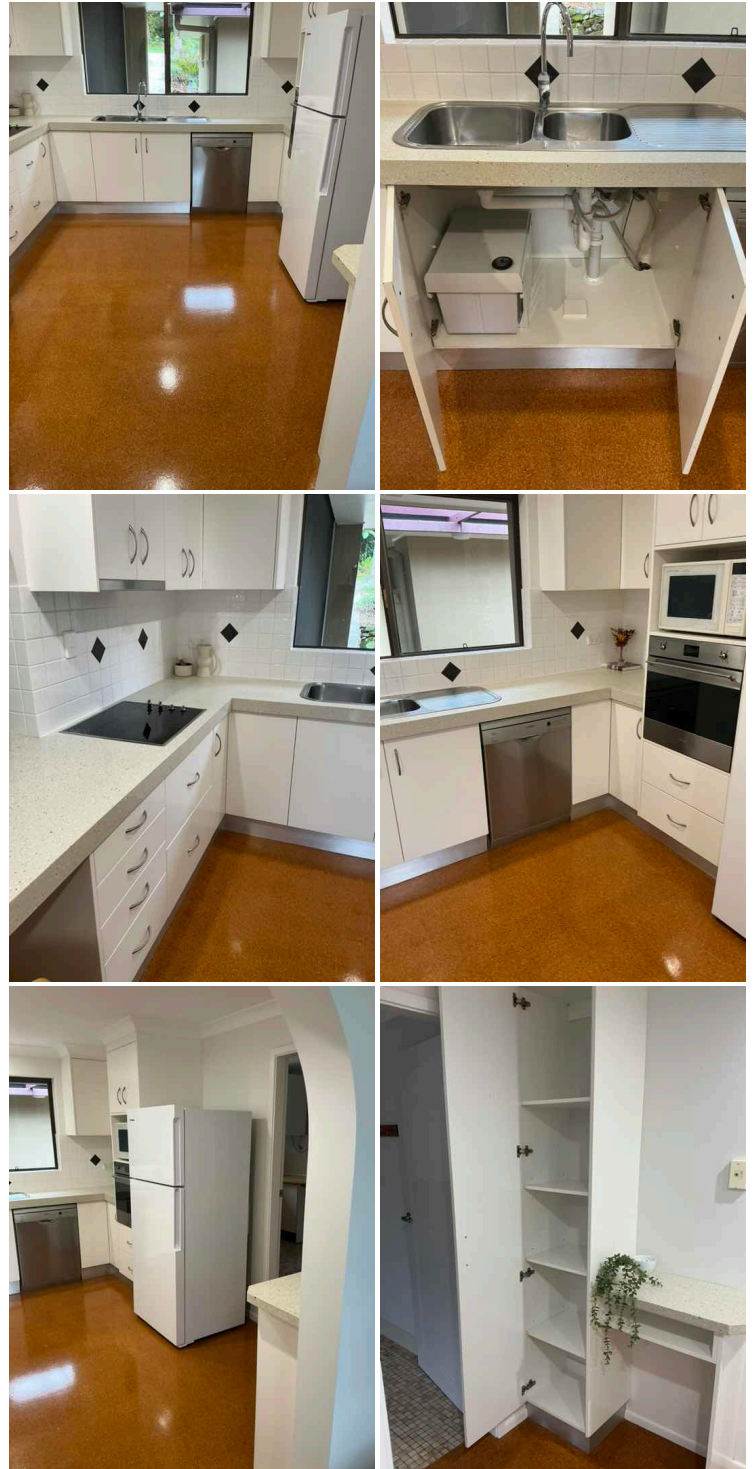
Of the visible areas, the general condition of the kitchen and pantry is serviceable or in reasonable condition for age of dwelling.

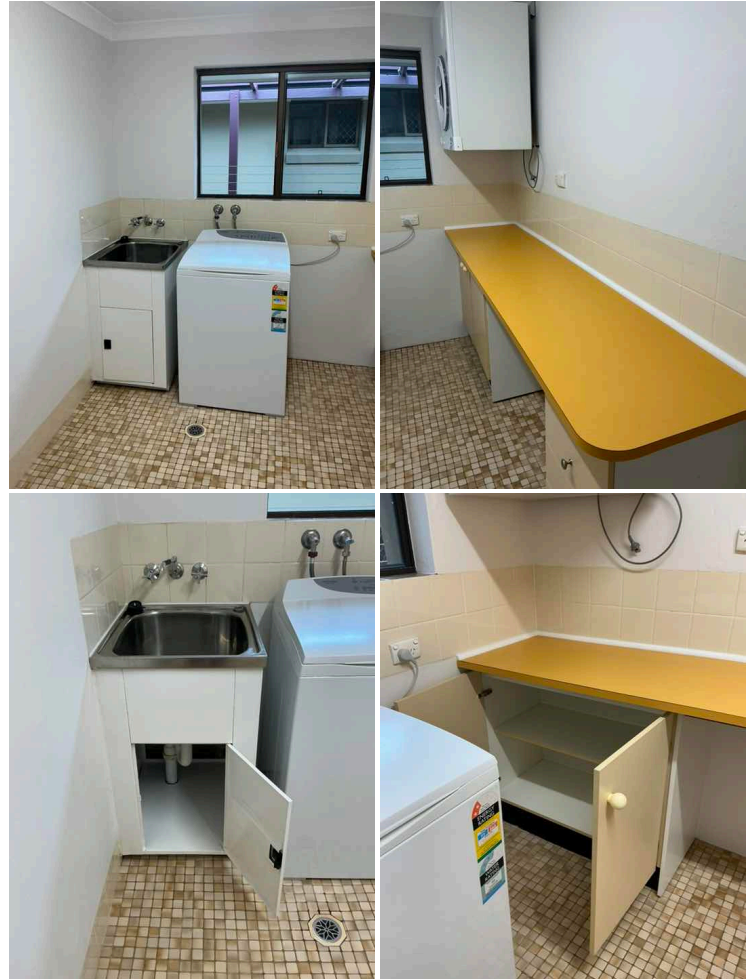
Of the visible areas, the general condition of the laundry is serviceable or in reasonable condition for age of dwelling.

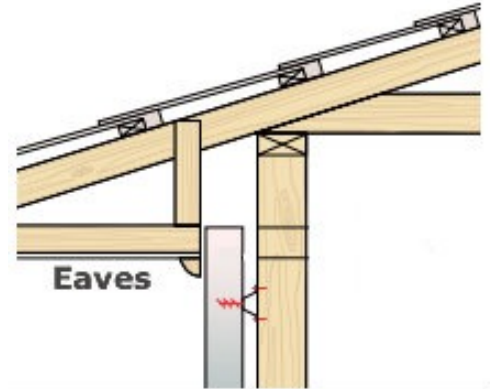
The soffit lining (eaves) are in a serviceable condition with no notable defects.

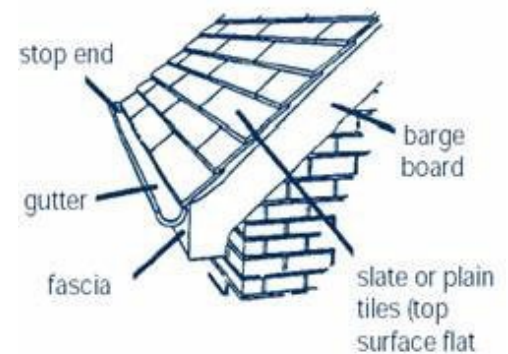
On visual inspection, the general condition of the fascia/barge boards is serviceable.

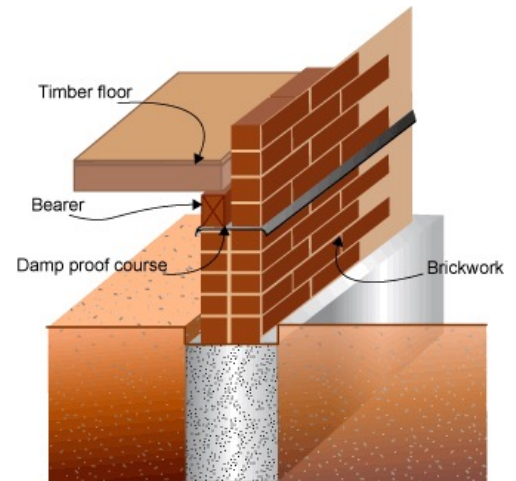
A damp proof course (DPC) was noted.

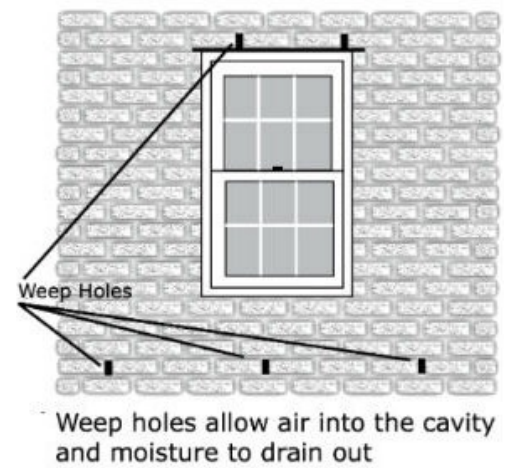
The weep holes are unobstructed .

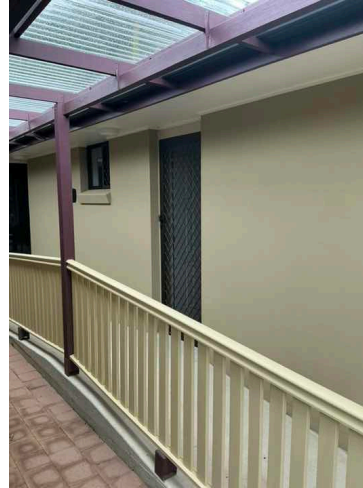
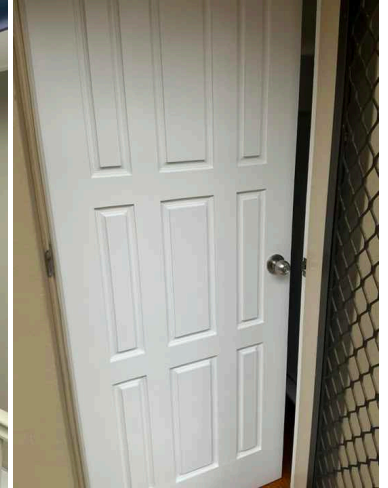
The doors are in serviceable condition with no notable defects observed.

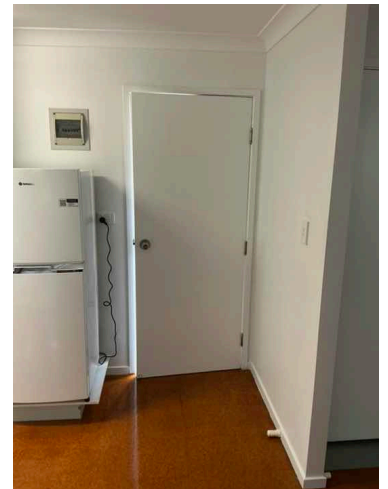
From the visible and accessible areas, this area appears to be in a serviceable condition for the age of the property with no notable structural defects sighted.

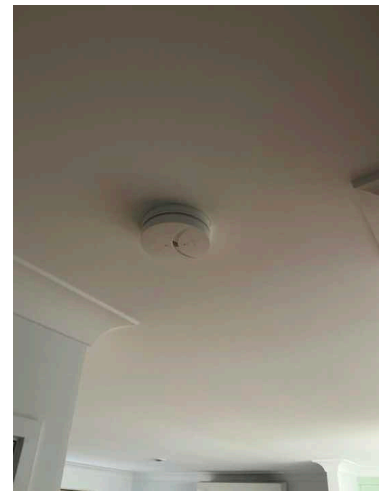
Yes a smoke alarm was sighted but not tested.

Legislation requires smoke Alarms to be installed. Check with your local council regarding type, locations and other related requirements.

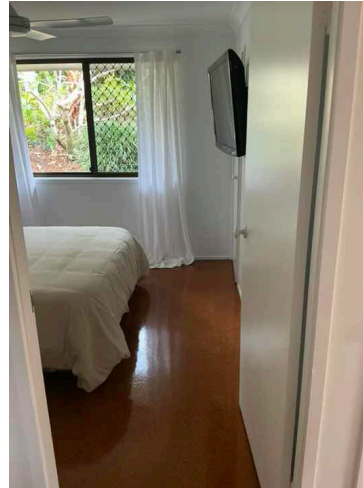
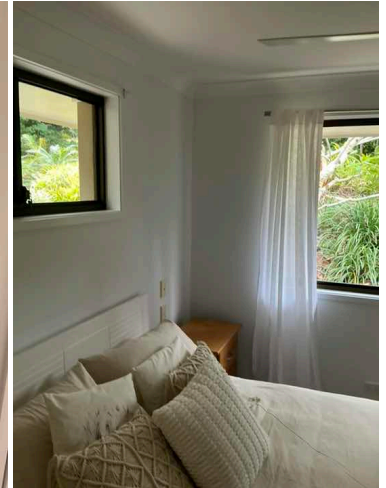
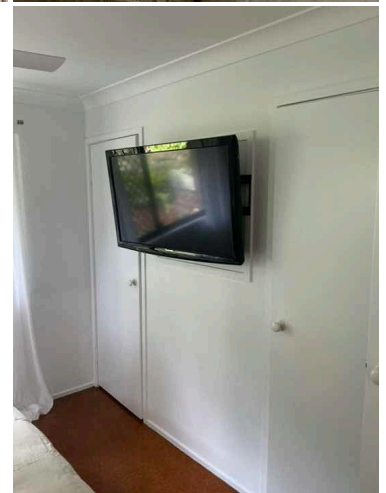
## **Bedroom 1**

From the visible and accessible areas, this bedroom appears to be in a serviceable condition for the age of the property with no notable structural defects sighted.

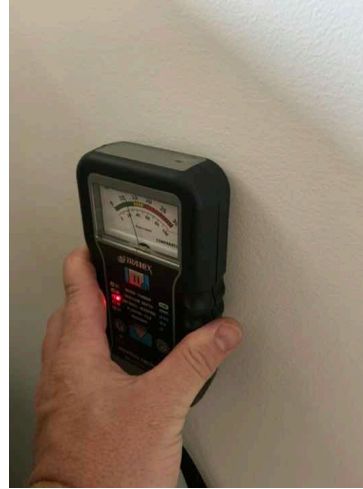
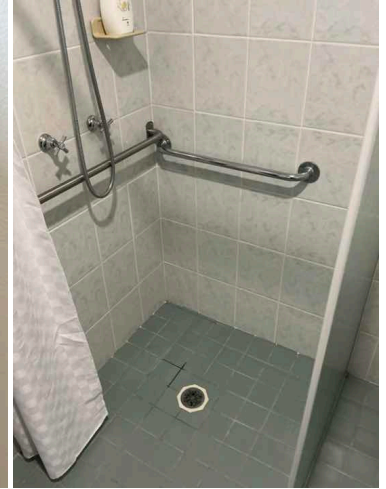
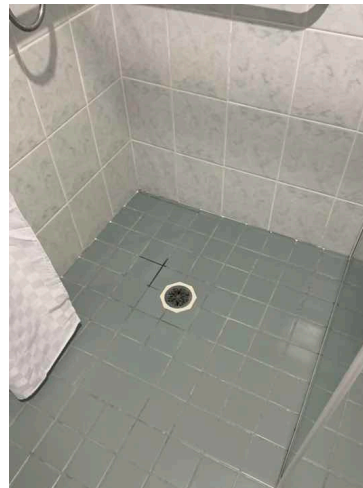
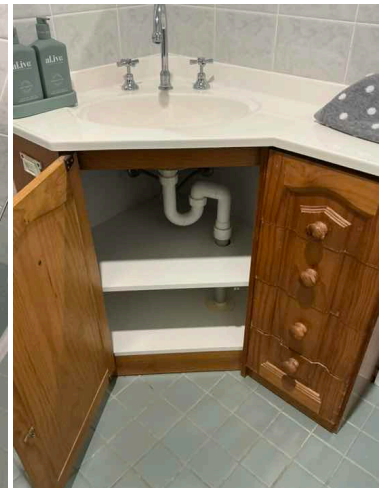
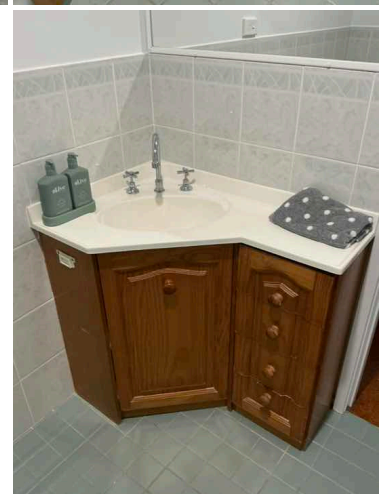
Of the visible areas, the general condition of this bathroom is serviceable or in reasonable condition for age of dwelling.

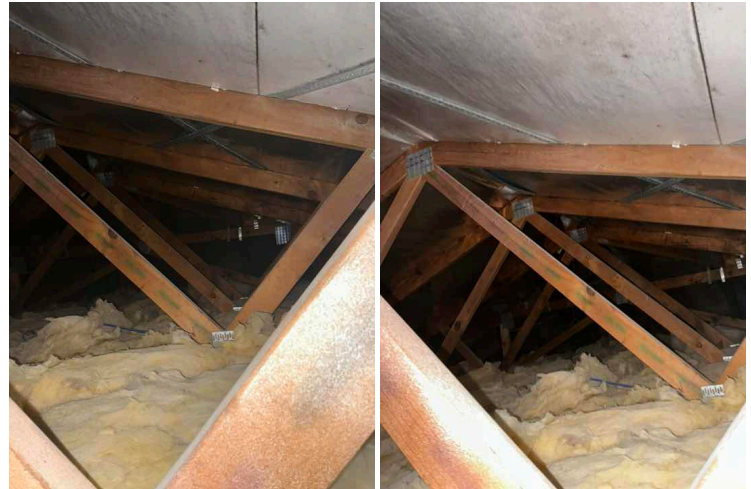
Visible sections of the roof void is in a serviceable condition for age of this dwelling.

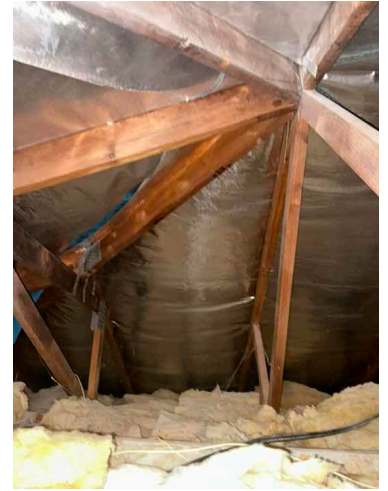
Where visible and accessible, the insulation appears to be in a serviceable condition.
