# PEST AND BUILDING PRE-PURCHASE REPORTS

# Inspection Report

**141 North Creek Rd , Lennox Head, NSW, 2478**

| Report/Agreement # | 100924025635423 |

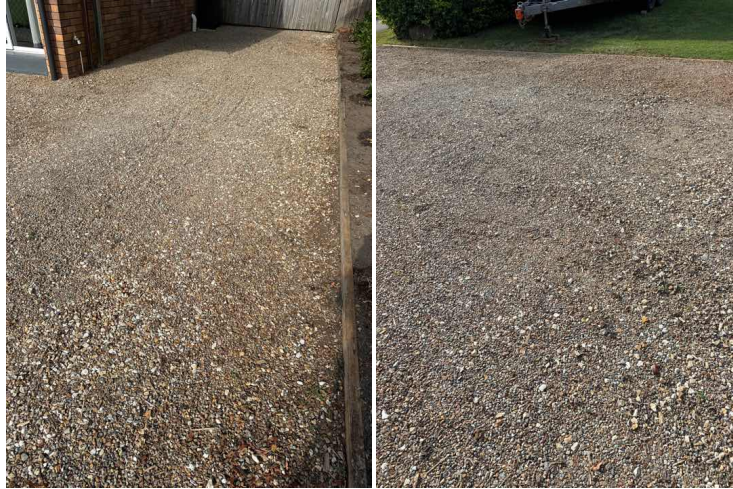
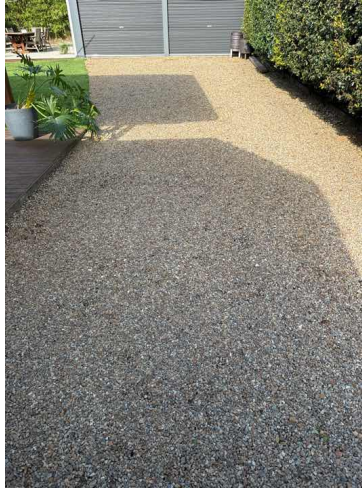
#### **Driveway Condition**

On visual inspection, the general condition of the driveway is serviceable.

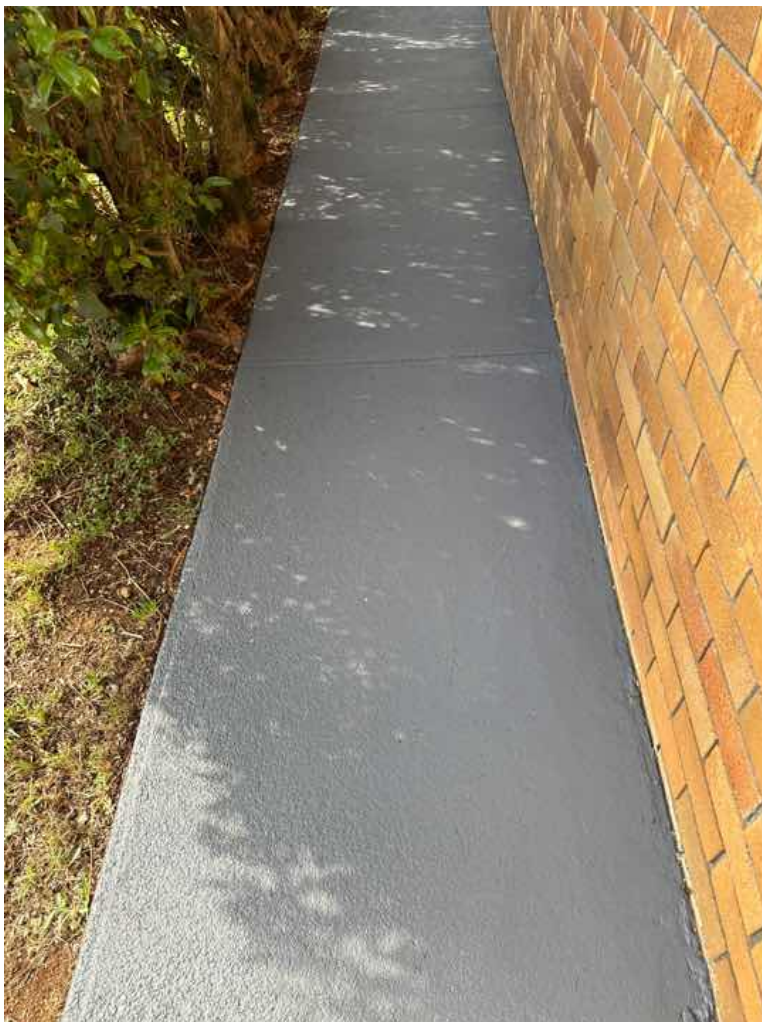
#### **Pathways Condition**

The paths around the home are in a serviceable condition for the age of this dwelling with no major defects visible.

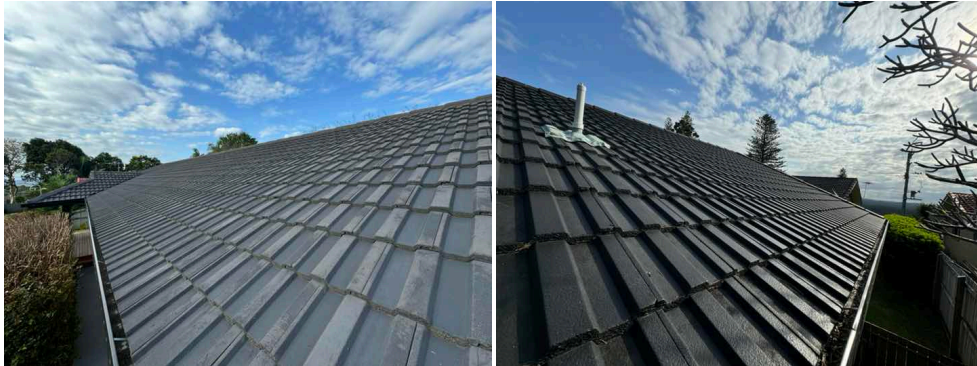
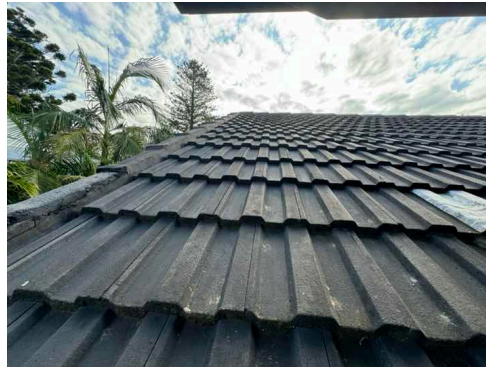
#### Overall Condition

Of the visible areas, the general condition of the roof is in serviceable condition for the age.

Note: In the absence of rainfall there is no guarantee that the roof won't leak.

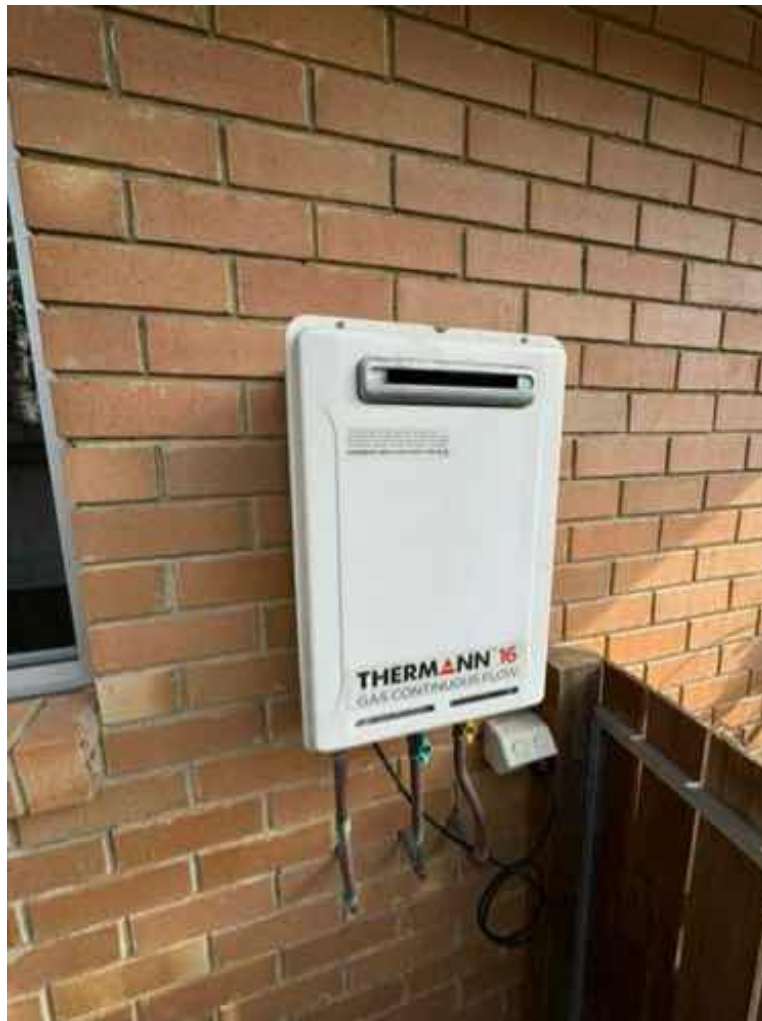
#### System Make

Thermann

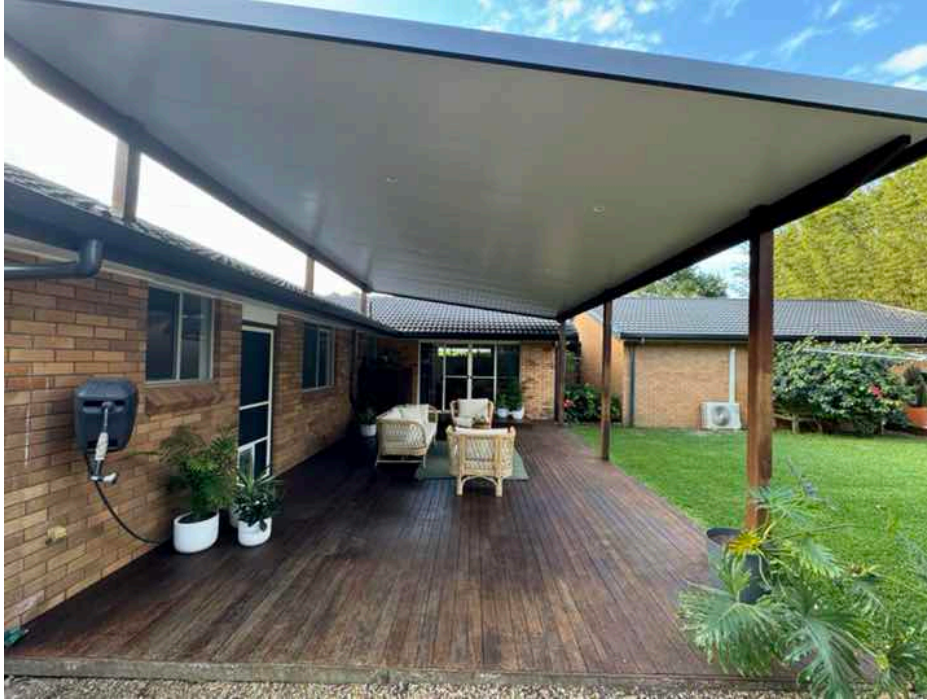
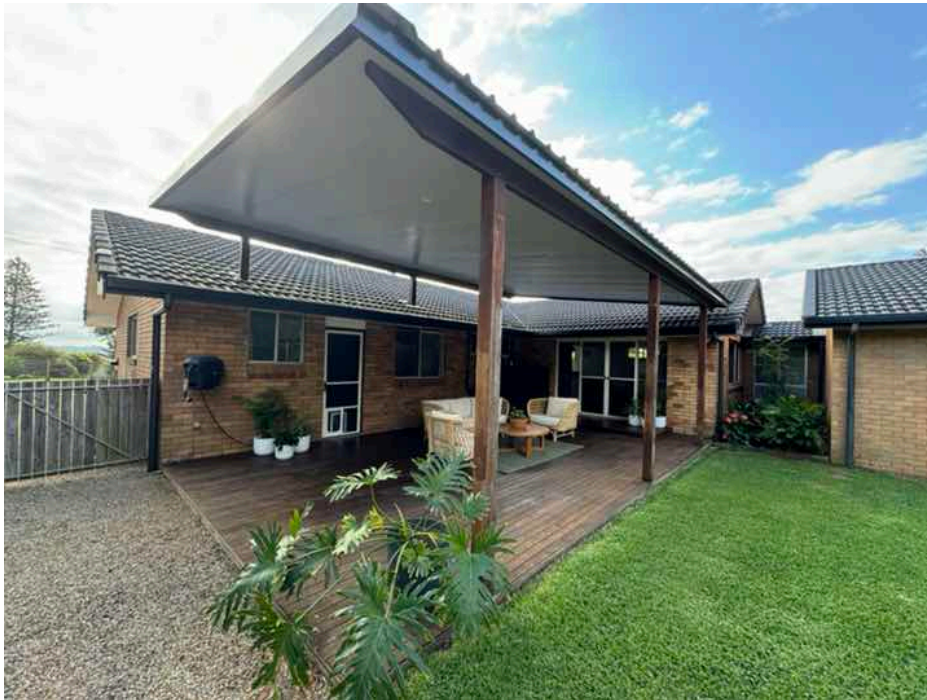
#### Overall Condition

Visible sections of the Alfresco area are serviceable or in reasonable or condition for the age of this dwelling.

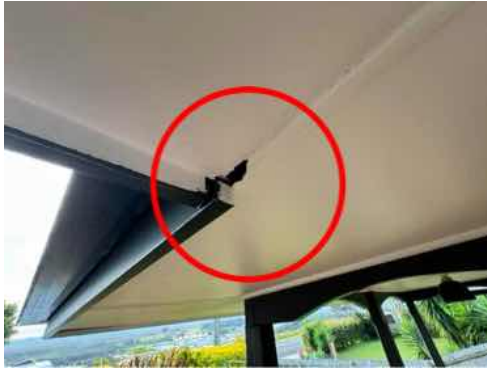
#### Eave Condition

Eave lining damage visible. Recommendations: A qualified carpenter should be engaged for repairs.

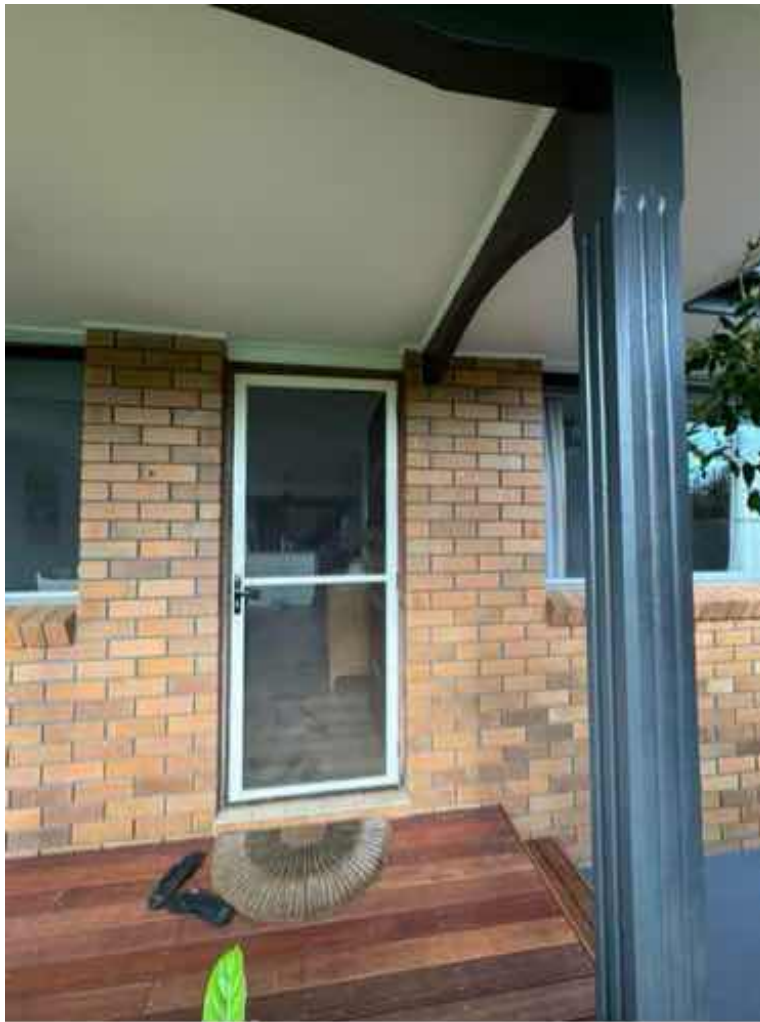
## **Entry Porch Area**

The entry porch serviceable or in reasonable or condition for the age of this dwelling.

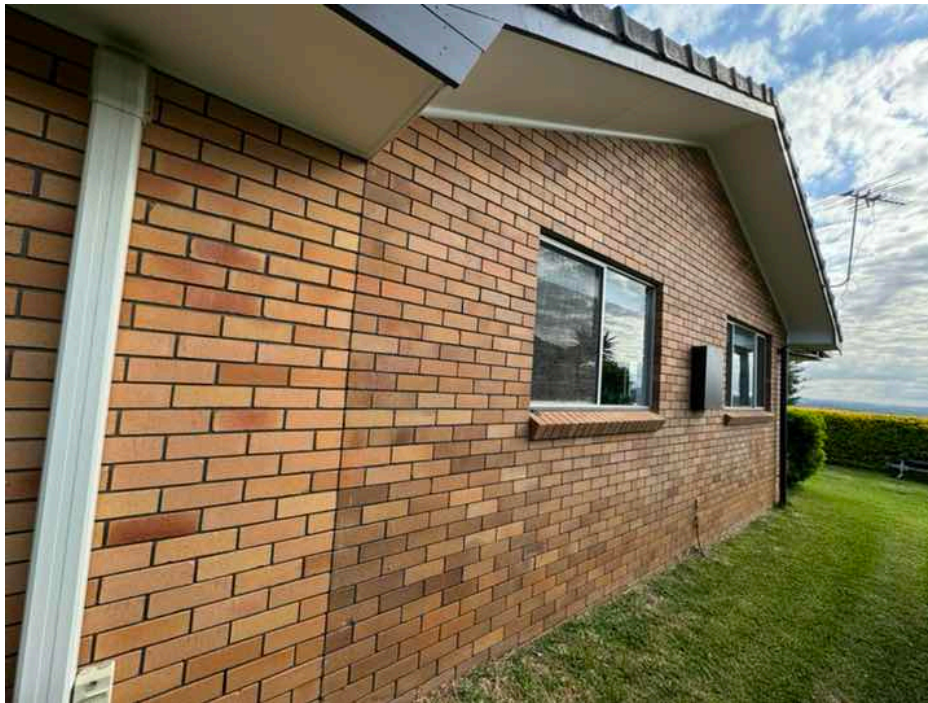
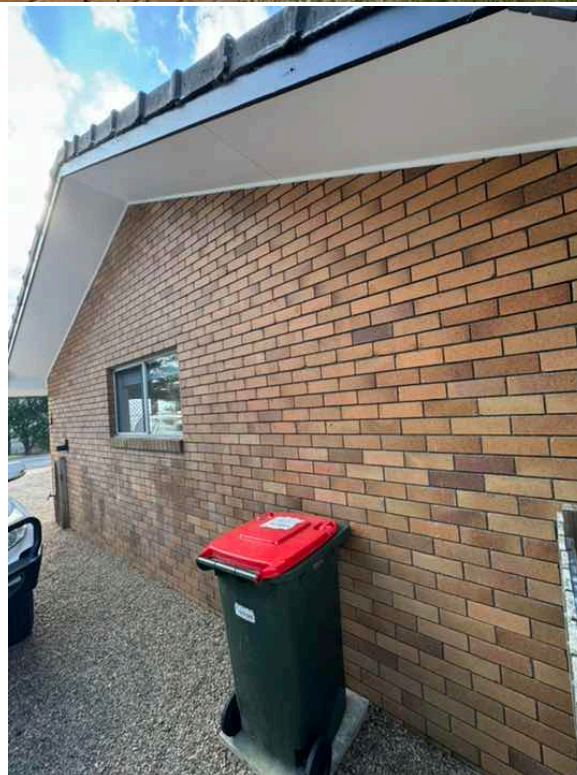
On visual inspection, the general condition of the exterior walls is serviceable for the age.

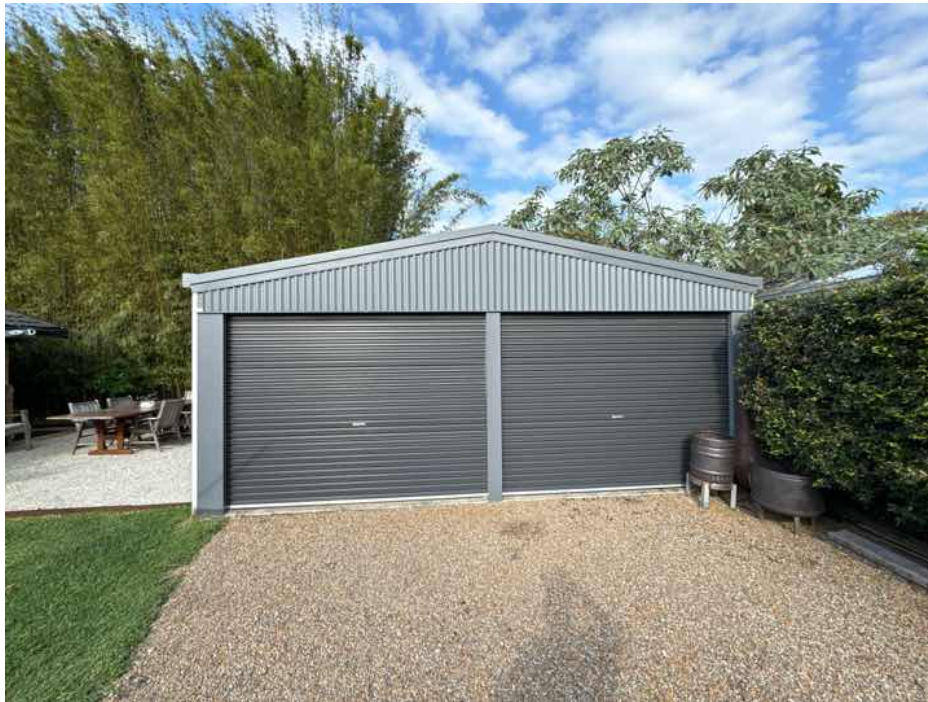
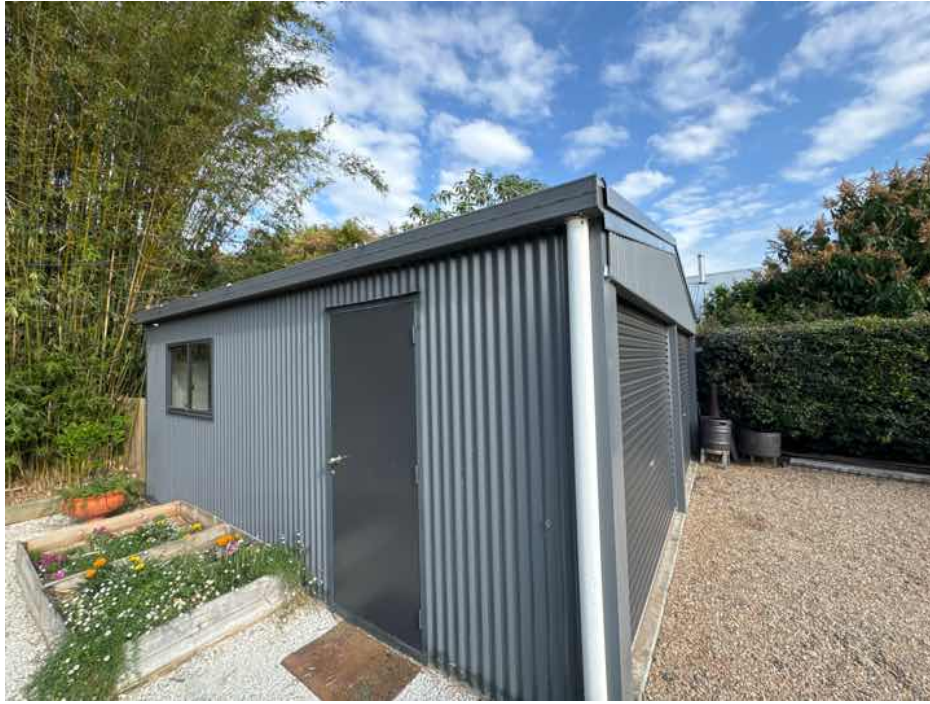
From the visible and accessible areas, the garage appears to be in a serviceable condition for the age of the property with no notable structural defects sighted.

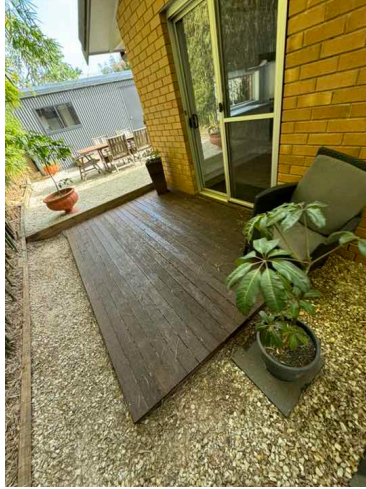
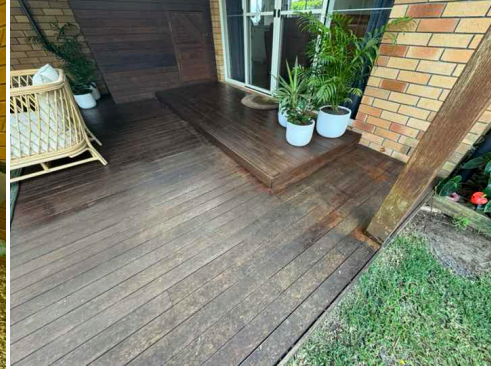
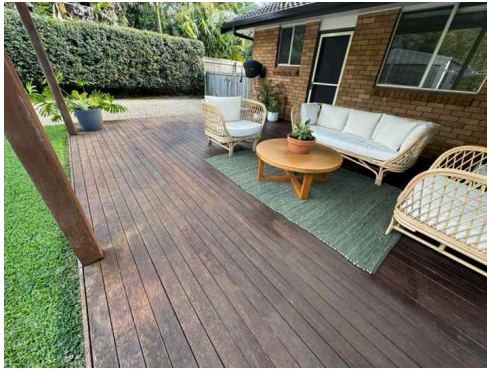
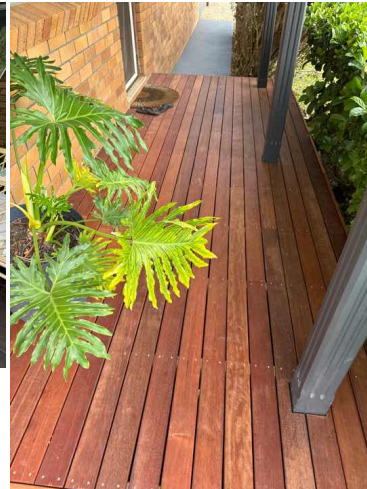
Of areas visible, the decking appears to be in a serviceable condition.

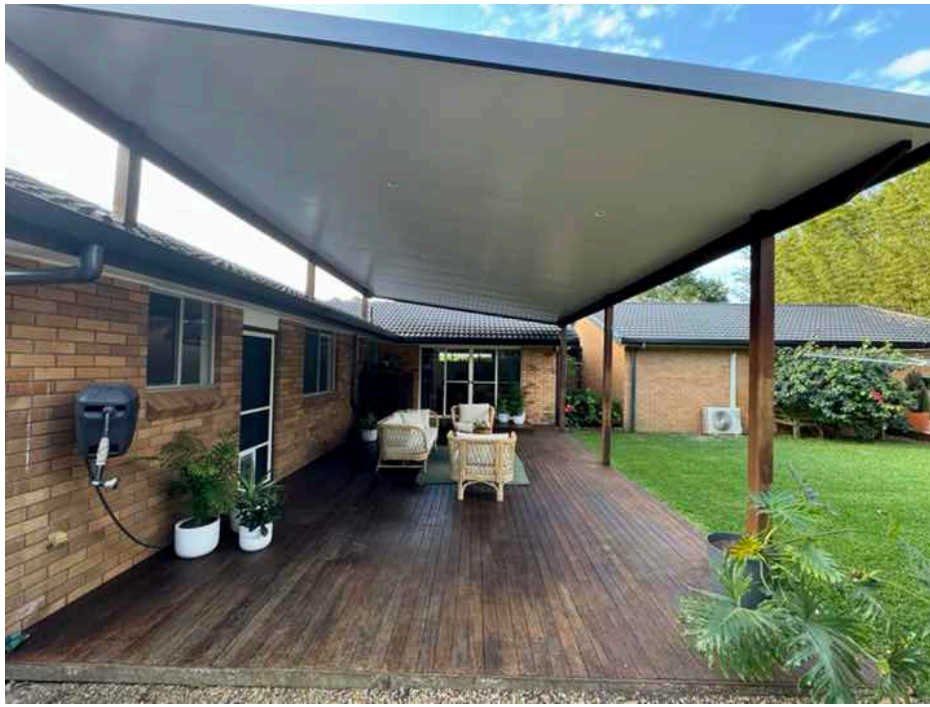
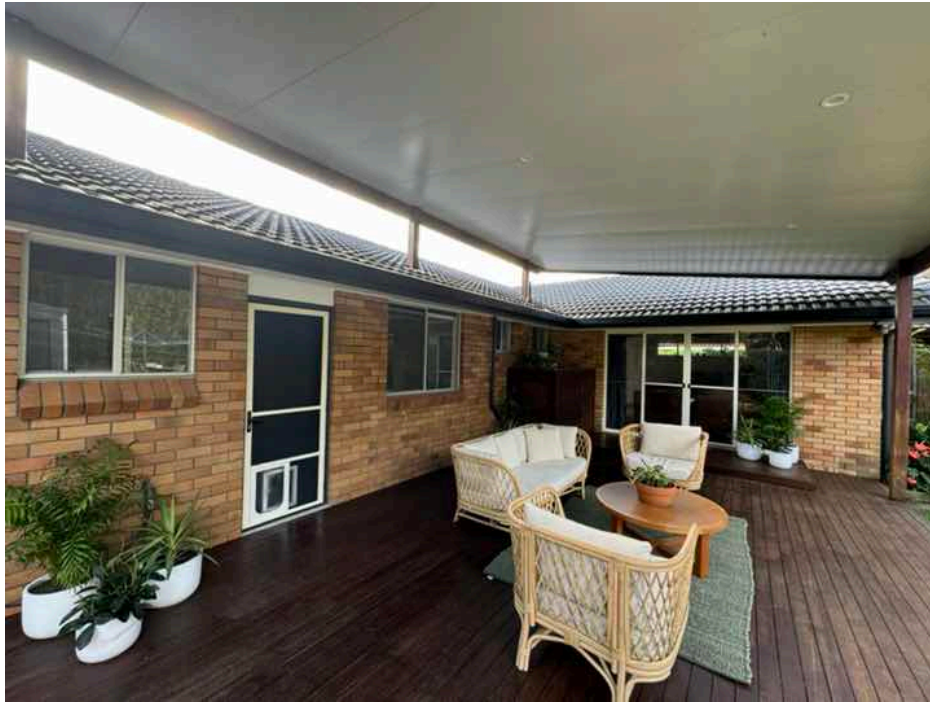
### Pergola Findings

The Pergola is in a serviceable condition with no notable defects sighted.

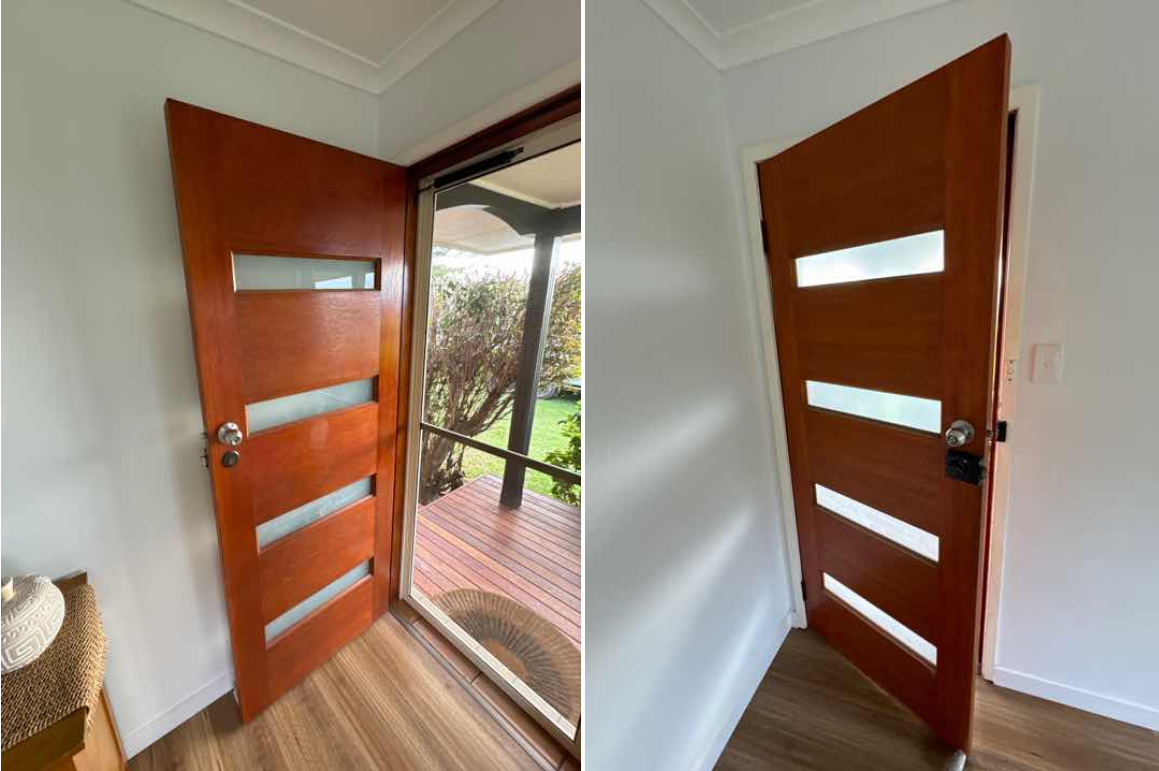
#### **Front Entry Doors**

The doors are in serviceable condition with no notable defects observed.

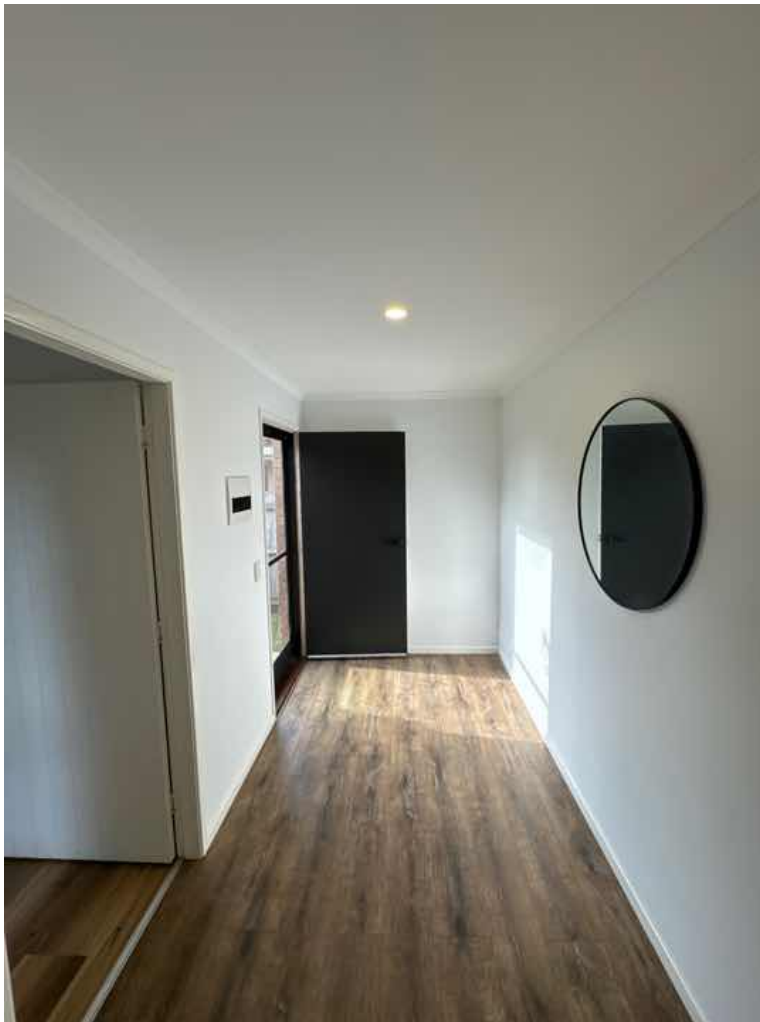
**Entry Foyer(1)**

From the visible and accessible areas, this area appears to be in a serviceable condition for the age of the property with no notable structural defects sighted.

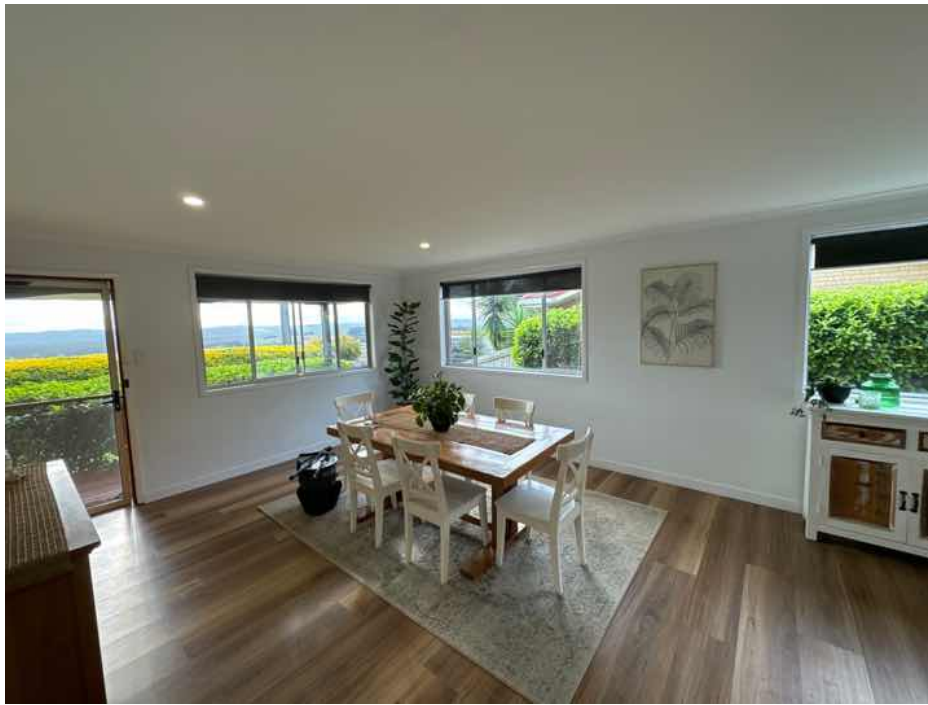
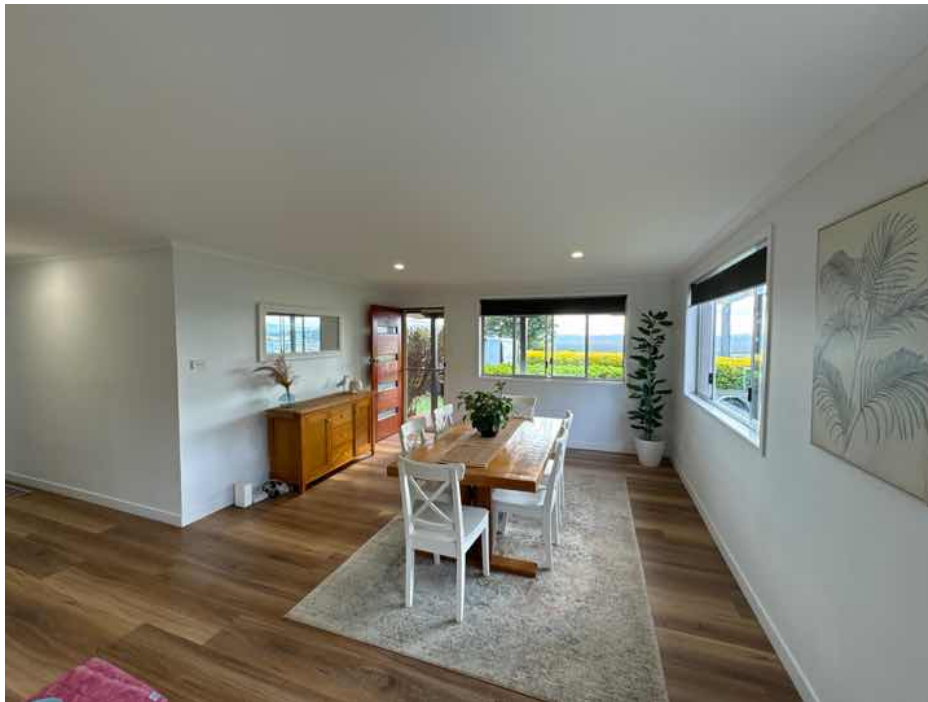
## **Dining Room**

From the visible and accessible areas, this room appears to be in a serviceable condition for the age of the property with no notable structural defects sighted.

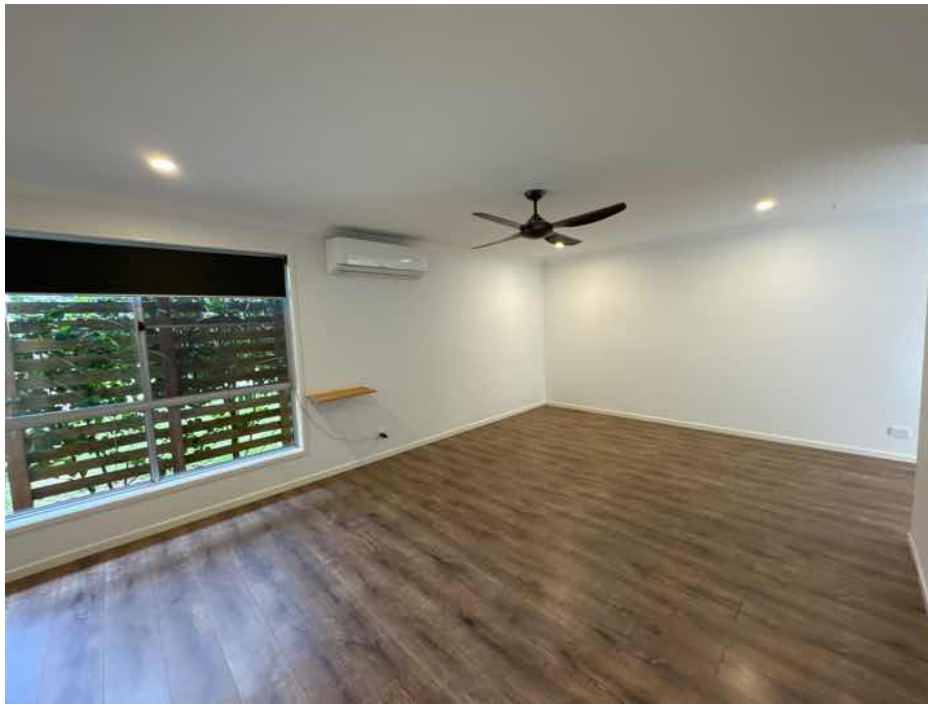
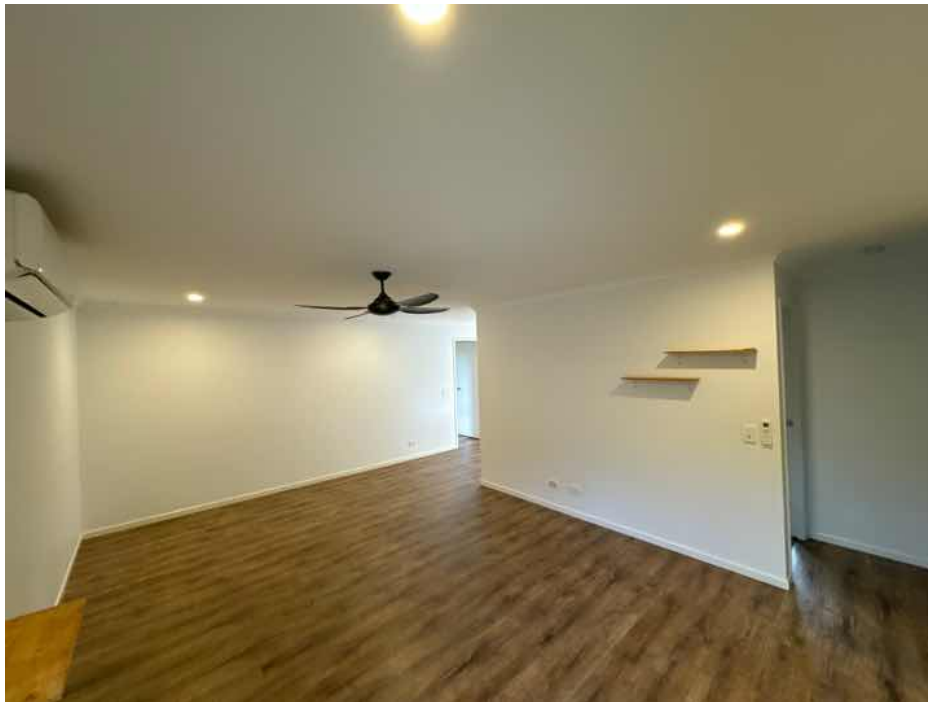
**Combined Living & Dining (granny flat)**

From the visible and accessible areas, this room appears to be in a serviceable condition for the age of the property with no notable structural defects sighted.

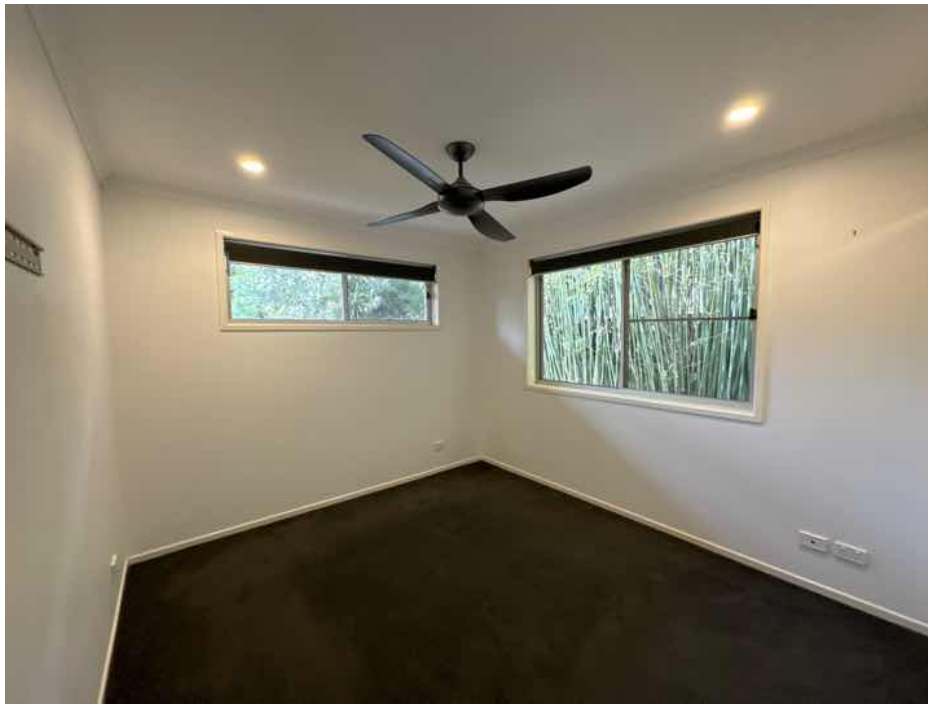
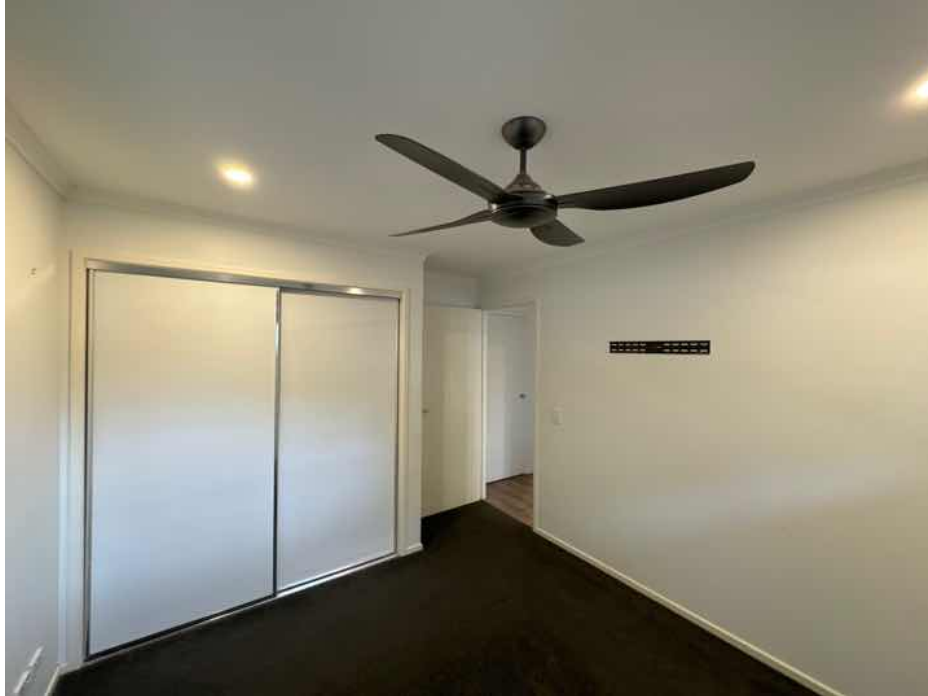
## **Bedroom 2**

From the visible and accessible areas, this bedroom appears to be in a serviceable condition for the age of the property with no notable structural defects sighted.

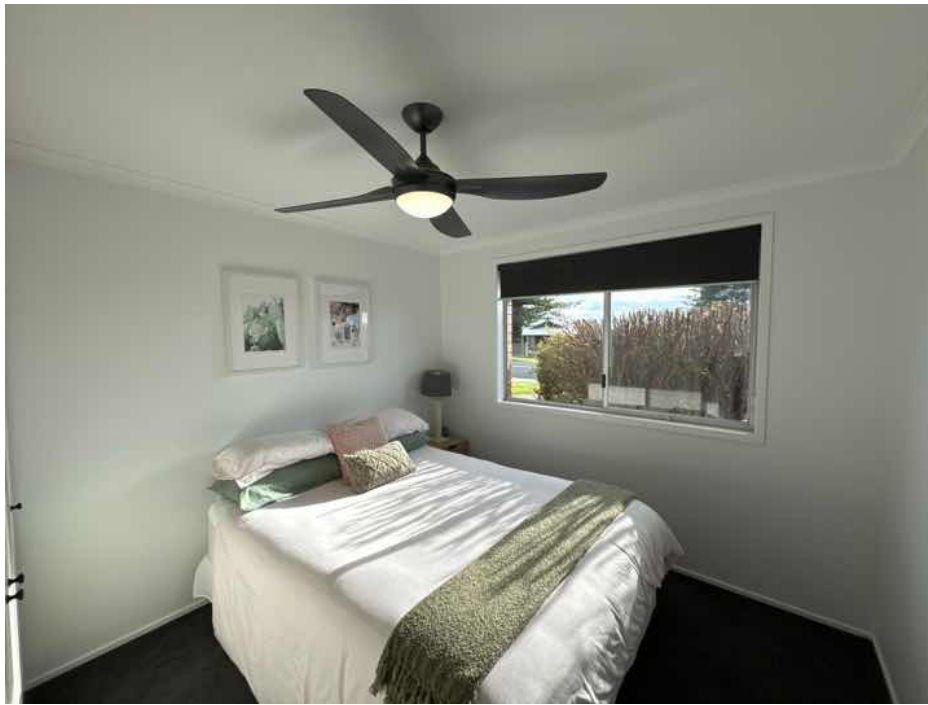
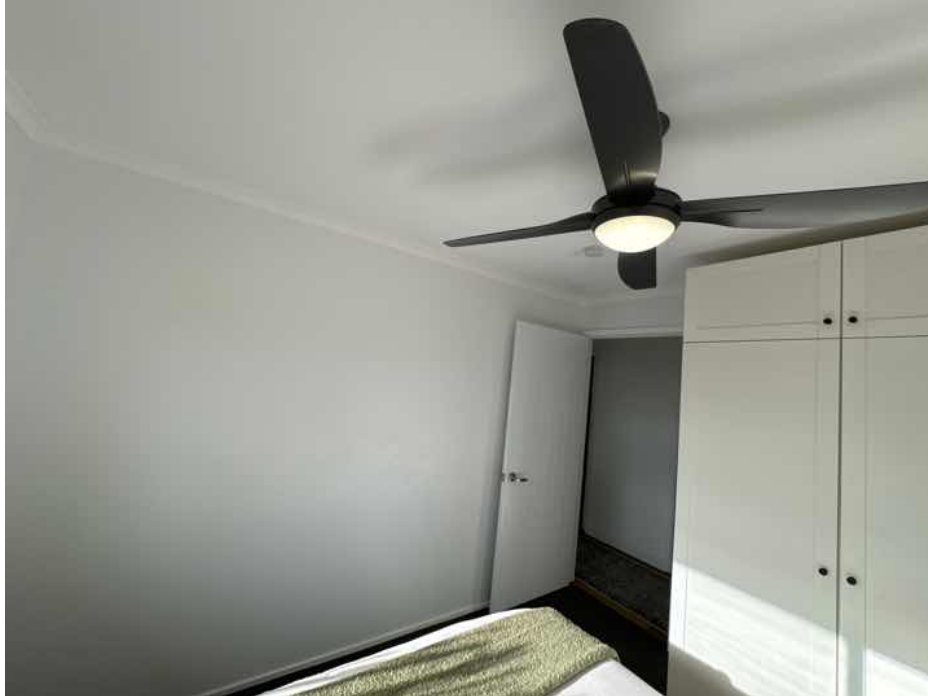
### **Ceiling**

Ceiling stains - No moisture readings obtained. These may have been repaired however you will need to monitor after a prolonged period of rainfall. If leaking persists, a qualified plumber should be engaged for advice and recommendations. All water damaged plaster should be replaced.

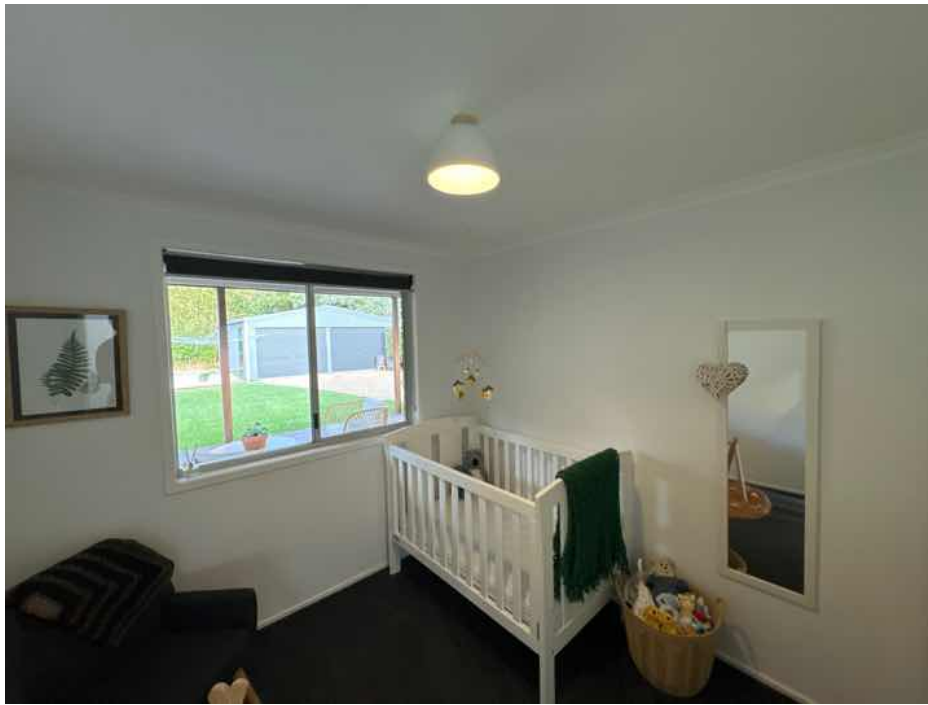
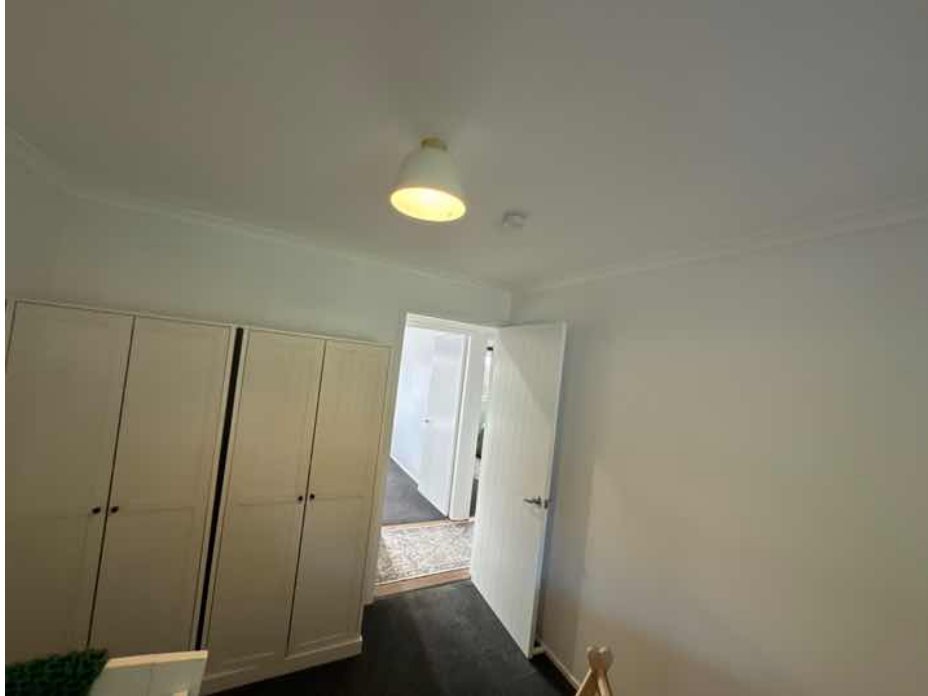
## Ceiling

Incomplete patch/paint repairs noted. I recommend you contact a qualified painter for repairs.

Ceiling stains - No moisture readings obtained. These may have been repaired however you will need to monitor after a prolonged period of rainfall. If leaking persists, a qualified plumber should be engaged for advice and recommendations. All water damaged plaster should be replaced.

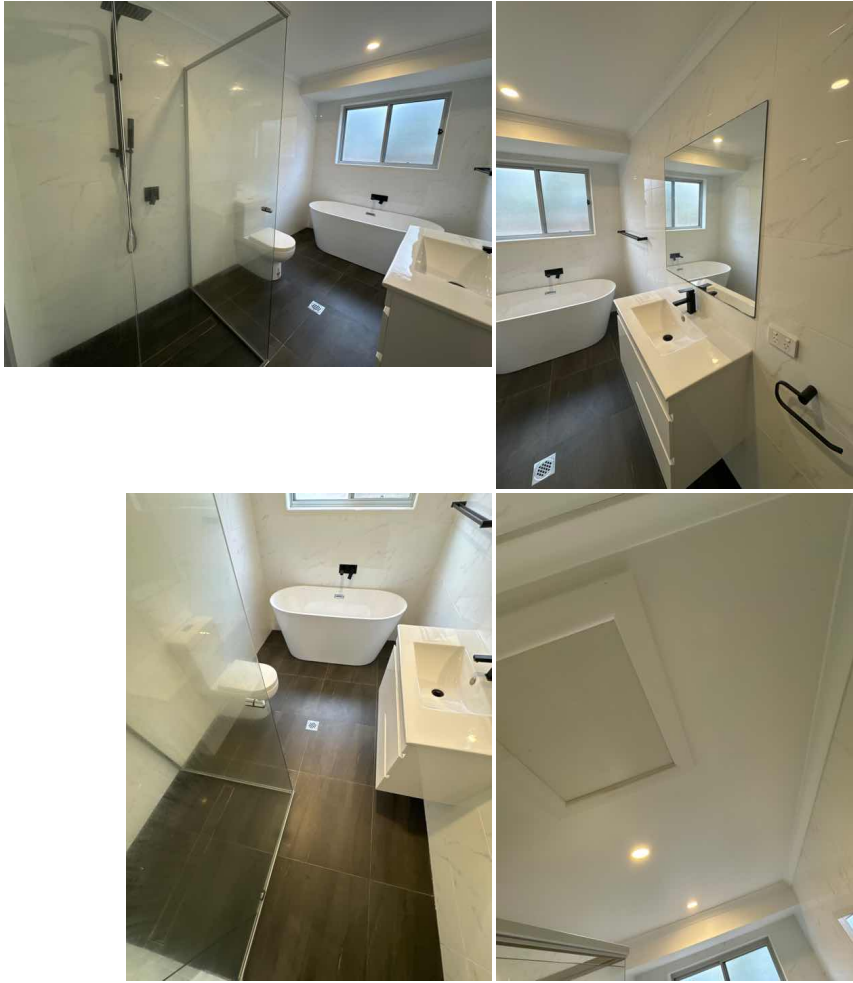
**Vanity/Sink/Taps**

The vanity mirror is desilvering at edges. Replacement recommended.

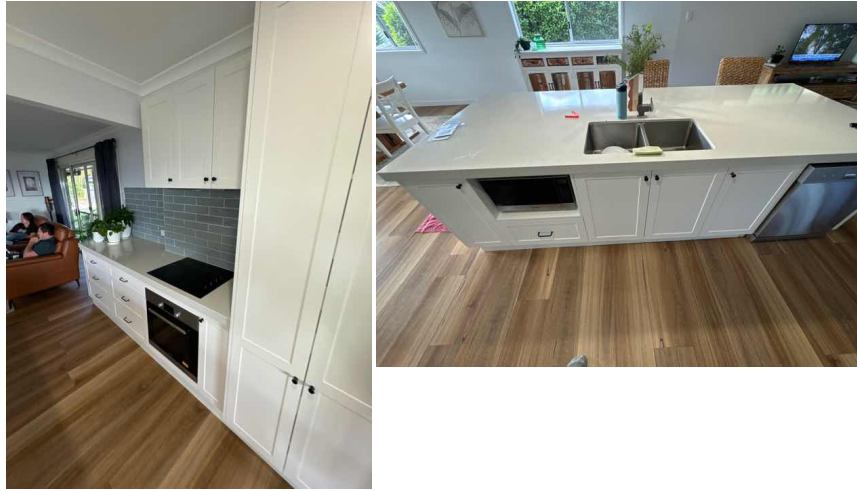
### **Cupboards And Bench Tops**

These components appear to be in a serviceable condition

Adjustment to cabinet doors required, in some instance hinges may need to be replaced.

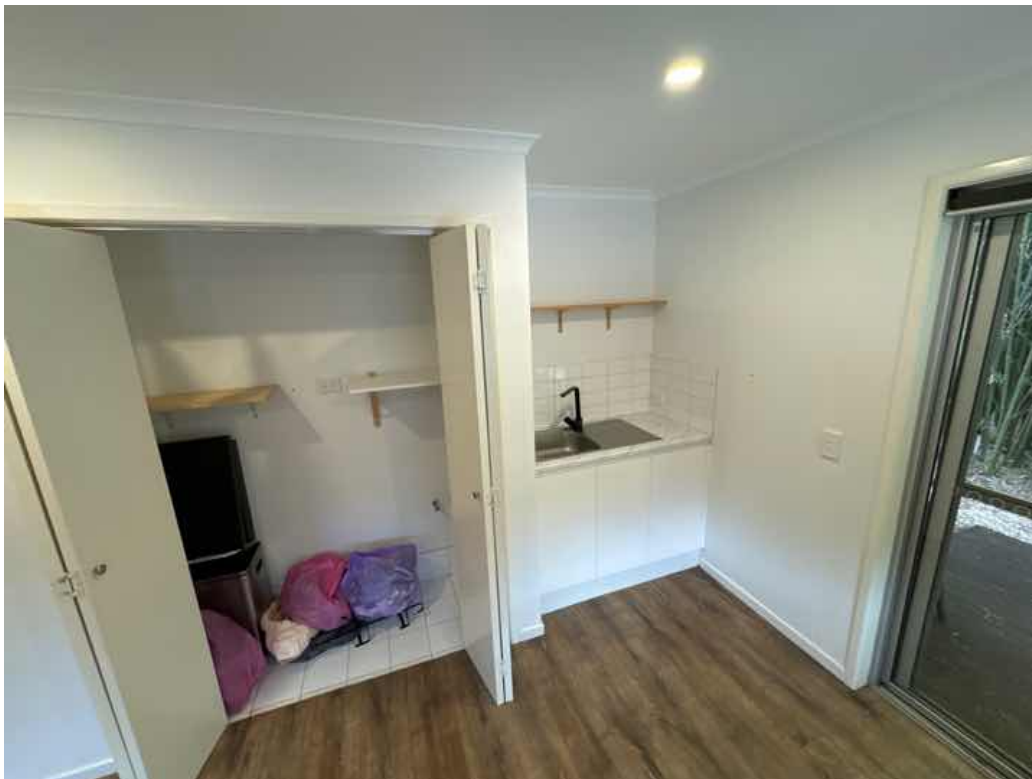
**Walls**

Incomplete Patch/Paint repairs noted. Call a licensed painter for repairs
