# Property Inspection Report

**94 Tanamera Drive ,  
Alstonville , 2477, NSW**

**Date of Inspection: 6/8/2026 | Time: 8:45AM**

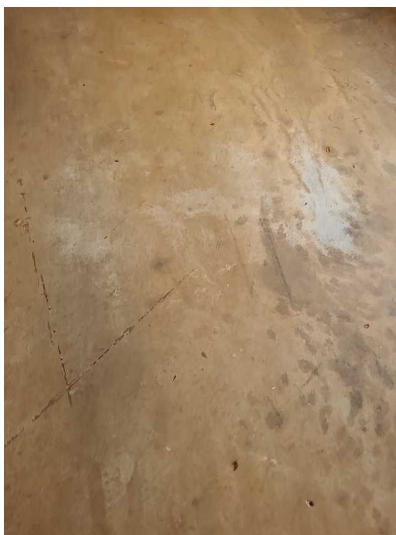
### 1. Slab Foundation

- Visible sections of the concrete slab appeared satisfactory.
- Most areas of the concrete slab not visible due to floor coverings.
- All concrete floor slabs experience some degree of cracking due to shrinkage in the drying process. In most instances floor coverings prevent recognition of cracks or settlement in all but the most severe cases. Where carpeting and other floor coverings are installed, the materials and condition of the flooring underneath cannot be determined.

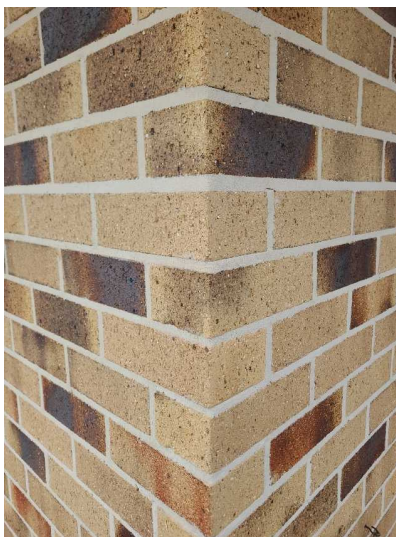
### 1. Wall Structure

- The wall structure components appeared functional.
- Externals walls are of a timber frame and brick veneer construction.

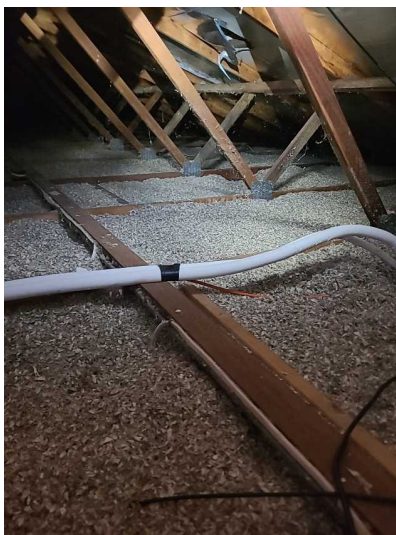
### 2. Ceiling Structure

- The ceiling structure appeared functional.
- Due to the placement of insulation on the top of the ceilings it is not possible to fully inspect the condition of the ceiling structure and supports. Inspection was limited and based on what was visually accessible at the time of the inspection.

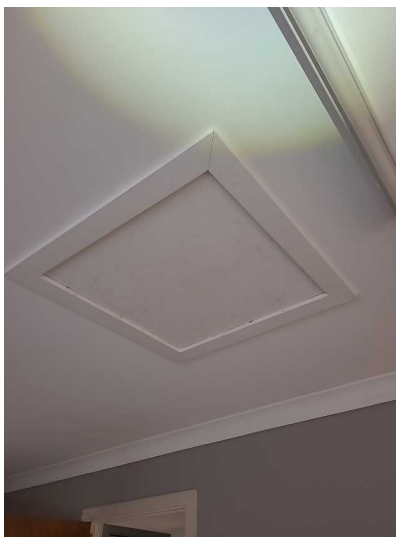
### 1. Access

- Access was available through a manhole in the garage.
- Could not access all areas of the roof space due to limited space.

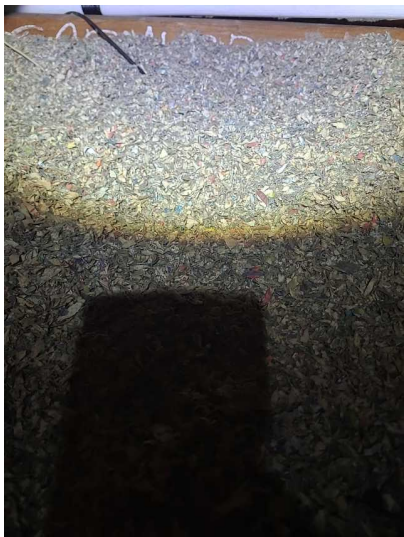
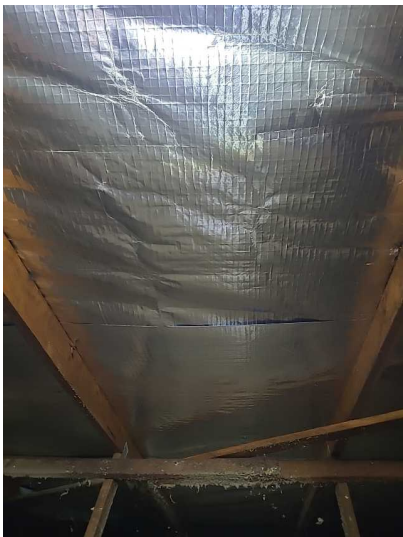
### 2. Insulation

- Insulation averages about 100mm to 125mm in depth.
- Insulation appears adequate.
- The sarking material appears in good condition.

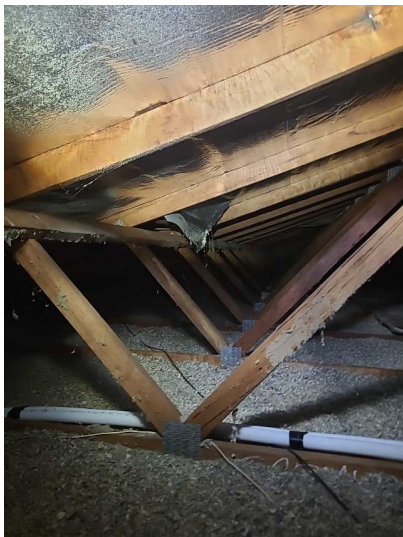
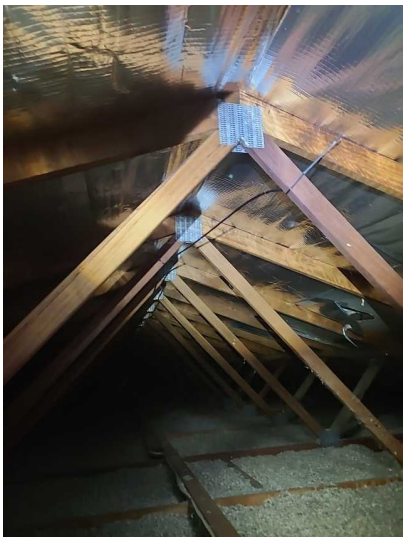
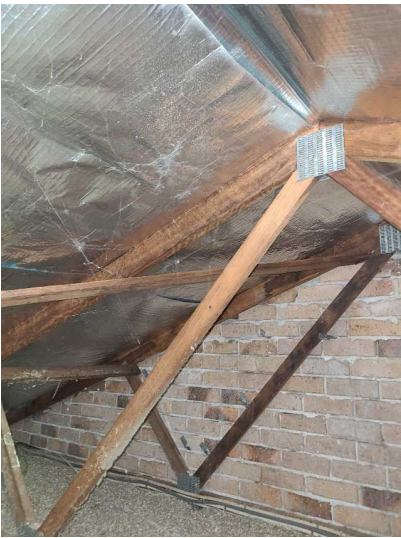
- The timber roof structure appears sound.

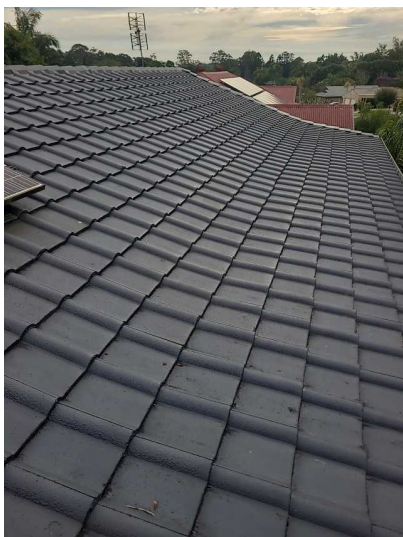
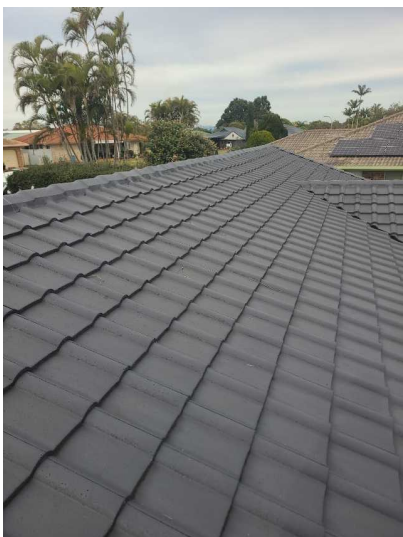
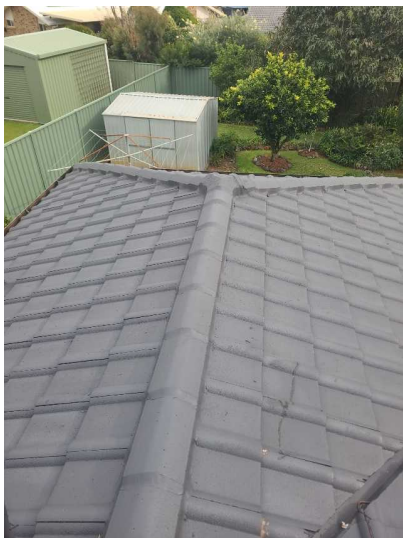
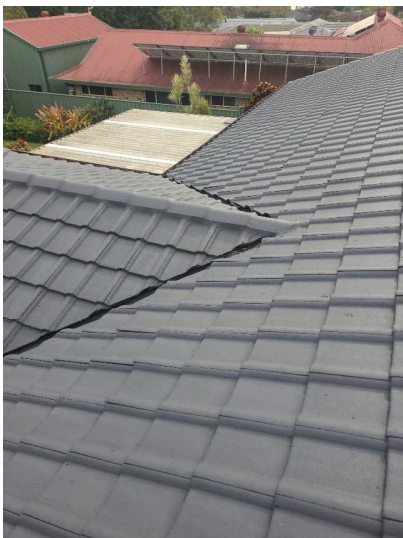
2. Roof Covering

- The concrete tile roofing material appeared to be in satisfactory condition other than noted.

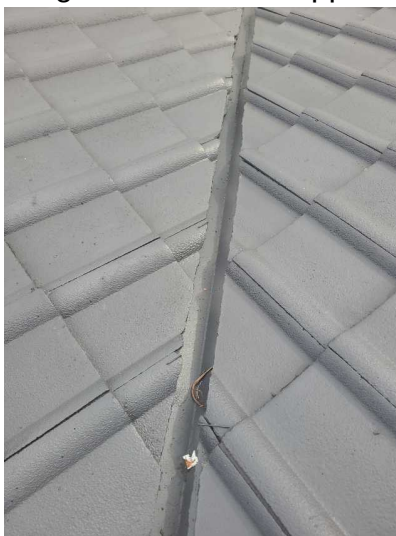
- Flashing is an impervious material (usually galvanized sheet metal) that comes in a variety of shapes and sizes and is used to cover, waterproof, and direct water away from roof penetrations and from valleys and intersections between the roof covering and other materials.
- The roof flashing, where visible, appears to be in satisfactory condition.

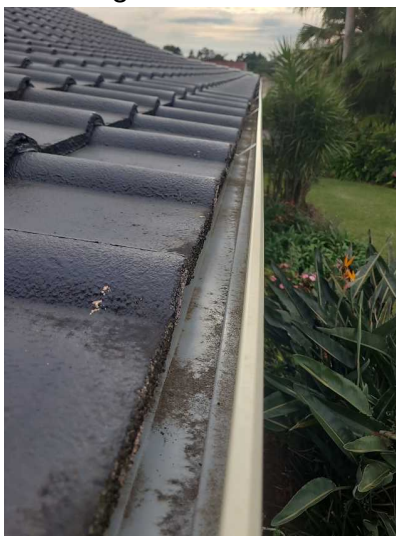
#### 5. Roof Drainage

- No major function concerns noted at the time of inspection.
- Consider installing a Gutter Guard or a similar product, to prevent the outlets from becoming blocked.

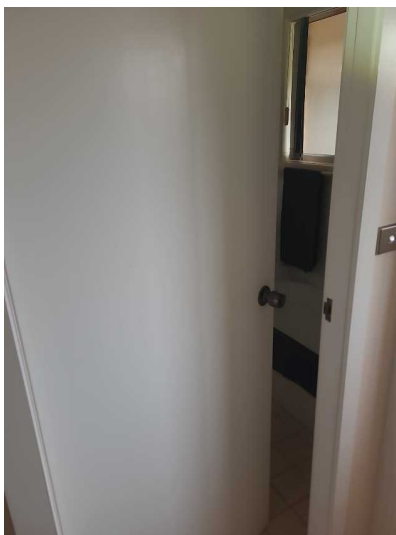
- The interior doors function satisfactorily.

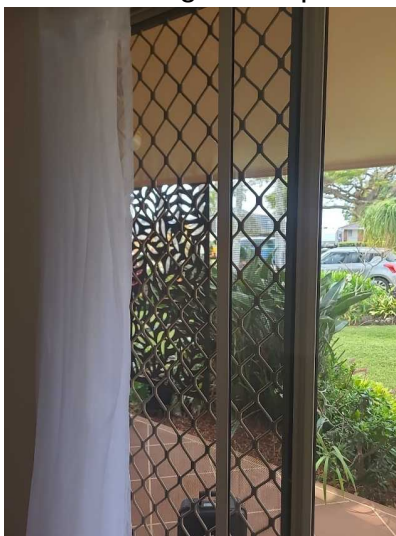
## 5. Window Condition

- Windows operated during the inspection appeared functional.

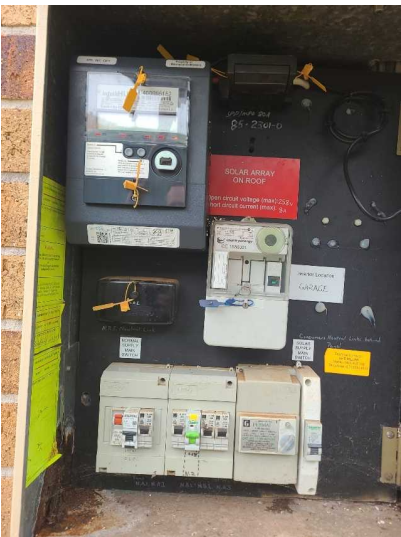
### 1. Electrical Panel

Observations: There are at least 2 RCD's installed which appear to protect both the power point and light circuits.

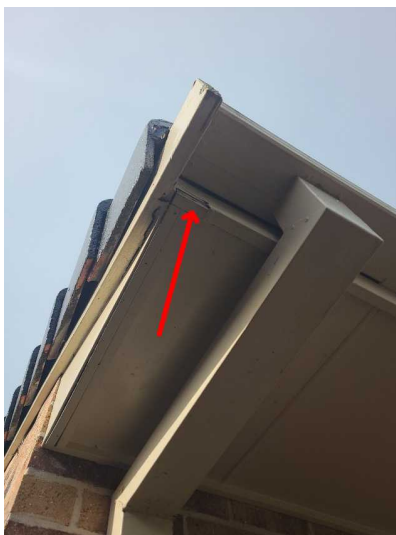
1. Eaves & Fascia

- Observations:
- The eaves are in satisfactory condition.
  - Moisture damage, wood decay, observed. Recommend review for repair as necessary.

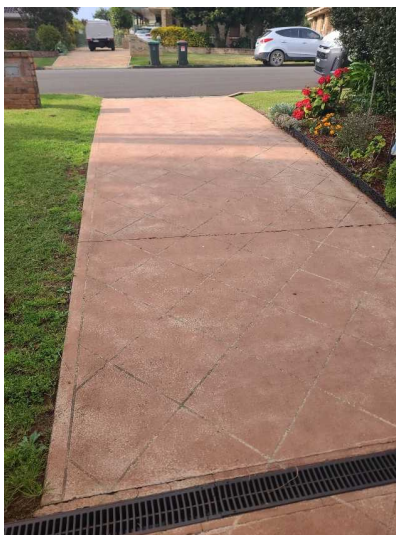
### 1. Driveway and Walkway Condition

- Concrete driveway noted.
- Driveway in reasonable shape for age and wear. No major deficiencies noted.

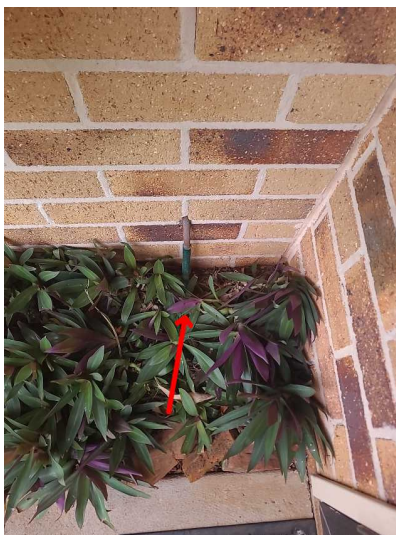
## 2. Grading and Drainage

- Surface drainage conditions within 3 metres of the inspected structure appeared satisfactory.
- There are no drains located beneath the outdoor taps. This can cause water pooling if the taps were to leak. Recommend drains be installed beneath the taps. Where this is not possible it is important to ensure taps are well maintained to prevent leaks.
- The hot water system overflow pipe discharges on the foundations. This should ideally be directed into the stormwater or at least 3 metres away from the building.

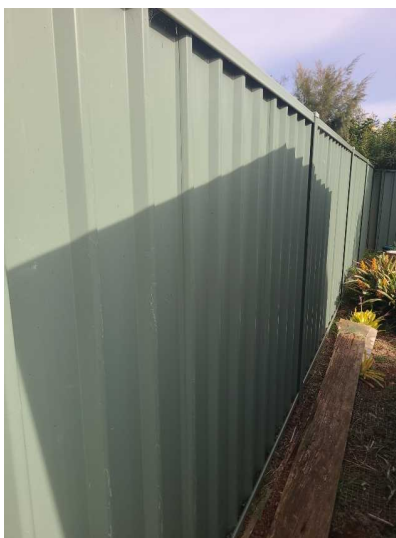
### 3. Fence Condition

- Metal.
- Unless otherwise noted, the perimeter fence appeared functional at the time of the inspection.

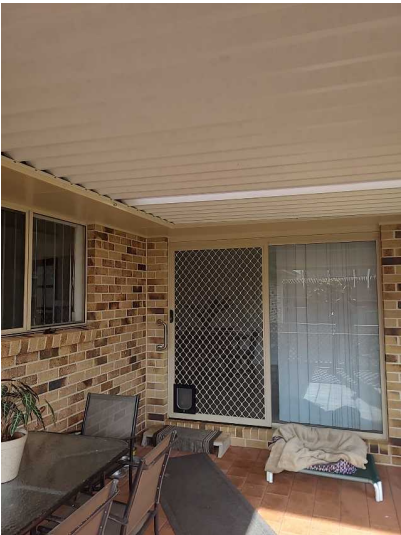
### 4. Patio & Pergola

- Patio appears in satisfactory and functional condition with normal wear for its age. Appears to be structurally sound.

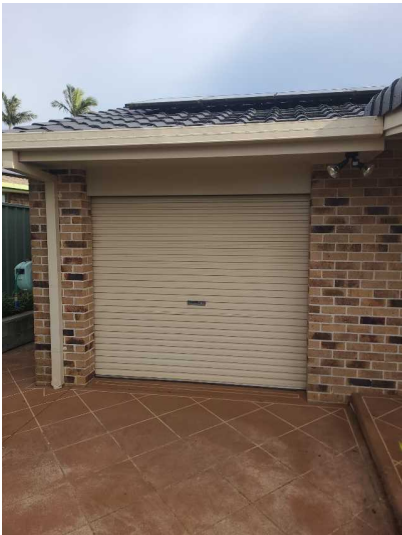
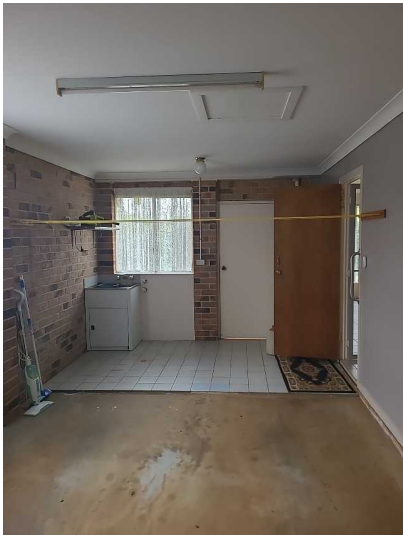
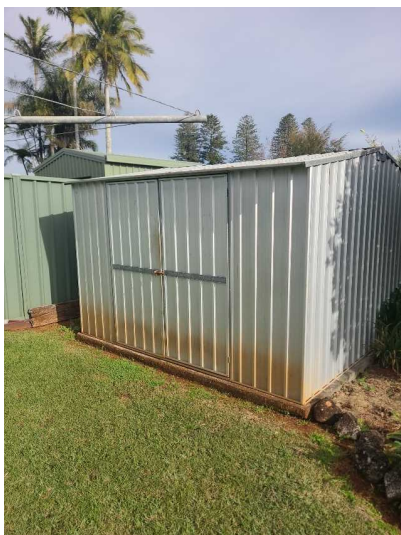
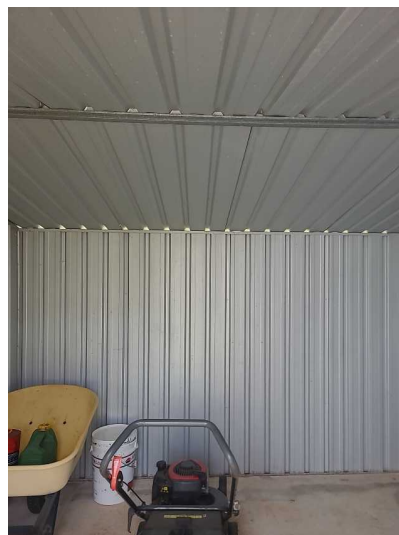
1. Garage and Shed

- Materials:
- The attached brick garage appears structurally sound.
  - The rear metal shed appears to be structurally sound.

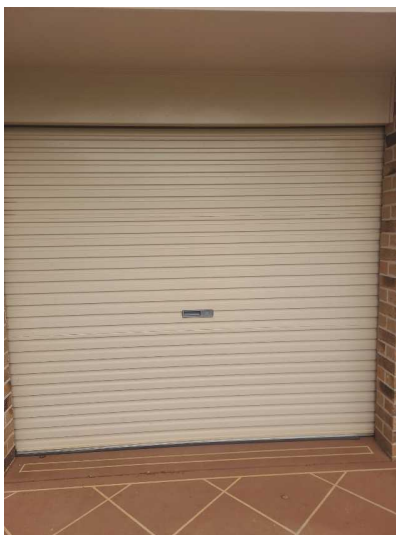
## 2. Garage Door Condition

- No deficiencies observed.

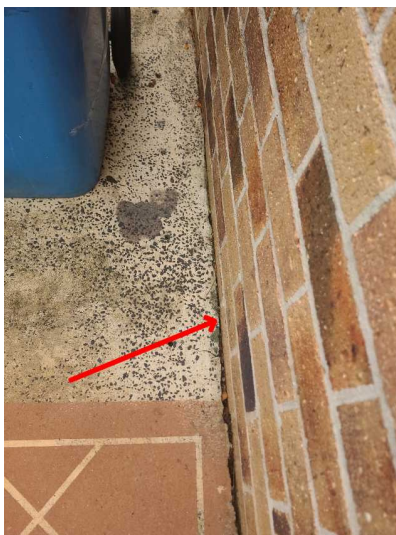
- Slab edges are covered by concrete. This may allow concealed termite entry into the wall frame. Slab edges should be monitored.

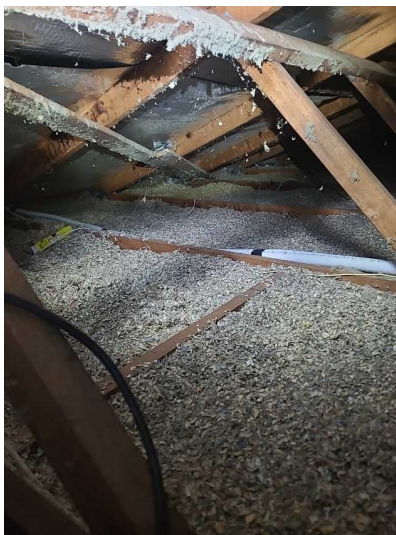
### 1. Roof Observations

- Access was available through a manhole in the garage.
- Could not access all areas of the roof space due to limited space.
- Limited visibility and access due to insulation and pitch.

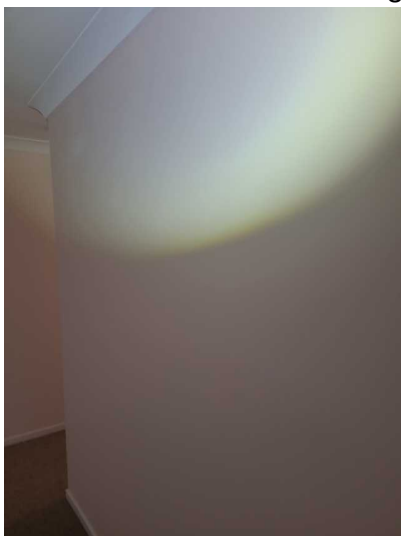
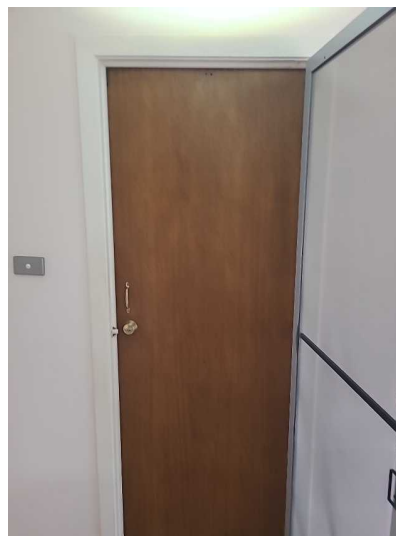
### 1. Wall Condition

- Timber skirting and door frames appear functional.

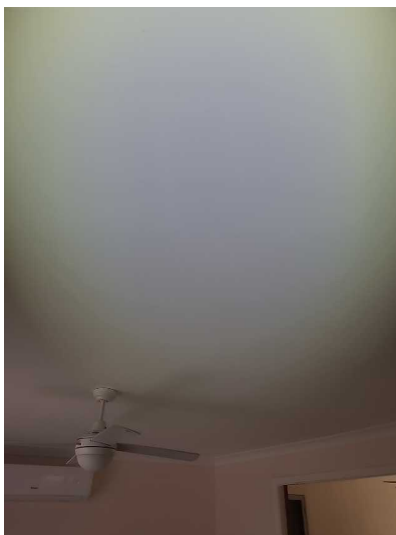
### 2. Ceiling Condition

- There are plasterboard/gyprock ceilings in the property which appear functional.

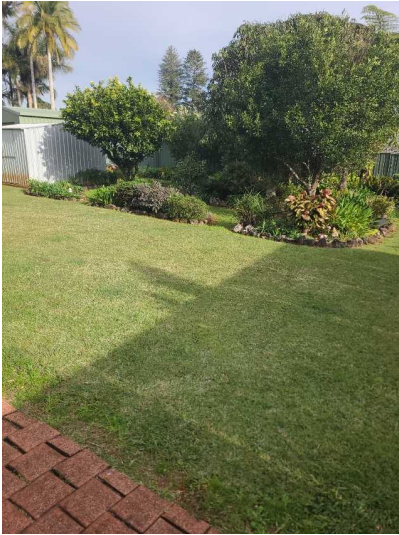
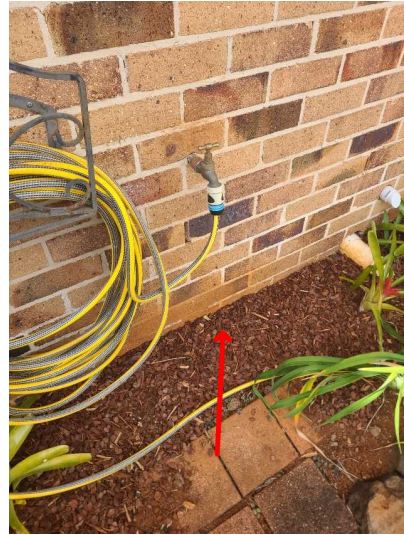
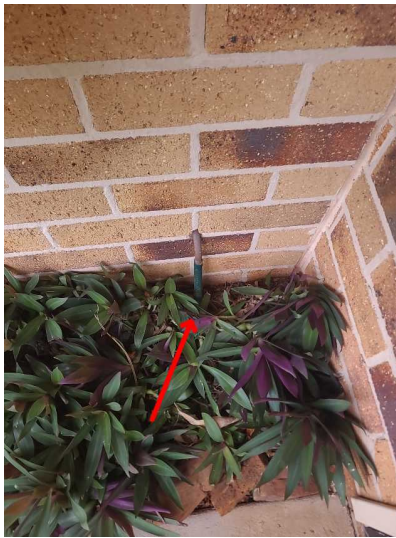
- It is important to redirect moisture away from the property to limit areas of excess moisture. Faulty gutters and downpipes in poor condition can cause water to seep into the foundations, causing conditions conducive to termites and fungal decay.
- Surface drainage conditions within 3 metres of the inspected structure appeared satisfactory.
- There are no drains located beneath the outdoor taps. This can cause water pooling if the taps were to leak. Recommend drains be installed beneath the taps. Where this is not possible it is important to ensure taps are well maintained to prevent leaks.
- The hot water system overflow pipe discharges on the foundations. This should ideally be directed into the storm water or at least 3 metres away from the building.

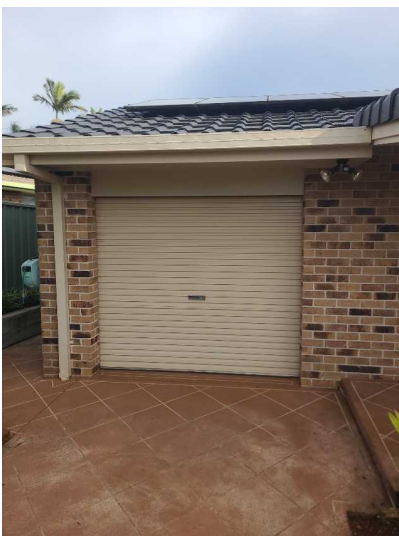
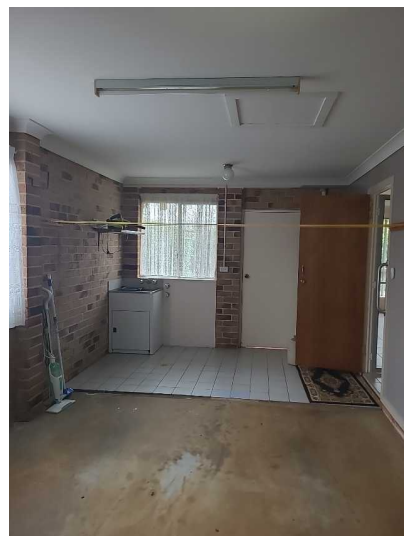
### 3. Garage/Shed Condition

Comments:  
• Appeared satisfactory.

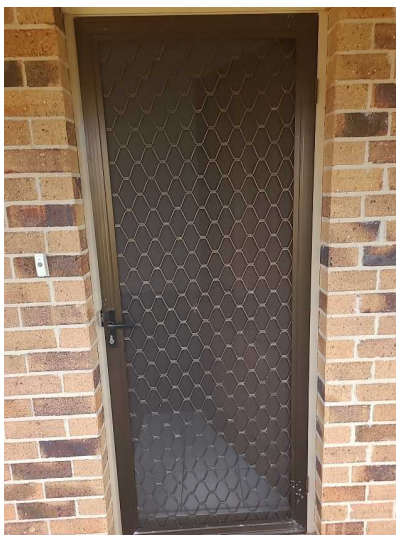
- Wood framed doors noted. In satisfactory condition.

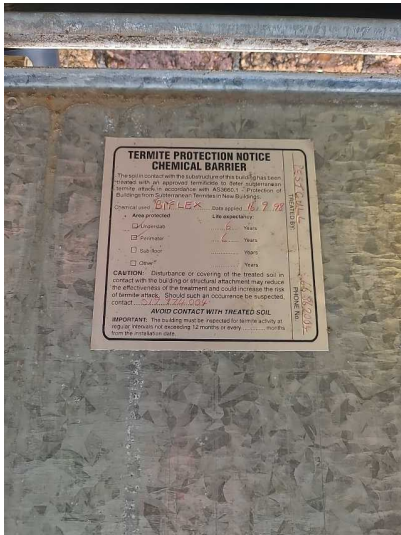
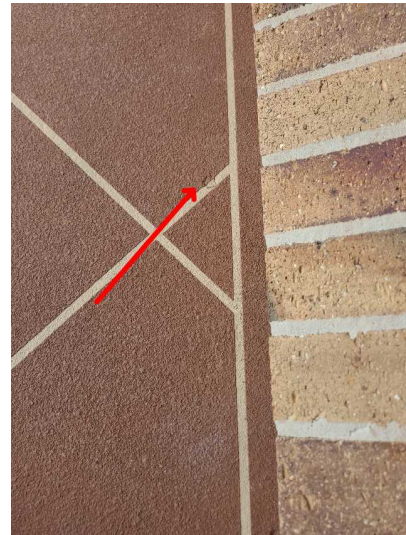
### 1. Recommendations

- It is recommended that any available records and associated paperwork from the current property owner is requested with regard to previous treatment.
- A termite management plan should be put in place. AS 3660.2 recommends that a routine inspection for termite management purposes be carried out at least annually.
- If termite activity or damage is noted it is possible that further termite damage may be present in concealed areas.
- There is a notice in the meter box to indicate that the home had a treatment in 1998 to the perimeter and slab. Chemical used Biflex.
- Drill holes abutting external perimeter noted.

- As a preventative measure, we recommend a termite management system be installed. Consult with Pest Treatment companies to determine the barrier or other management system which best meets your requirements. Termite inspections should be undertaken every 12 months.
