# Building and Pest Report

## 5/24-26 Sunrise Cres Lennox Head

Report/Agreement #	150525091549445
Inspection Date:	15 May 2025
Inspection Time:	09:15 am

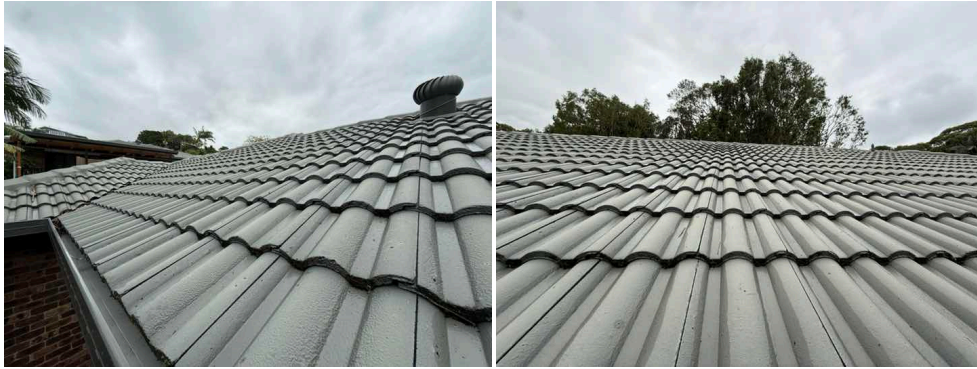
Of the visible areas, the general condition of the roof is in serviceable condition for the age.

Note: In the absence of rainfall there is no guarantee that the roof won't leak.

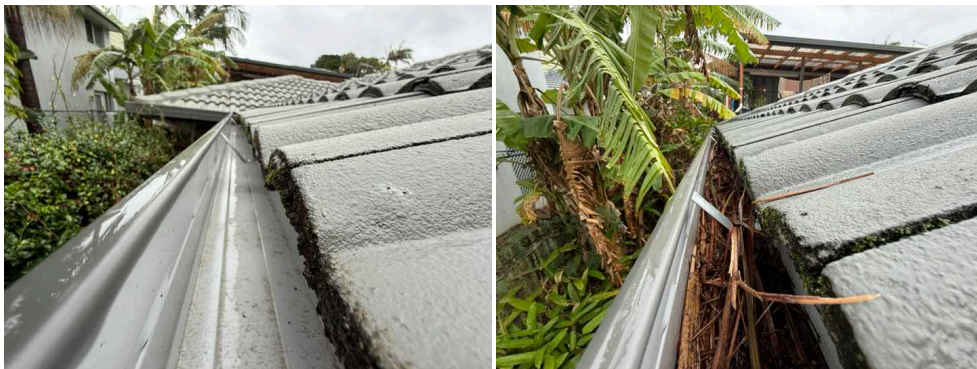
All visible and accessible of the physical nature of the guttering system appears to be in a serviceable condition with no apparent defects at the time of inspection. In the absence of prolonged rain fall efficiency of the guttering can not be assessed and you may find that further investigation or repairs maybe required. Note: Periodic maintenance checks should be carried out for rust penetrations and leaks.

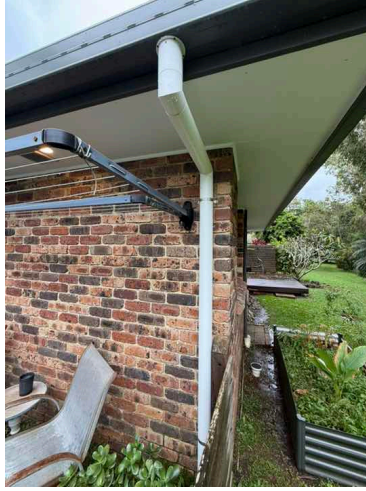
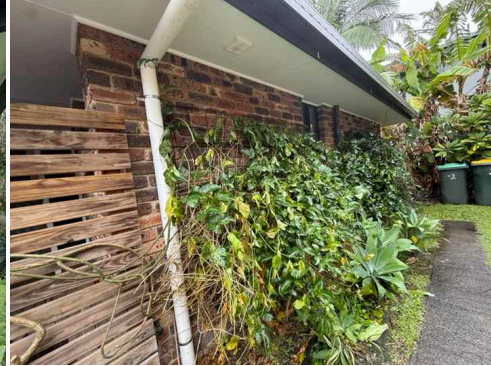
On visual inspection no apparent defects were noted to the down pipes and are considered serviceable, however no comment can be made with regard to blockages or connections to stormwater or functionality in the absence of rain. Note: Periodic maintenance checks should be carried out for rust penetrations and leaks.

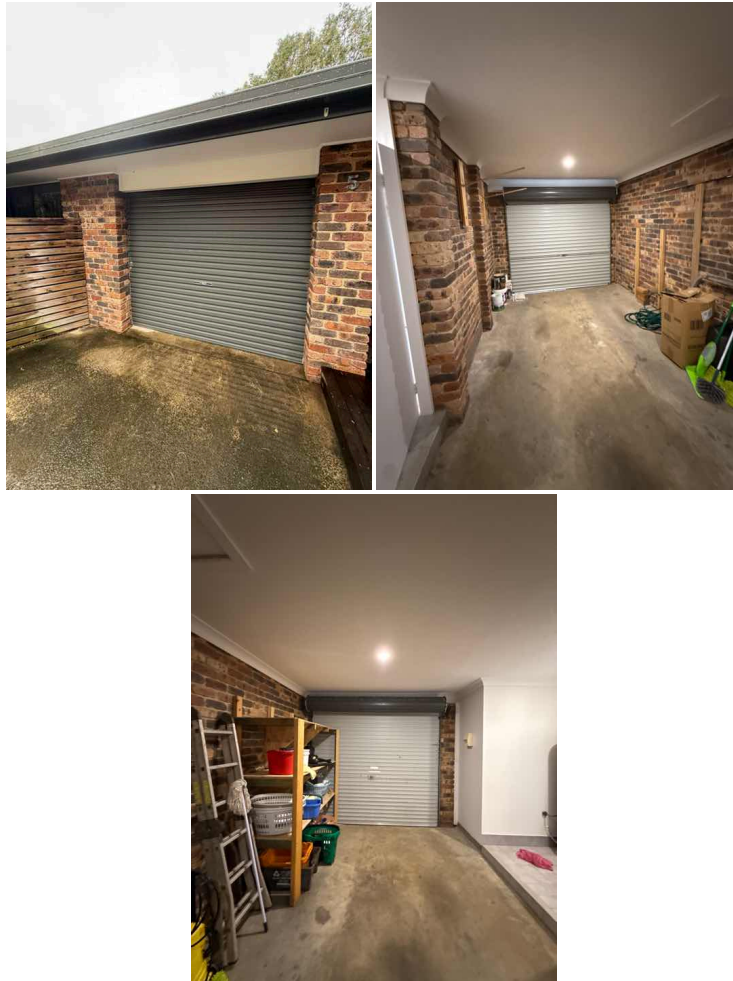
From the visible and accessible areas, the garage appears to be in a serviceable condition for the age of the property with no notable structural defects sighted.

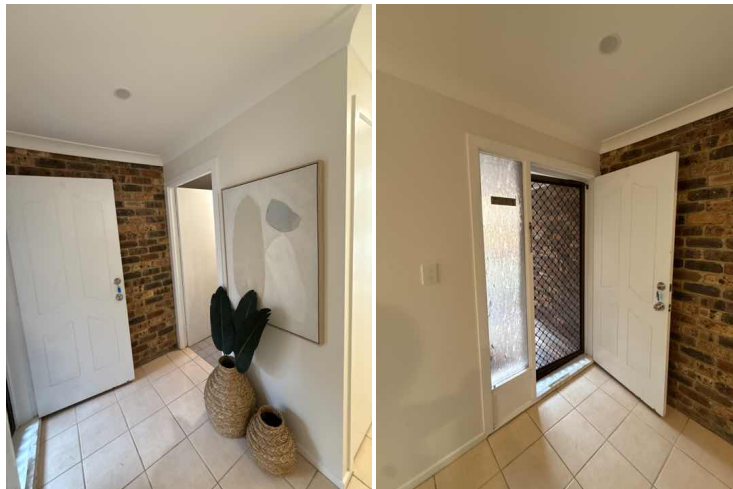
From the visible and accessible areas, this area appears to be in a serviceable condition for the age of the property with no notable structural defects sighted.

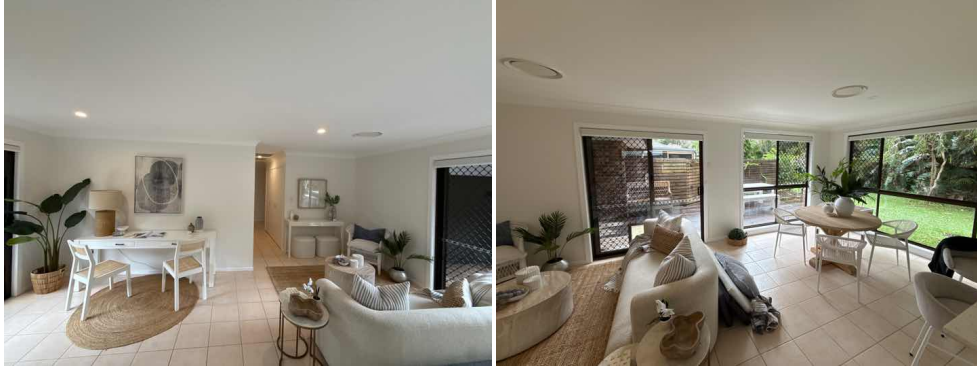
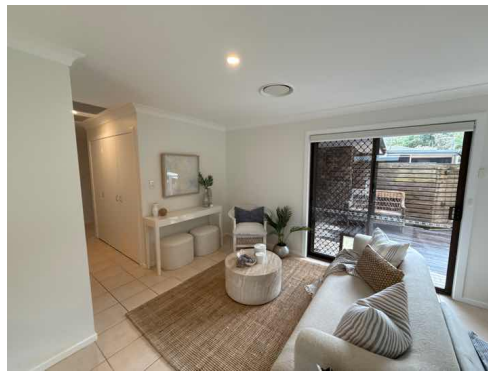
From the visible and accessible areas, this room appears to be in a serviceable condition for the age of the property with no notable structural defects sighted.

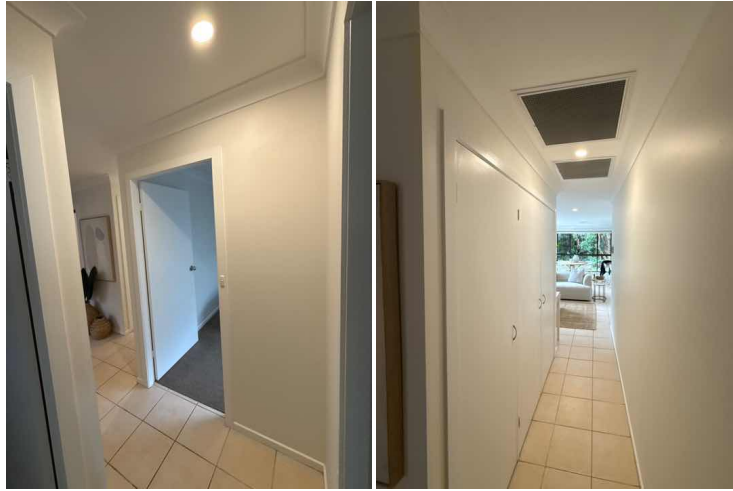
From the visible and accessible areas, the hallway/ appears to be in a serviceable condition for the age of the property with no notable structural defects sighted.

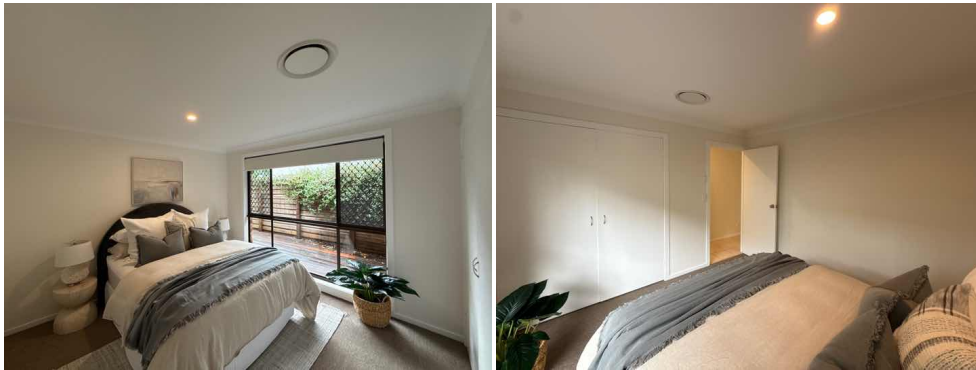
From the visible and accessible areas, this bedroom appears to be in a serviceable condition for the age of the property with no notable structural defects sighted.

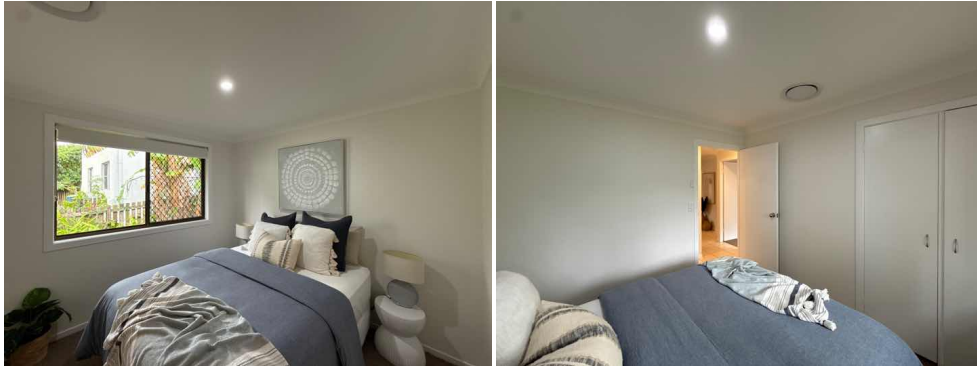
From the visible and accessible areas, this bedroom appears to be in a serviceable condition for the age of the property with no notable structural defects sighted.

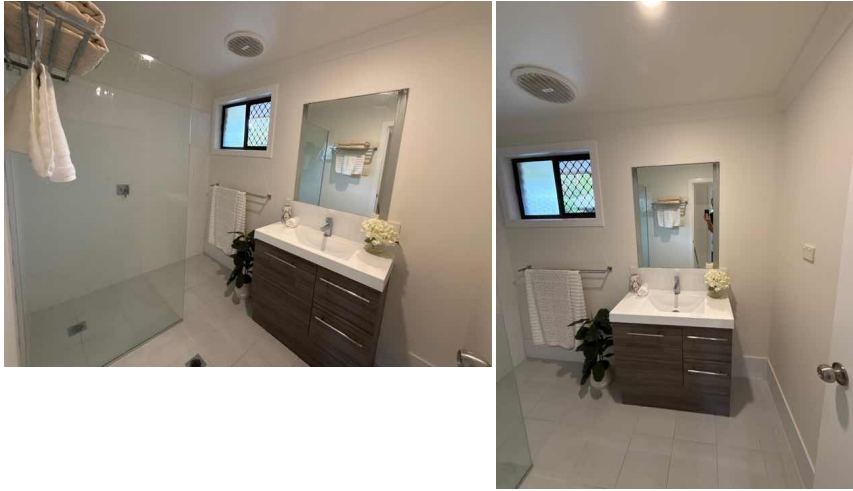
Of the visible areas, the general condition of this bathroom is serviceable or in reasonable condition for age of dwelling.

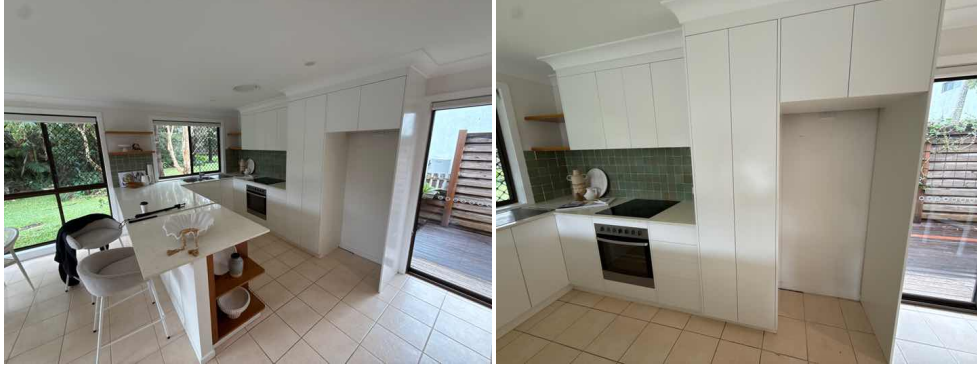
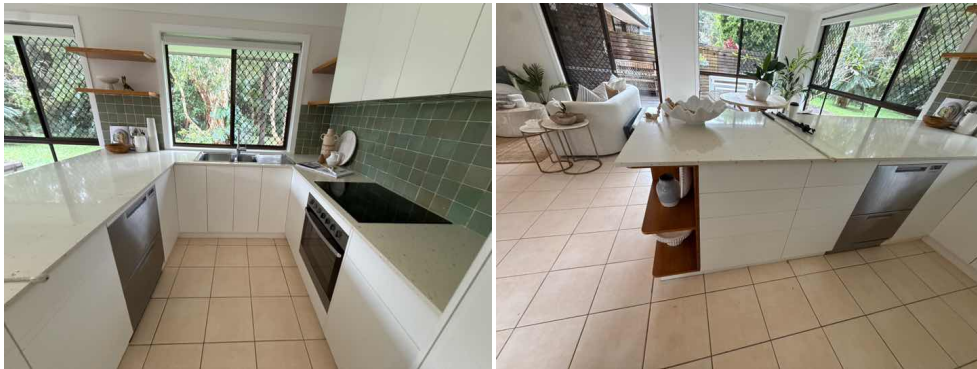
Of the visible areas, the general condition of the kitchen and pantry is serviceable or in reasonable condition for age of dwelling.

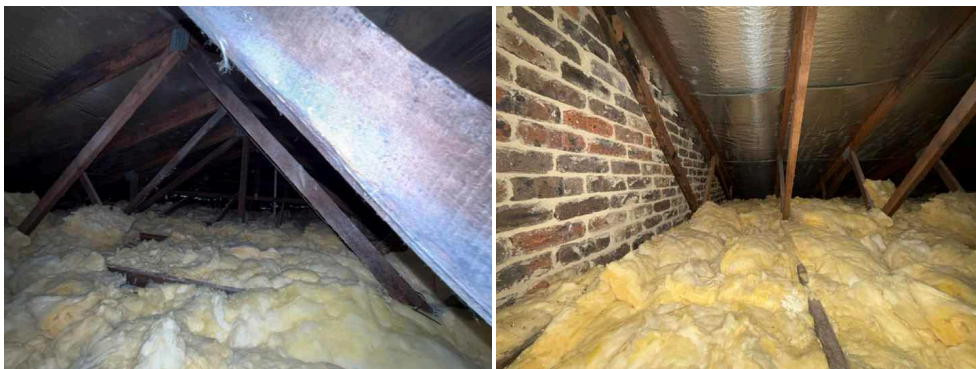
Visible sections of the roof void is in a serviceable condition for age of this dwelling.
