Building and Pest Report

14 Gardenia
Street
Ballina

Inspection Report

14 Gardenia Street , Ballina, NSW, 2478

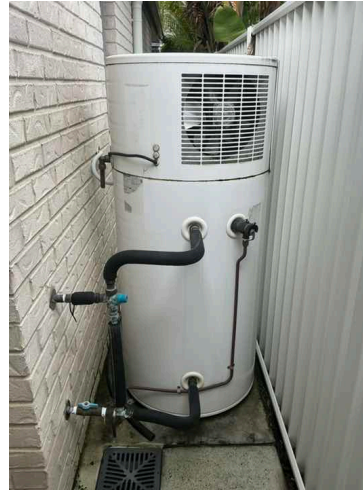
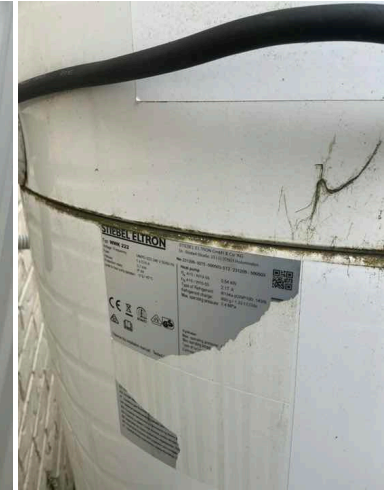
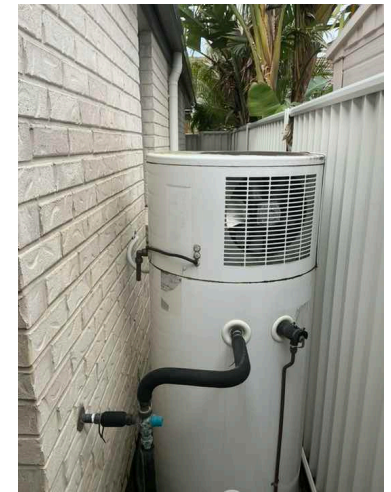
Hot Water Unit Findings

The hot water system appears to be in a serviceable condition. No specific tests other than running the hot water from a tap was carried out. No determination has been made as to the suitability or adequacy of the hot water system in relation to capacity or otherwise.

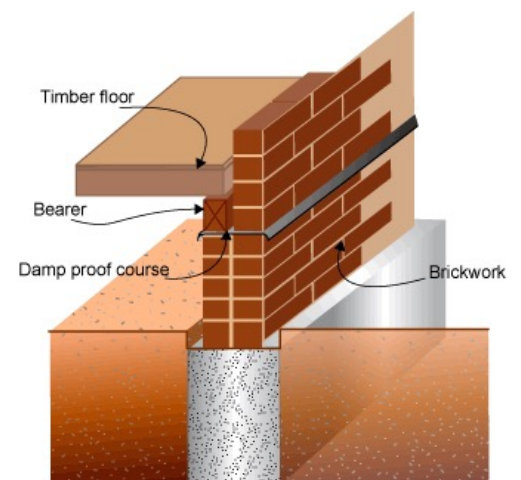
Damp Proof Course

A damp proof course (DPC) was noted.

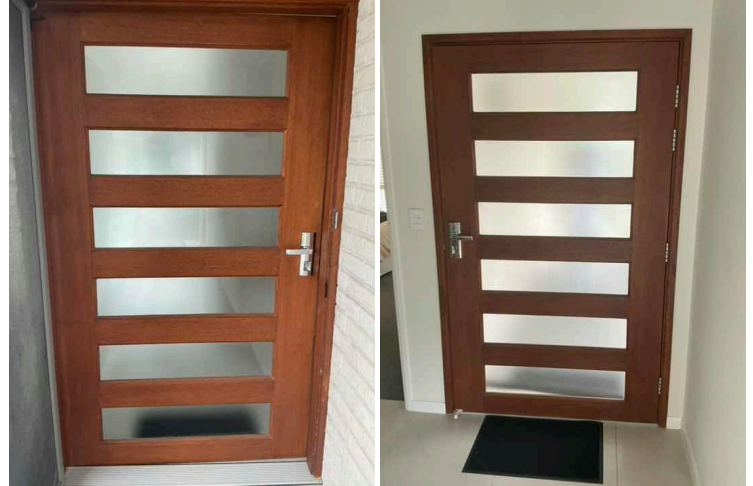
Front Entry Doors

The doors are in serviceable condition with no notable defects observed.

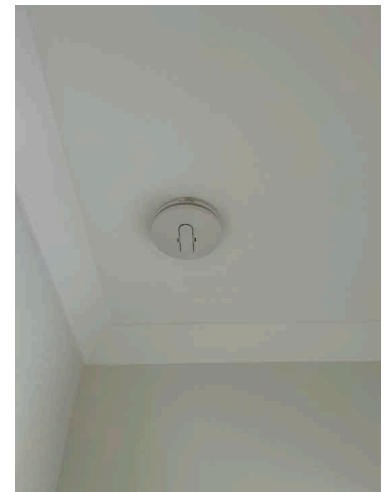
Yes a smoke alarm was sighted but not tested.

Legislation requires smoke Alarms to be installed. Check with your local council regarding type, locations and other related requirements.

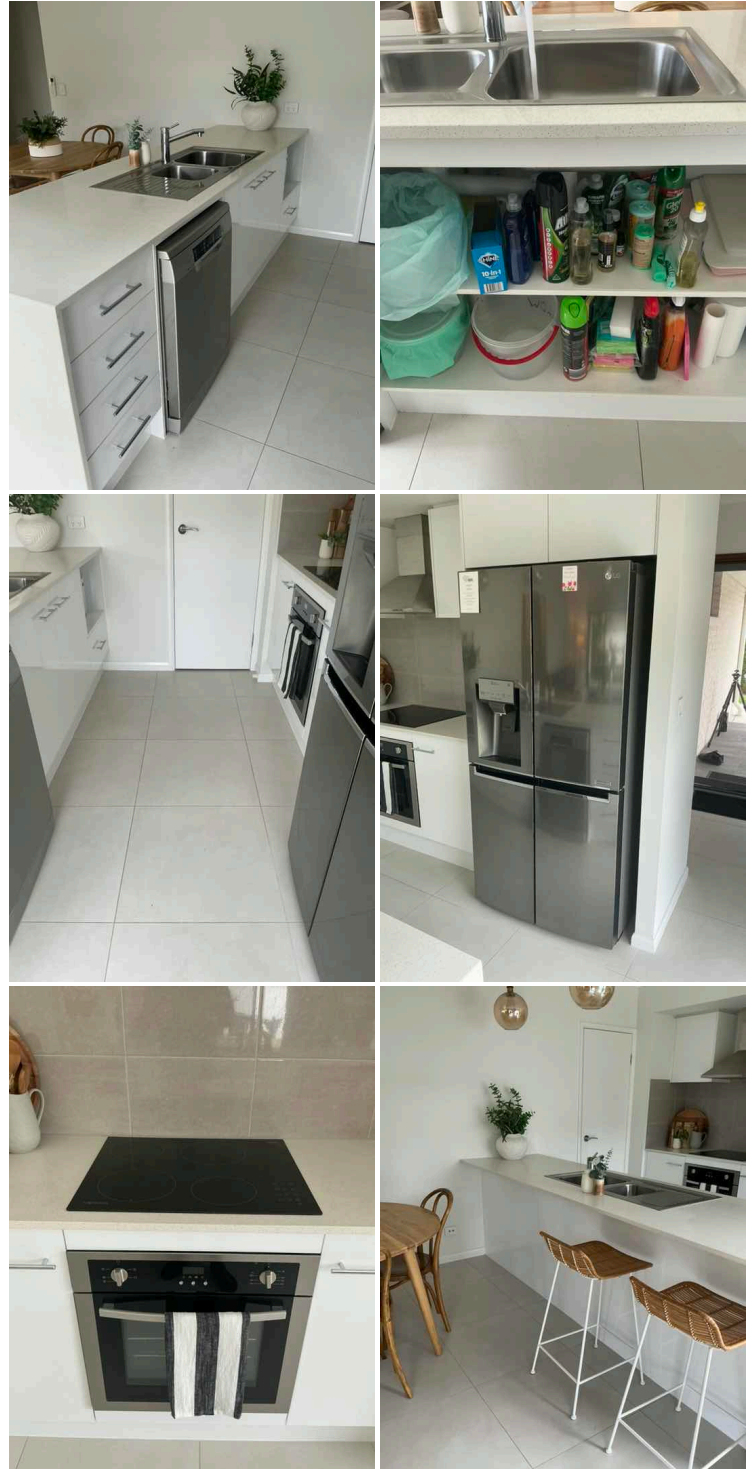
Of the visible areas, the general condition of the kitchen and pantry is serviceable or in reasonable condition for age of dwelling.

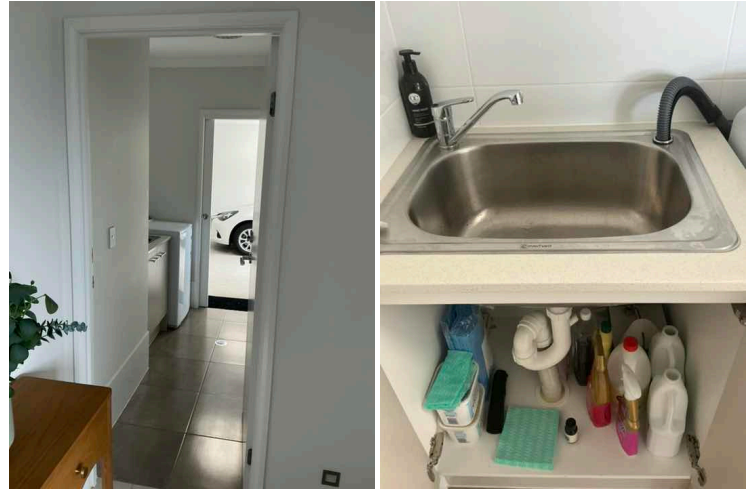
Of the visible areas, the general condition of the laundry is serviceable or in reasonable condition for age of dwelling.

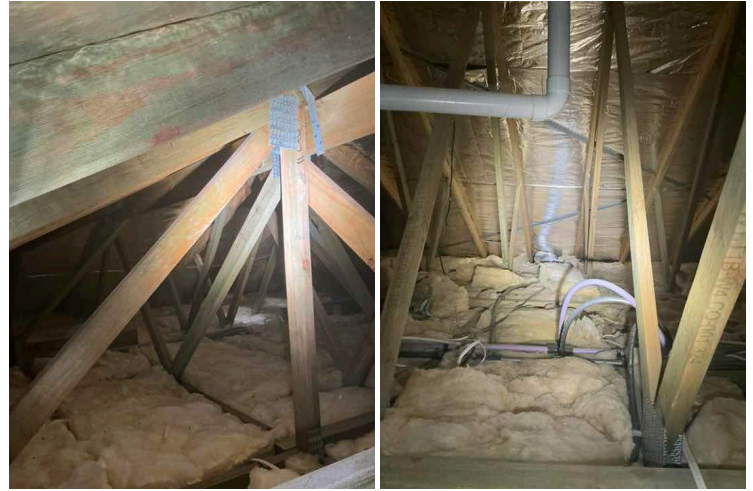
Visible sections of the roof void is in a serviceable condition for age of this dwelling.

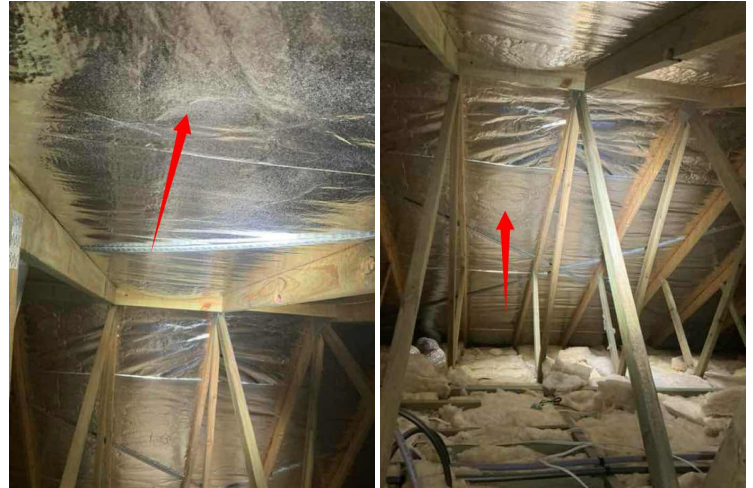
Sarking is installed.

The sarking generally is in a serviceable condition.
