# Building and Pest Report

## 8 Angus Kennedy Close, Lennox Head

# Inspection Report

**8 Angus Kennedy Close, Lennox Head, NSW, 2478**

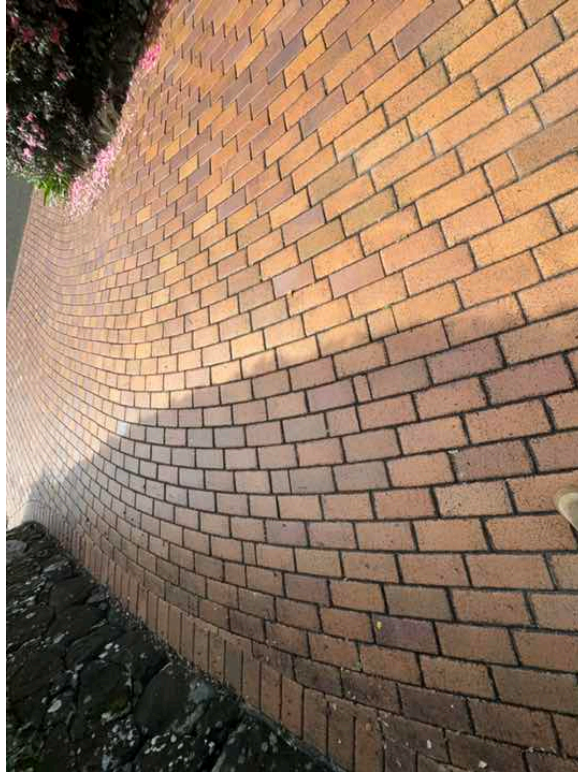
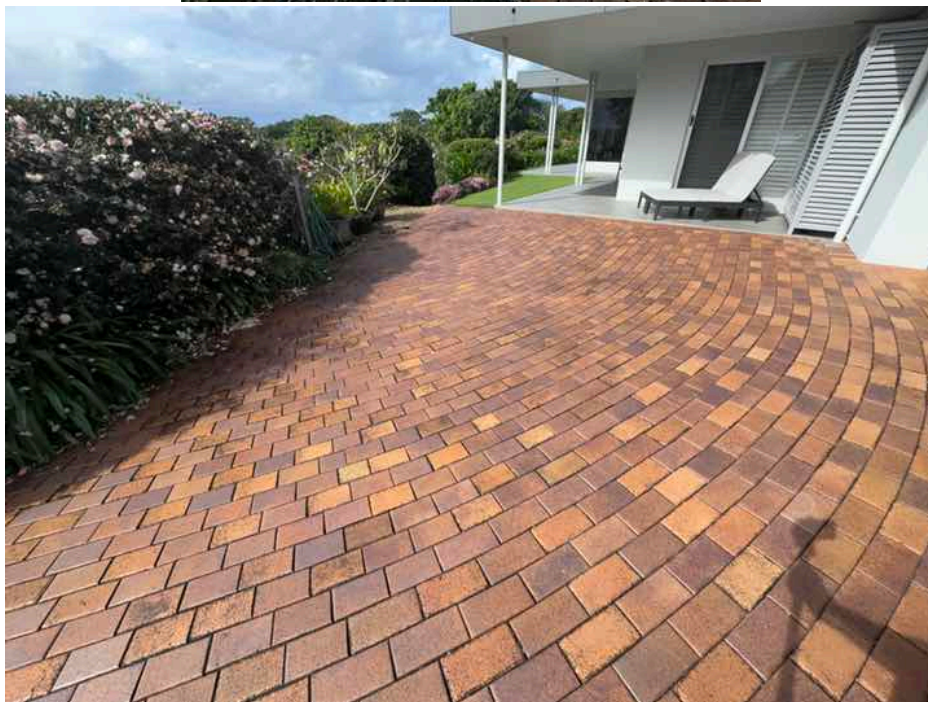
On visual inspection, the general condition of the driveway is serviceable.

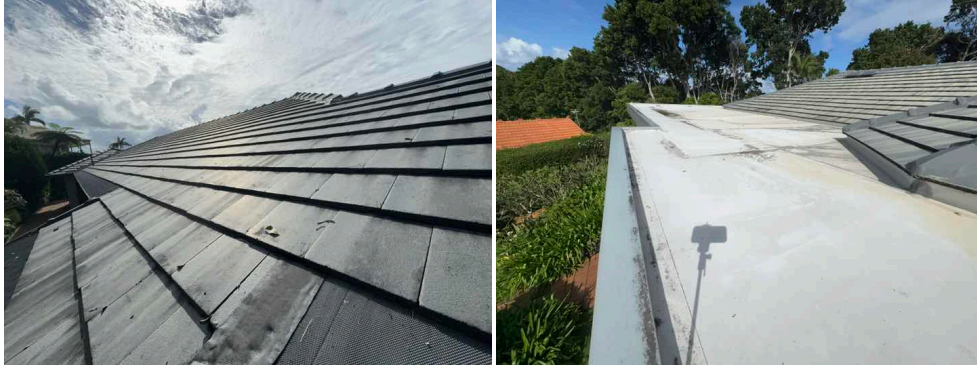
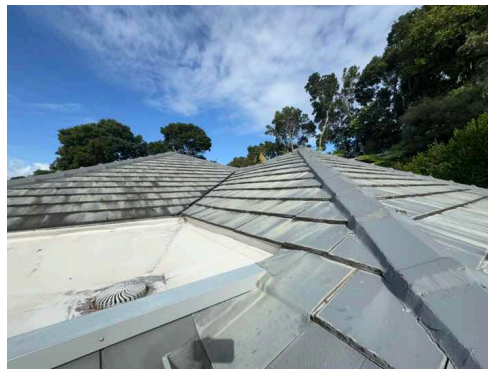
Of the visible areas, the general condition of the roof is in serviceable condition for the age.

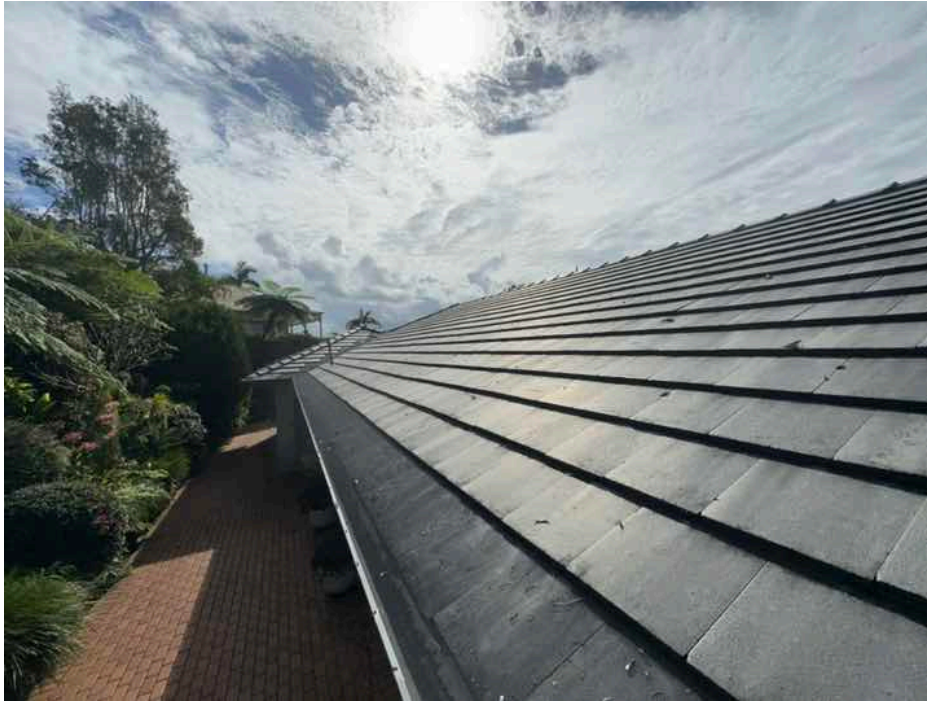
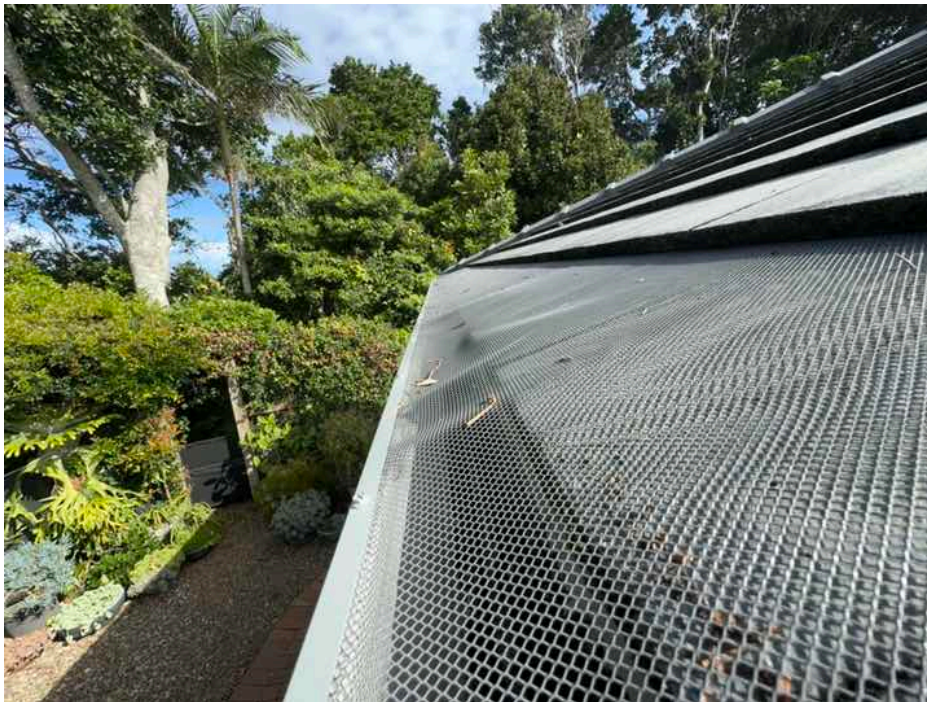
All visible and accessible of the physical nature of the guttering system appears to be in a serviceable condition with no apparent defects at the time of inspection. In the absence of prolonged rain fall efficiency of the guttering can not be assessed and you may find that further investigation or repairs maybe required. Note: Periodic maintenance checks should be carried out for rust penetrations and leaks.

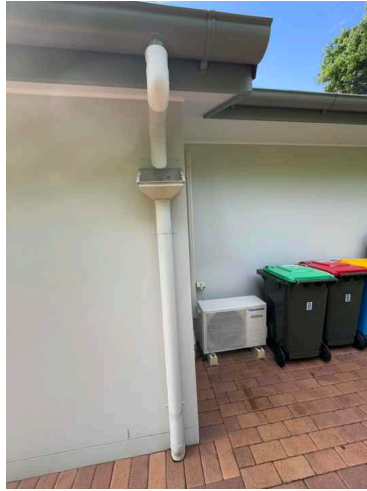
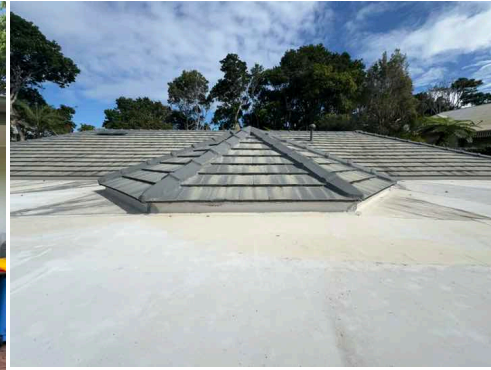
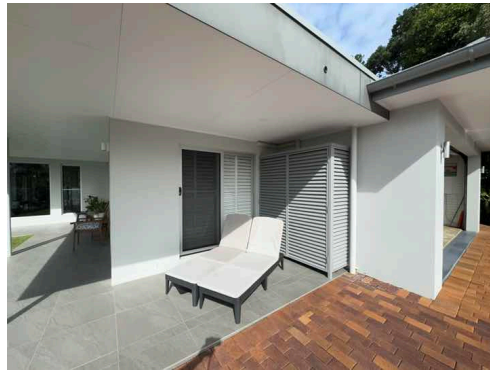
On visual inspection no apparent defects were noted to the down pipes and are considered serviceable, however no comment can be made with regard to blockages or connections to stormwater or functionality in the absence of rain. Note: Periodic maintenance checks should be carried out for rust penetrations and leaks.

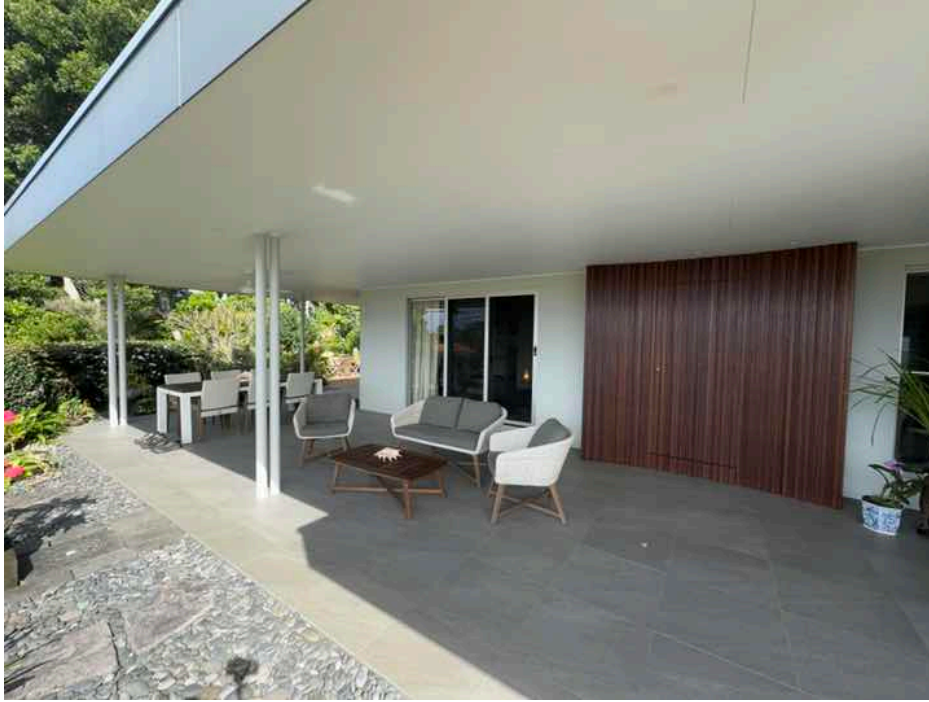
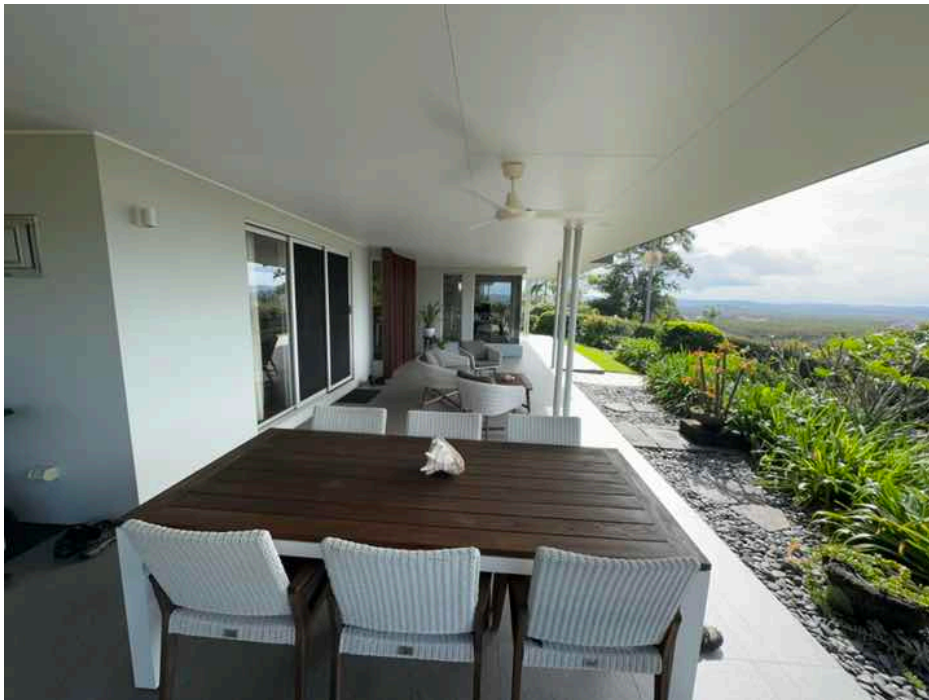
Visible sections of the Alfresco area are serviceable or in reasonable or condition for the age of this dwelling.

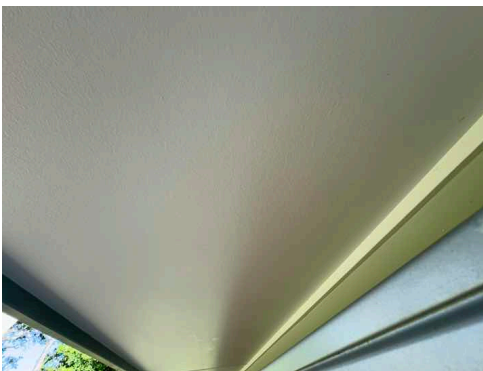
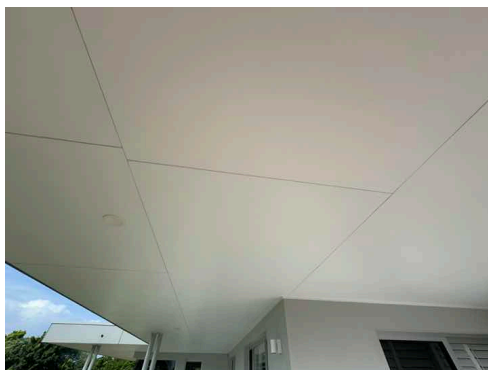
The soffit lining (eaves) are in a serviceable condition with no notable defects.

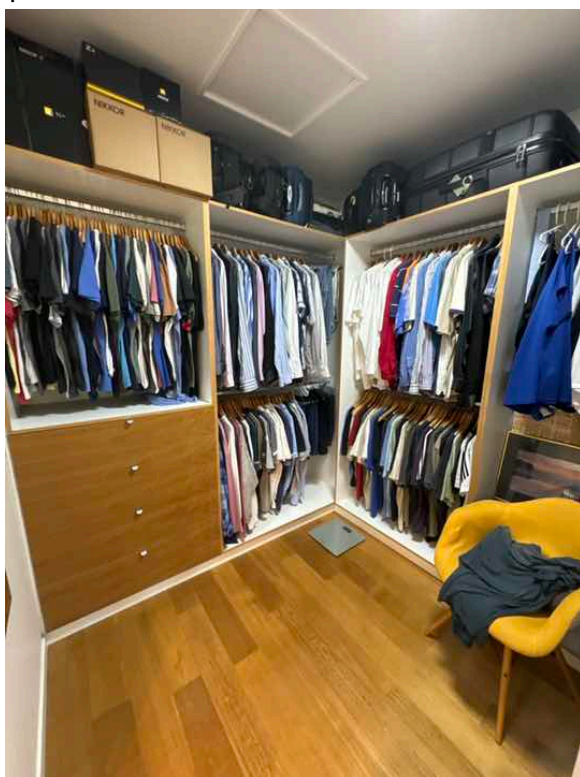
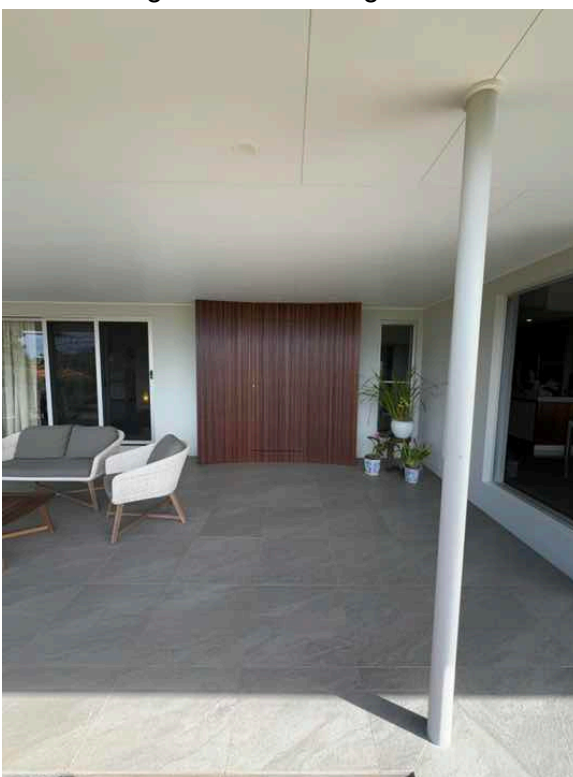
The entry porch serviceable or in reasonable or condition for the age of this dwelling.

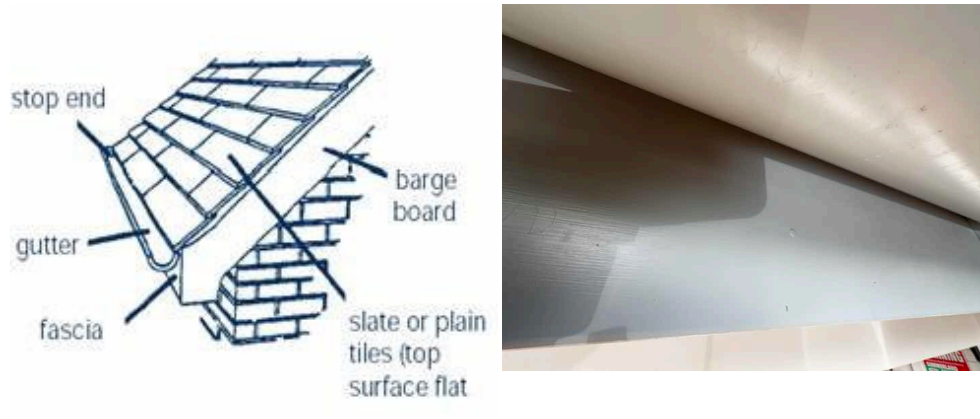
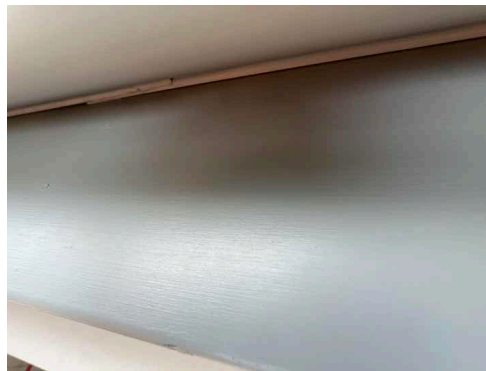
On visual inspection, the general condition of the fascia/barge boards is serviceable.

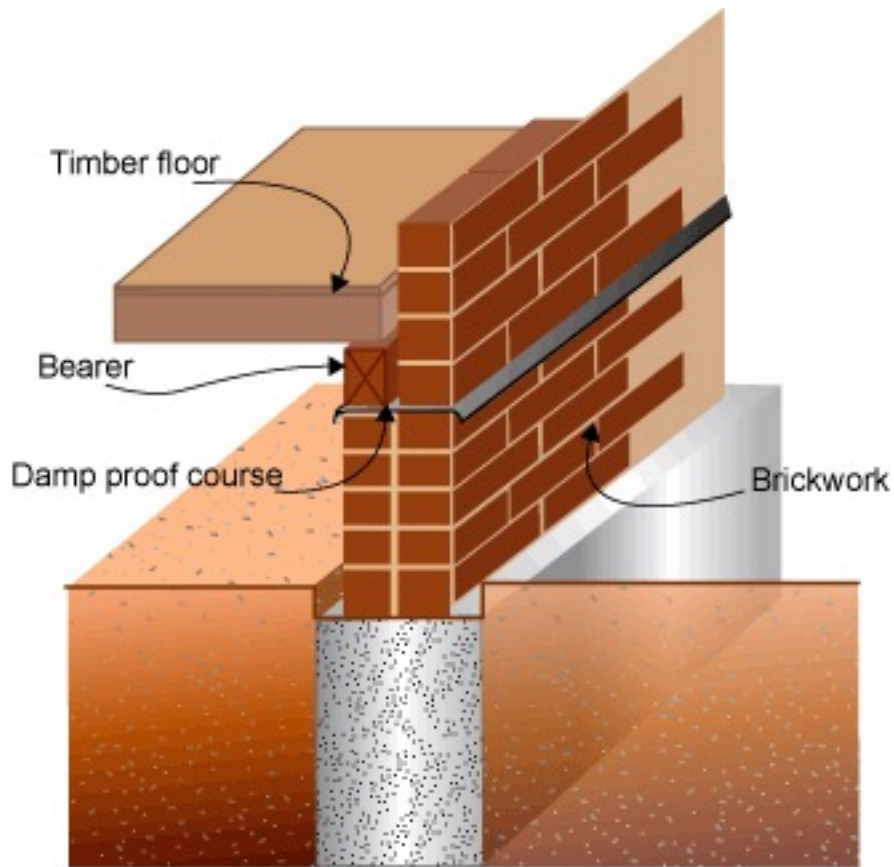
A damp proof course (DPC) was noted.

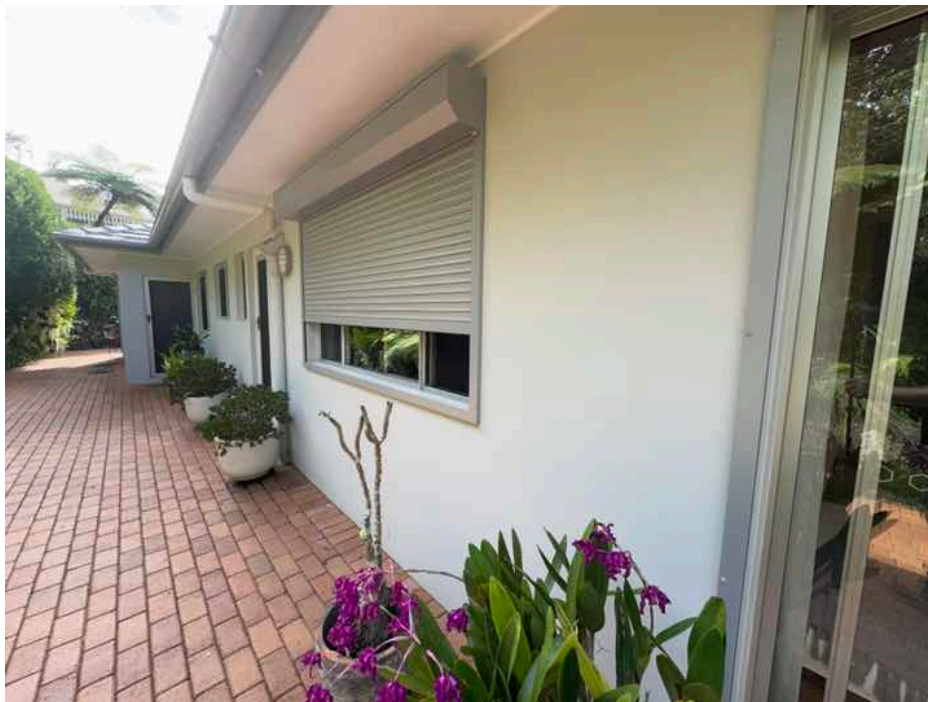
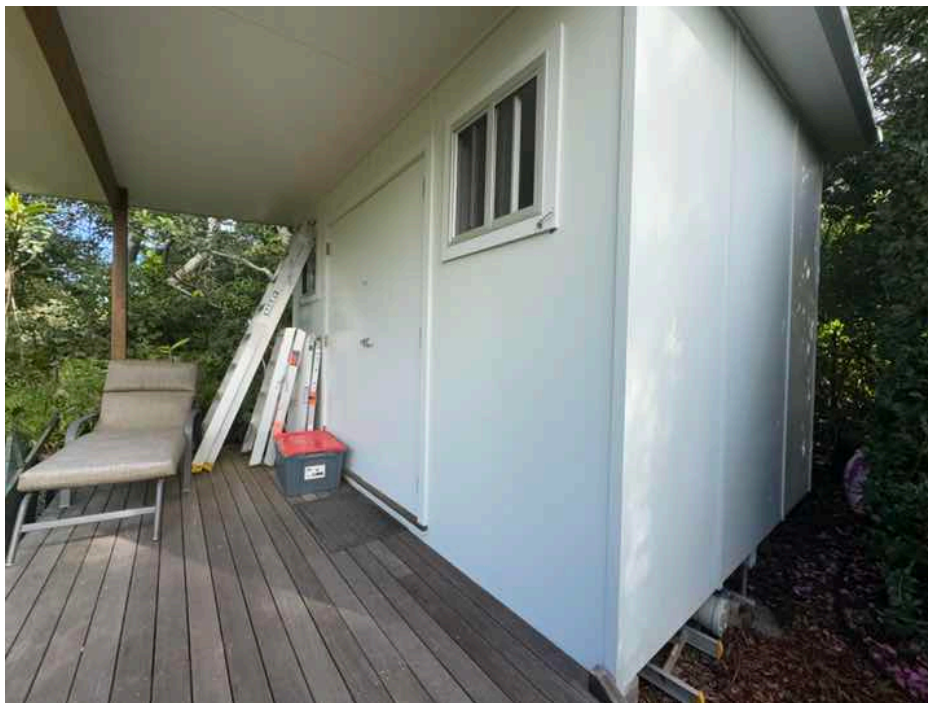
On visual inspection, the general condition of the exterior walls is serviceable for the age.

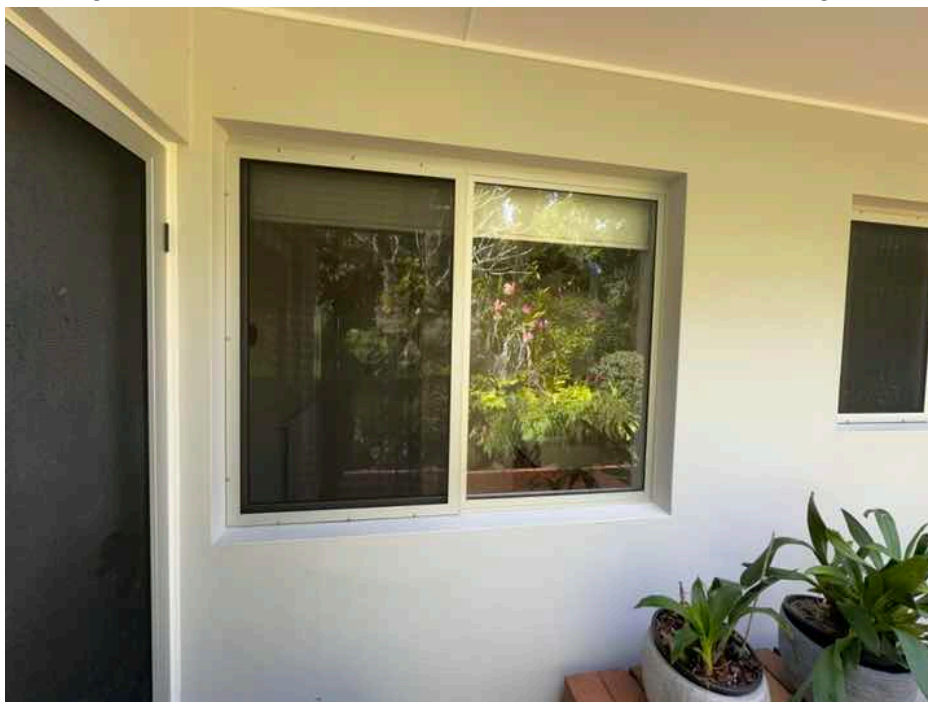
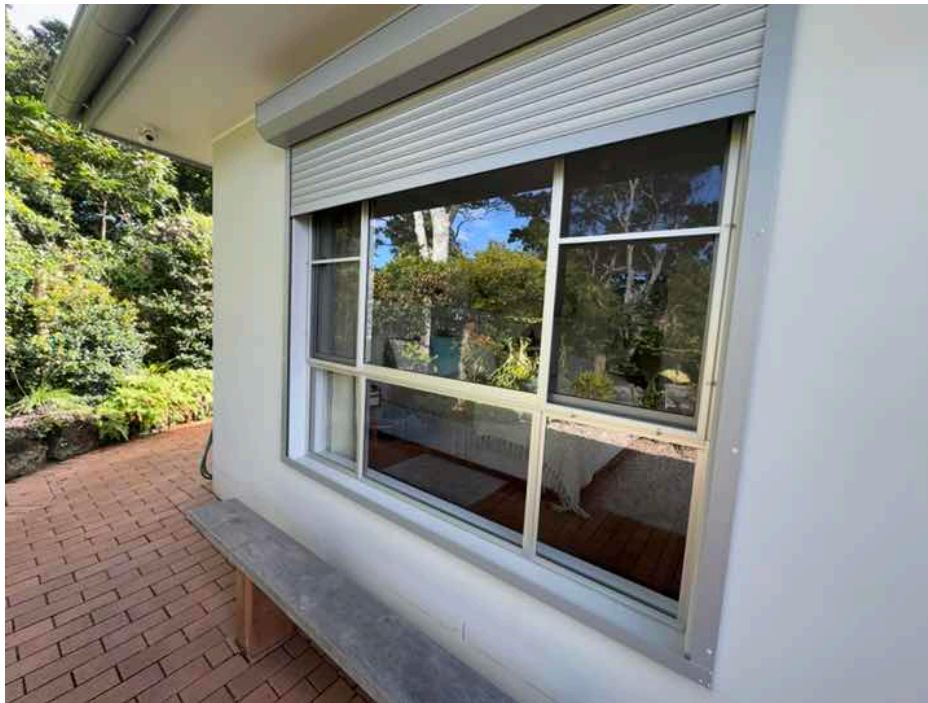
On visual inspection, the general condition of the windows is serviceable for the age.

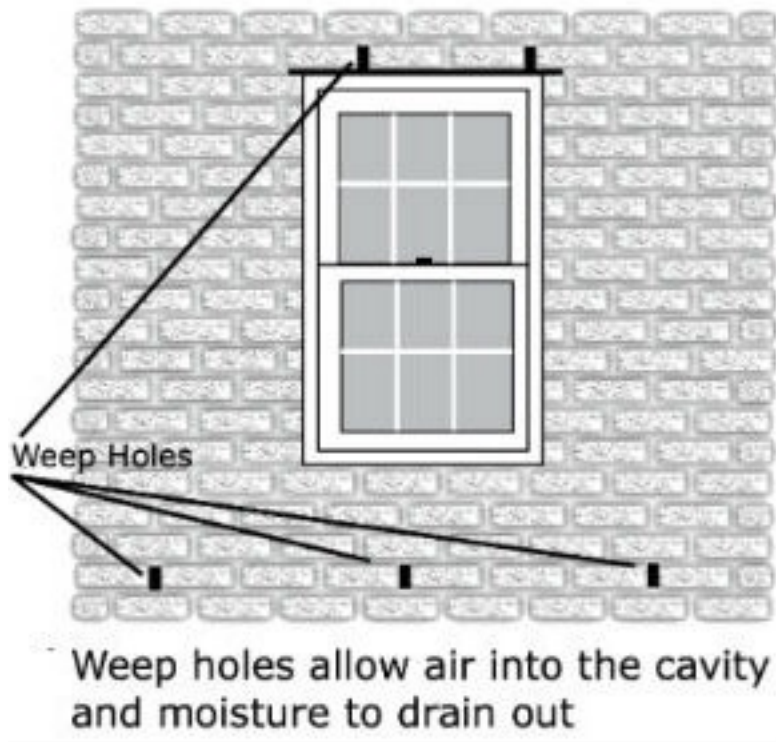
The weep holes are unobstructed .

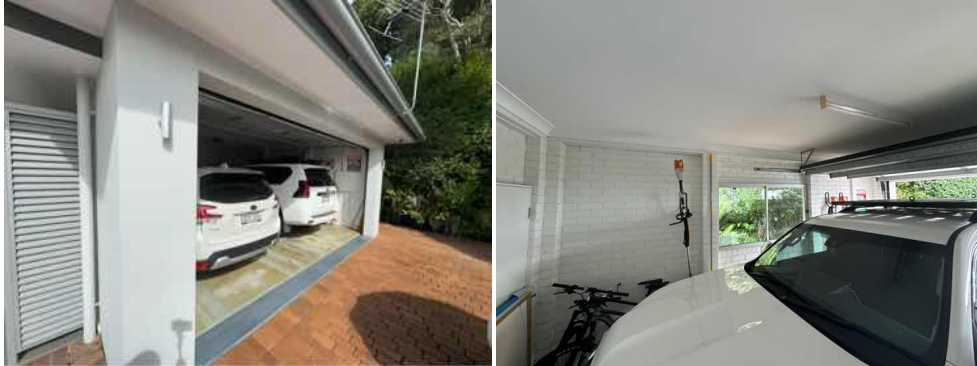
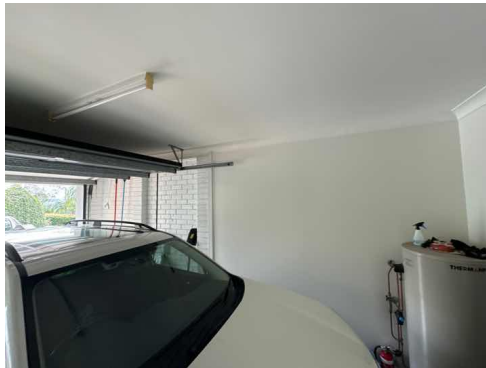
From the visible and accessible areas, the garage appears to be in a serviceable condition for the age of the property with no notable structural defects sighted.

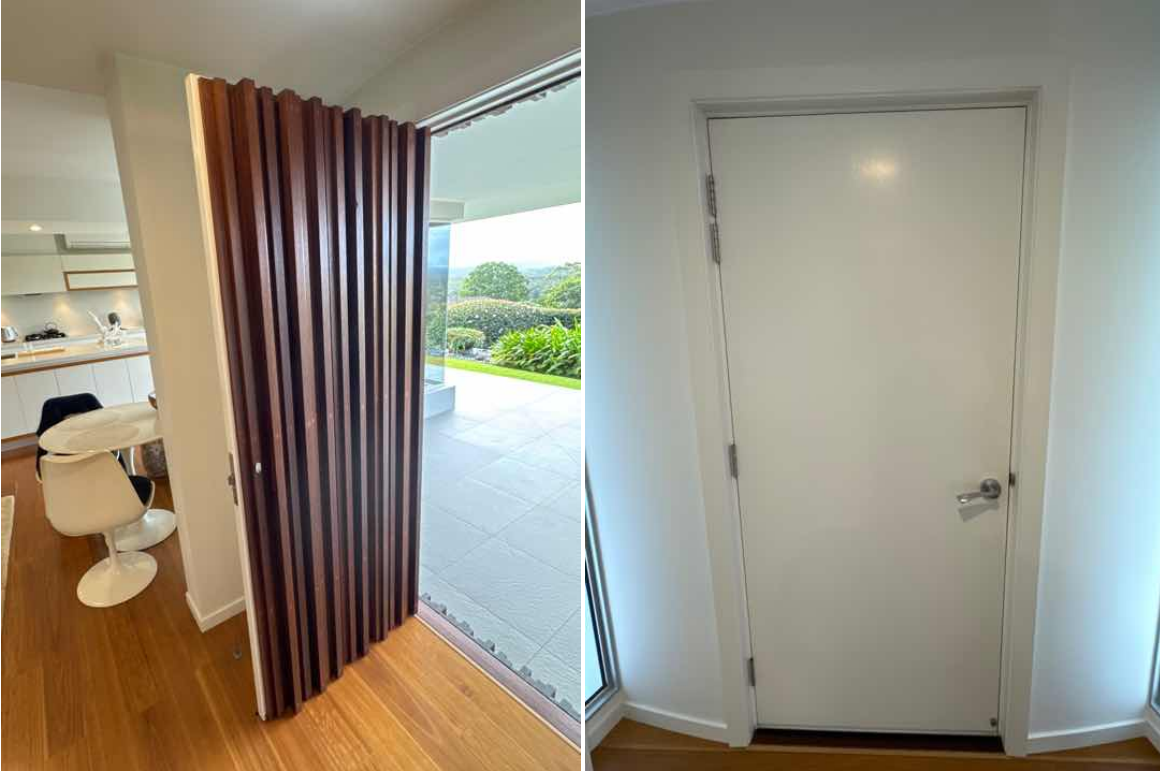
The doors are in serviceable condition with no notable defects observed.

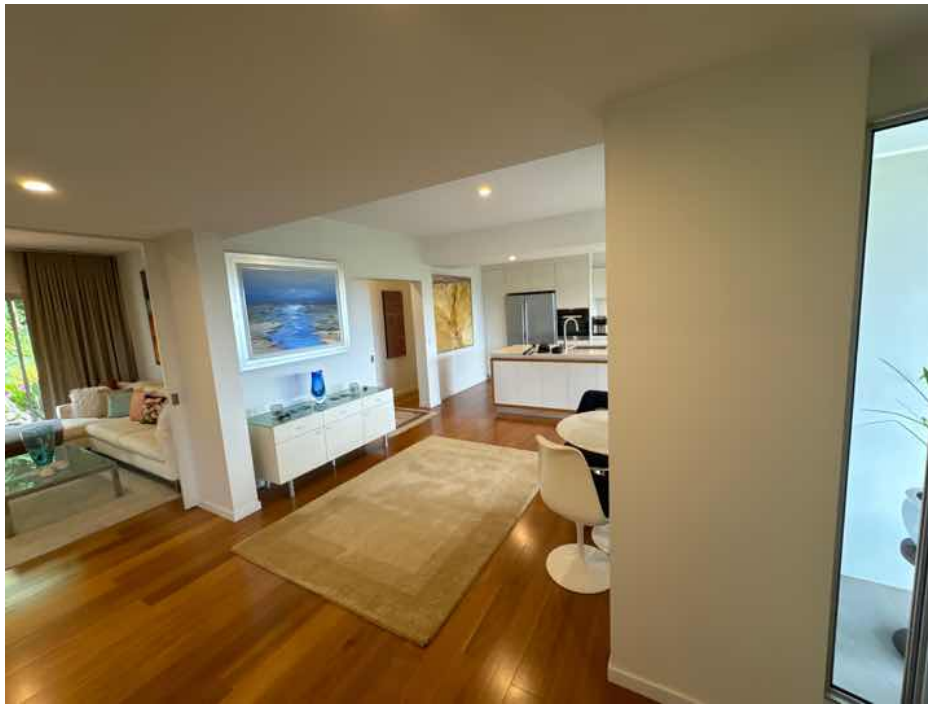
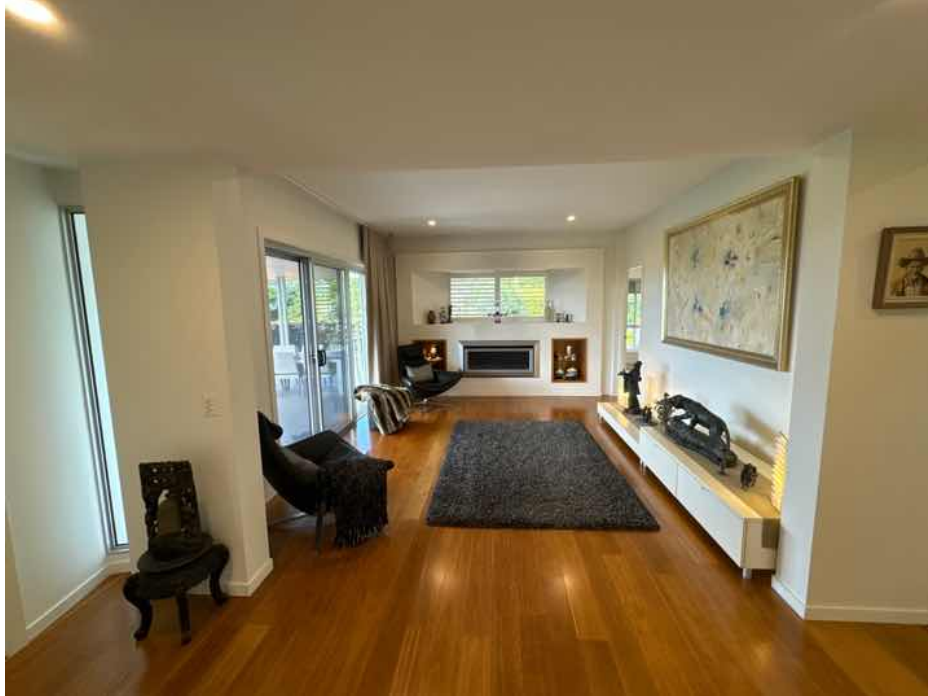
From the visible and accessible areas, this area appears to be in a serviceable condition for the age of the property with no notable structural defects sighted.

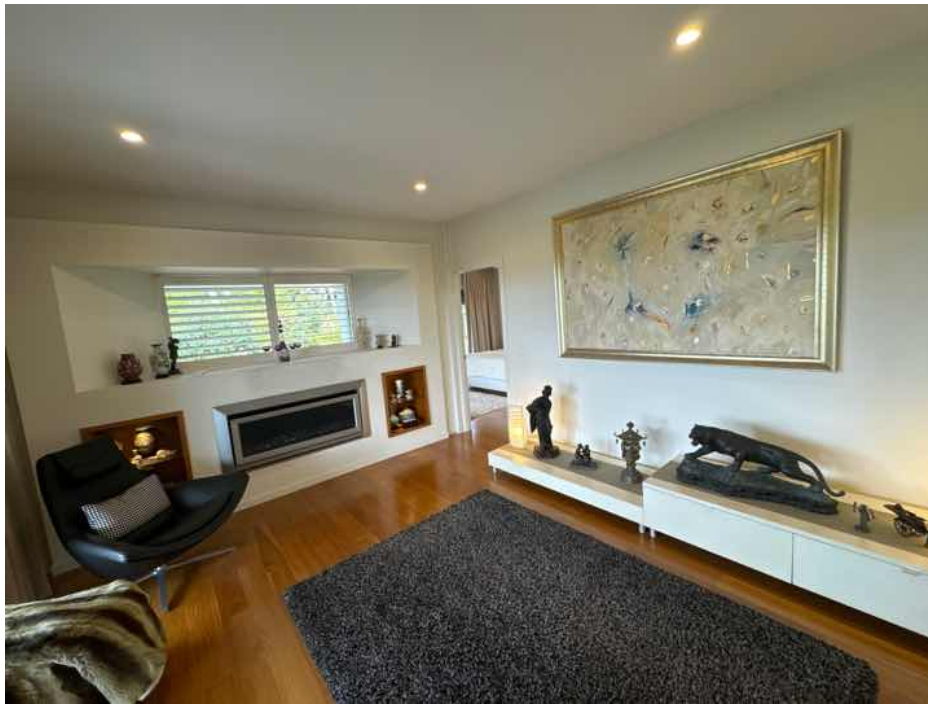
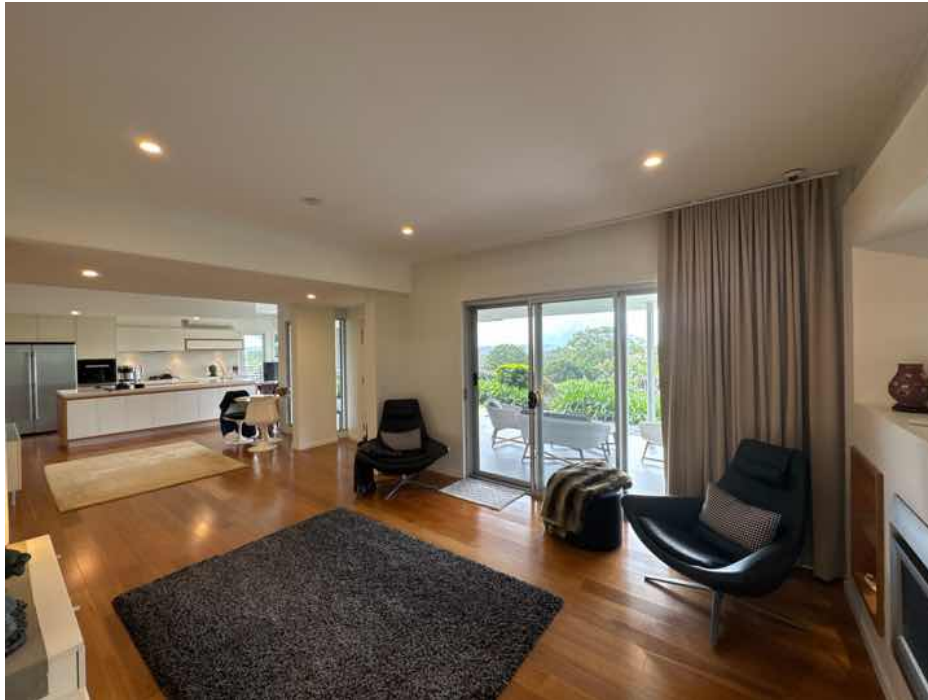
From the visible and accessible areas, this room appears to be in a serviceable condition for the age of the property with no notable structural defects sighted.

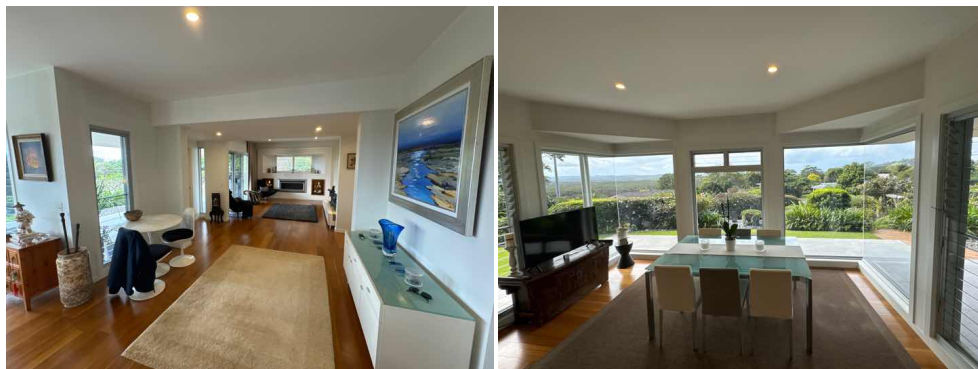
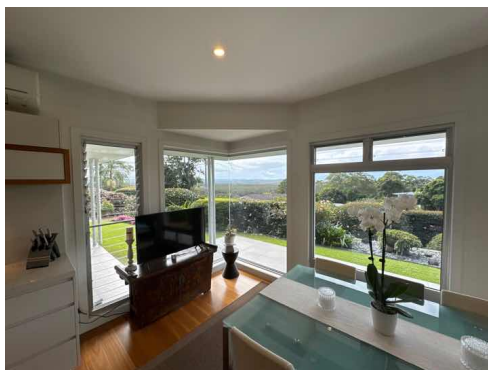
From the visible and accessible areas, this room appears to be in a serviceable condition for the age of the property with no notable structural defects sighted.

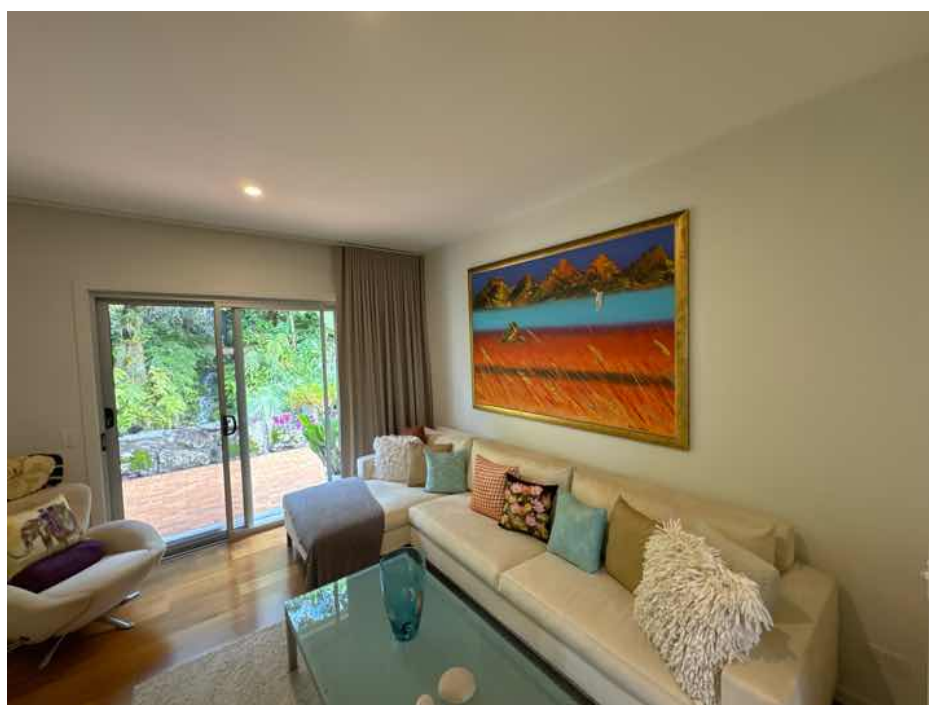
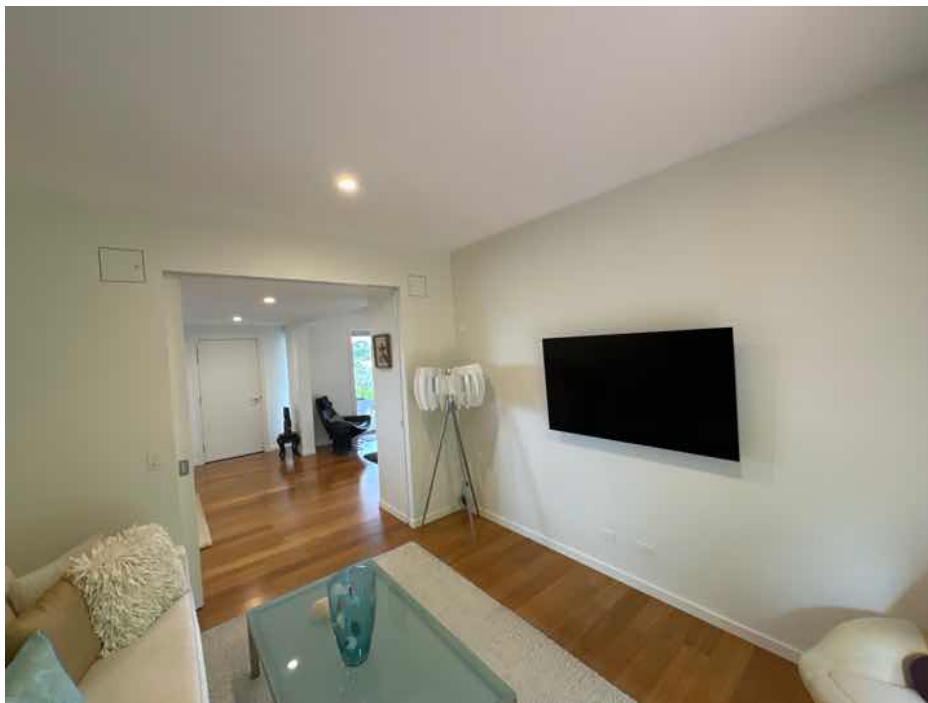
From the visible and accessible areas, this room appears to be in a serviceable condition for the age of the property with no notable structural defects sighted.

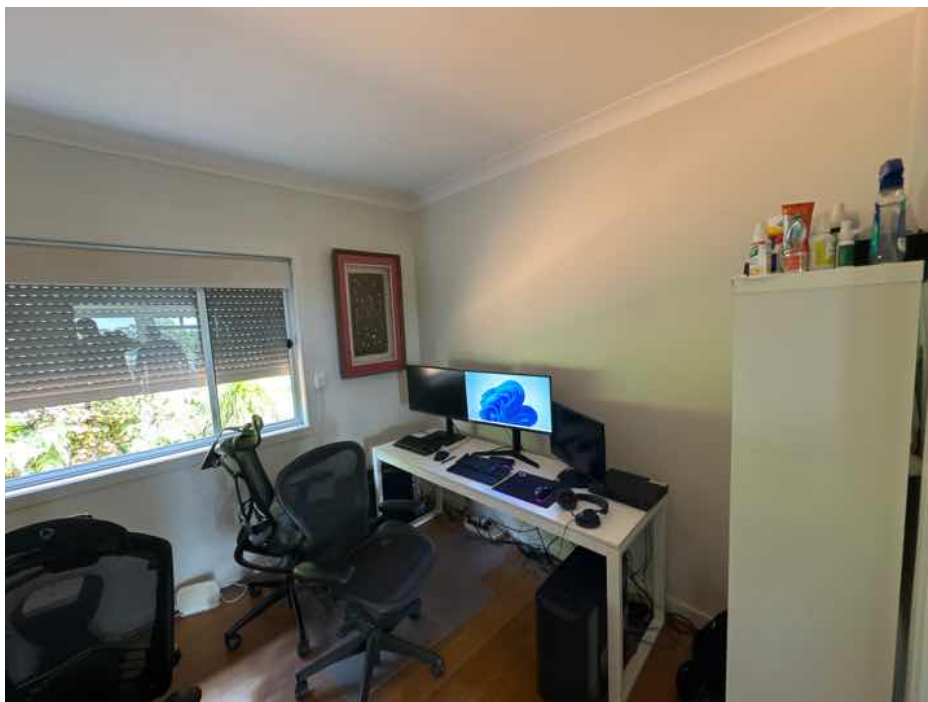
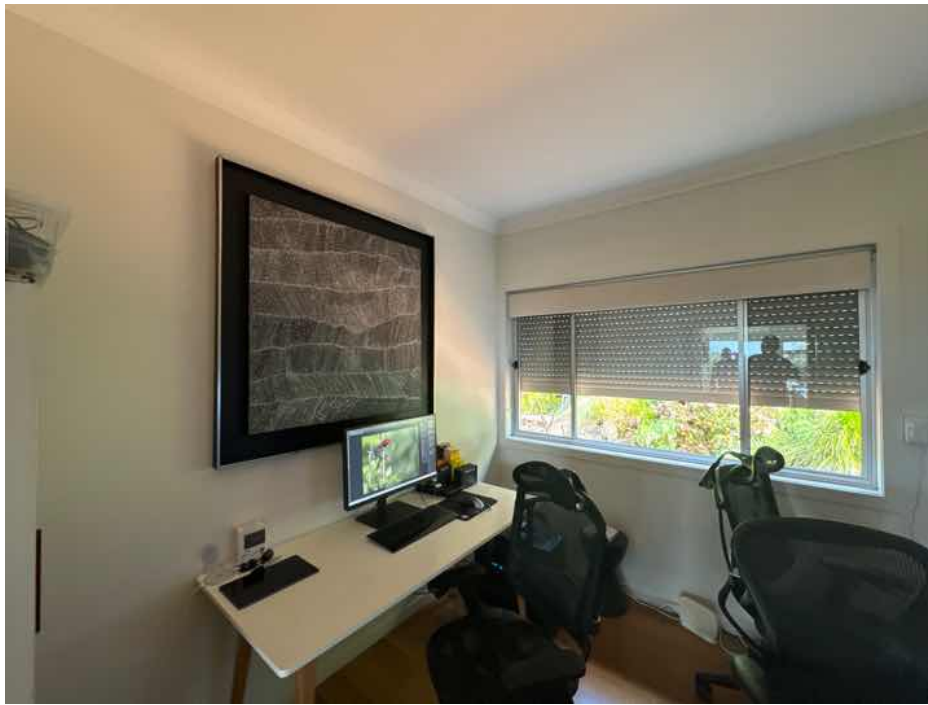
From the visible and accessible areas, this room appears to be in a serviceable condition for the age of the property with no notable structural defects sighted.

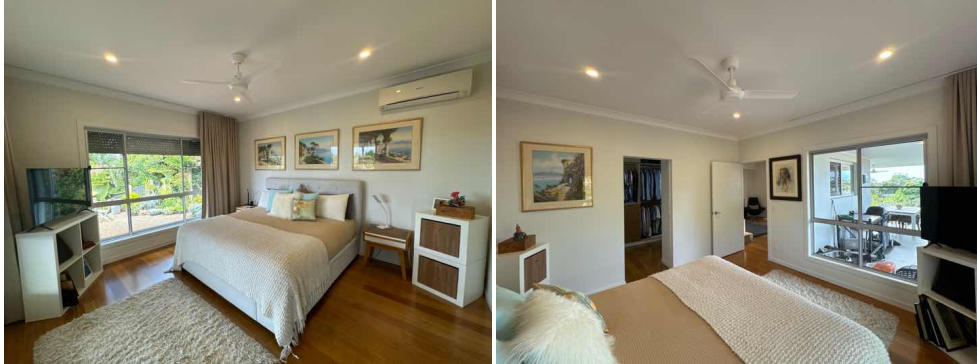
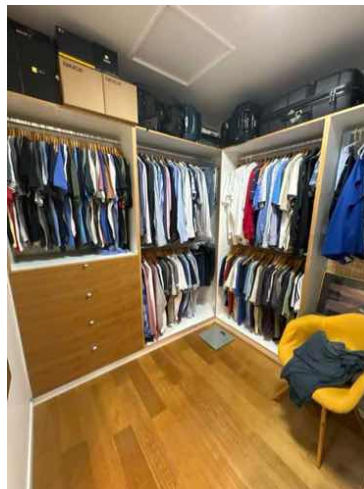
From the visible and accessible areas, this bedroom appears to be in a serviceable condition for the age of the property with no notable structural defects sighted.

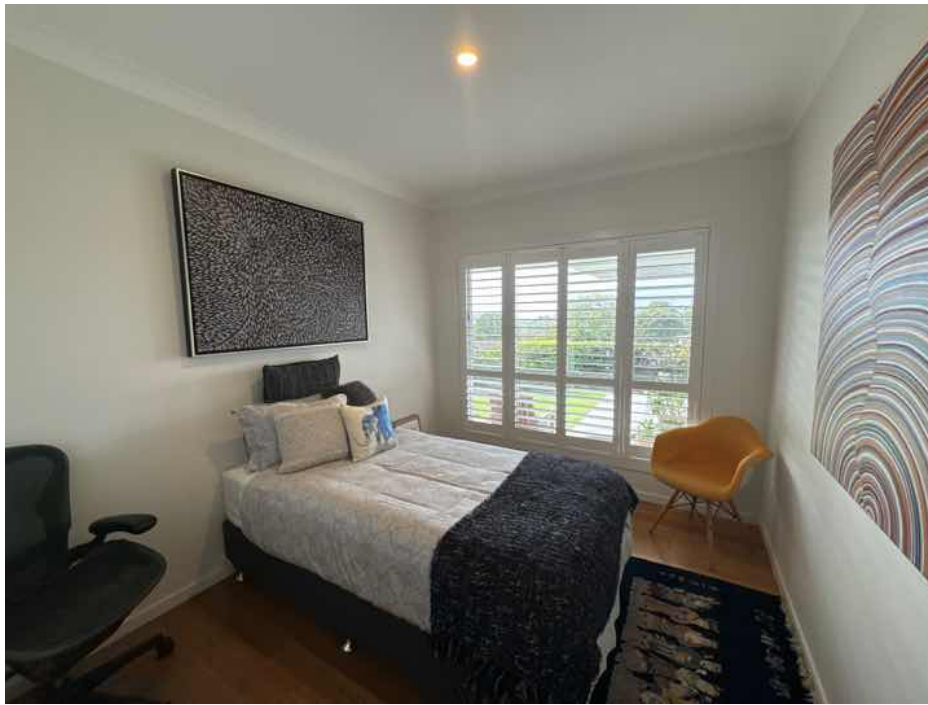
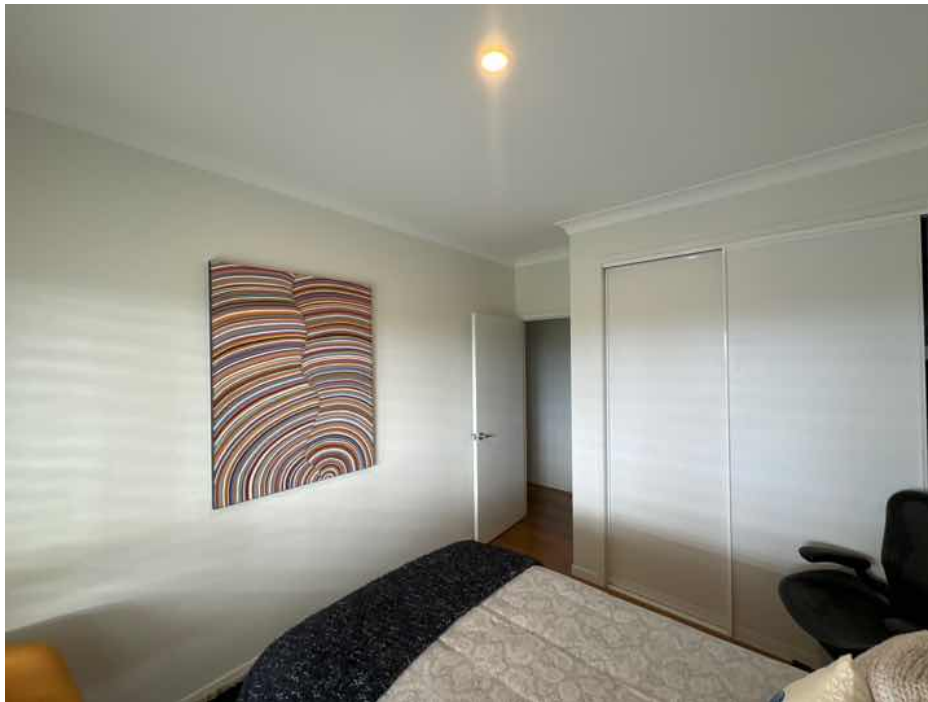
## Bedroom 2

From the visible and accessible areas, this bedroom appears to be in a serviceable condition for the age of the property with no notable structural defects sighted.

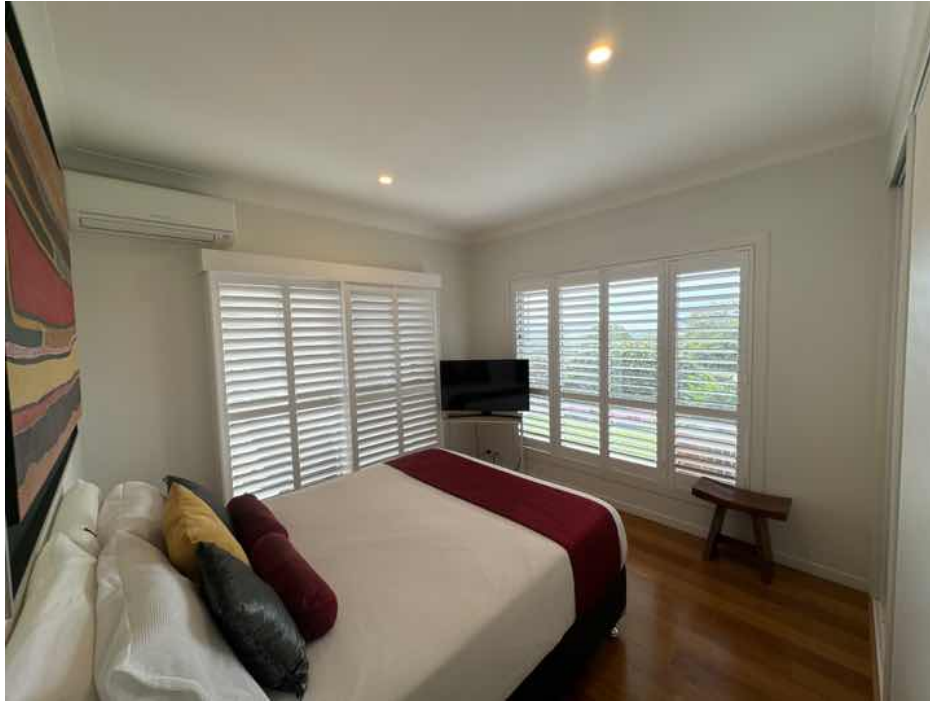
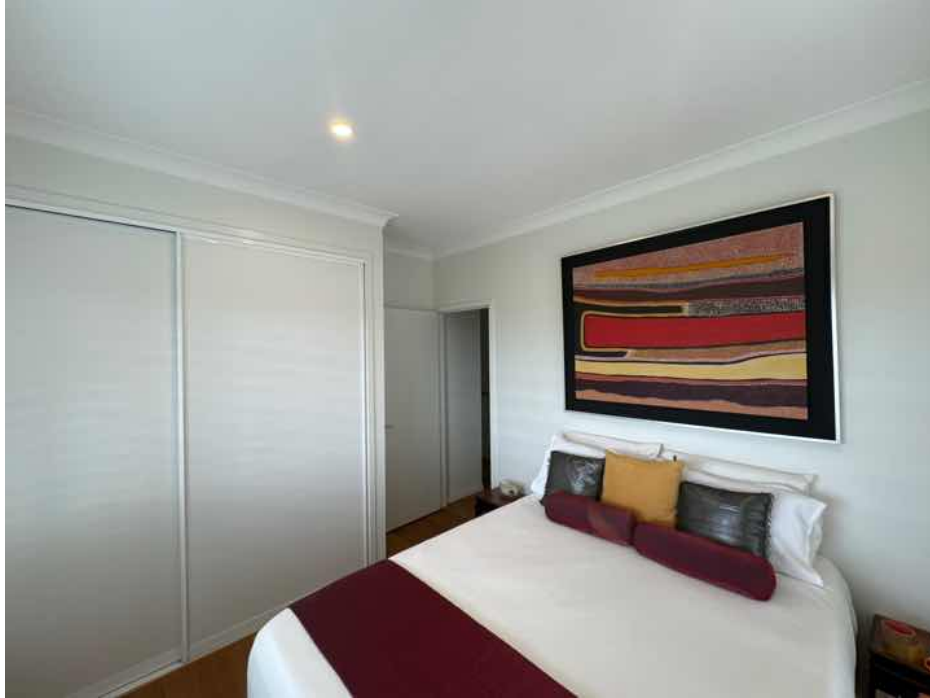
### **Bedroom 3**

From the visible and accessible areas, this bedroom appears to be in a serviceable condition for the age of the property with no notable structural defects sighted.

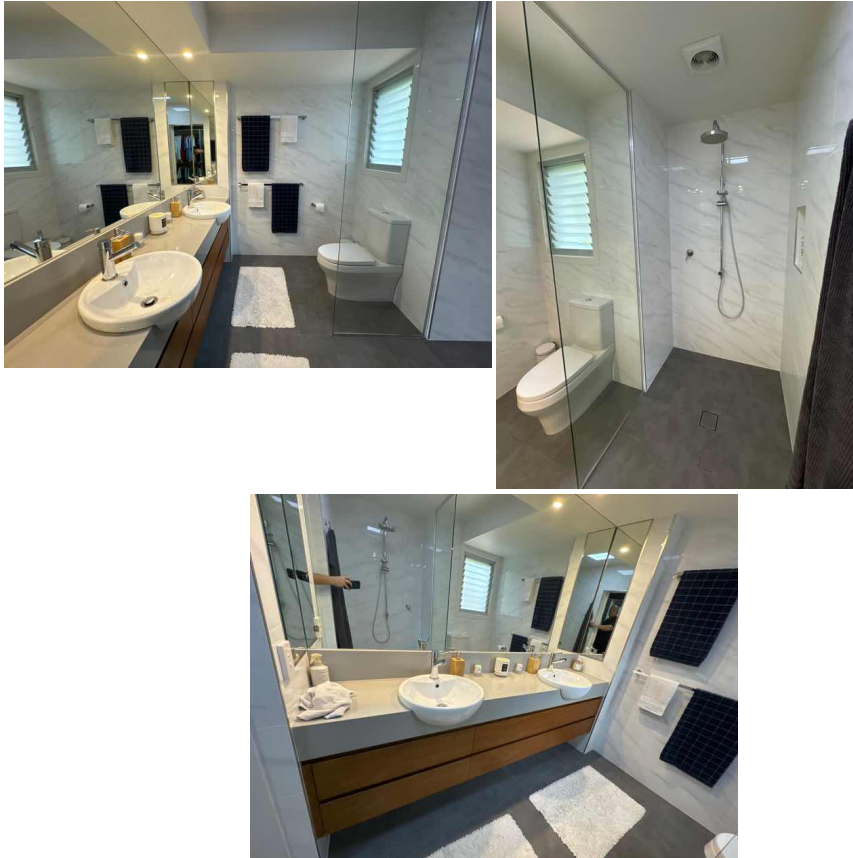
Of the visible areas, the general condition of this bathroom is serviceable or in reasonable condition for age of dwelling.

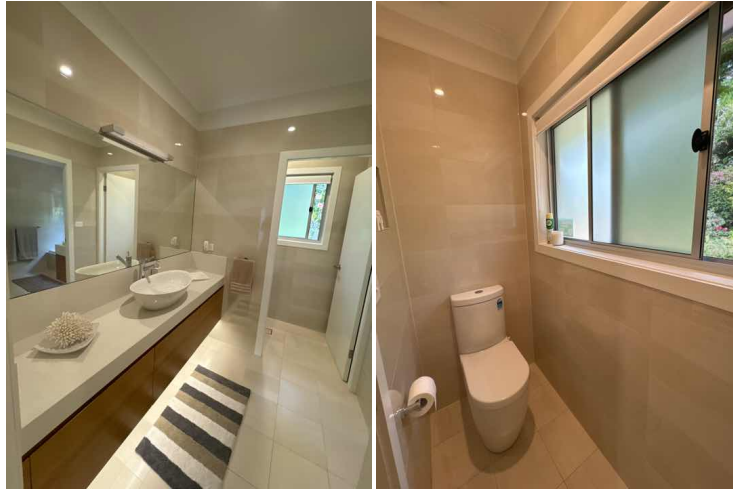
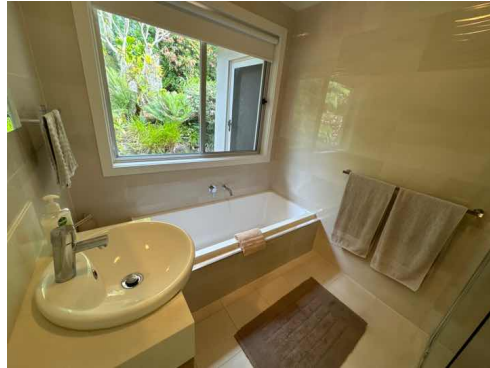
Of the visible areas, the general condition of this bathroom is serviceable or in reasonable condition for age of dwelling.
