# Building and Pest Report

## 8 Angus Kennedy Close, Lennox Head

# Inspection Report

**8 Angus Kennedy Close, Lennox Head, NSW, 2478**

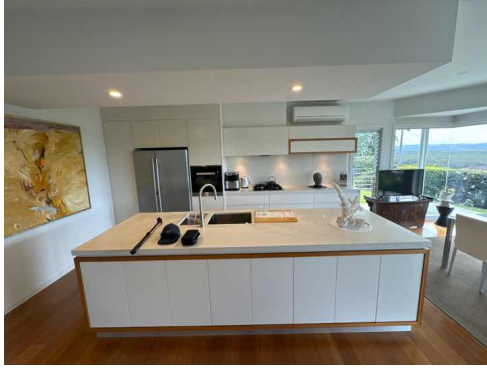
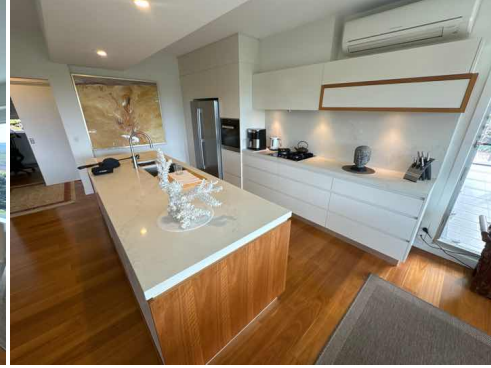
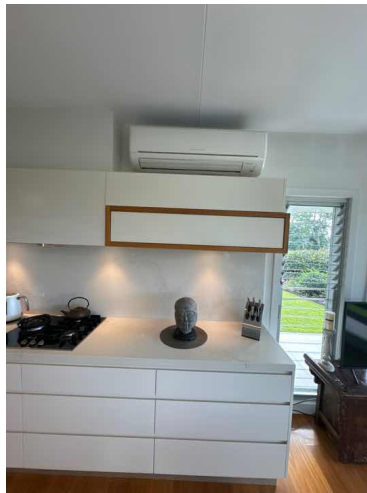
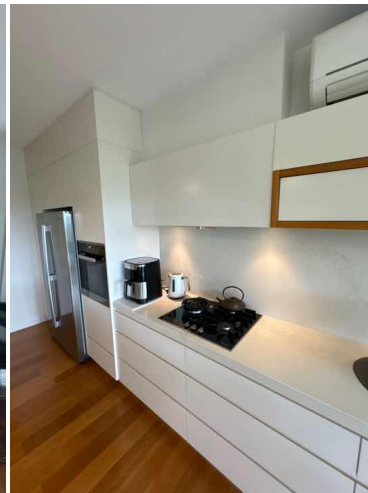
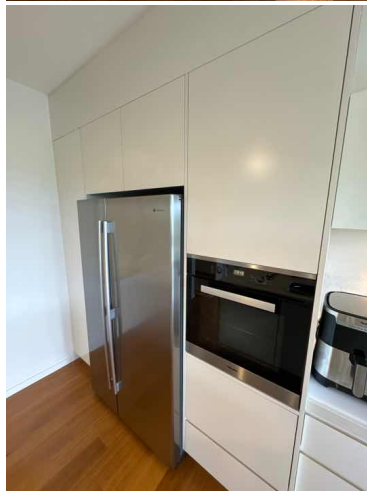
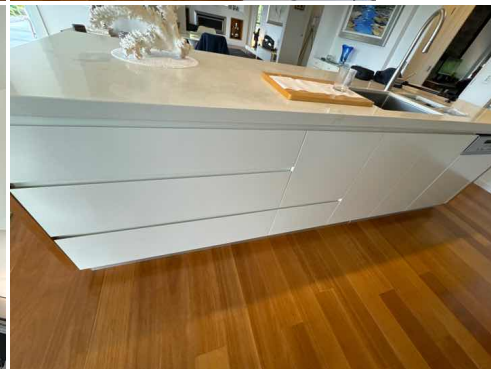
Of the visible areas, the general condition of the kitchen and pantry is serviceable or in reasonable condition for age of dwelling.

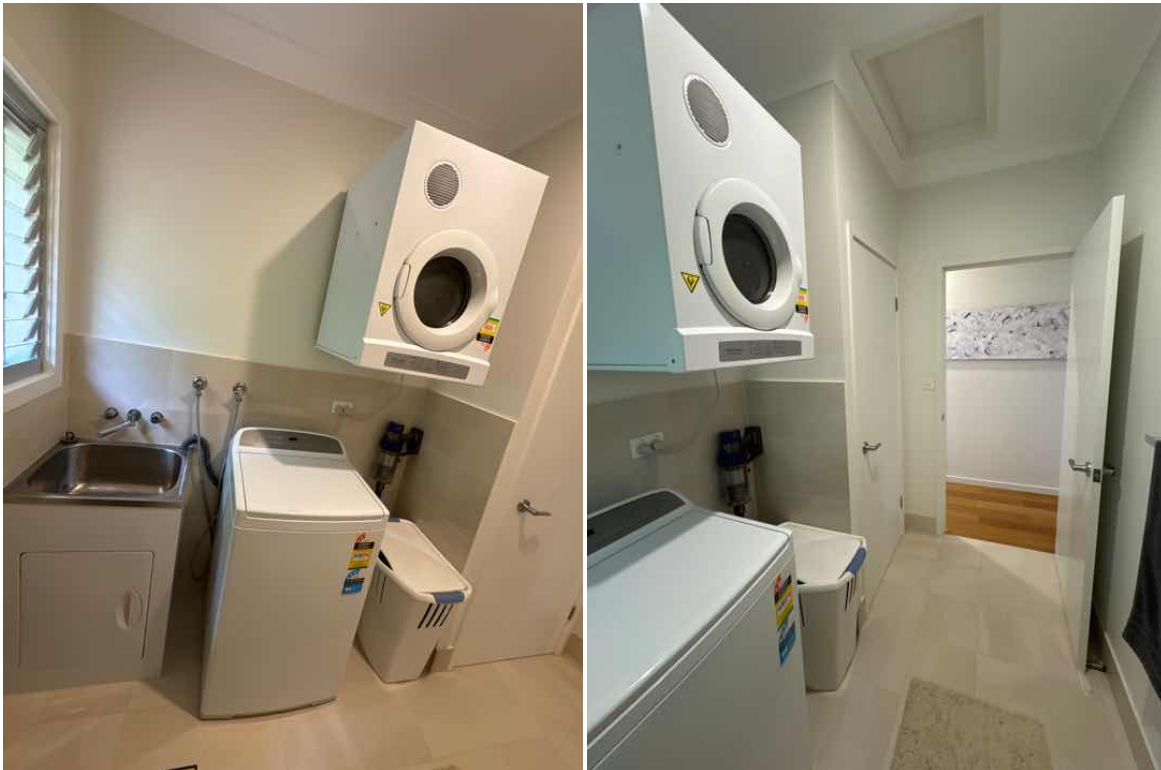
Of the visible areas, the general condition of the laundry is serviceable or in reasonable condition for age of dwelling.

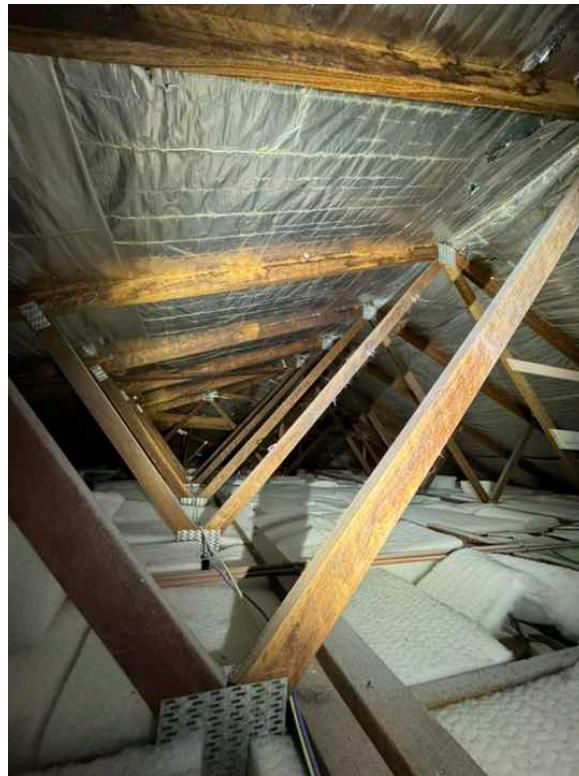
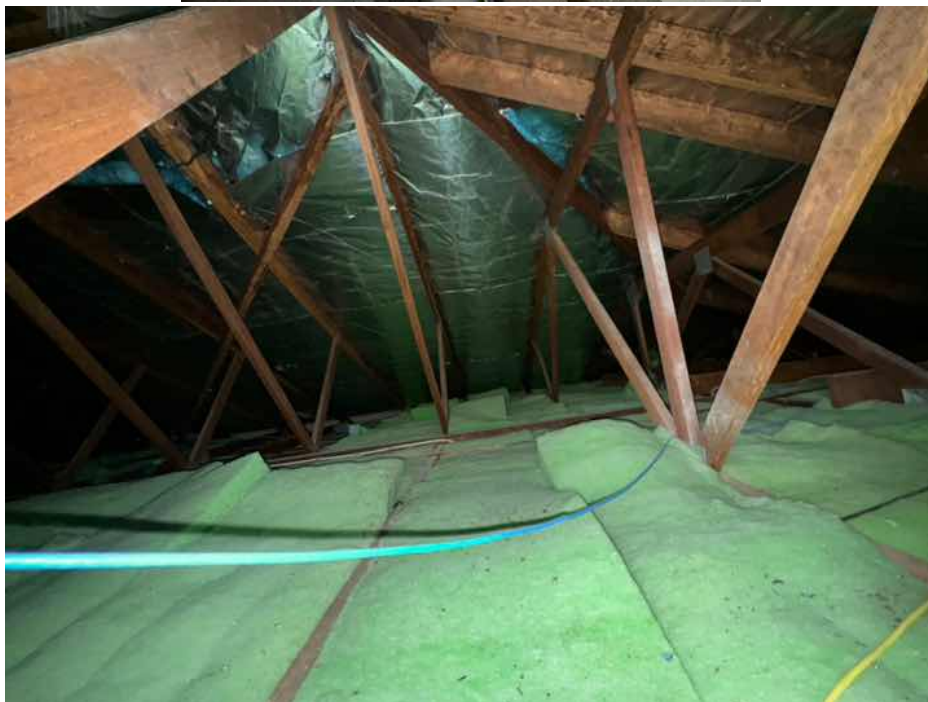
Visible sections of the roof void is in a serviceable condition for age of this dwelling.
