# Building and Pest Report

## 1/28 Kell Mather Drive Lennox Head

### Pest And Building Inspection

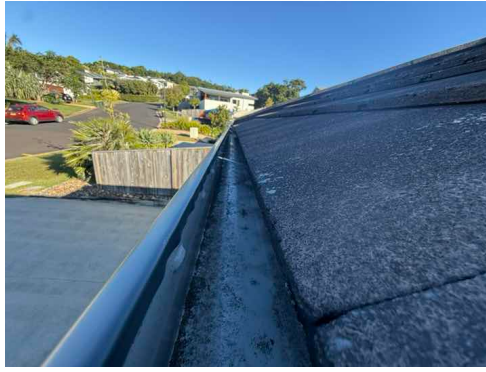
All visible and accessible of the physical nature of the guttering system appears to be in a serviceable condition with no apparent defects at the time of inspection. In the absence of prolonged rain fall efficiency of the guttering can not be assessed and you may find that further investigation or repairs maybe required. Note: Periodic maintenance checks should be carried out for rust penetrations and leaks.

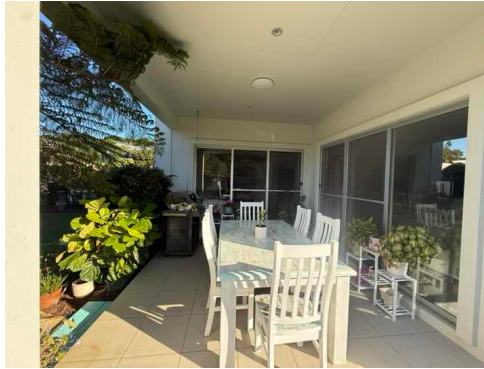
Visible sections of the Alfresco area are serviceable or in reasonable or condition for the age of this dwelling.

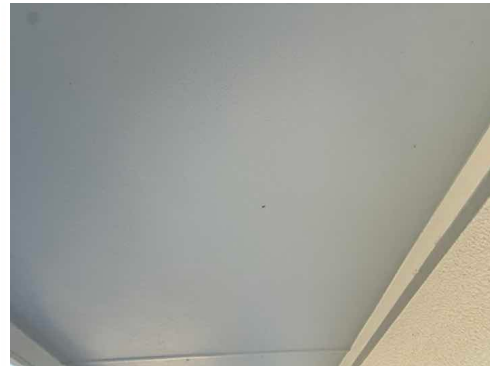
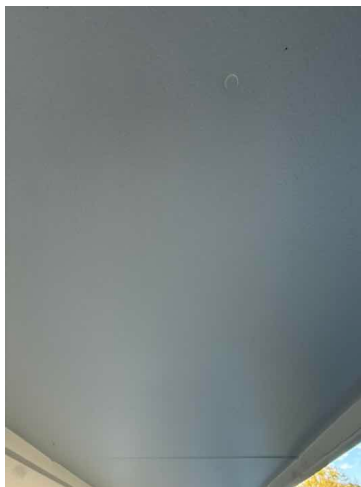
The soffit lining (eaves) are in a serviceable condition with no notable defects.

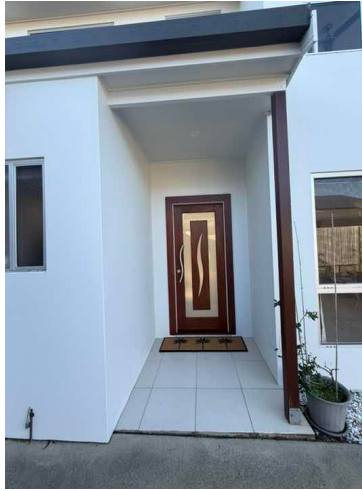
The entry porch serviceable or in reasonable or condition for the age of this dwelling.

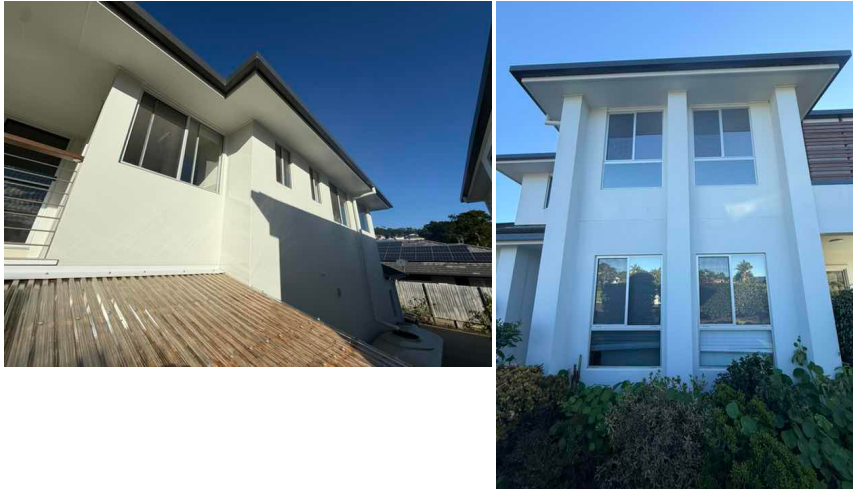
On visual inspection, the general condition of the exterior walls is serviceable for the age.

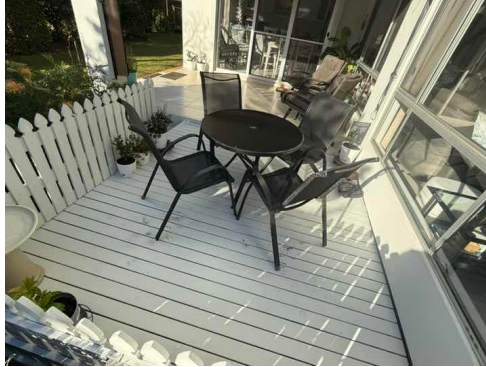
Of areas visible, the decking appears to be in a serviceable condition.

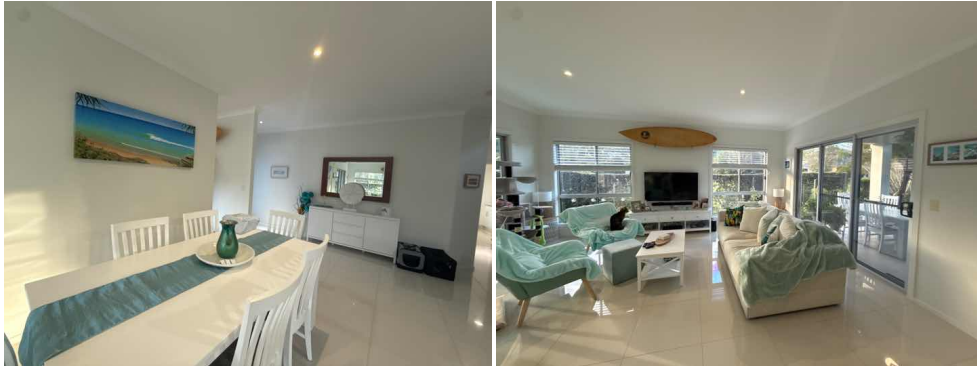
From the visible and accessible areas, this room appears to be in a serviceable condition for the age of the property with no notable structural defects sighted.

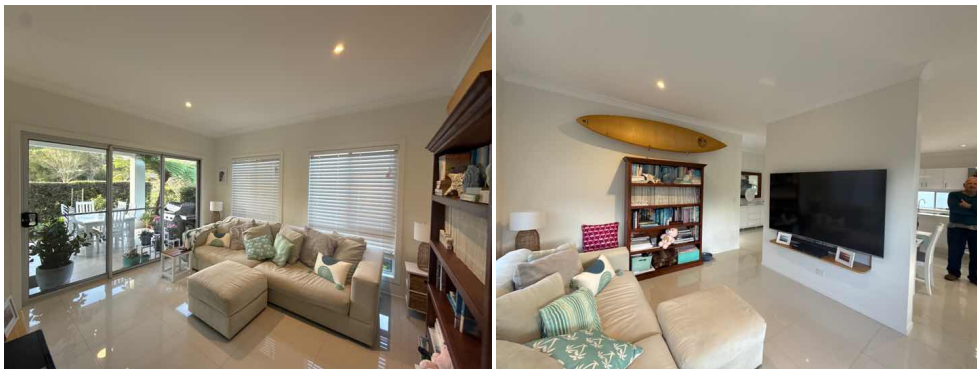
From the visible and accessible areas, this room appears to be in a serviceable condition for the age of the property with no notable structural defects sighted.

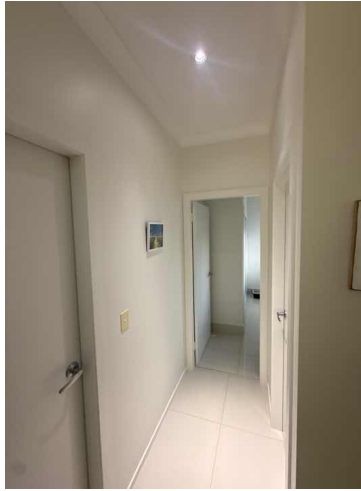
From the visible and accessible areas, the hallway/s/ appears to be in a serviceable condition for the age of the property with no notable structural defects sighted.

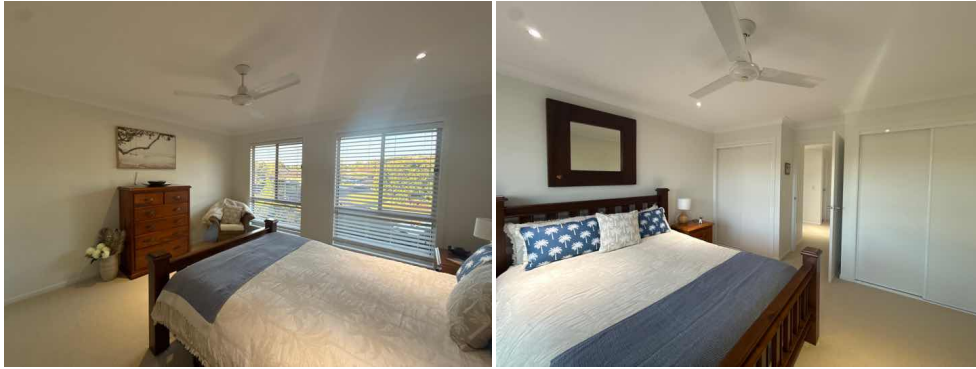
From the visible and accessible areas, this bedroom appears to be in a serviceable condition for the age of the property with no notable structural defects sighted.

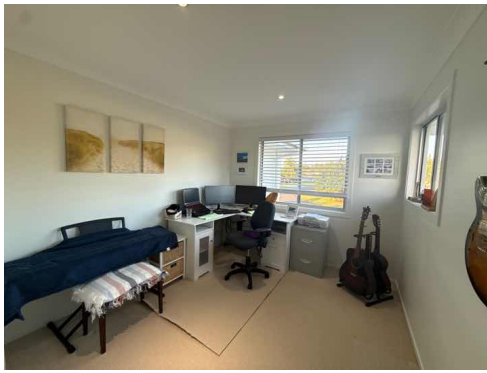
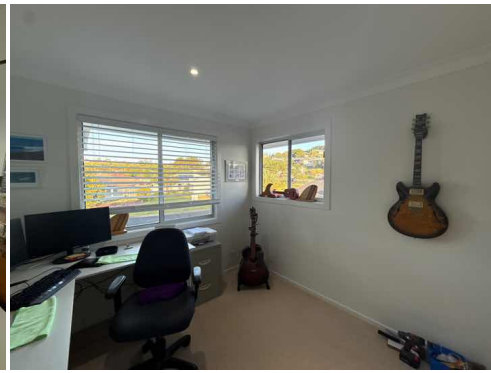
From the visible and accessible areas, this bedroom appears to be in a serviceable condition for the age of the property with no notable structural defects sighted.

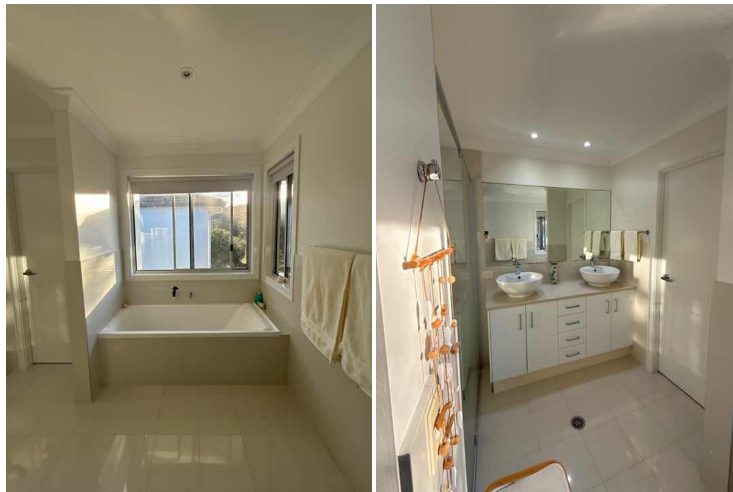
Of the visible areas, the general condition of this bathroom is serviceable or in reasonable condition for age of dwelling.
