PEST AND BUILDING PRE-PURCHASE REPORTS

BPI BUILDING & PEST INSPECTIONS

31 Linderman Street
West Ballina

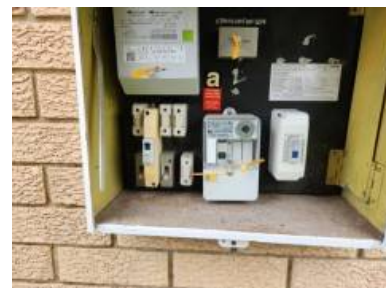
ELECTRICAL SAFETY SWITCH:

Whilst not an electrician, it appears that an electrical safety switch is present.

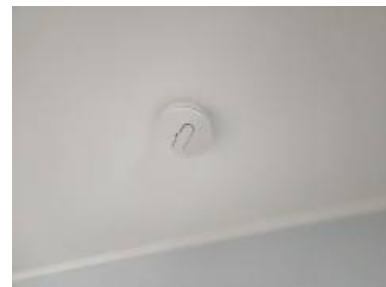
SMOKE DETECTORS / ALARMS:

Present - Hall.

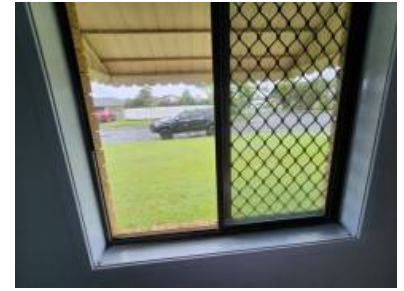
Metal.

Kitchen window reveal require repainting.

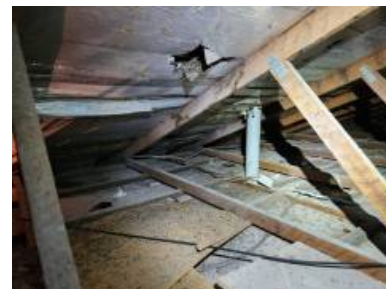
Inspection over the eaves was restricted due to the low pitch and construction allowing only a limited visual inspection from a distance of some areas to be carried out.

Clearance within sections of the roof was too low to allow body access. Outer top wall plates and framing timbers were not inspected due to the area being too low to allow body access. This allows only a limited visual inspection from a distance of some areas to be carried out.

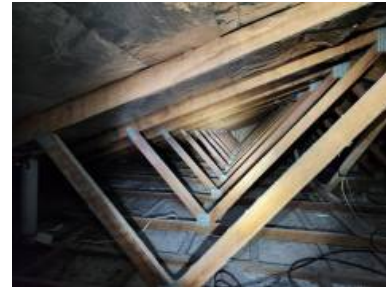
Roof Void & Framing - Condition

The roof framing is in satisfactory / typical condition for the age / construction date.

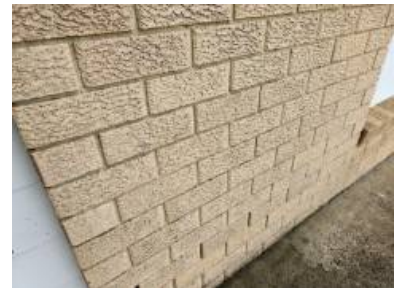
Some mortar to some brickwork next to front door shows signs of erosion and requires repair / patching. I recommend that a qualified bricklayer be engaged for further investigation / rectification.

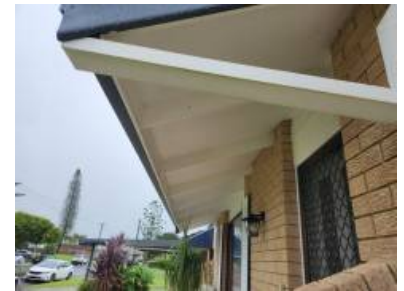
PAINTING

Condition:
The external paintwork / finish to the external surfaces and timberwork is generally in good condition. There may be sections / areas that require touching up / repainting.

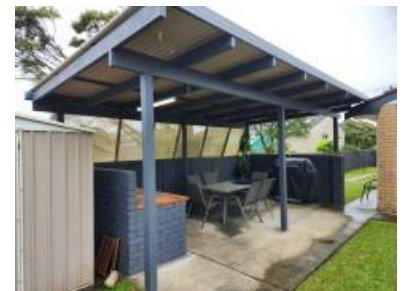
Condition:
Some fascia / barge timbers show signs of weather damage.

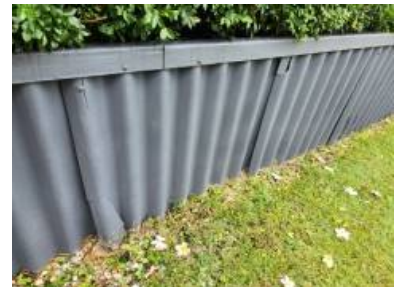
Please be aware that Asbestos may be contained within some fencing around the property. We Strongly Recommend that you obtain an Asbestos Inspection / Report to identify all areas that contain Asbestos product / material.
