Building and Pest Report

100 Phoenix Drive, Tintenbar

Inspection Report

100 Phoenix Dr, Tintenbar, NSW, 2487

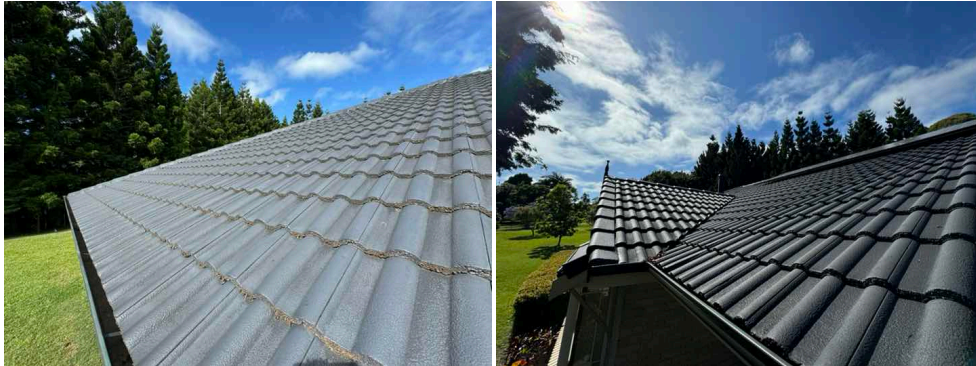
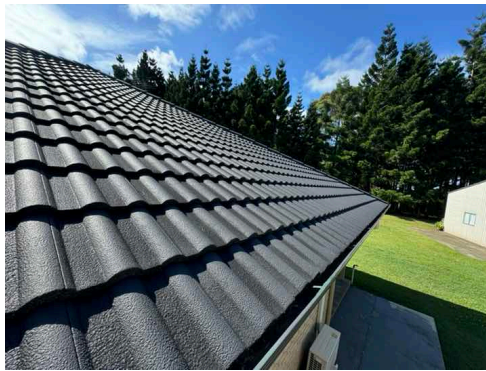
Of the visible areas, the general condition of the roof is in serviceable condition for the age.

Note: In the absence of rainfall there is no guarantee that the roof won't leak.

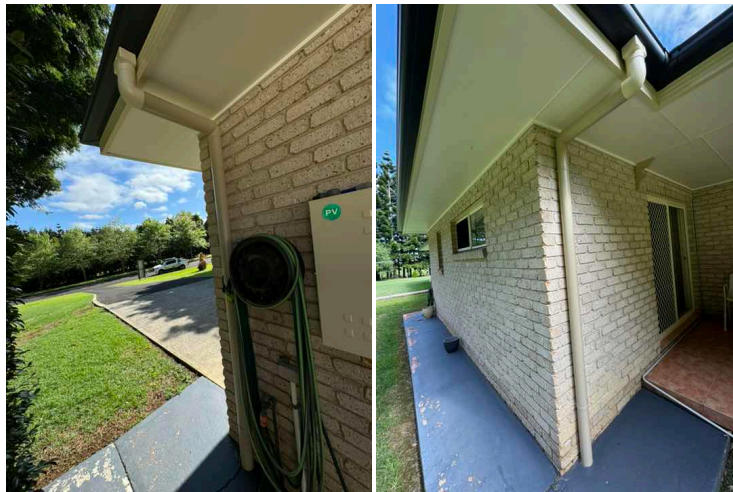
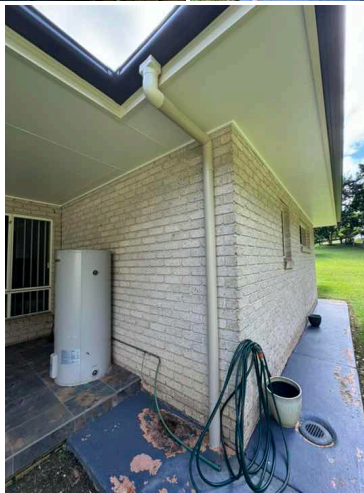
Downpipe Findings

On visual inspection no apparent defects were noted to the down pipes and are considered serviceable, however no comment can be made with regard to blockages or connections to stormwater or functionality in the absence of rain. Note: Periodic maintenance checks should be carried out for rust penetrations and leaks.

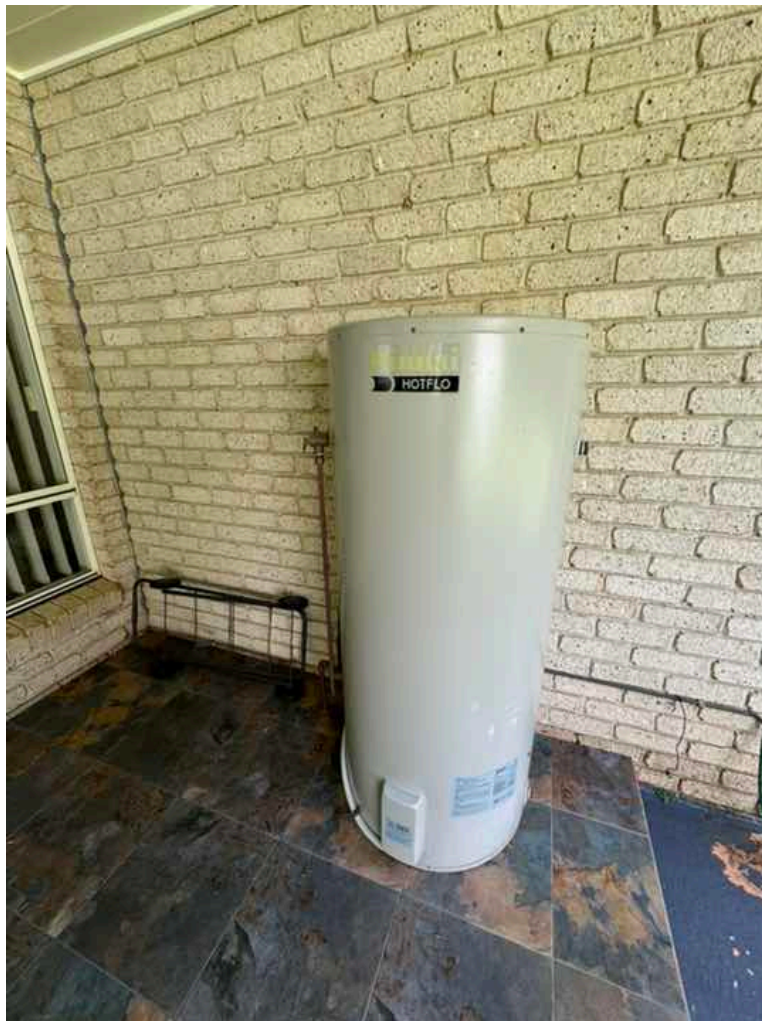
The make of the hot water unit is rinnai.

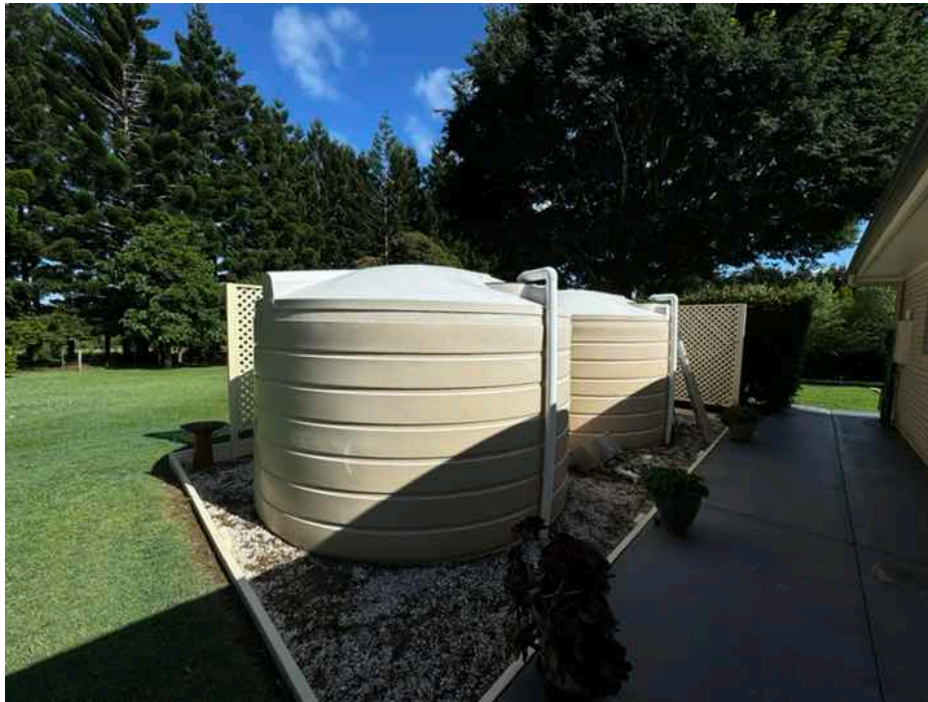
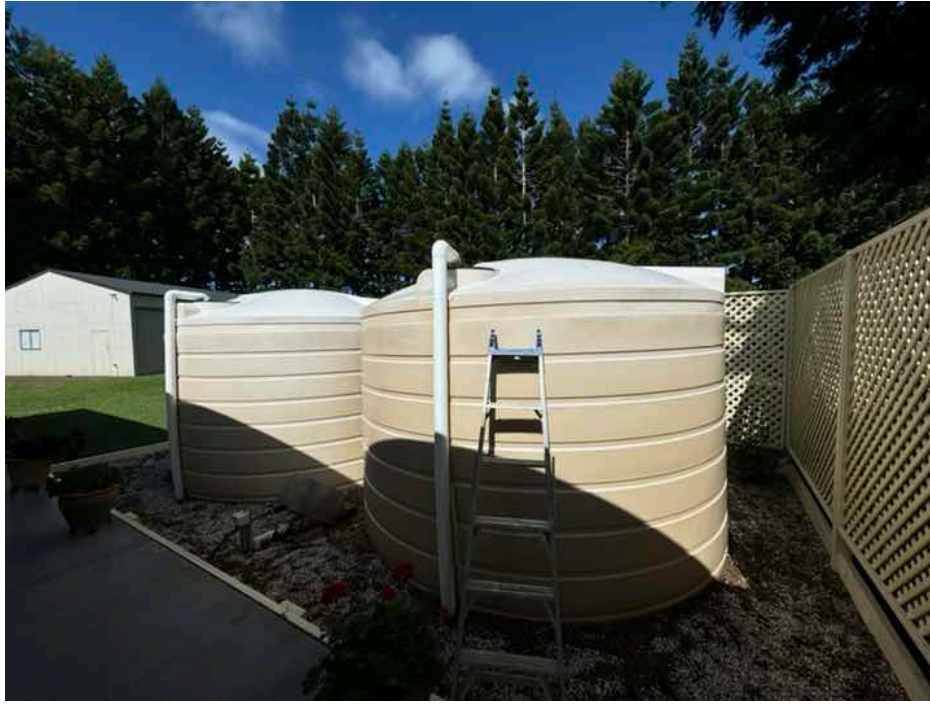
Water Tank Condition

On Visual Inspection the water tank appears serviceable, but should be checked by a qualified plumber.

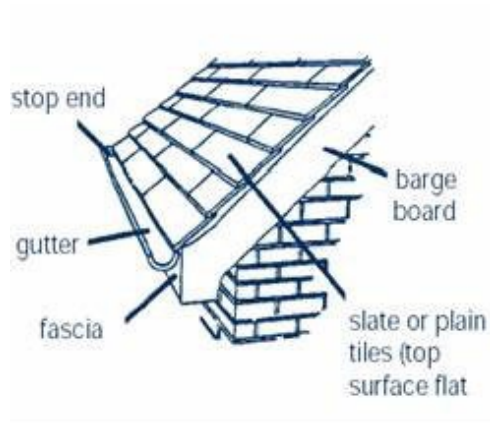
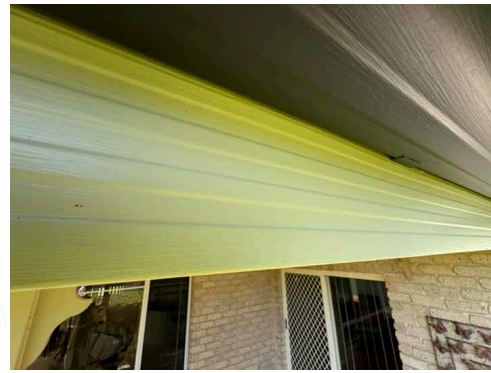
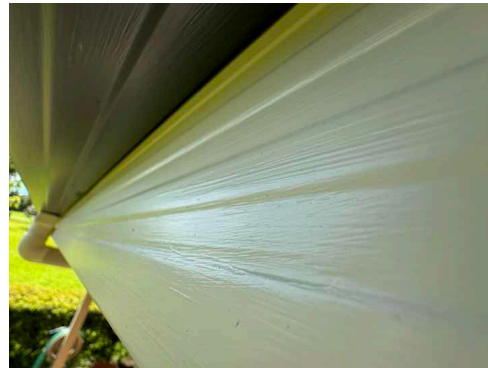
On visual inspection, the general condition of the fascia/barge boards is serviceable.

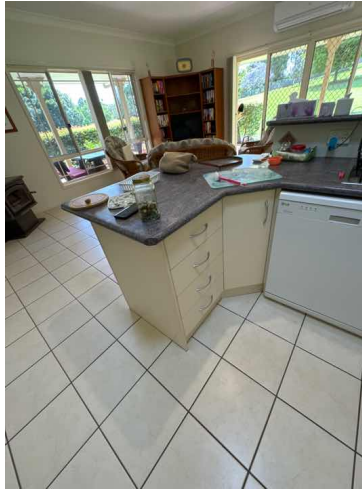
Ceiling

Cornice separation. I recommend you contact a licensed painter for repairs.
