# PEST AND BUILDING PRE-PURCHASE REPORTS

# Inspection Report

## East Coast Building Solutions

**61 Daintree , Lennox Head, NSW, 2478**

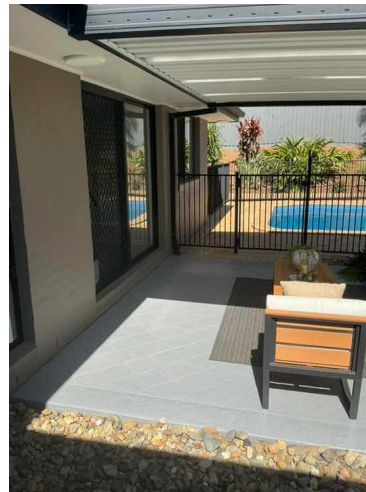
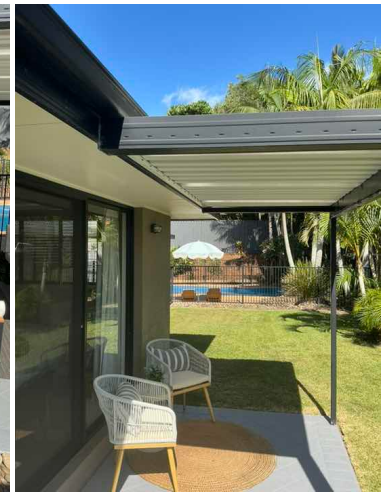
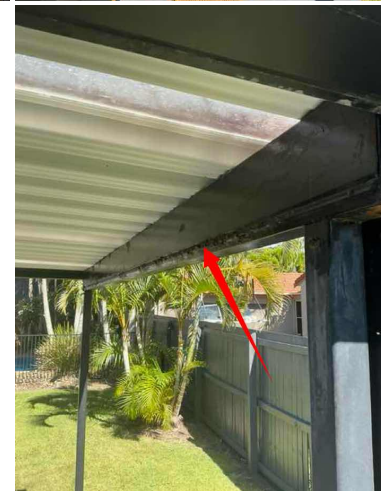
Visible sections of the Alfresco area are serviceable or in reasonable or condition for the age of this dwelling. Upon visual inspection, there appears to be corrosion on the metal beam. It is recommended to have a licensed tradesperson assess and treat the rust to prevent further deterioration. Consider applying a protective coating to extend the lifespan of the structure. Regular maintenance checks should be scheduled to monitor the condition of the metal components.

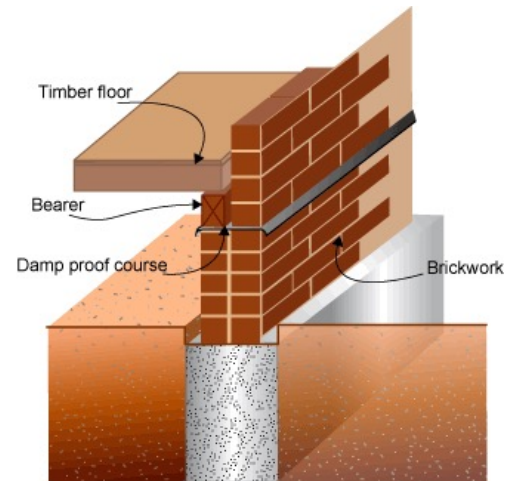
Upon visual inspection, the wall appears to have minor cracks and potential moisture exposure at the base. Recommend sealing cracks with appropriate filler and applying a waterproof sealant. Ensure proper drainage away from the wall to prevent further moisture issues. Consult a licensed tradesperson for a detailed assessment and repair.

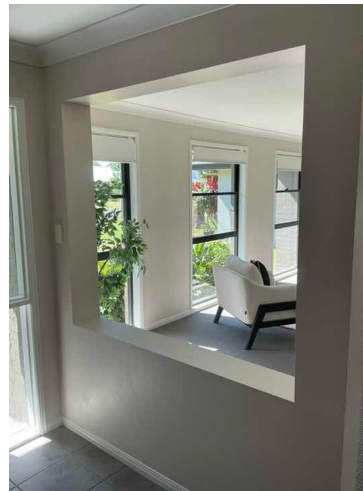
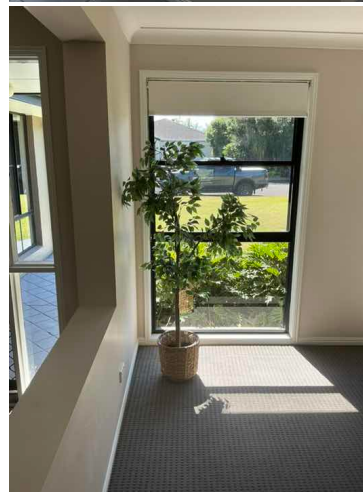
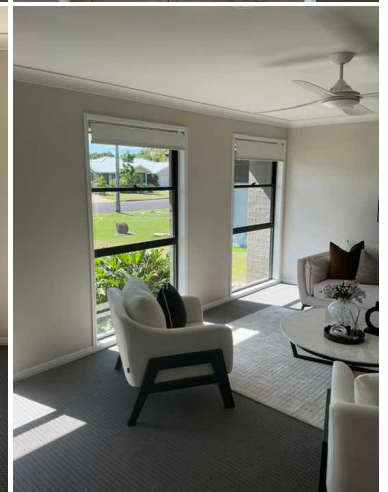
## Family Room

Upon visual inspection, the carpet shows signs of wear and possible damage near the window area. It is recommended to have a licensed flooring specialist assess and repair or replace the affected section to prevent further deterioration and ensure safety.

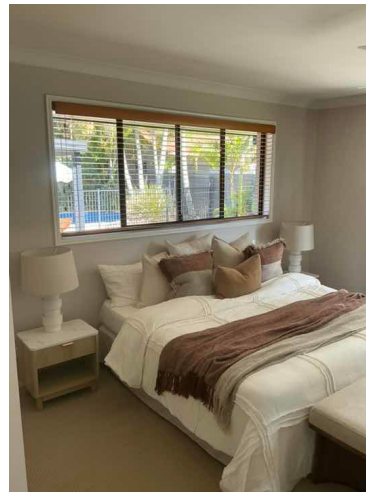
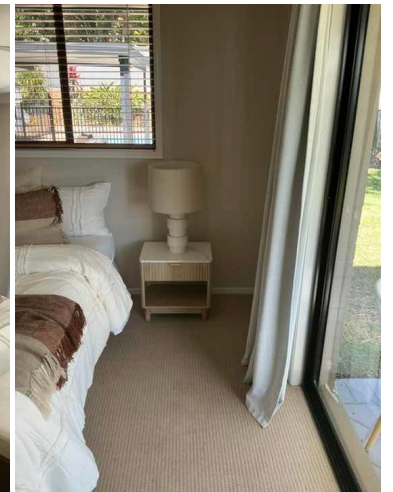
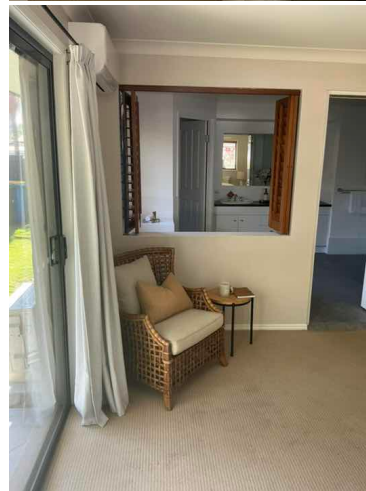
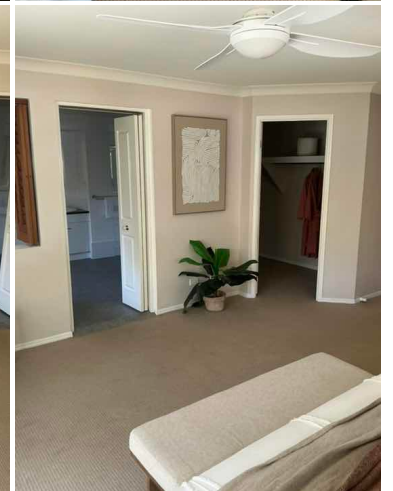
Upon visual inspection, the glass panel is cracked, posing a safety hazard. Immediate replacement by a licensed glazier is recommended to prevent injury and ensure structural integrity. Additionally, inspect the surrounding frame for any potential damage or misalignment that may have contributed to the crack.

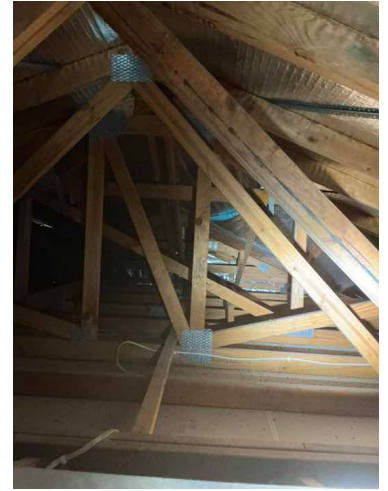
No insulation installed. Recommendations: Engage insulation contractor to assess.
