# PEST AND BUILDING PRE-PURCHASE REPORTS

# Inspection Report

## East Coast Building Solutions

**245 Hutley Drive , Lennox Head, NSW, 2478**

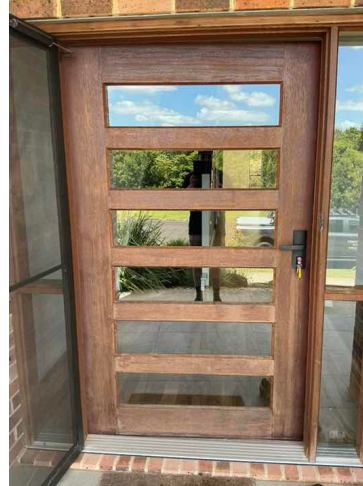
#### Front Entry Doors

Upon visual inspection, the wooden door appears well-maintained with no visible defects. The glass panels are intact, and the door frame shows no signs of damage. Ensure regular maintenance to preserve the wood finish and check for any potential weather-related wear. Consider consulting a licensed tradesperson for routine inspections to maintain optimal condition. Recommend planing bottom of door for full functionality

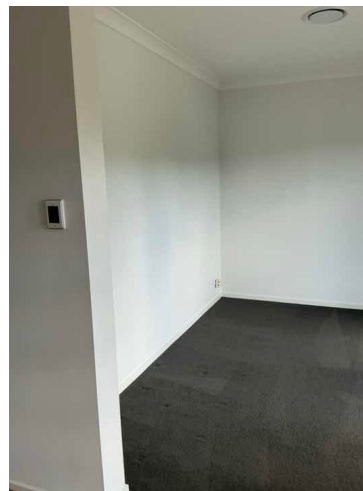
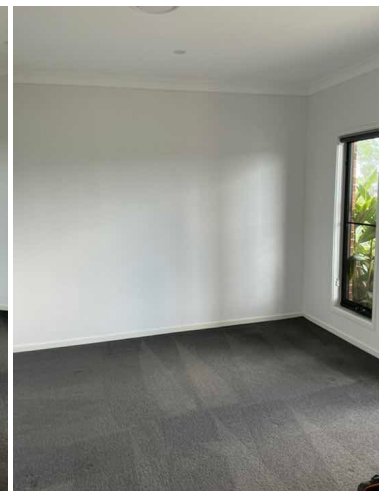
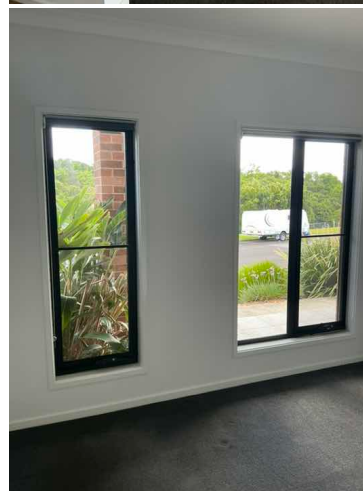
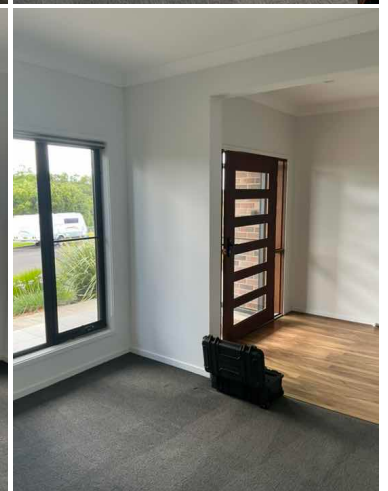
## Study

From the visible and accessible areas, this room appears to be in a serviceable condition for the age of the property with no notable structural defects sighted.

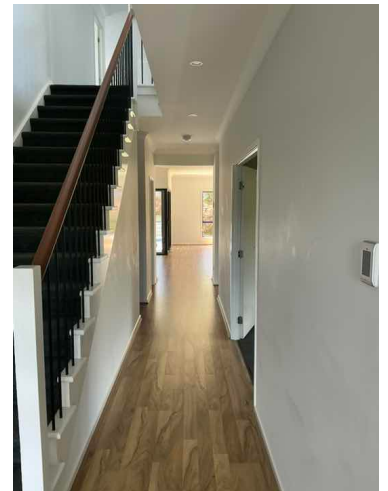
## Hallway/s

From the visible and accessible areas, the hallway/s/ appears to be in a serviceable condition for the age of the property with no notable structural defects sighted.

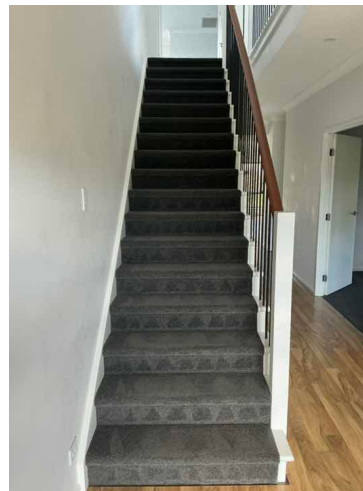
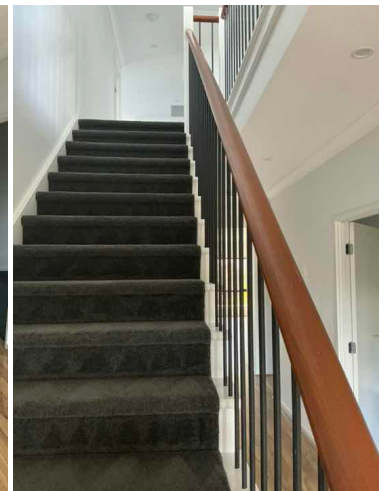
## Internal Stair Case

The internal staircase and components appear to be in a serviceable condition for the age with no notable defects sighted.

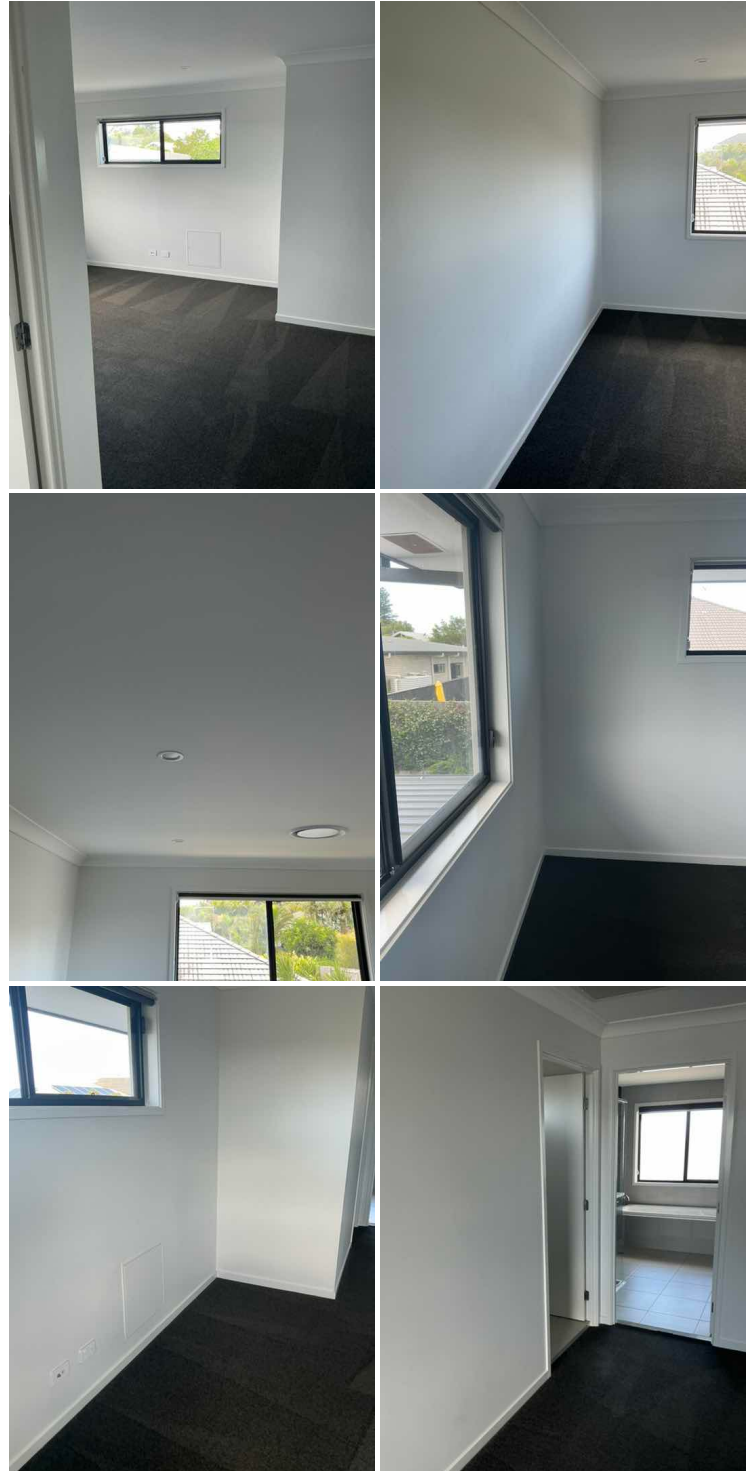
## Upstairs Leisure Room

From the visible and accessible areas, this room appears to be in a serviceable condition for the age of the property with no notable structural defects sighted.

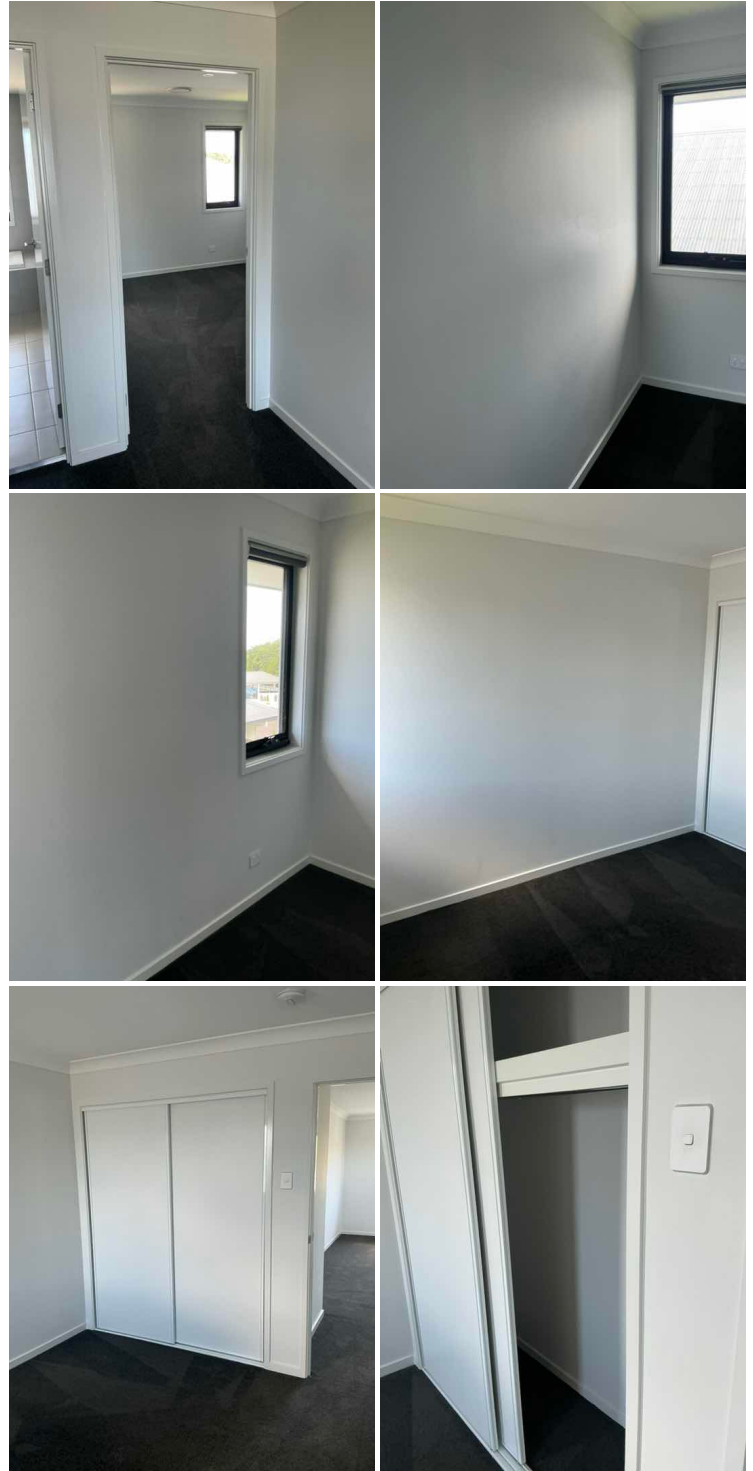
## **Bedroom 2**

From the visible and accessible areas, this bedroom appears to be in a serviceable condition for the age of the property with no notable structural defects sighted.

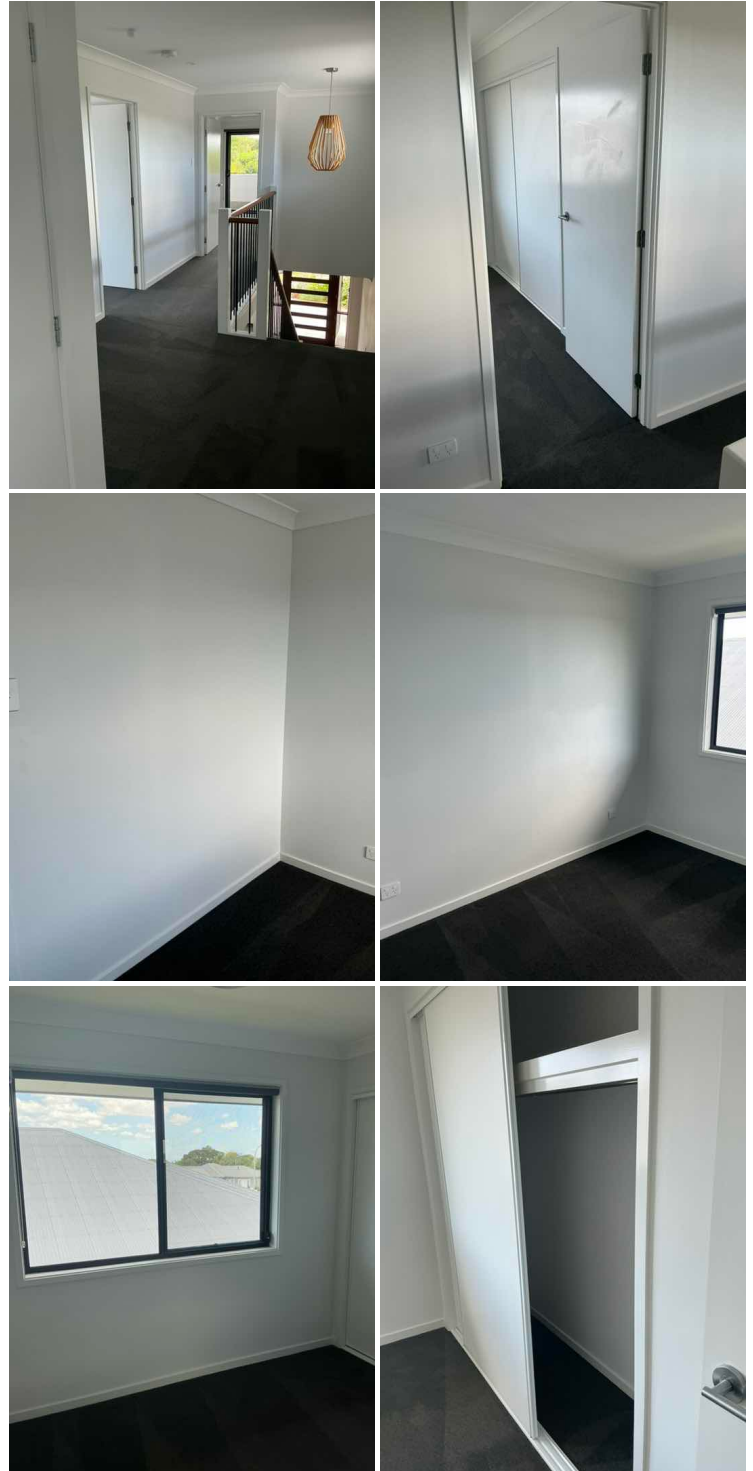
## **Bedroom 3**

From the visible and accessible areas, this bedroom appears to be in a serviceable condition for the age of the property with no notable structural defects sighted.

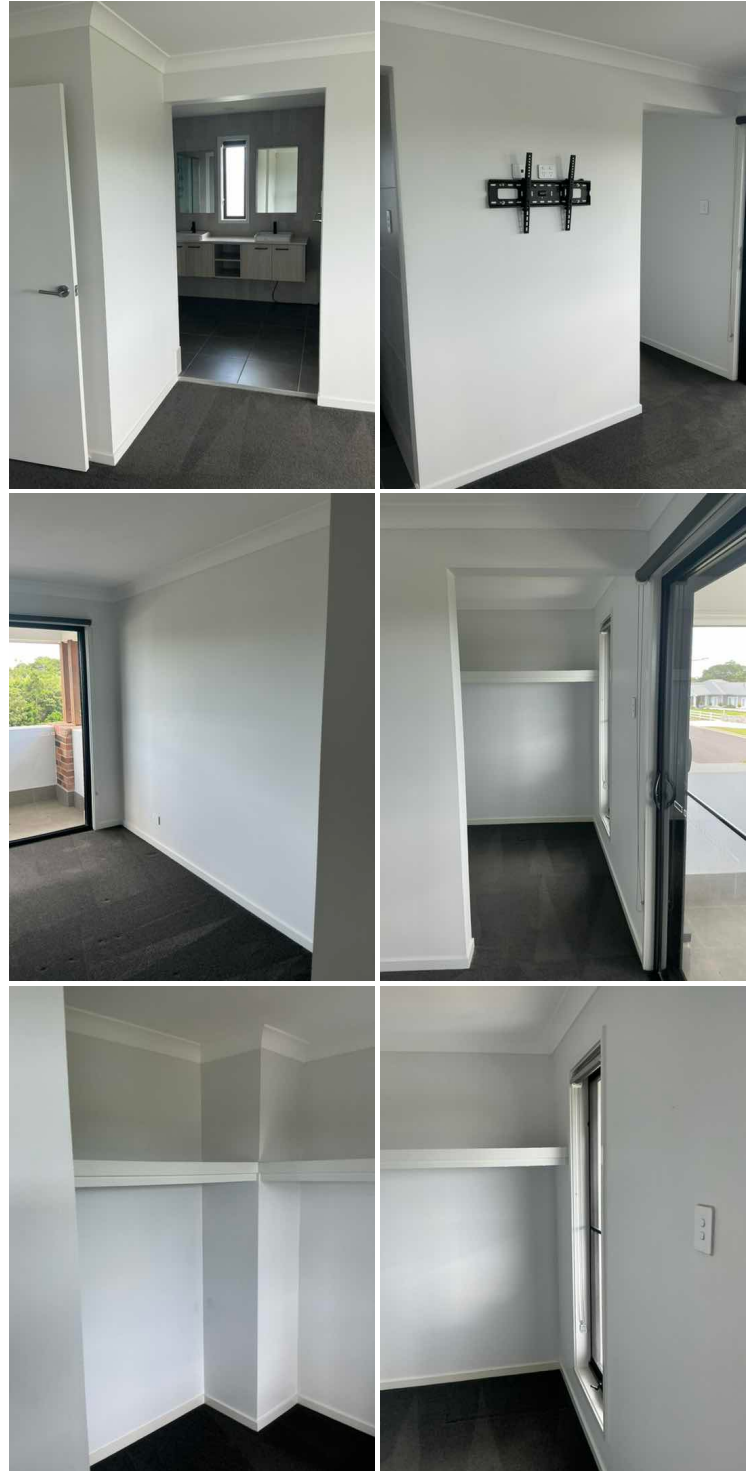
## **Bedroom 4**

From the visible and accessible areas, this bedroom appears to be in a serviceable condition for the age of the property with no notable structural defects sighted.

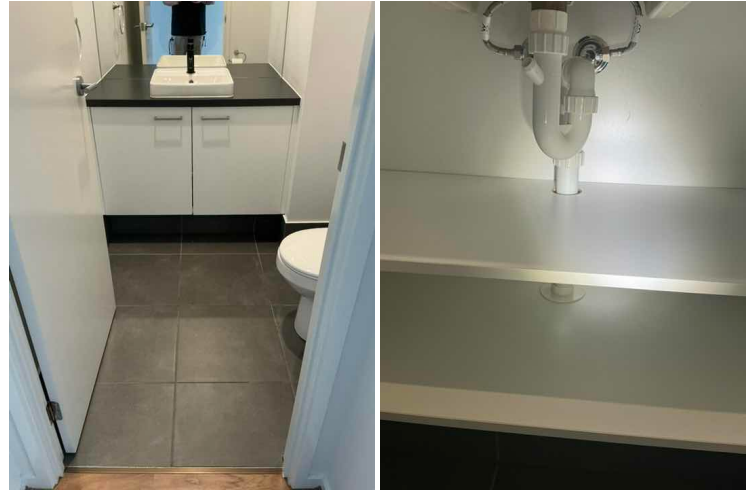
This bathroom is located in the lower level.

Of the visible areas, the general condition of this bathroom is serviceable or in reasonable condition for age of dwelling.

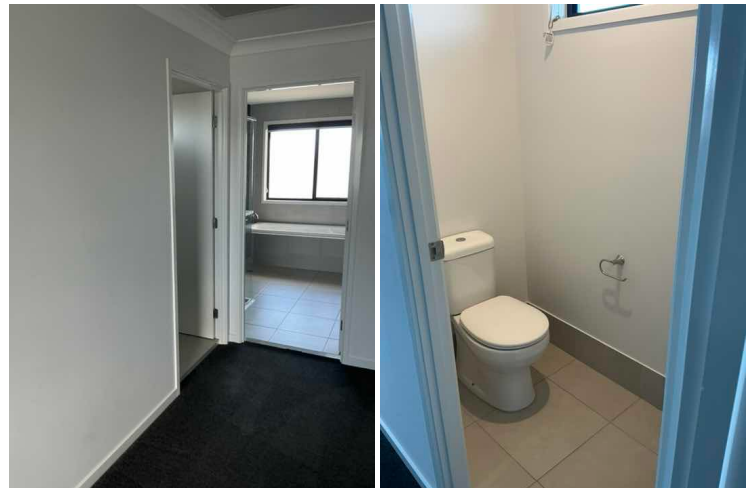
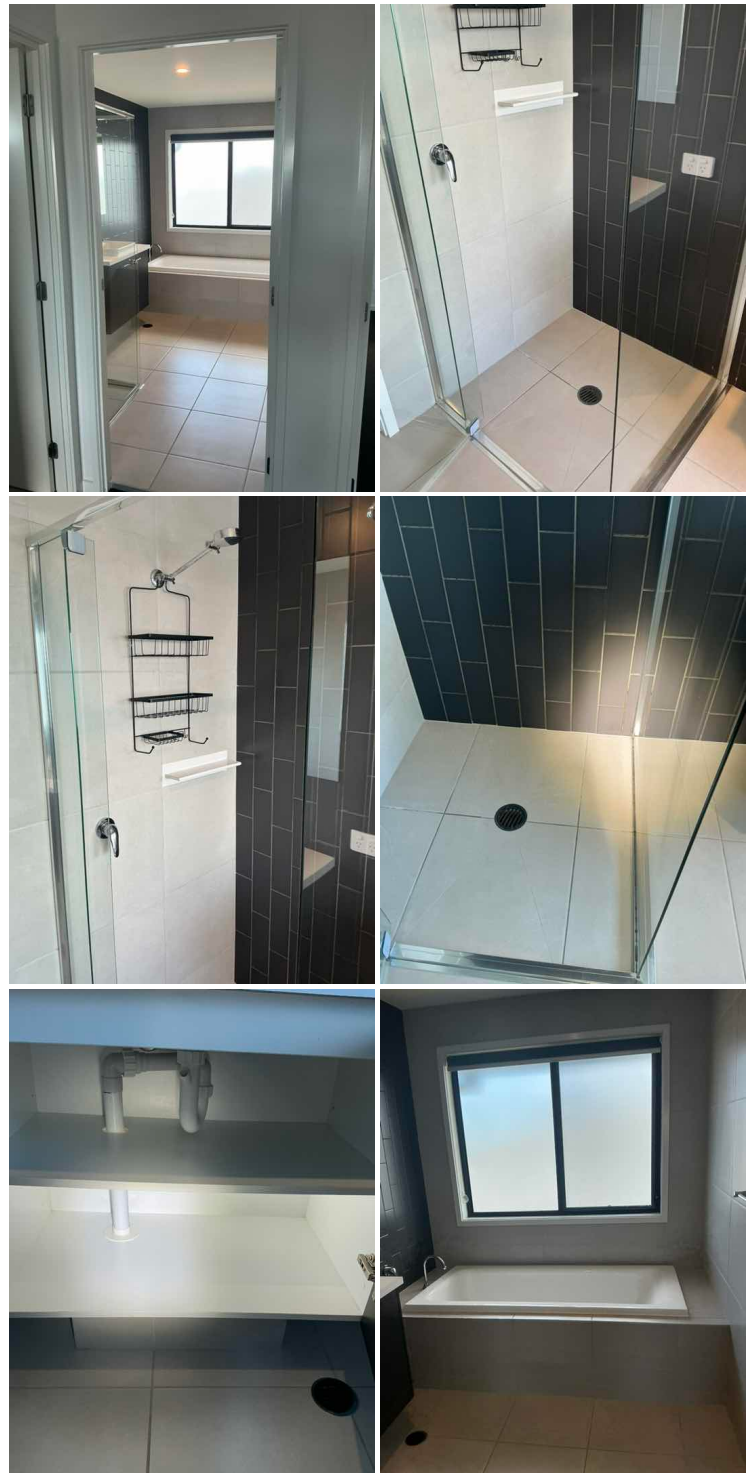
This bathroom is located in the upper level.

Of the visible areas, the general condition of this bathroom is serviceable or in reasonable condition for age of dwelling.

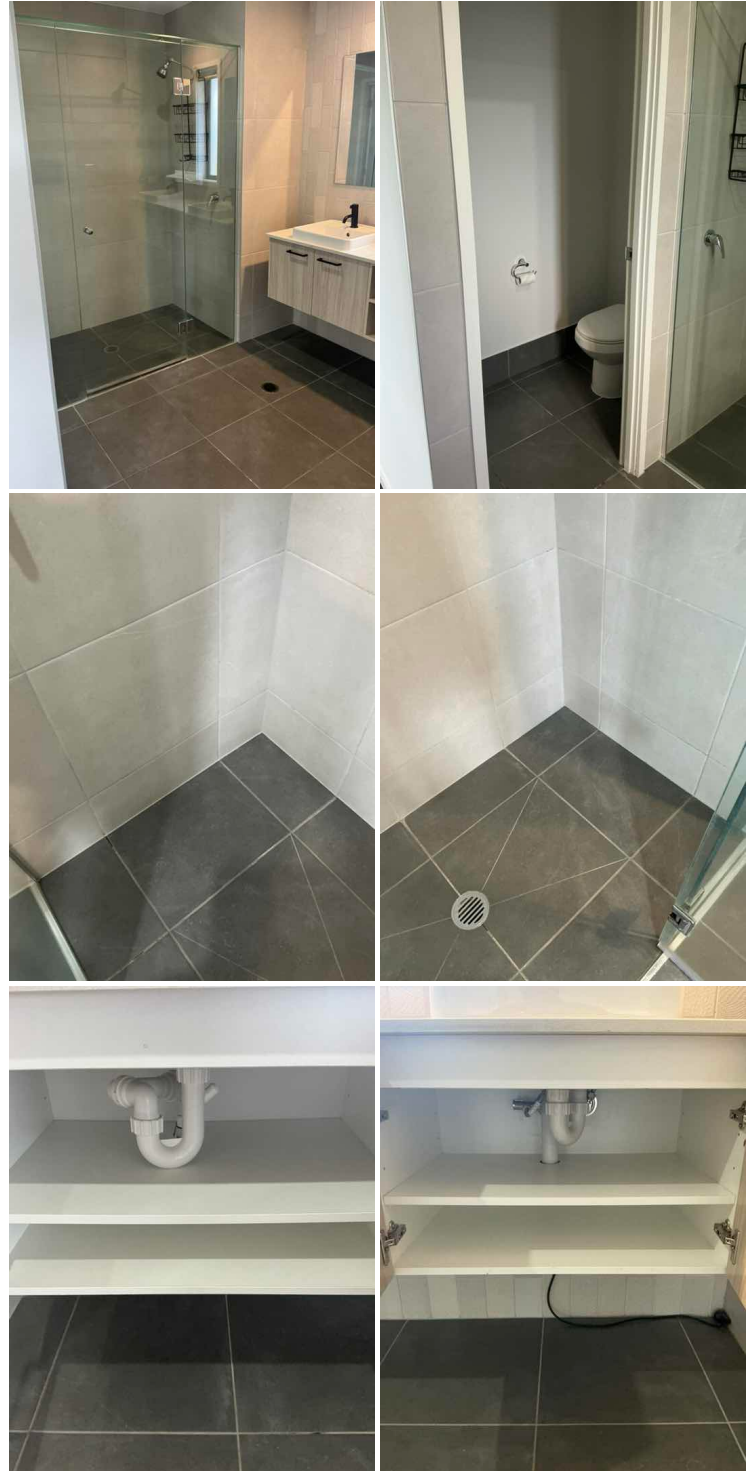
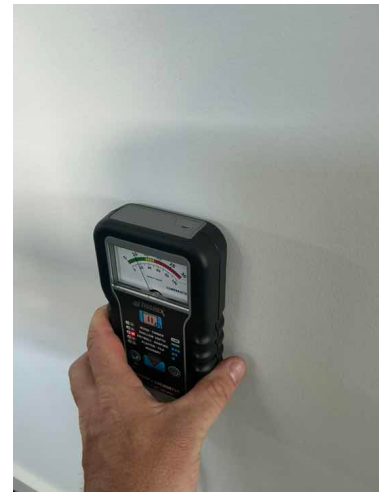
This bathroom is located in the master bedroom.

Of the visible areas, the general condition of this bathroom is serviceable or in reasonable condition for age of dwelling.

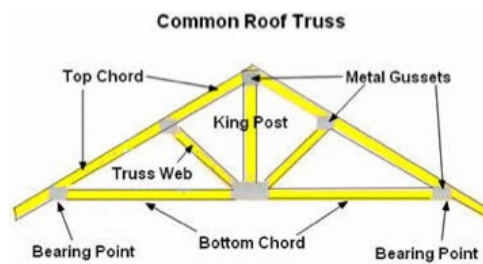
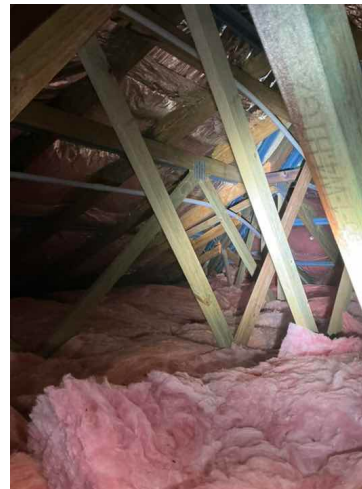
There is heating and/or cooling ducting present in the roof space. This is preventing a full inspection from being undertaken. It is strongly recommended that full access be gained as it could be harbouring timber pest activity, damage or defects.

There is insulation present in the roof space/void. This is preventing a full inspection of ceiling joists from being undertaken. It is strongly recommended that full access be gained as it could be harbouring timber pest activity, damage or defects.

The roof frame is a truss timber frame.
