PEST AND BUILDING PRE-PURCHASE REPORTS

Inspection Report

37 Montwood Dr, Lennox Head, NSW, 2478

Pest And Building Inspection

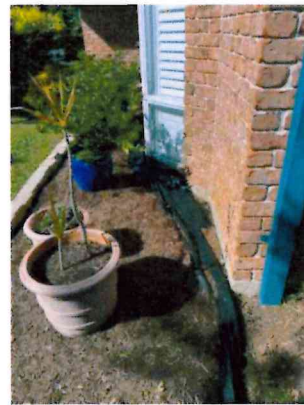
Showing newly exposed slab edge in front garden.

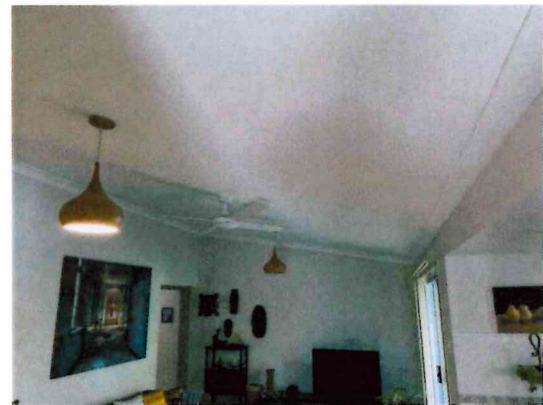
Showing internal roof structure.
