# Building and Pest Report

## 10 Kurrajong Crt East Ballina

| Report/Agreement # | 30102509452070 |
| Inspection Date: | 30 Oct 2025 |

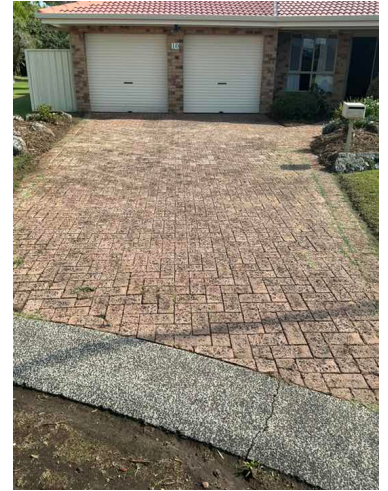
On visual inspection, the general condition of the driveway is serviceable.

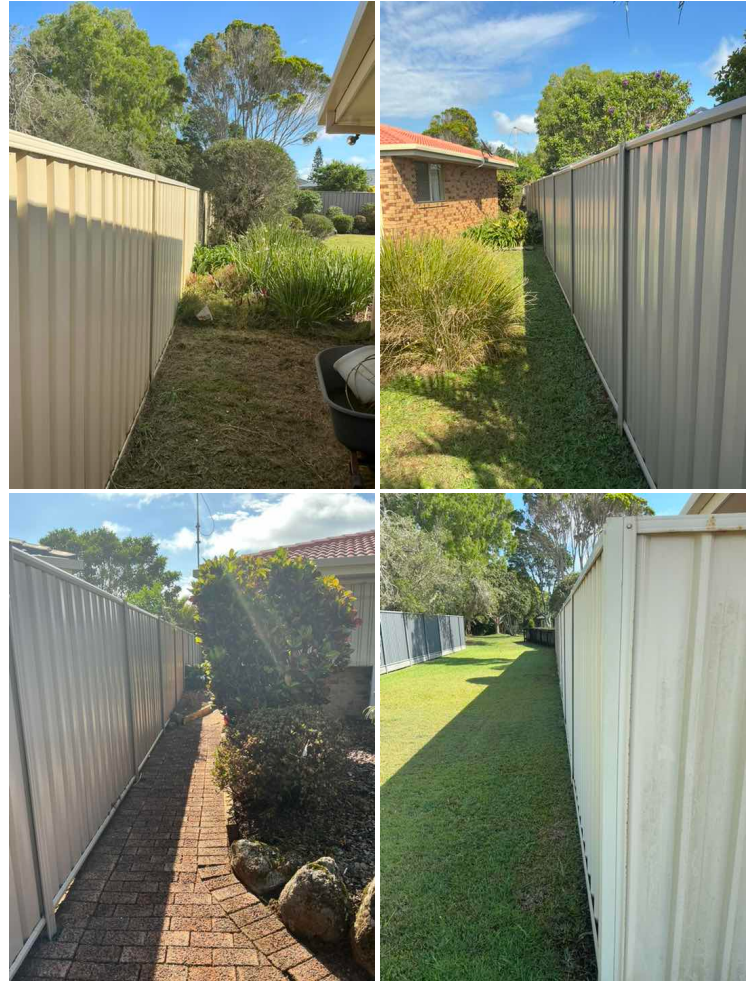
Of the visible areas, the general condition of the fences and gates is serviceable for the age of dwelling.

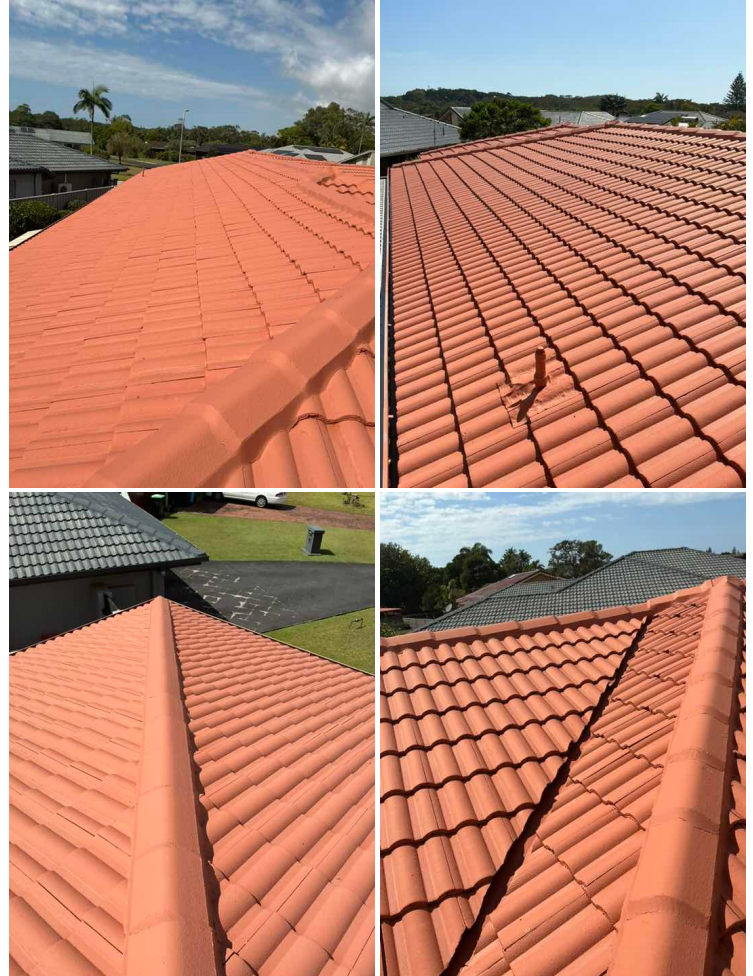
Of the visible areas, the general condition of the roof is in serviceable condition for the age.

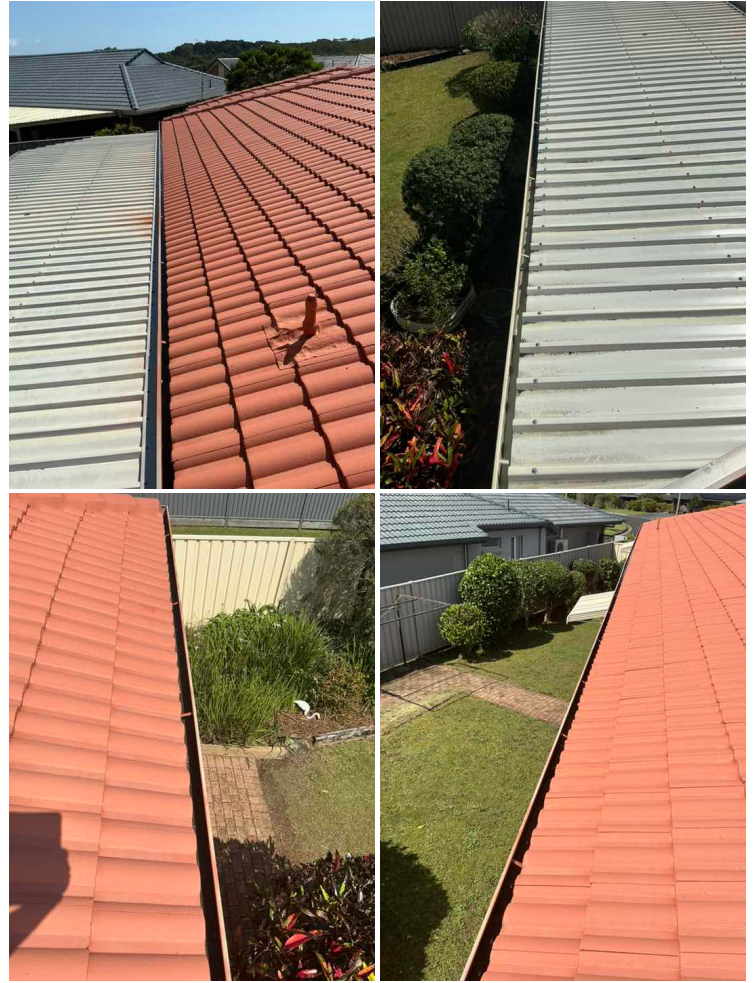
All visible and accessible of the physical nature of the guttering system appears to be in a serviceable condition with no apparent defects at the time of inspection. In the absence of prolonged rain fall efficiency of the guttering can not be assessed and you may find that further investigation or repairs maybe required. Note: Periodic maintenance checks should be carried out for rust penetrations and leaks.

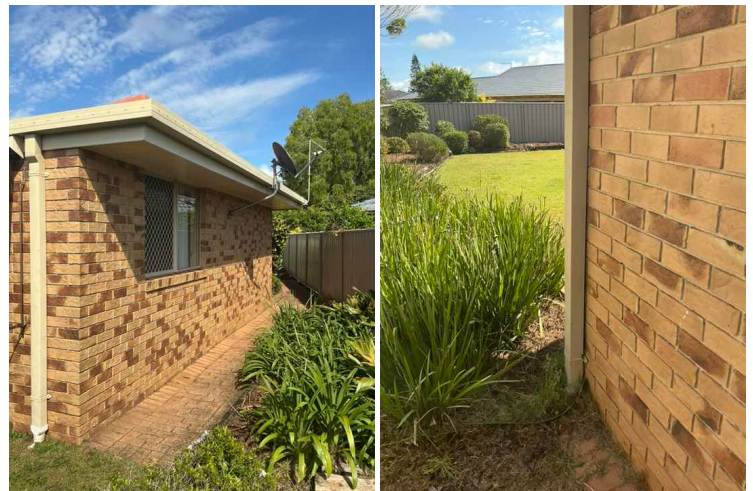
On visual inspection no apparent defects were noted to the down pipes and are considered serviceable, however no comment can be made with regard to blockages or connections to stormwater or functionality in the absence of rain. Note: Periodic maintenance checks should be carried out for rust penetrations and leaks.

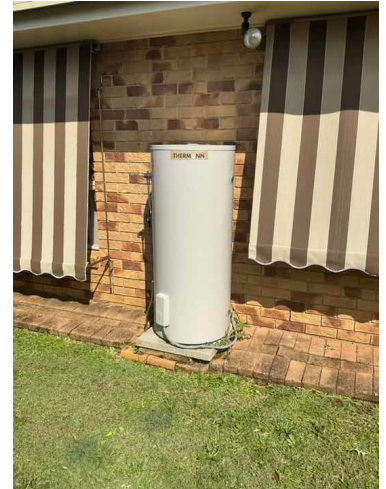
The hot water system appears to be in a serviceable condition. No specific tests other than running the hot water from a tap was carried out. No determination has been made as to the suitability or adequacy of the hot water system in relation to capacity or otherwise.

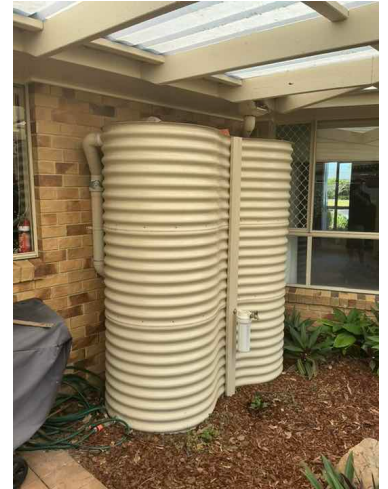
On Visual Inspection the water tank appears serviceable, but should be checked by a qualified plumber.

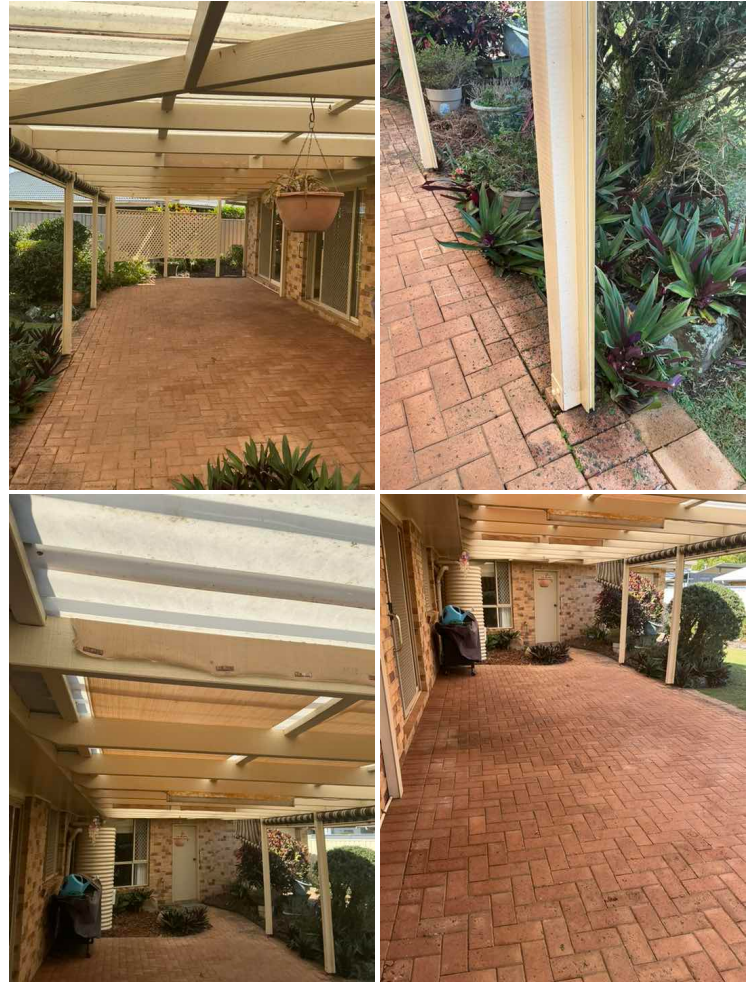
Visible sections of the Alfresco area are serviceable or in reasonable or condition for the age of this dwelling.

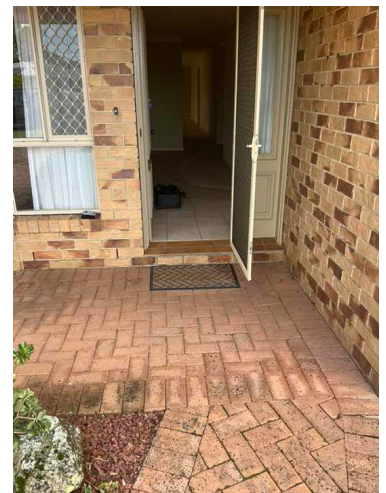
The entry porch serviceable or in reasonable or condition for the age of this dwelling.

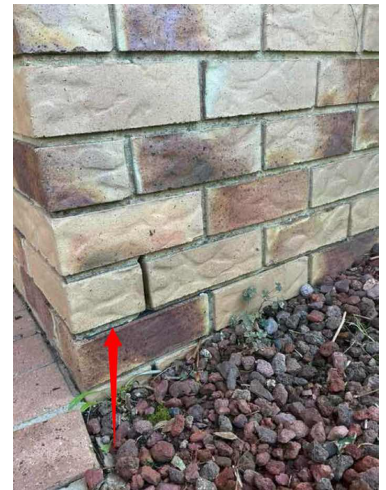
Of the visible and accessible areas, there was no visible evidence of excessive rising damp on the external walls at time of inspection.

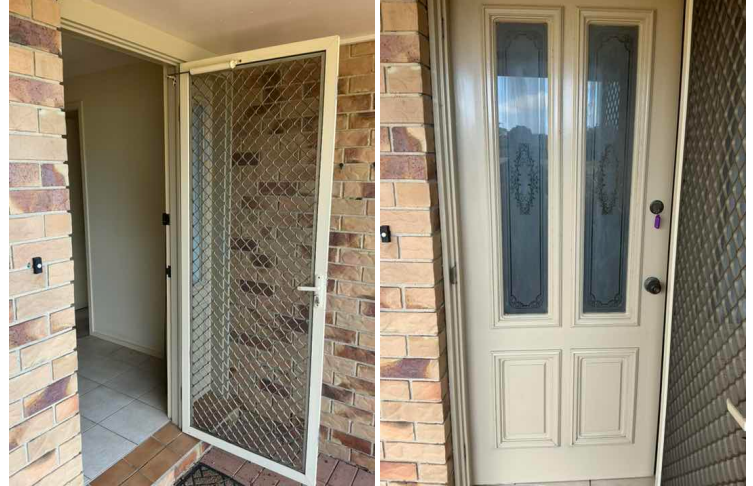
#3. Binding door - Doors that bind on the frame can relate to some differential settlement, frame movement, age, expansion, shrinkage or poor hanging. A qualified carpenter should be engaged for repairs.

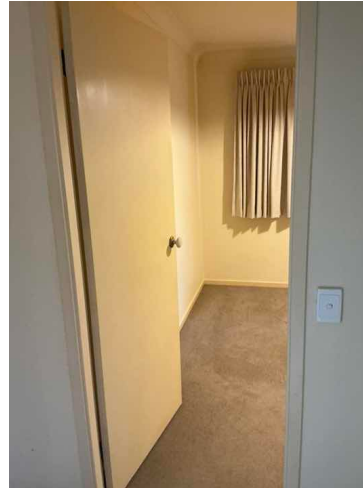
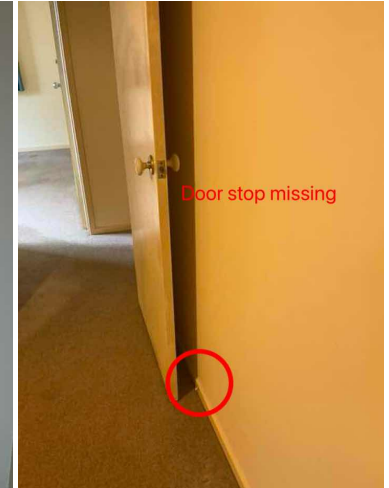
On inspection, defects were present that will require further assessing and recommendations by a qualified trades persons, please read below for details.

#4. Uneven / out of square door causing binding. A qualified carpenter should be engaged to refit.

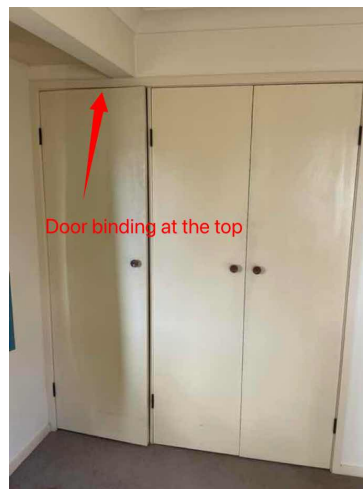
On inspection, defects were present that will require further assessing and recommendations by a qualified trades persons, please read below for details.

#5. Uneven / out of square door causing binding. A qualified carpenter should be engaged to refit.

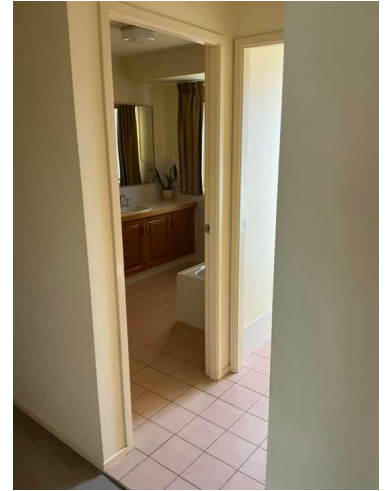
On inspection, defects were present that will require further assessing and recommendations by licensed and qualified trades persons, please read below for details.

Upon visual inspection, there is a noticeable gap between the wall and the tiles, indicating potential structural movement or poor installation. It is recommended to consult a licensed tradesperson to assess and repair the gap, ensuring proper sealing and alignment to prevent moisture ingress and further damage.

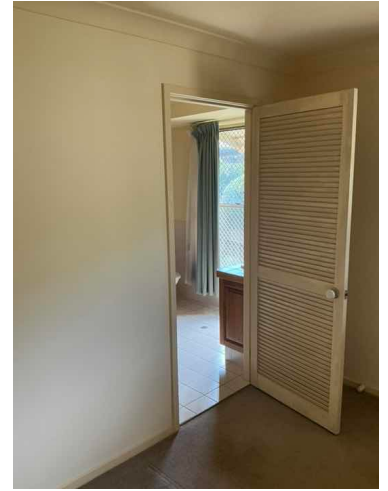
Of the visible areas, the general condition of this bathroom is serviceable or in reasonable condition for age of dwelling.

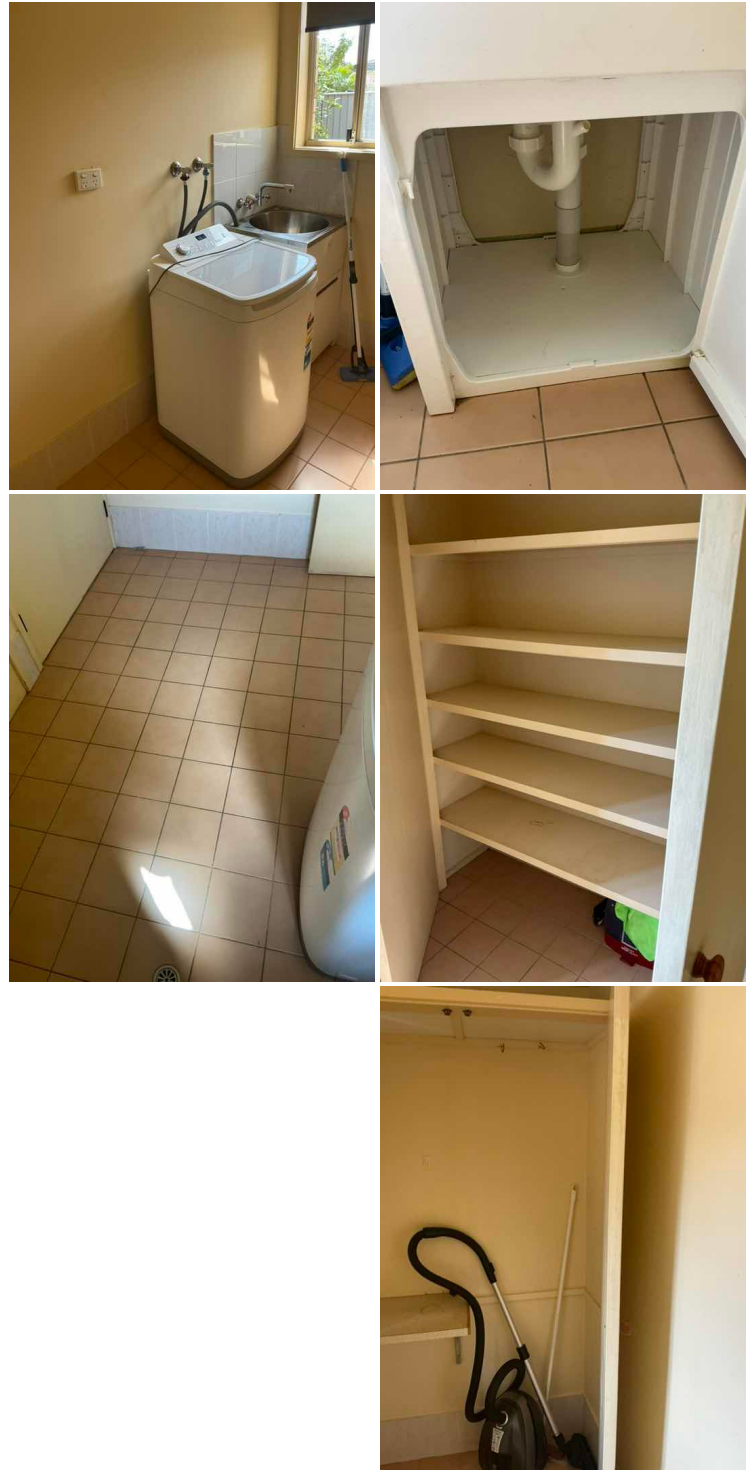
Appliances and the like restricted a full visual inspection.

Of the visible areas, the general condition of the laundry is serviceable or in reasonable condition for age of dwelling.

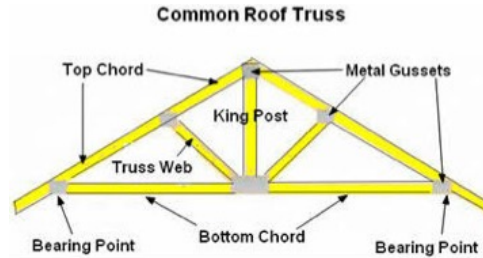
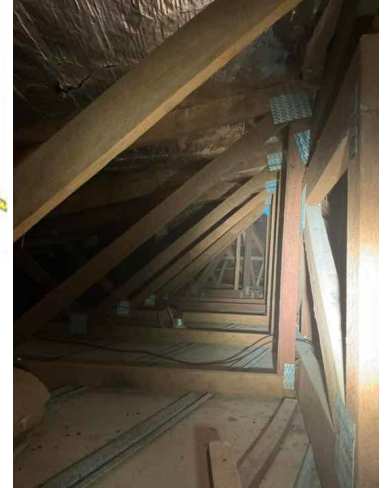
The roof frame is a truss timber frame.

Visible sections of the roof void is in a serviceable condition for age of this dwelling.

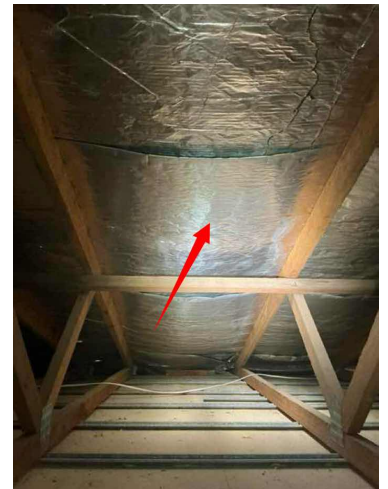
Sarking is installed.

The sarking generally is in a serviceable condition.

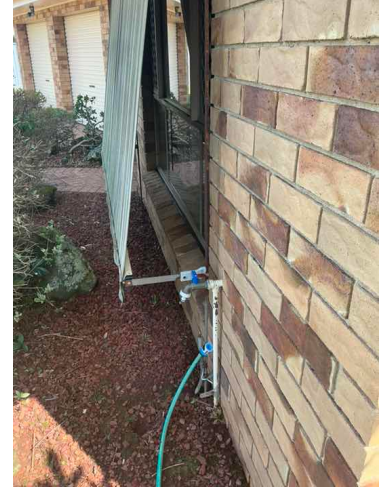
The slab edge has been covered by paths/paving/garden vegetation or soil. Slab edges where the slab and base brick courses join is an area where termite access can easily be obtained. This provides undetected termite entry and the degree of risk of termite infestation is high. It is essential that at least 75 mm of the slab edge be exposed so inspections can be made for any termite activity/entry between the base brick and the slab.

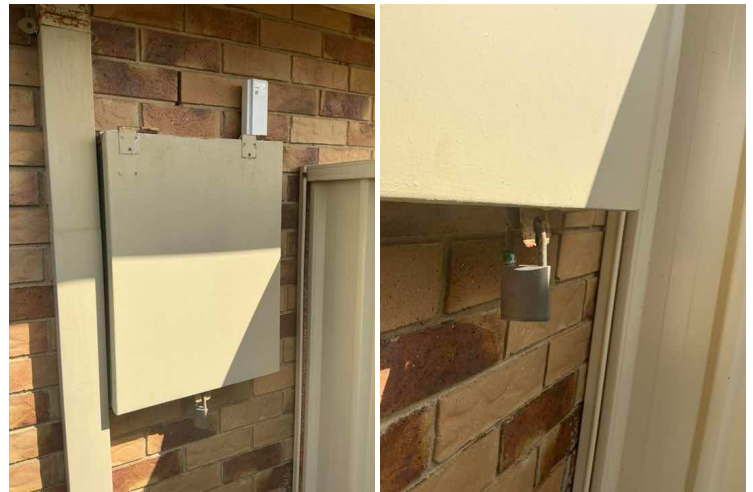
Locked meter box

No, a durable notice was not found during the inspection.

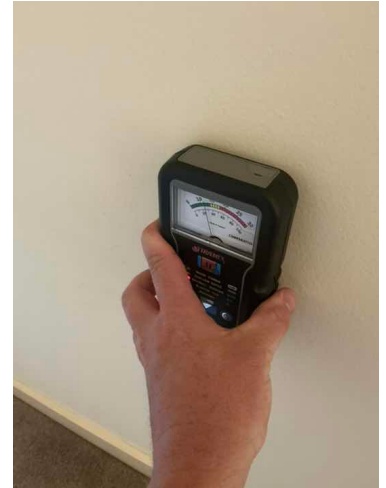
At the time of the inspection, our electronic moisture meter readings were normal.
