Building and Pest Report

33 Outrigger Rd, Lennox Head

Pest And Building Inspection

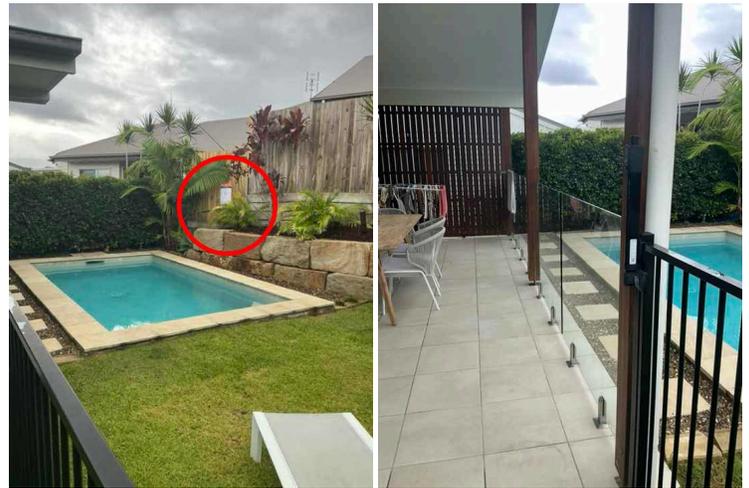
Pool Fence

Pool fence and signage were sighted.

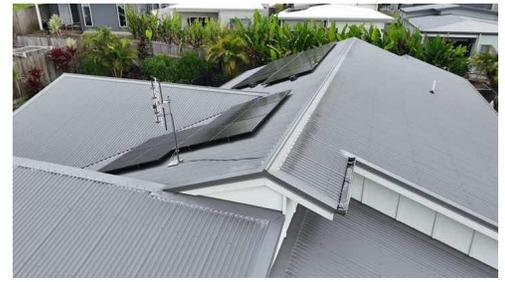
Guttering

All visible and accessible of the physical nature of the guttering system appears to be in a serviceable condition with no apparent defects at the time of inspection. In the absence of prolonged rain fall efficiency of the guttering can not be assessed and you may find that further investigation or repairs maybe required. Note: Periodic maintenance checks should be carried out for rust penetrations and leaks.

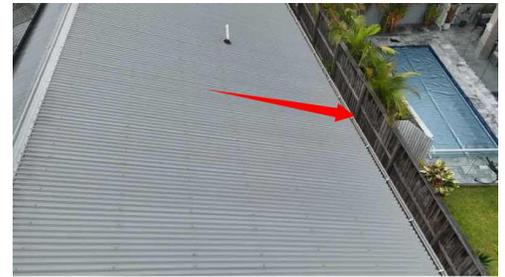
Downpipes

On visual inspection no apparent defects were noted to the down pipes and are considered serviceable, however no comment can be made with regard to blockages or connections to stormwater or functionality in the absence of rain. Note: Periodic maintenance checks should be carried out for rust penetrations and leaks.

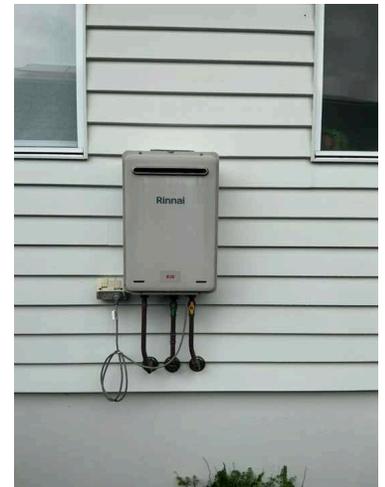
System Make

The make of the hot water unit is rinnai.

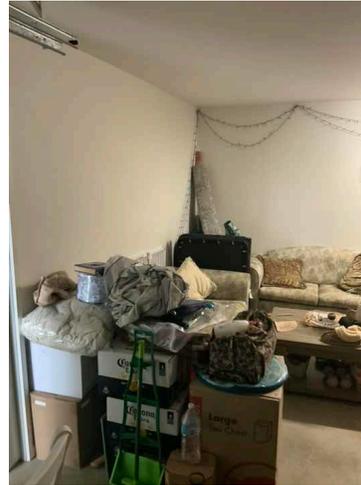
Areas Restricted

Stored items restricted a full and thorough inspection of this area. Defects may exist in the obstructed and inaccessible areas. It is strongly recommended that full access be granted to enable a thorough inspection as there may be timber pest activity, damage or defects. Note: Where vehicles and storage has restricted a full inspection it is advised that this area be cleared so a full and unobstructed inspection can be carried out.

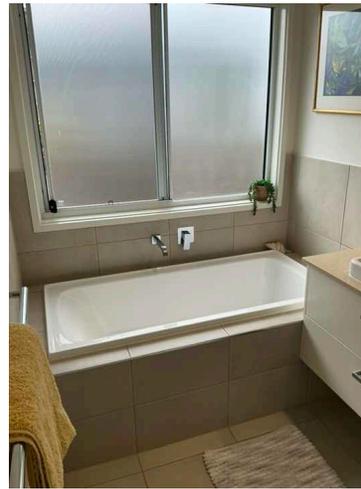
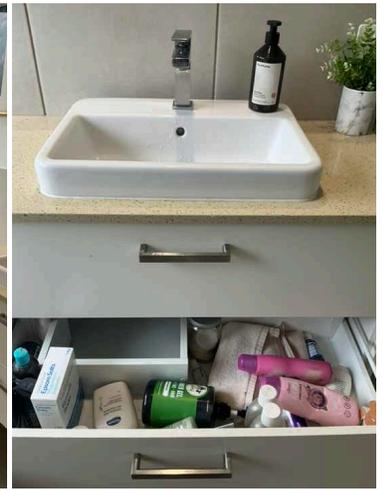
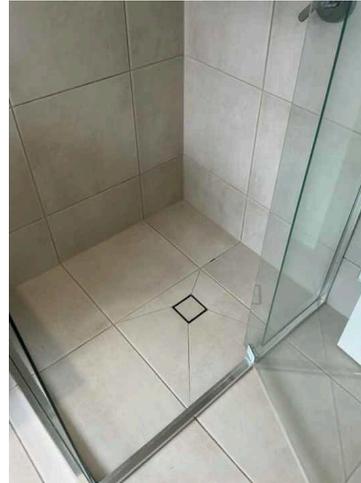
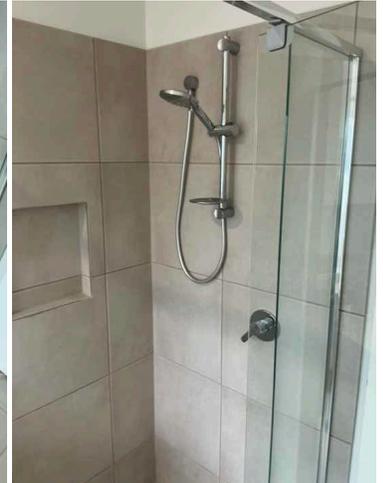
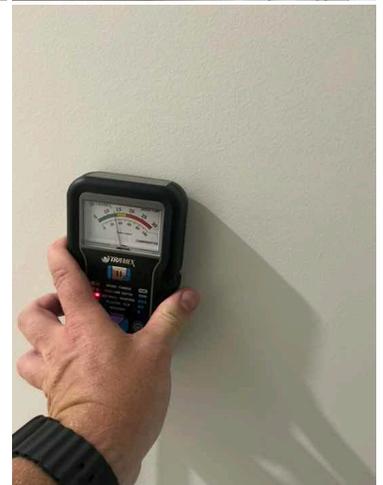
Of the visible areas, the general condition of this bathroom is serviceable or in reasonable condition for age of dwelling.

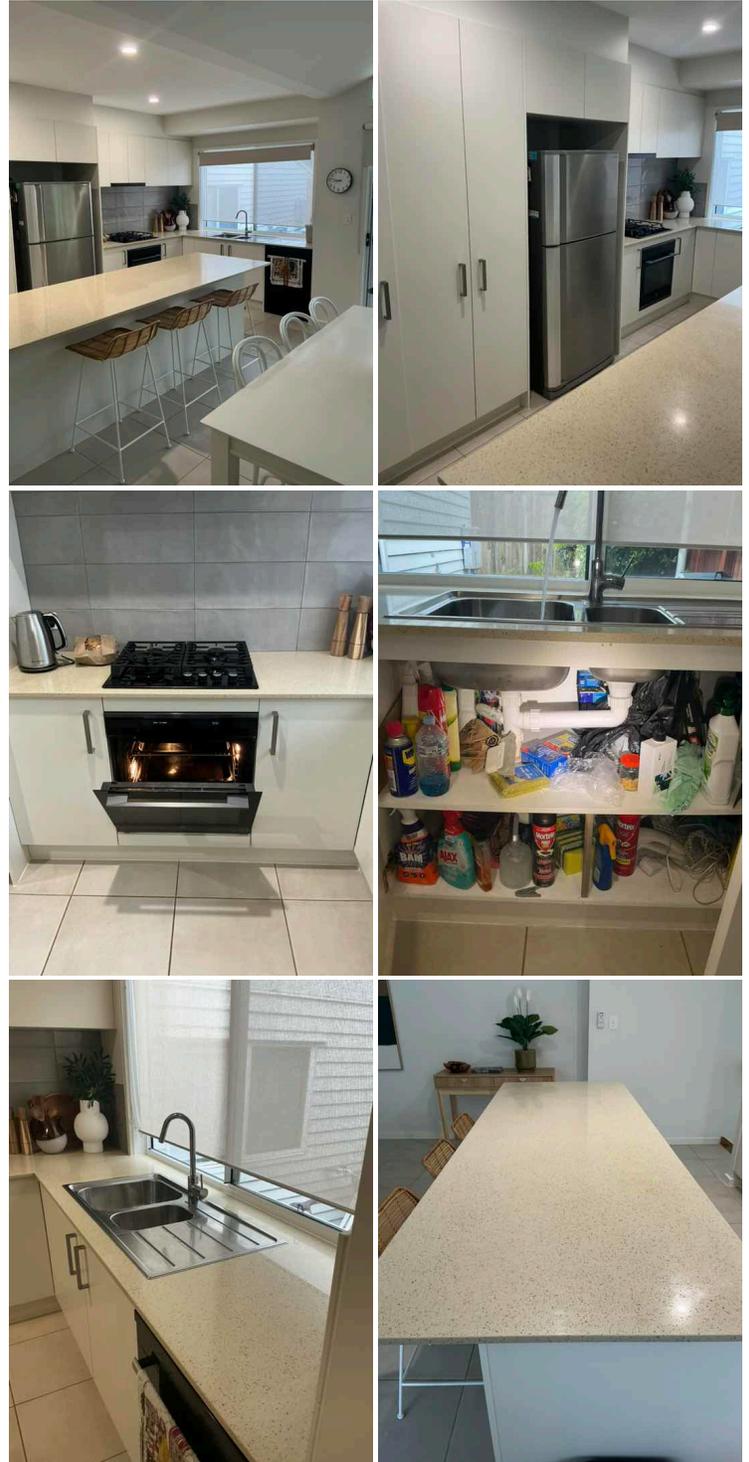
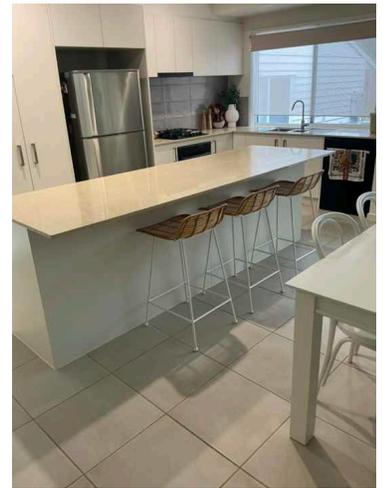
Of the visible areas, the general condition of the kitchen and pantry is serviceable or in reasonable condition for age of dwelling.

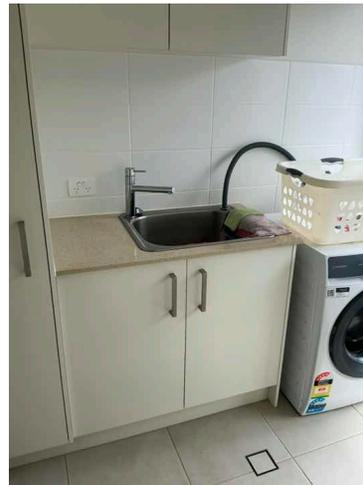
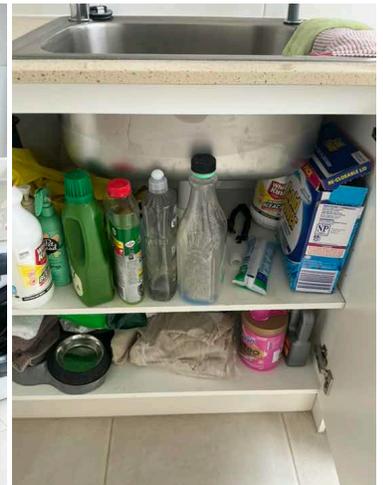
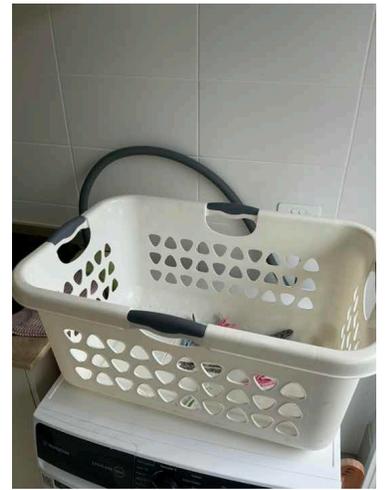
Of the visible areas, the general condition of the laundry is serviceable or in reasonable condition for age of dwelling.

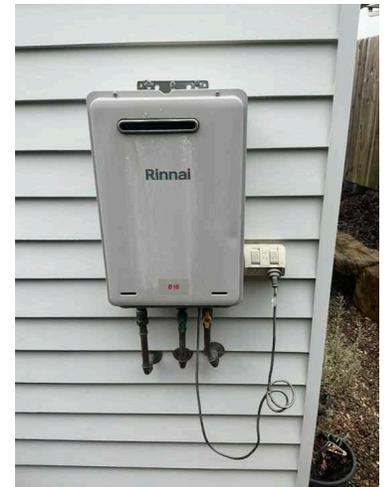
The make of the hot water unit is rinnai.

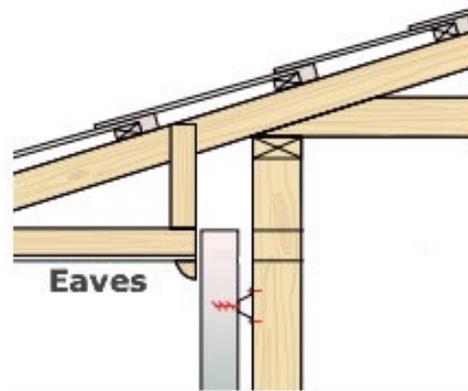
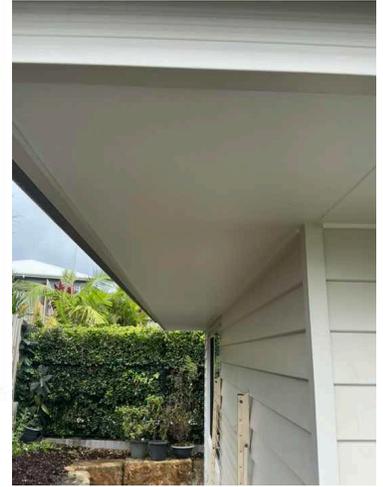
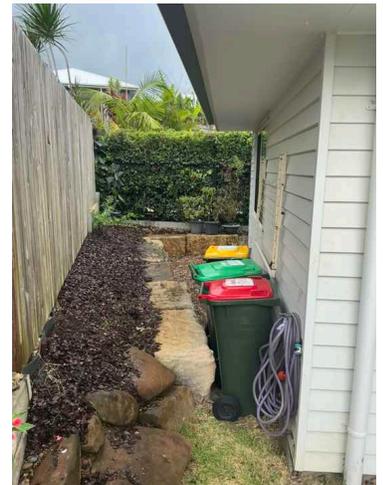
The soffit lining (eaves) are in a serviceable condition with no notable defects.

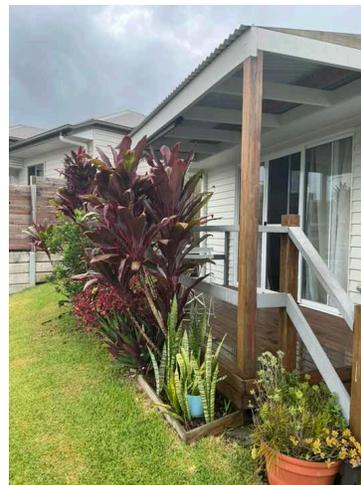
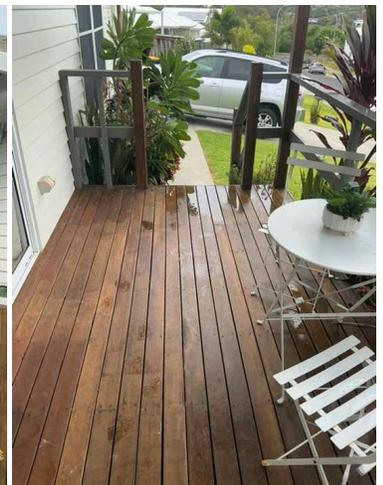
The entry porch serviceable or in reasonable or condition for the age of this dwelling.

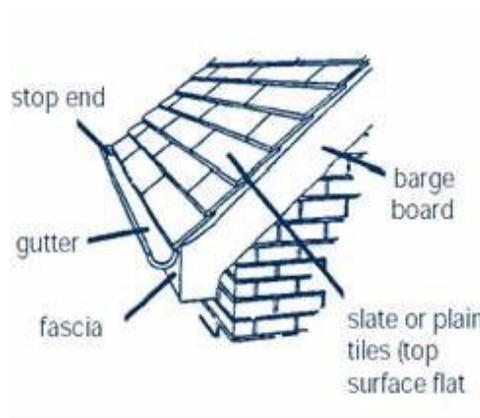
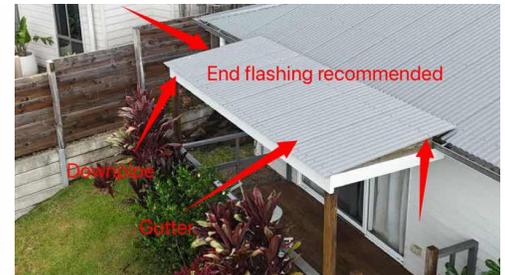
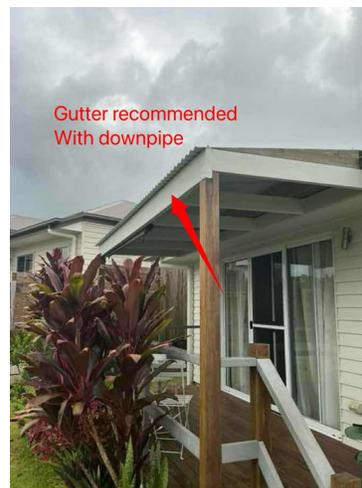
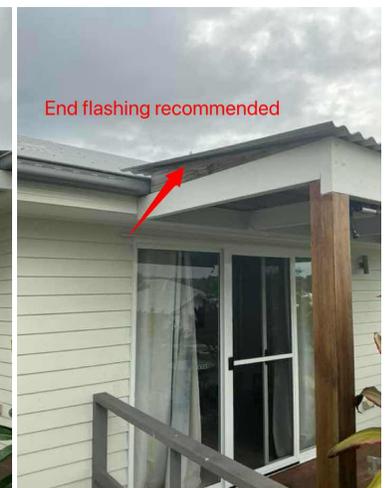
On visual inspection, the general condition of the fascia/barge boards is serviceable.

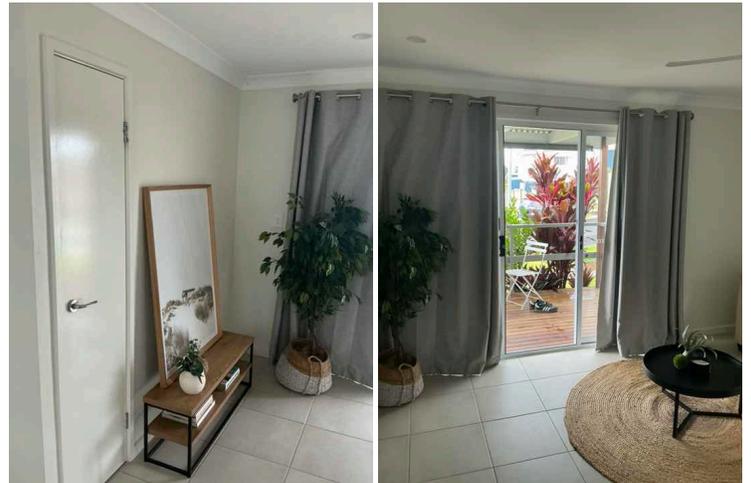
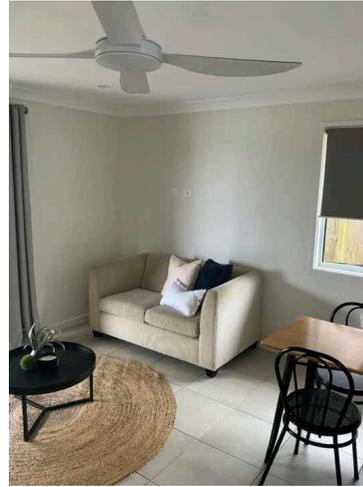
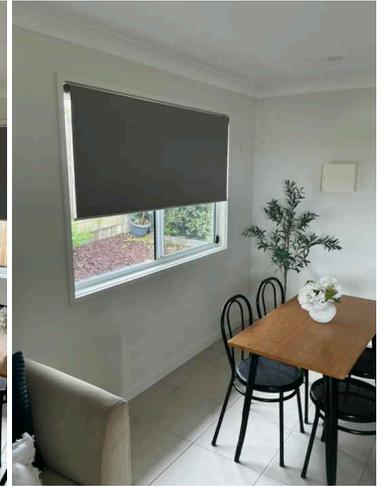
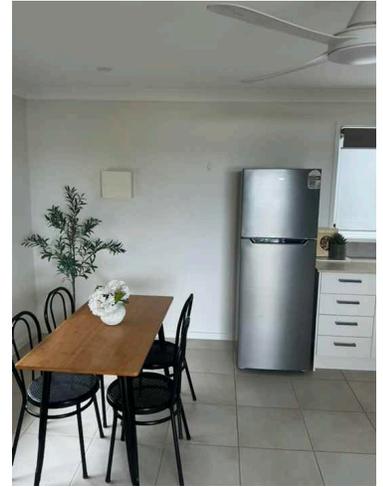
From the visible and accessible areas, this room appears to be in a serviceable condition for the age of the property with no notable structural defects sighted.

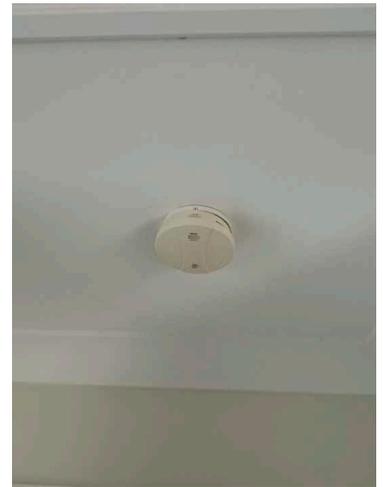
Yes a smoke alarm was sighted but not tested.

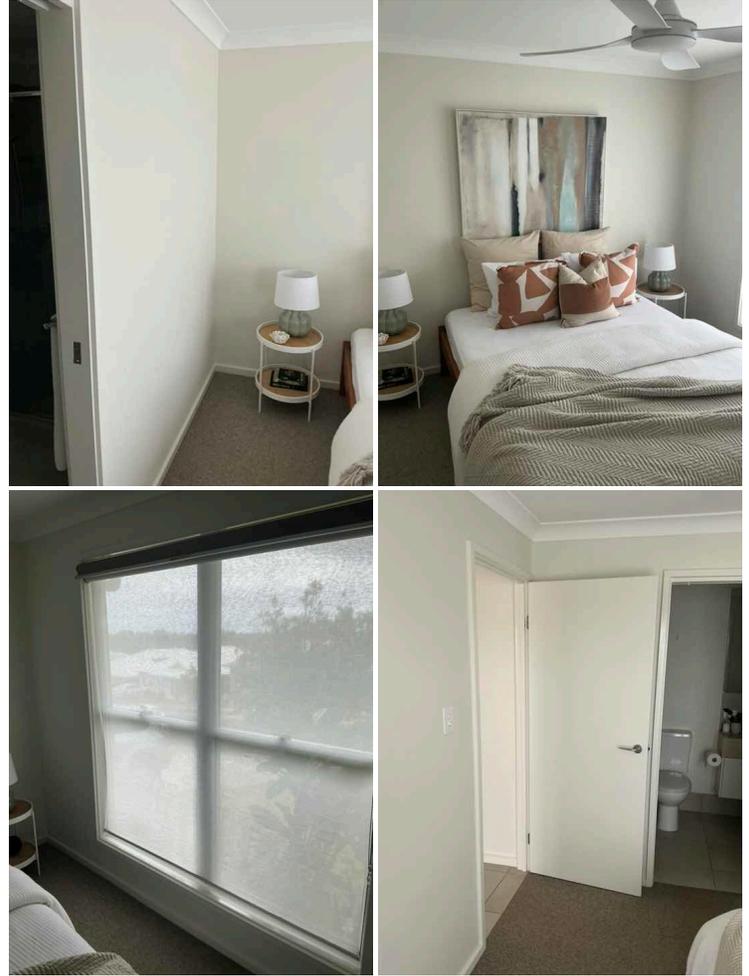
Bedroom 1

From the visible and accessible areas, this bedroom appears to be in a serviceable condition for the age of the property with no notable structural defects sighted.

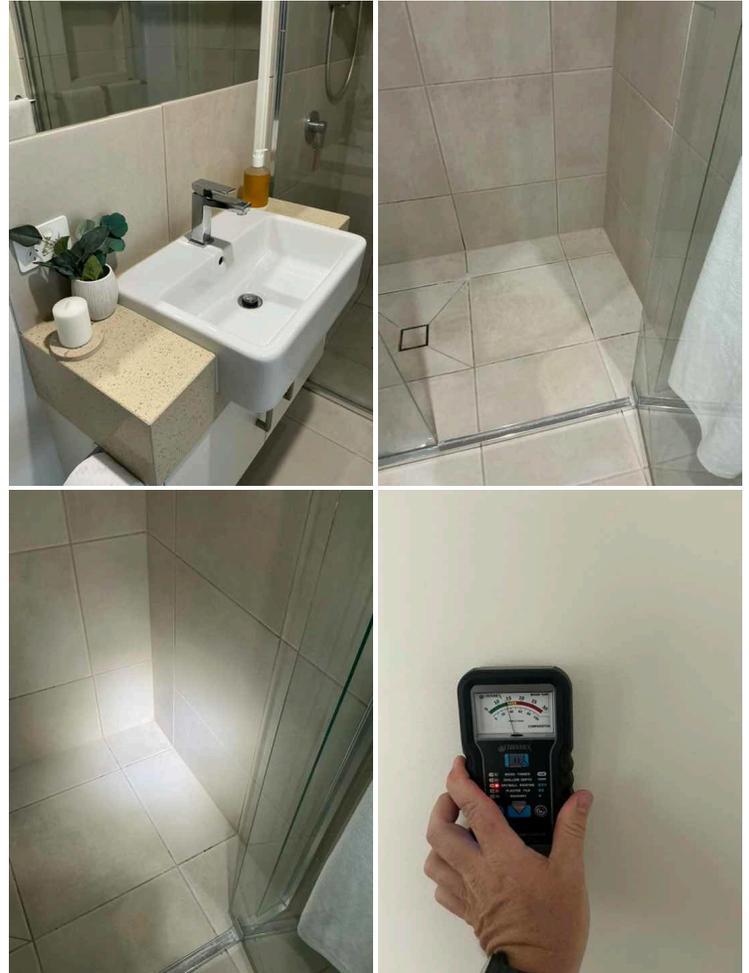
Of the visible areas, the general condition of this bathroom is serviceable or in reasonable condition for age of dwelling.

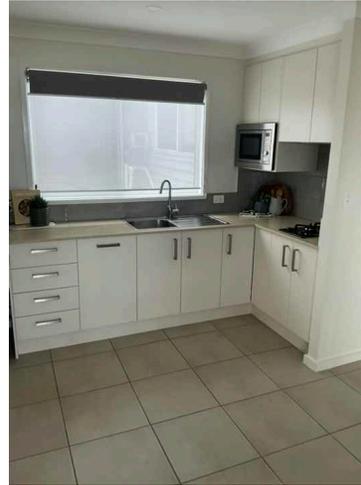
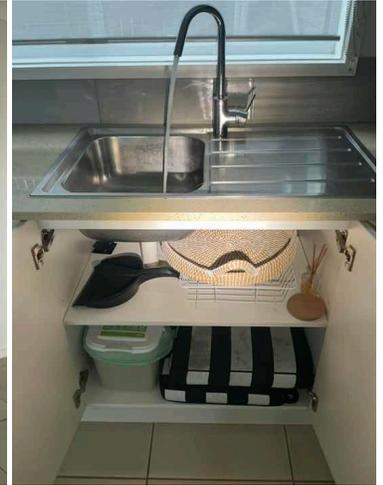
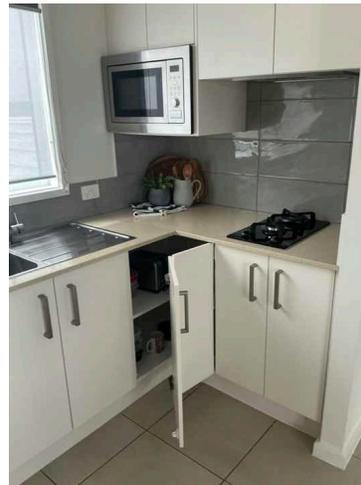
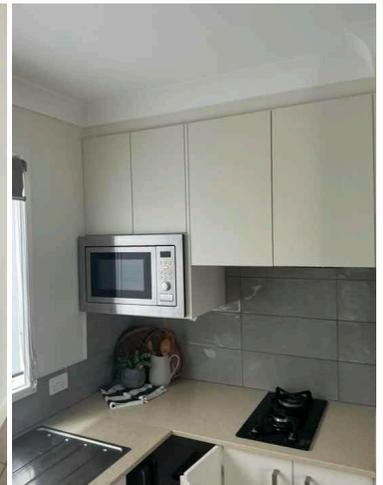
Of the visible areas, the general condition of the kitchen is serviceable or in reasonable condition for age of dwelling.

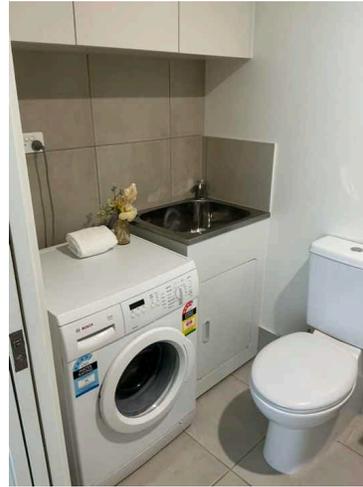
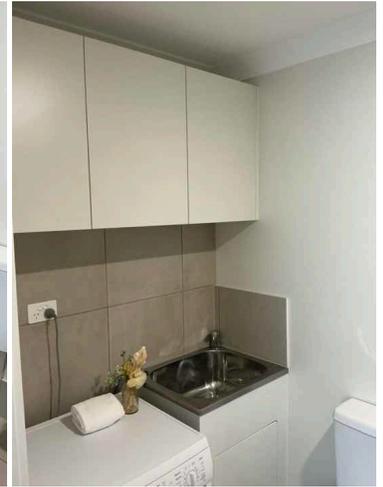
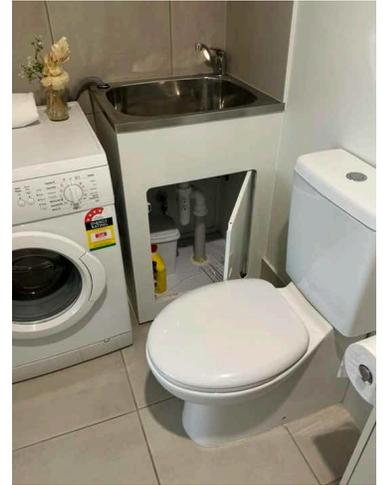
Of the visible areas, the general condition of the laundry is serviceable or in reasonable condition for age of dwelling.

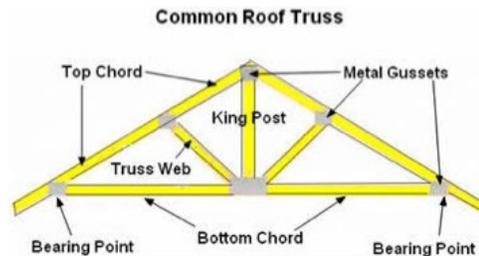
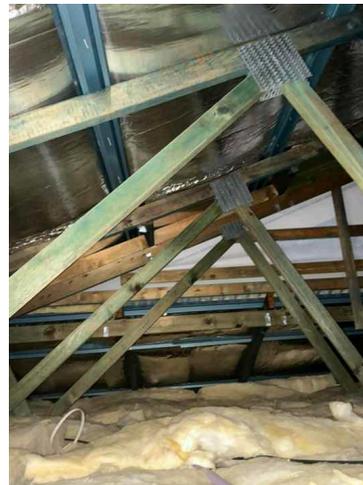
Visible sections of the roof void is in a serviceable condition for age of this dwelling.

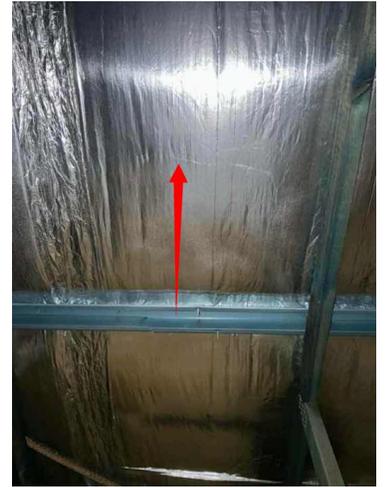
Sarking is installed.

The sarking generally is in a serviceable condition.
