Building and Pest Report

1/35 Dress Circle Drive Lennox Head

Inspection Report

Pest And Building Inspection

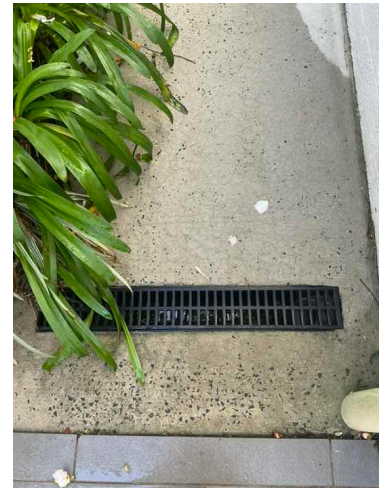
There was no visible evidence of excess ponding or fall towards the property walls at the time of the inspection. Regardless, it is difficult to ascertain in dry conditions and it is therefore recommended that you assess same after a rainfall period to be able to sufficiently ascertain if any problems exist in this regard. If water is ponding around perimeter walls and paths or appears to be flowing into the footings/ foundations you must have assessed by a qualified plumber or landscaper.

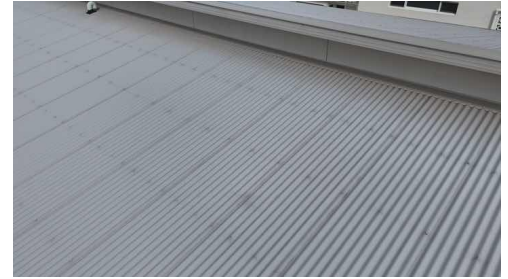
Guttering

All visible and accessible of the physical nature of the guttering system appears to be in a serviceable condition with no apparent defects at the time of inspection. In the absence of prolonged rain fall efficiency of the guttering can not be assessed and you may find that further investigation or repairs maybe required. Note: Periodic maintenance checks should be carried out for rust penetrations and leaks.

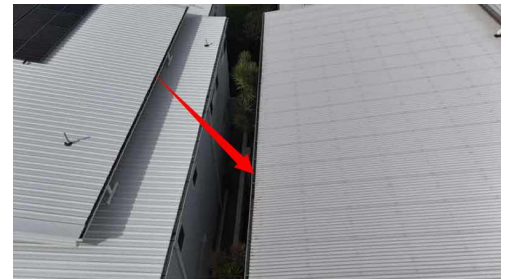
Downpipes

On visual inspection no apparent defects were noted to the down pipes and are considered serviceable, however no comment can be made with regard to blockages or connections to stormwater or functionality in the absence of rain. Note: Periodic maintenance checks should be carried out for rust penetrations and leaks.

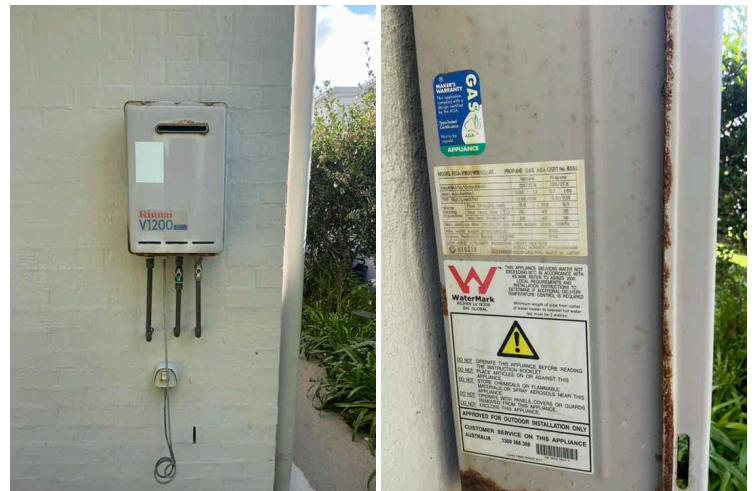
The hot water system appears to be in a serviceable condition. No specific tests other than running the hot water from a tap was carried out. No determination has been made as to the suitability or adequacy of the hot water system in relation to capacity or otherwise.

The make of the hot water unit is rinnai.

Unable to determine , no label

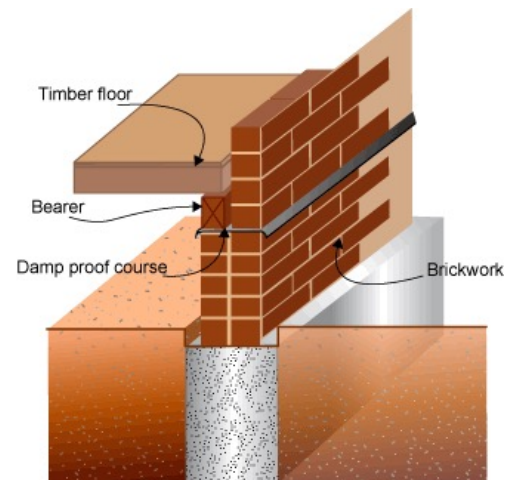
Walls

On visual inspection, the general condition of the exterior walls is serviceable for the age.

#1. There appears to have been some settlement in the building which has caused some cracking to the walls. These cracks are categorized as 0 to 2. This can also cause some doors to bind or be out of square. In the inspectors opinion these cracks are due to settlement, usually due to ground movement and subsequent movement to building materials can be expected. Any cracks should be monitored and if cracks increase in size, further investigation should be carried out by a structural engineer.

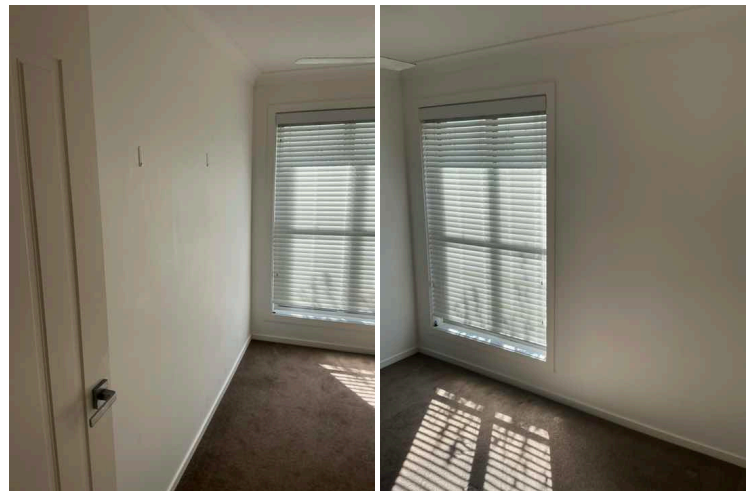
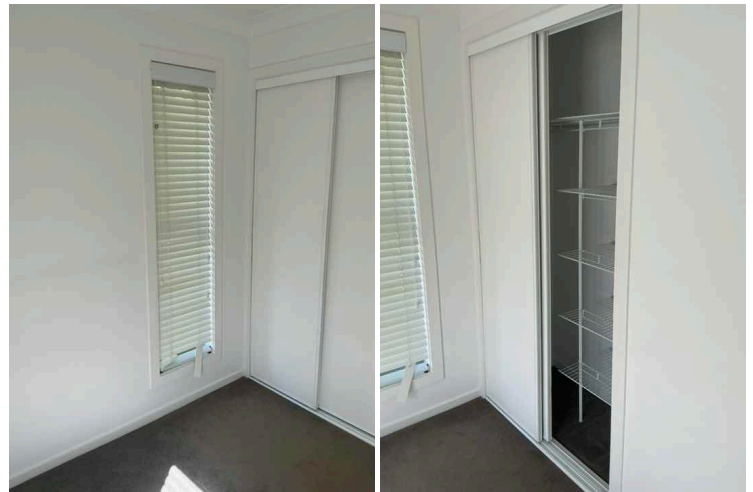
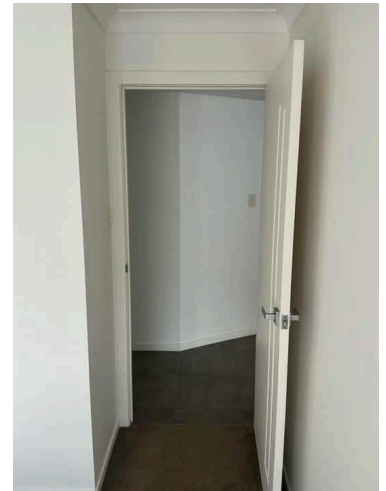
Bedroom 2

From the visible and accessible areas, this bedroom appears to be in a serviceable condition for the age of the property with no notable structural defects sighted.

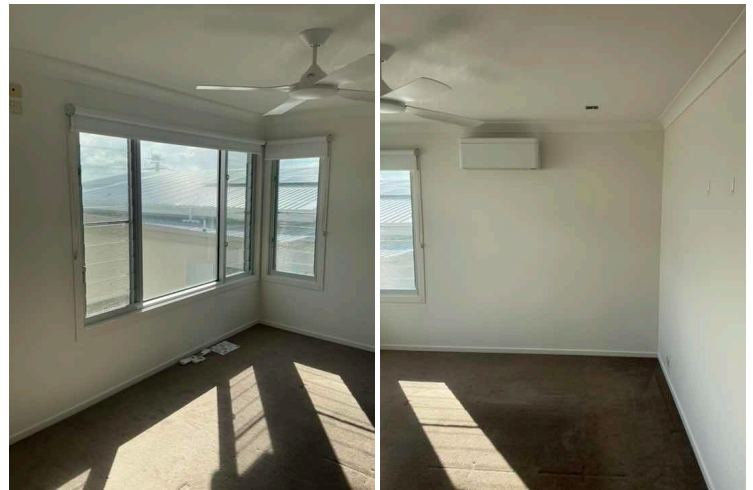
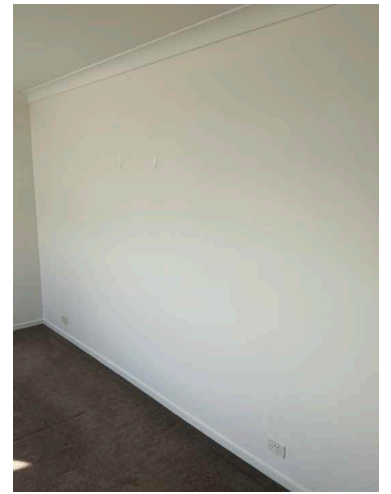
Bedroom 3

From the visible and accessible areas, this bedroom appears to be in a serviceable condition for the age of the property with no notable structural defects sighted.

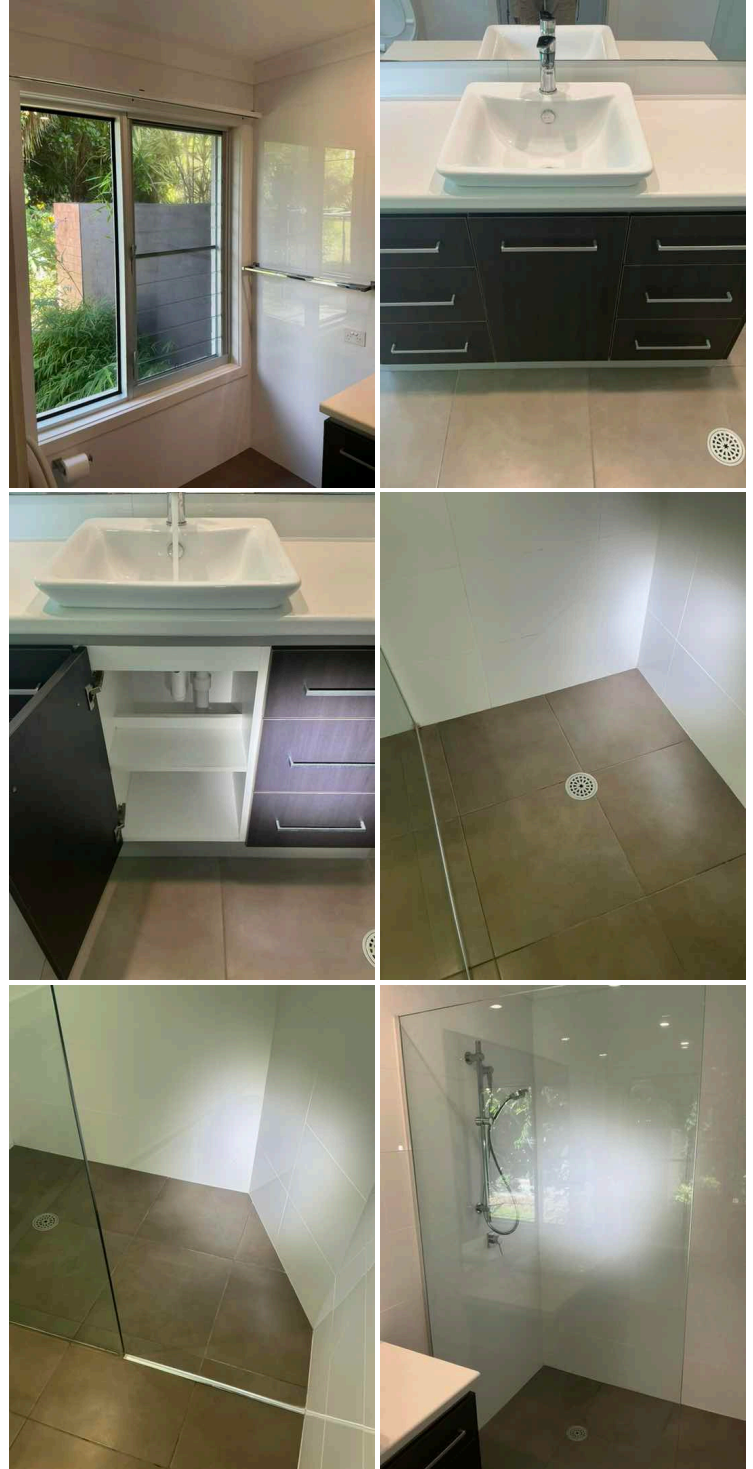
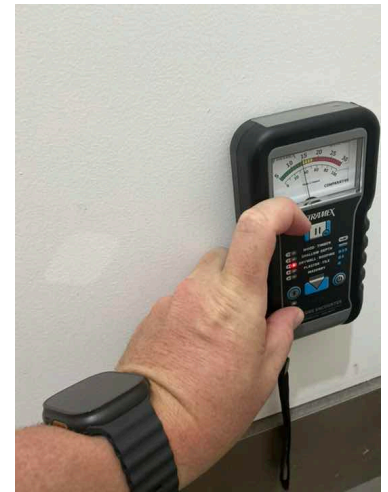
Of the visible areas, the general condition of this bathroom is serviceable or in reasonable condition for age of dwelling.

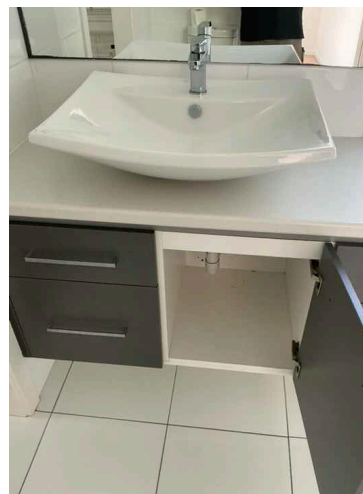
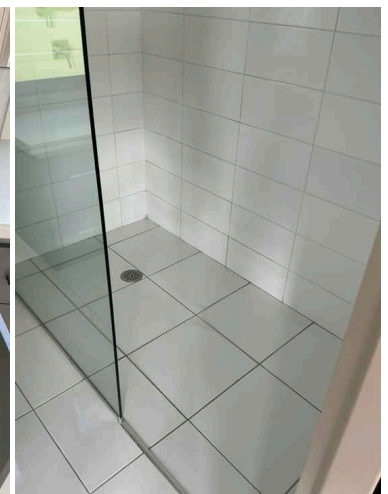
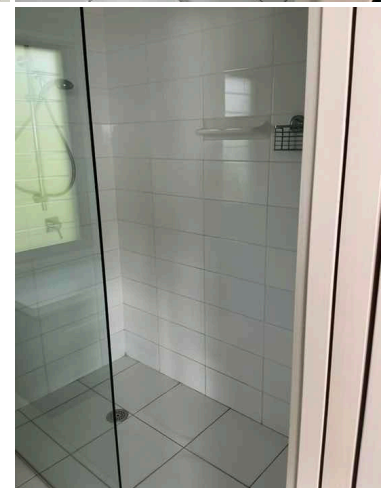
Of the visible areas, the general condition of this bathroom is serviceable or in reasonable condition for age of dwelling.

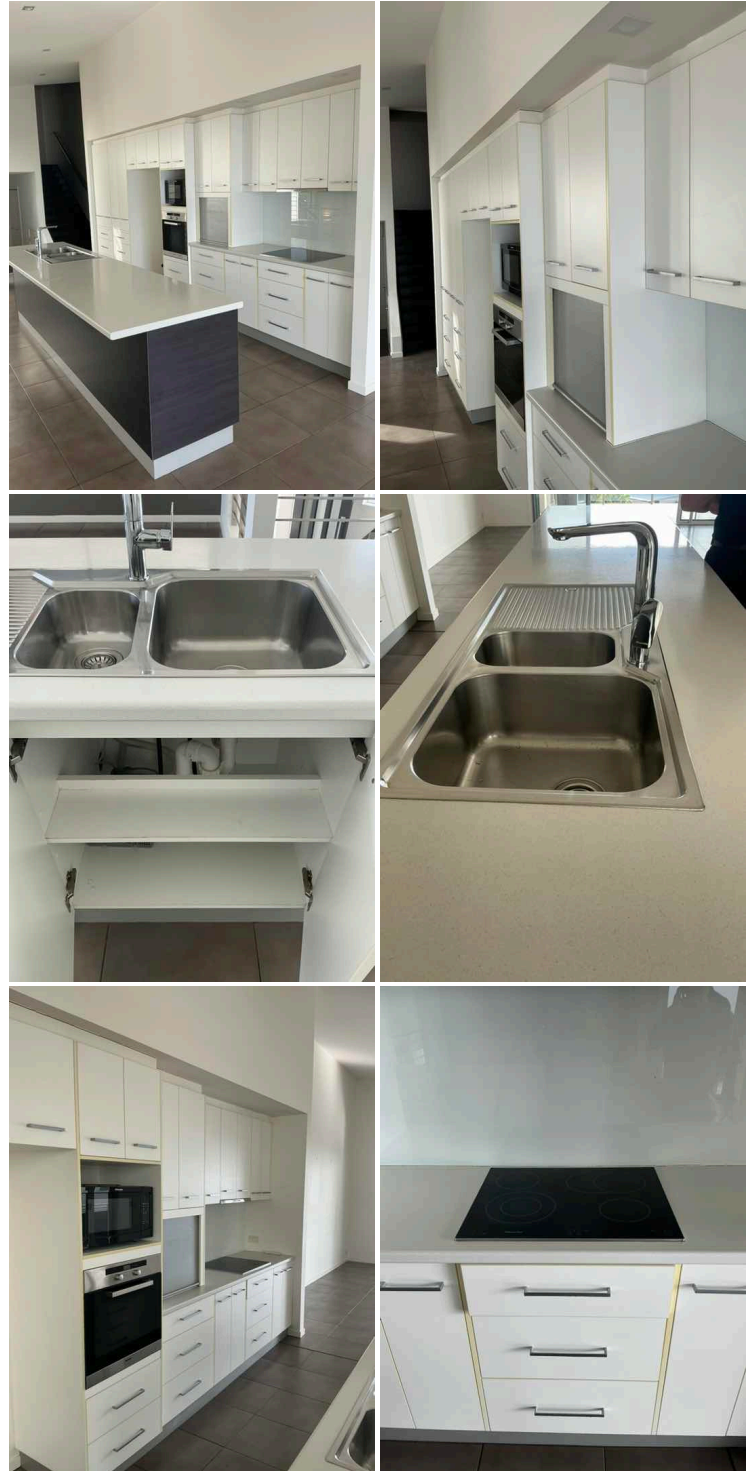
Of the visible areas, the general condition of the kitchen and pantry is serviceable or in reasonable condition for age of dwelling.

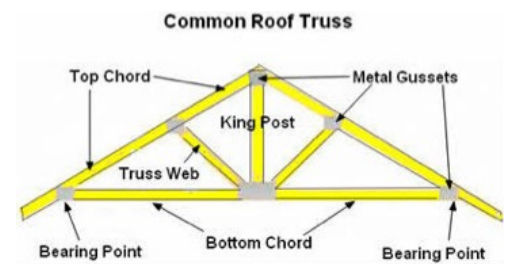
Roof Frame Type

The roof frame is a truss timber frame.

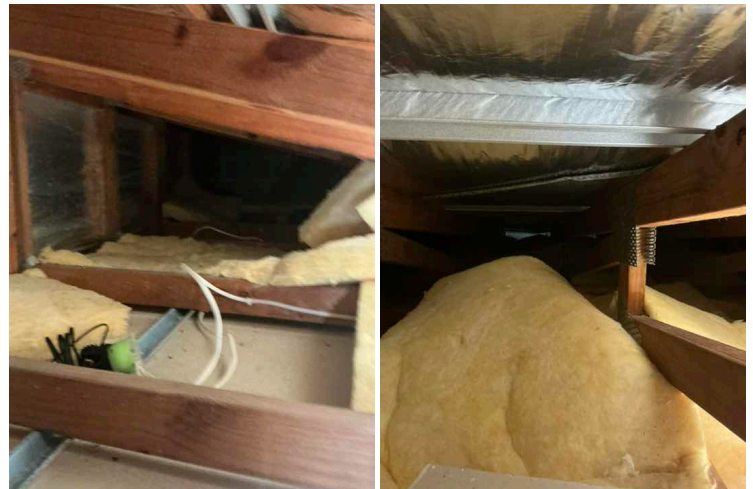
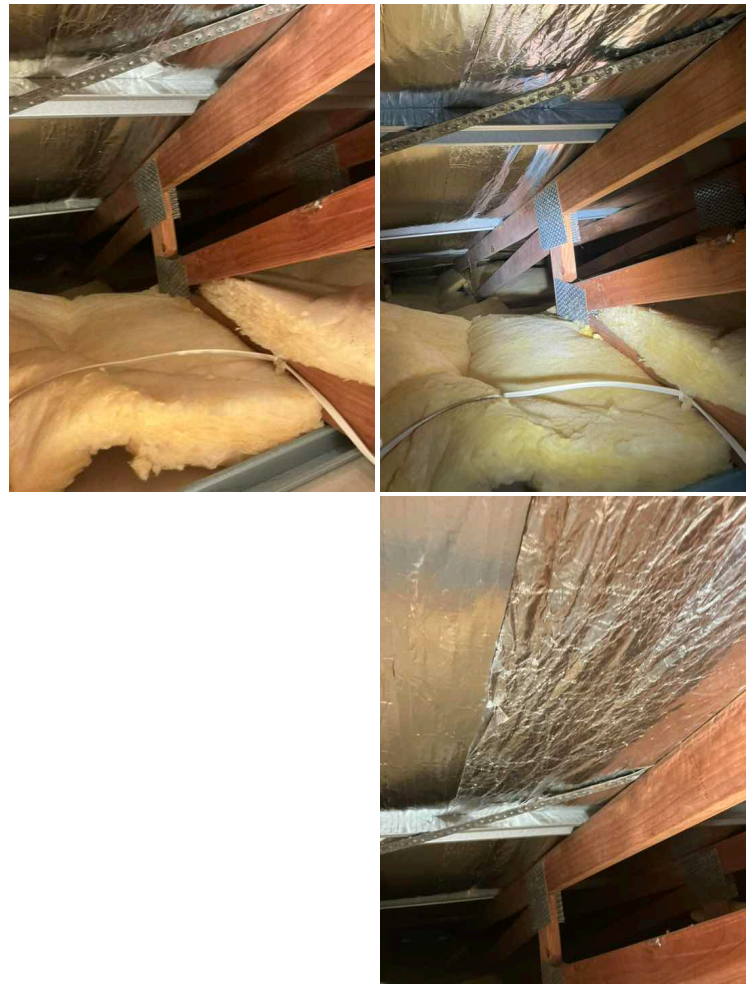
Overall Condition

Visible sections of the roof void is in a serviceable condition for age of this dwelling.

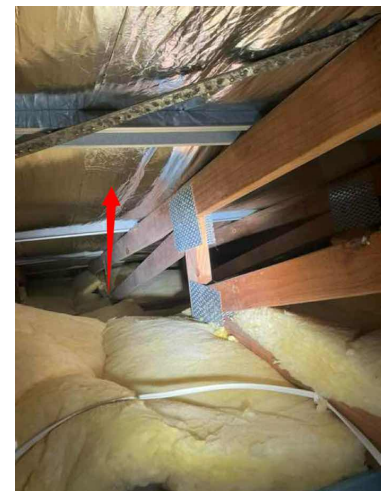
The sarking generally is in a serviceable condition.

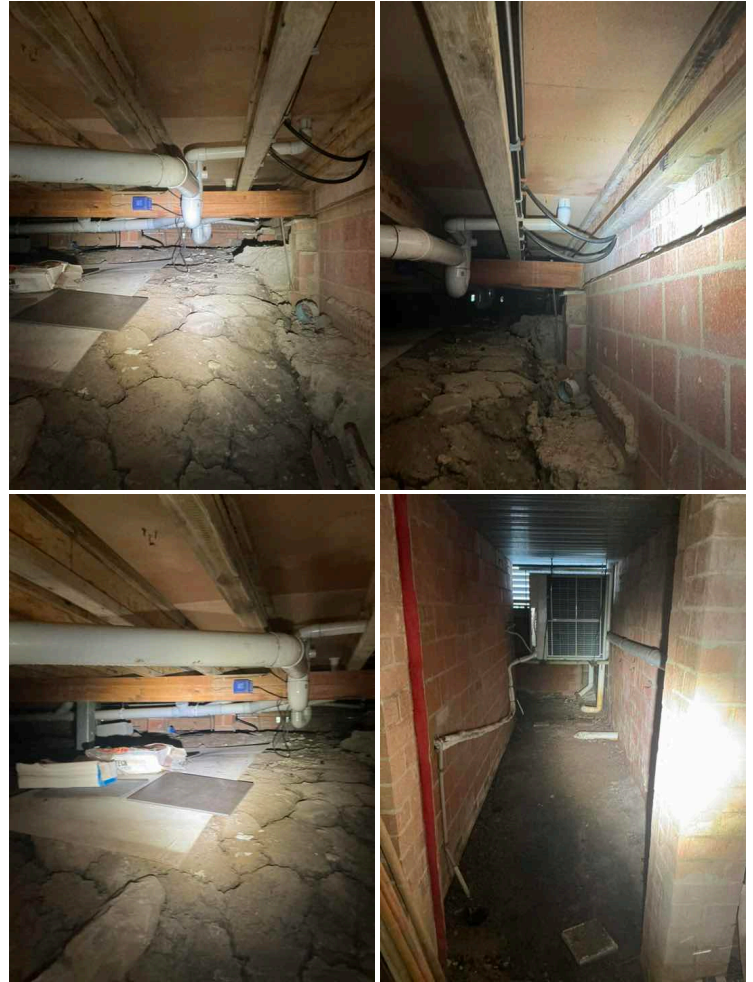
General Condition

Of areas accessible and visible, the subfloor and components appeared to be in a serviceable condition.

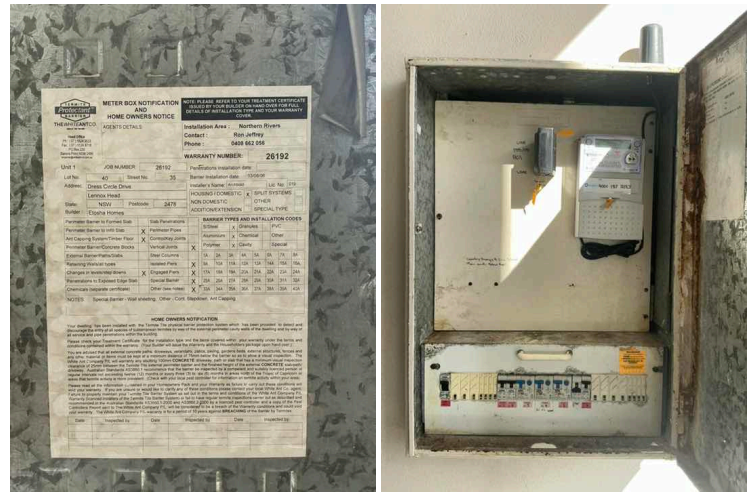
Yes, a durable notice was found in the meter-box during the inspection.

This firm can give no assurances with regard to work that may have been previously performed by other firms. You should obtain copies of all paperwork and make your own inquiries as to the quality of the treatment, when it was carried out and warranty information. In most cases you should arrange for a treatment in accord with Australian Standard 3660 be carried out to reduce the risk of further attack.
