# PEST AND BUILDING PRE-PURCHASE REPORTS

# BPI BUILDING & PEST INSPECTIONS

### INSPECTION ADDRESS

40 Byron Street  
Lennox Head

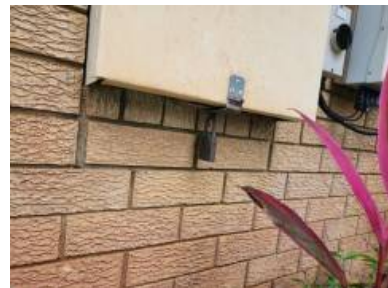
#### **ELECTRICIAL SAFETY SWITCH:**

Locked.

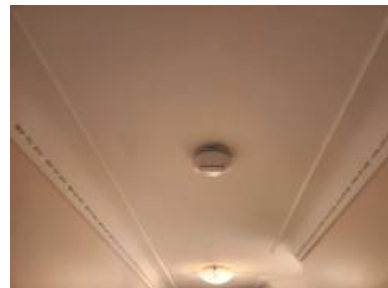
Present - Kitchen, Hall.

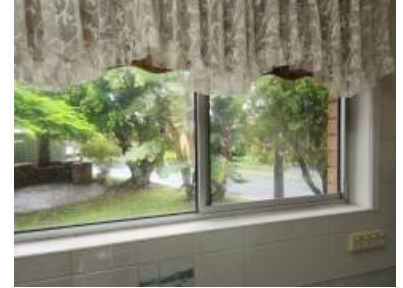
Metal.

Some window reveals require repainting.

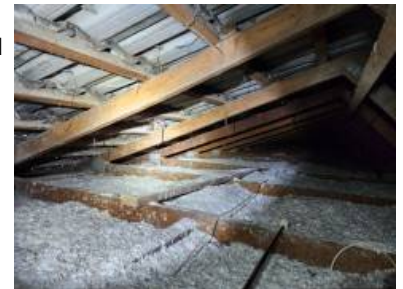
Inspection over the eaves was restricted due to the low pitch and construction allowing only a limited visual inspection from a distance of some areas to be carried out.

Clearance within sections of the roof was too low to allow body access. Outer top wall plates and framing timbers were not inspected due to the area being too low to allow body access. This allows only a limited visual inspection from a distance of some areas to be carried out.

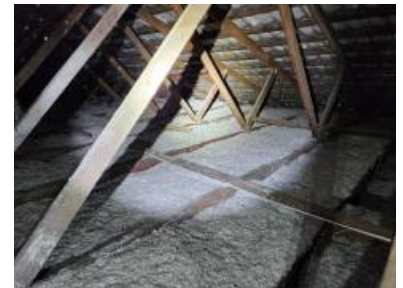
Insulation is present in the roof cavity. This restricted inspection to some roofing & ceiling members and wall top plates. Removal of insulation is not within the scope of a standard building inspection report.

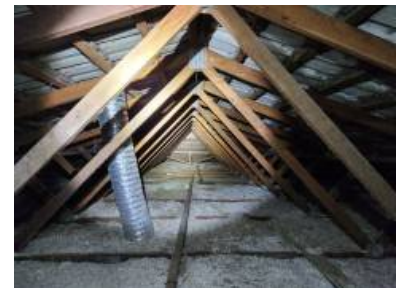
Truss - Hardwood.

Older roof frames do not comply with current wind ratings. The roof framing is in satisfactory / typical condition for the age / construction date.

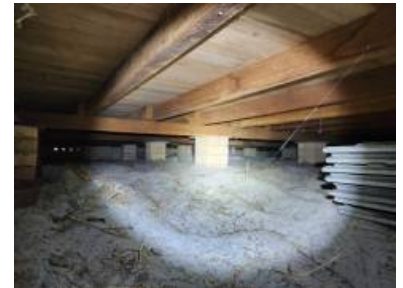
Crawl space was limited due to the method of construction resulting in a limited visual inspection from a distance being carried out. Where inspection is limited, damage / deterioration of some members may be present but not identified within this report.

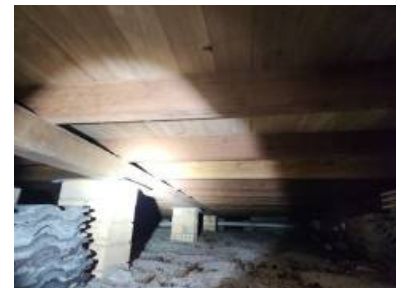
Older floor frames do not comply with current wind ratings. This subfloor / frame is in satisfactory / typical condition for the age / construction date.

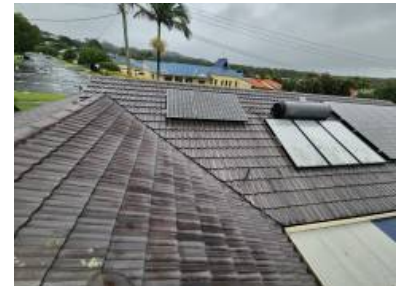
Some sheet roofing and flashings require major rectification and/or replacement. I recommend that a qualified roofer be engaged for further inspection and to quote the cost of rectification prior to making a purchase decision. Read the entire report. The tile roofing and flashings are in reasonably good condition.

We recommend that a qualified roofer be engaged to inspect & detail the condition of the roof exterior, gutters, downpipes & stormwater pipes and any rectification required prior to making a final purchase decision.

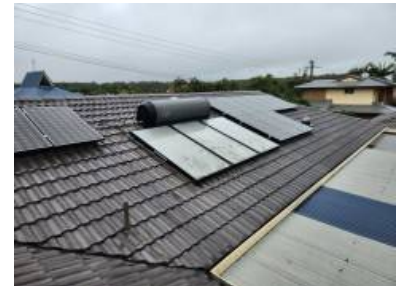
Solar Panels are present to the Roof Exterior and restricted the inspection of the roofing material beneath. Concealed damage may be present but not identified in the report. A Solar Hot Water System is present to the Roof Exterior and restricted the inspection of the roofing material beneath. Concealed damage may be present but not identified in the report.
