# PEST AND BUILDING PRE-PURCHASE REPORTS

# Inspection Report

**76 Survey St Lennox Head , Lennox Head , NSW, 2478**

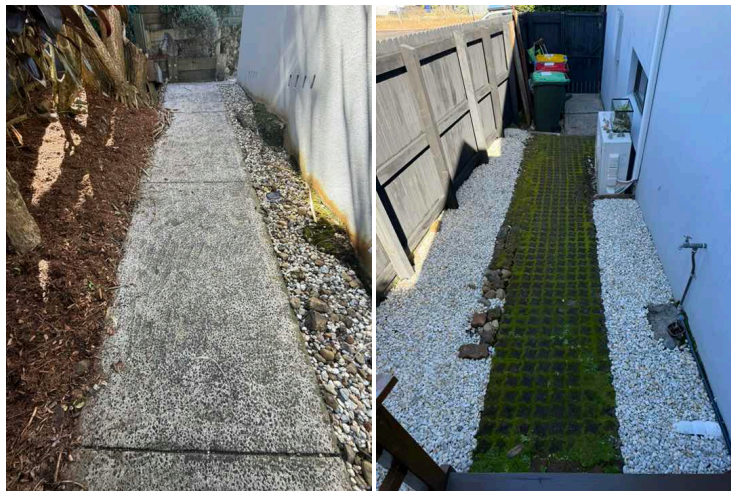
The paths around the home are in a serviceable condition for the age of this dwelling with no major defects visible.

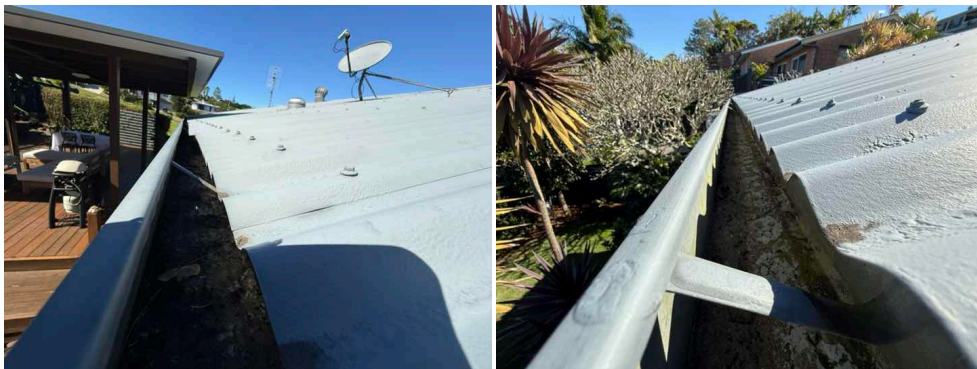
All visible and accessible of the physical nature of the guttering system appears to be in a serviceable condition with no apparent defects at the time of inspection. In the absence of prolonged rain fall efficiency of the guttering can not be assessed and you may find that further investigation or repairs maybe required. Note: Periodic maintenance checks should be carried out for rust penetrations and leaks.

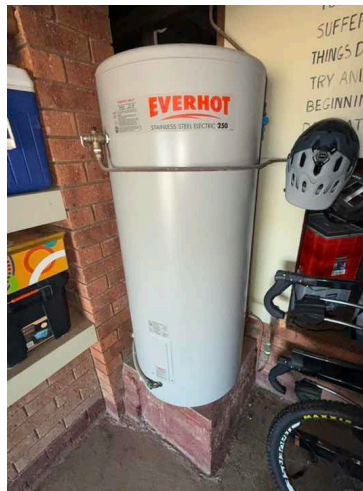
Everhot

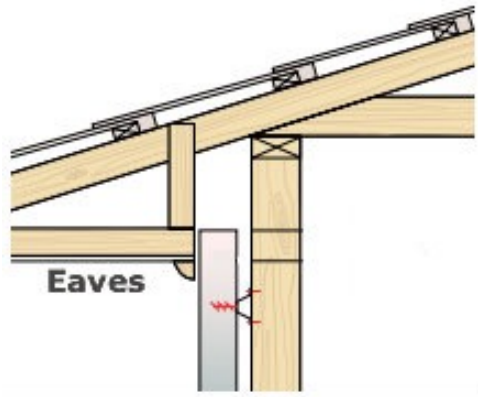
The soffit lining (eaves) are in a serviceable condition with no notable defects.

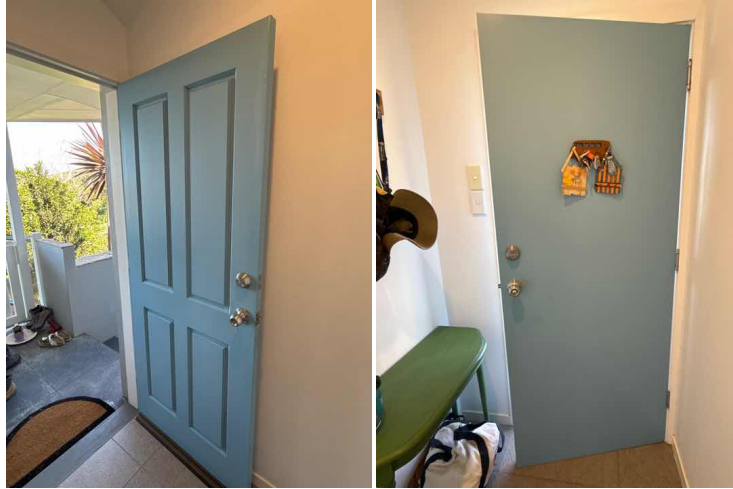
The doors are in serviceable condition with no notable defects observed.

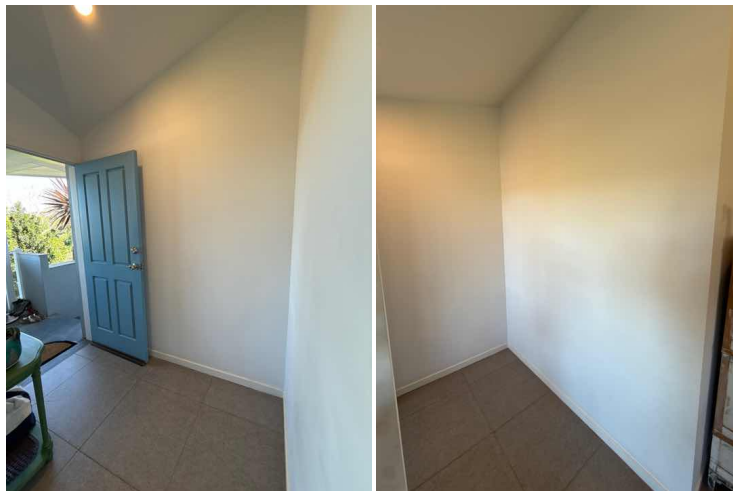
From the visible and accessible areas, this area appears to be in a serviceable condition for the age of the property with no notable structural defects sighted.

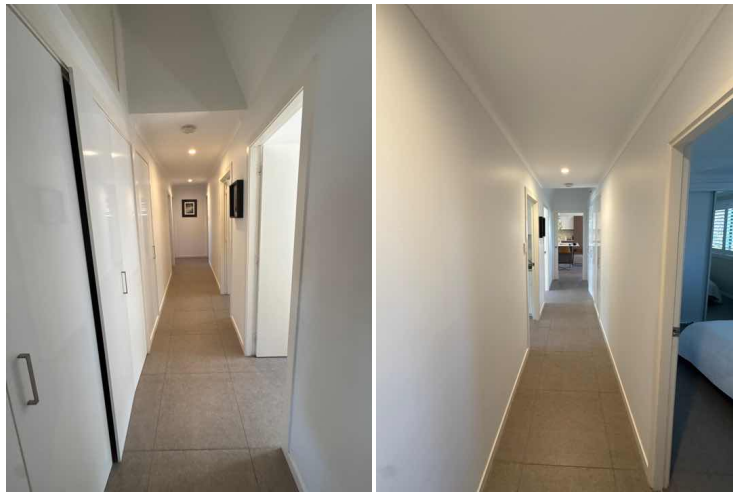
From the visible and accessible areas, the hallway/s/ appears to be in a serviceable condition for the age of the property with no notable structural defects sighted.

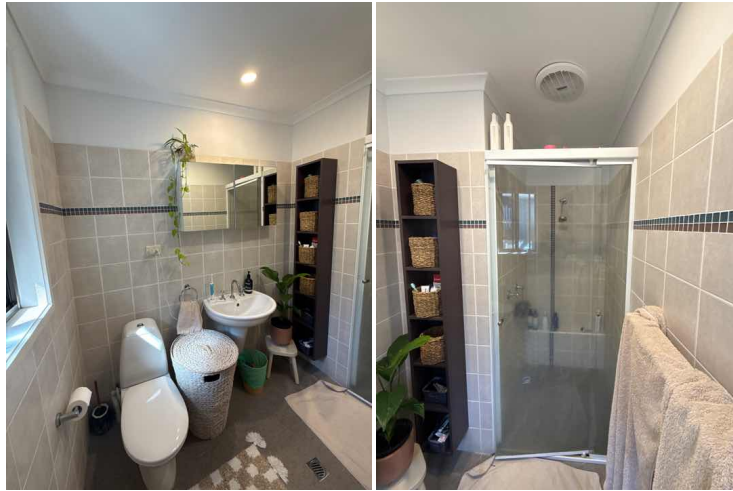
Of the visible areas, the general condition of this bathroom is serviceable or in reasonable condition for age of dwelling.

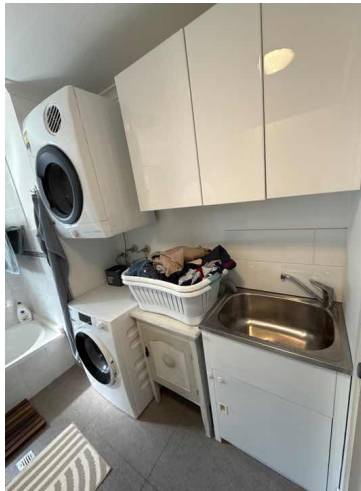
Of the visible areas, the general condition of the laundry is serviceable or in reasonable condition for age of dwelling.

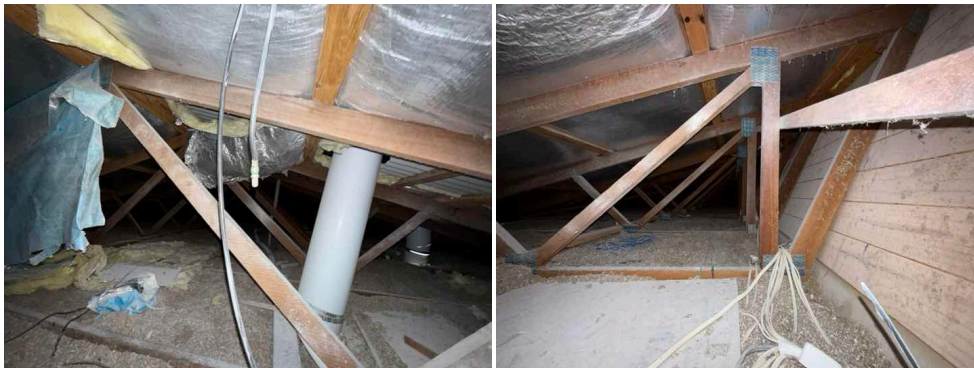
Visible sections of the roof void is in a serviceable condition for age of this dwelling.
