# Building and Pest Report

## 39A Fox Valley Way Lennox Head

# **BPI BUILDING & PEST INSPECTIONS**

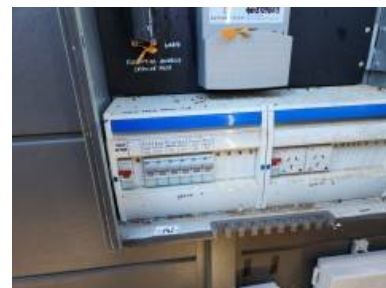
#### **ELECTRICIAL SAFETY SWITCH:**

Whilst not an electrician, it appears that an electrical safety switch is present.

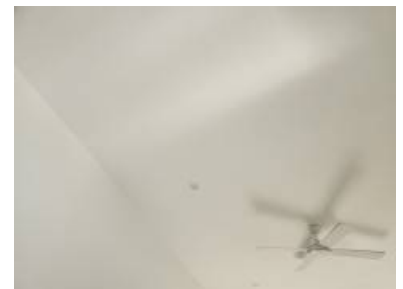
**Cracking / Sagging / Defective Lining**

Satisfactory.

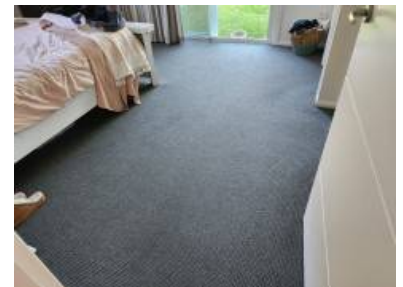
**Restrictions**  
The concrete slabs were covered by flooring coverings and no inspection of the concrete surfaces could be carried out.

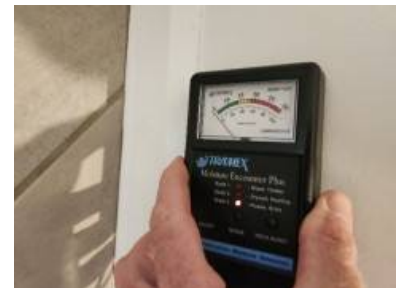
**Leakage**

At the time of inspection no moisture was detected to the wall/s to the rear or side of the shower(s).

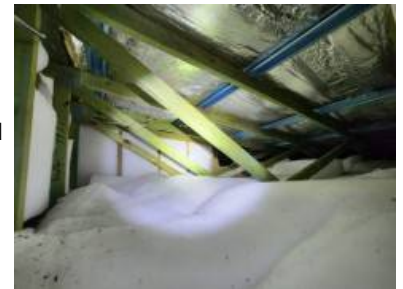
Inspection over the eaves was restricted due to the low pitch and construction allowing only a limited visual inspection from a distance of some areas to be carried out.

Clearance within sections of the roof was too low to allow body access. Outer top wall plates and framing timbers were not inspected due to the area being too low to allow body access. This allows only a limited visual inspection from a distance of some areas to be carried out.

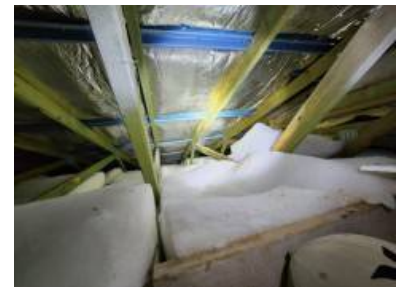
#### Roof Void & Framing - Condition

The roof framing is in satisfactory / typical condition for the age / construction date.

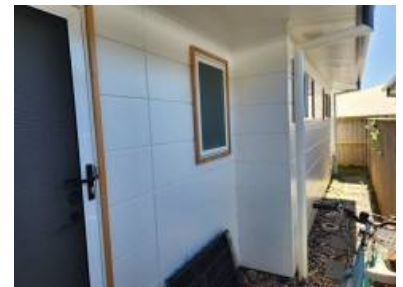
#### Condition:

The external paintwork / finish to the external surfaces and timberwork is generally in good condition. There may be sections / areas that require touching up / repainting.

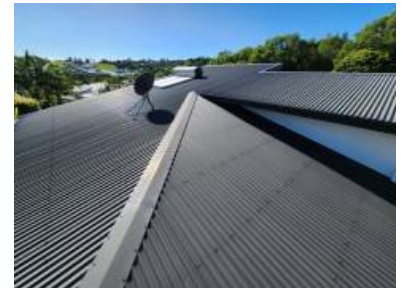
#### SHEET ROOFING

Condition:  
Satisfactory.

We recommend that a qualified roofer be engaged to inspect & detail the condition of the roof exterior, gutters, downpipes & stormwater pipes and any rectification required prior to making a final purchase decision.
