# Building and Pest Report

## 35 Kell Mather Dr Lennox Head

| Report/Agreement # | 12112512582274 |
| Inspection Date: | 12 Nov 2025 |

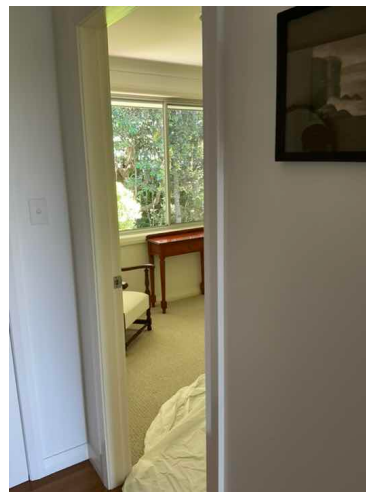
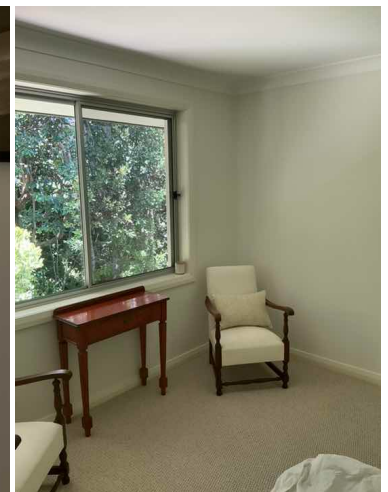
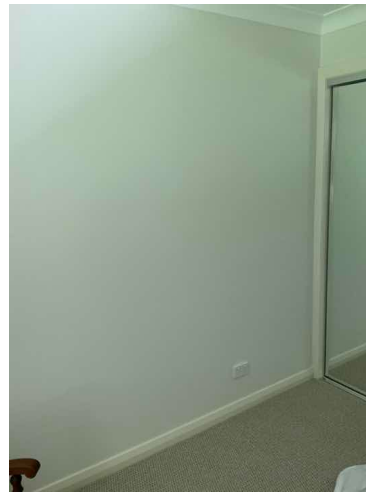
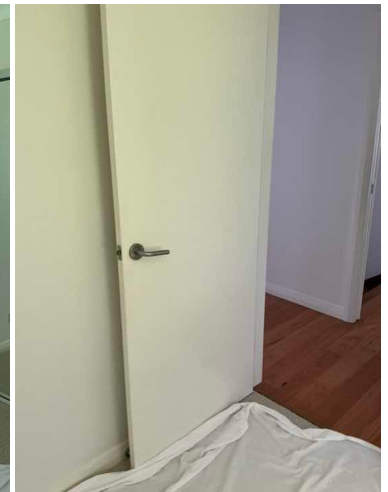
From the visible and accessible areas, this bedroom appears to be in a serviceable condition for the age of the property with no notable structural defects sighted.

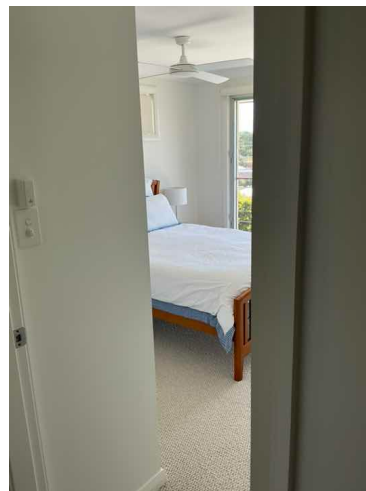
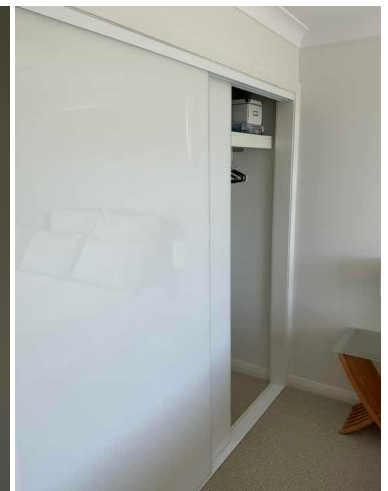
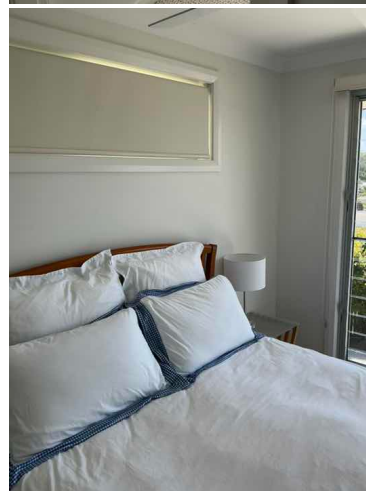
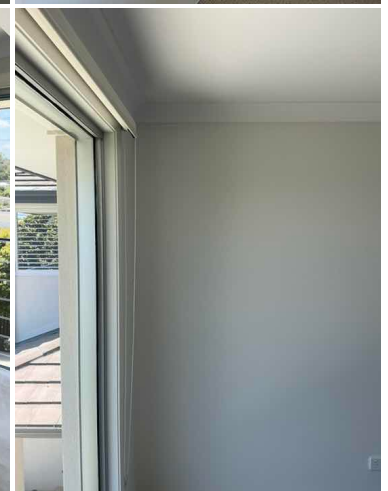
## **Bedroom 4**

From the visible and accessible areas, this bedroom appears to be in a serviceable condition for the age of the property with no notable structural defects sighted.

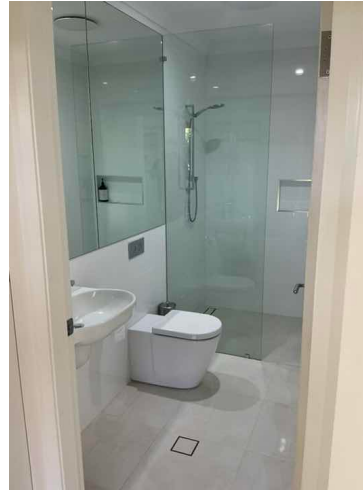
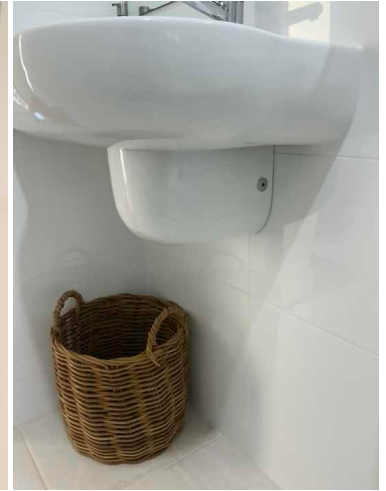
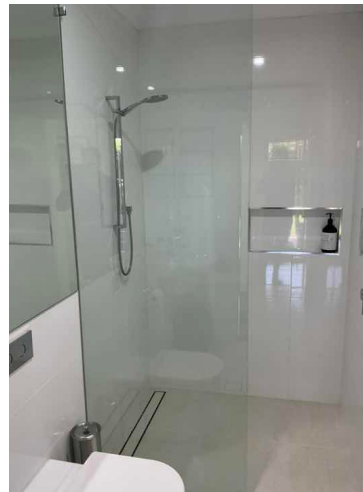
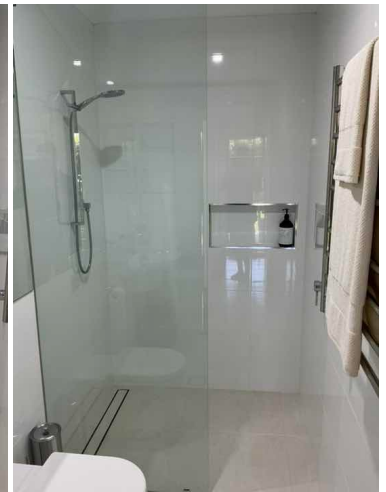
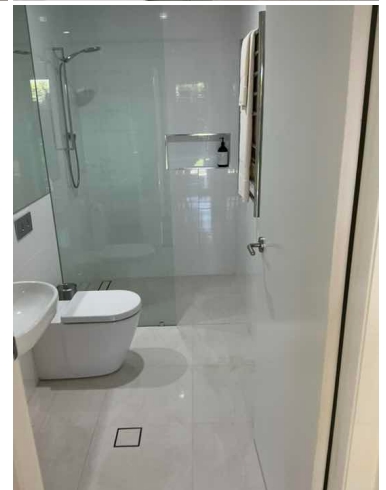
This bathroom is located in the lower level.

Of the visible areas, the general condition of this bathroom is serviceable or in reasonable condition for age of dwelling.

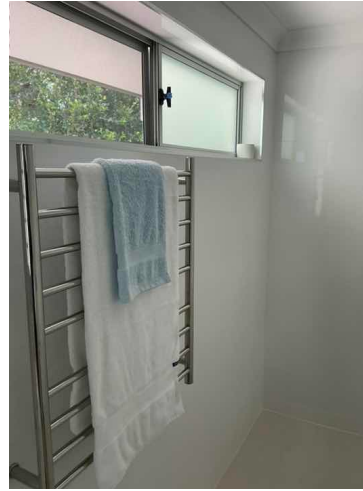
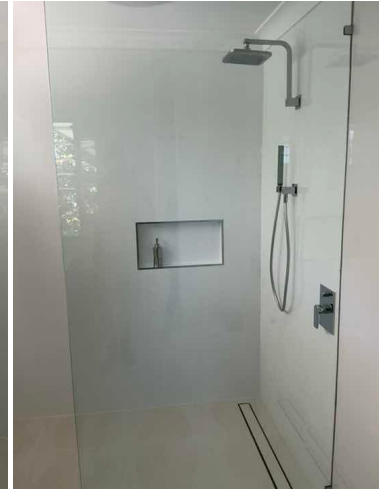
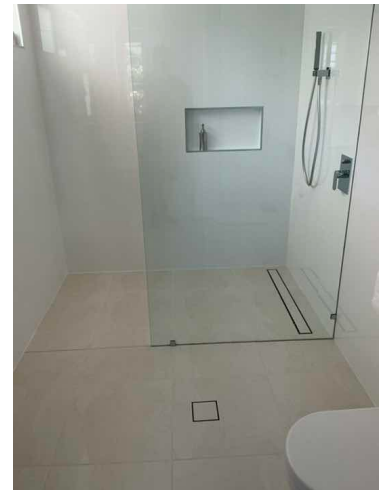
This bathroom is located off the bedroom.

Of the visible areas, the general condition of this bathroom is serviceable or in reasonable condition for age of dwelling.

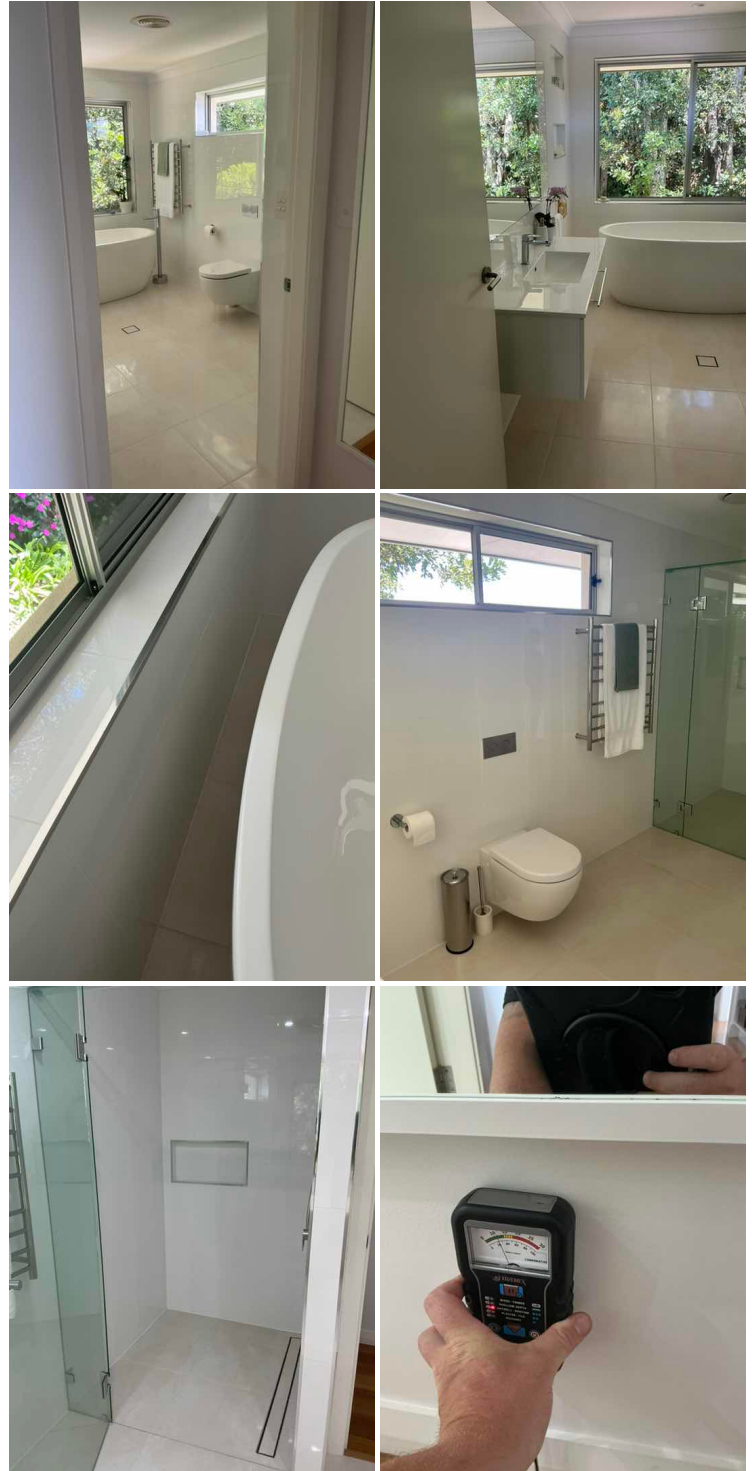
This bathroom is located in the upper level.

Of the visible areas, the general condition of this bathroom is serviceable or in reasonable condition for age of dwelling.

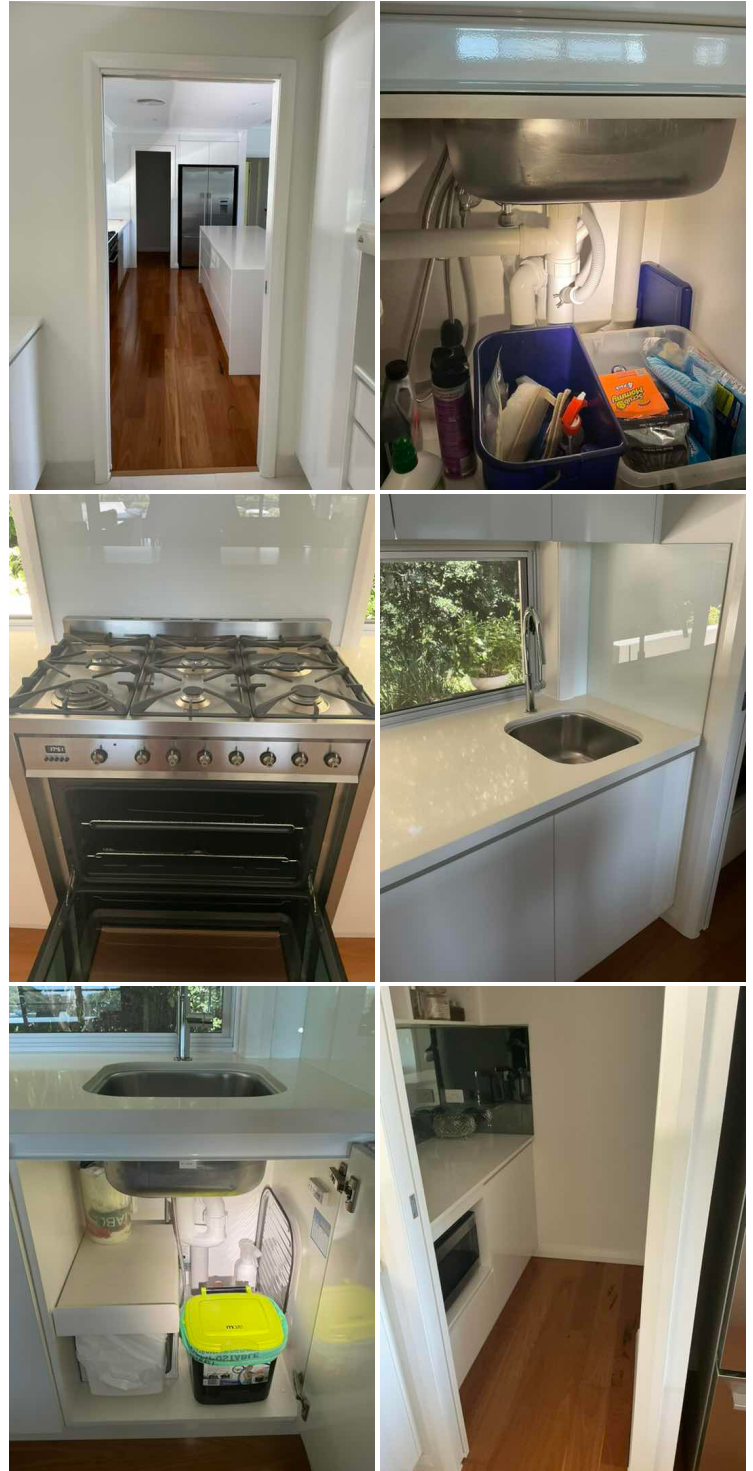
Of the visible areas, the general condition of the kitchen and pantry is serviceable or in reasonable condition for age of dwelling.

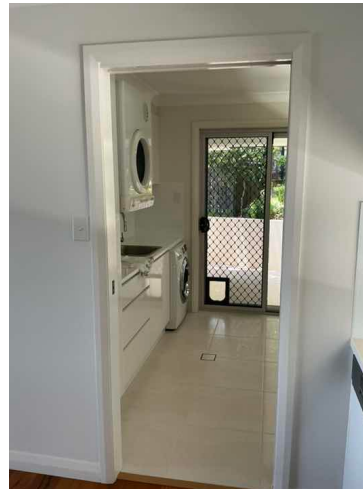
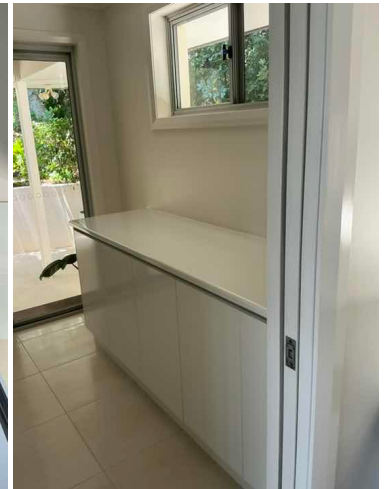
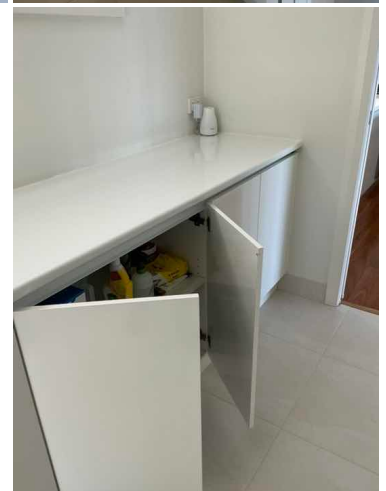
Of the visible areas, the general condition of the laundry is serviceable or in reasonable condition for age of dwelling.

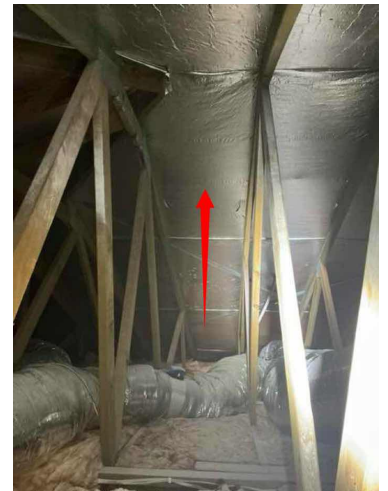
The sarking generally is in a serviceable condition.

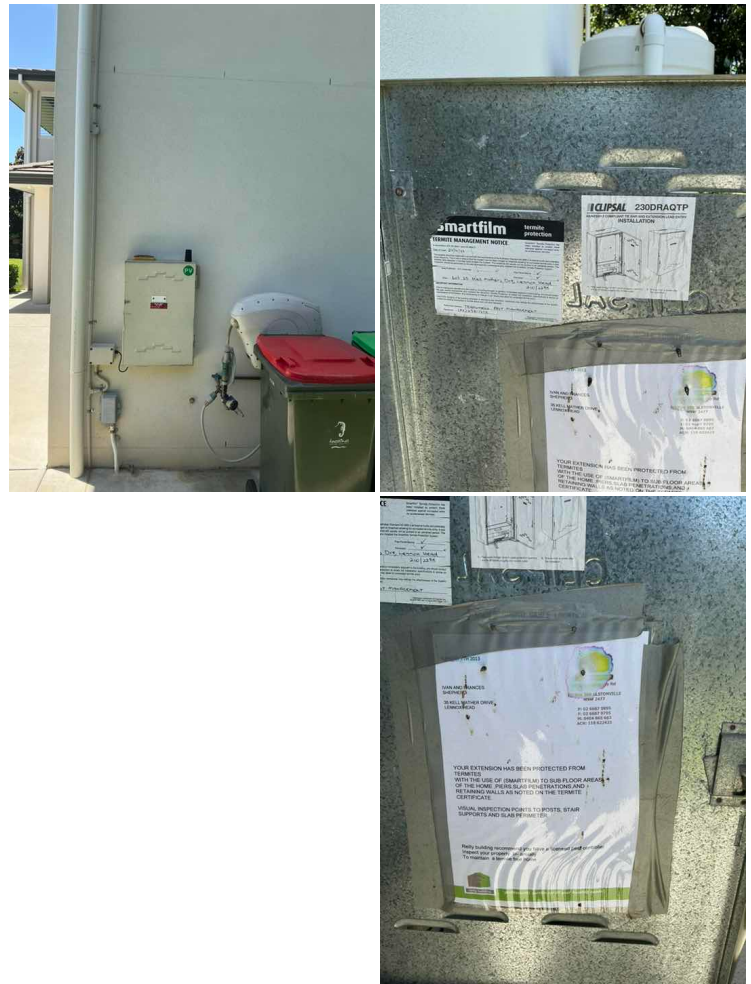
Yes, a durable notice was found in the meter-box during the inspection.

This firm can give no assurances with regard to work that may have been previously performed by other firms. You should obtain copies of all paperwork and make your own inquiries as to the quality of the treatment, when it was carried out and warranty information. In most cases you should arrange for a treatment in accord with Australian Standard 3660 be carried out to reduce the risk of further attack.

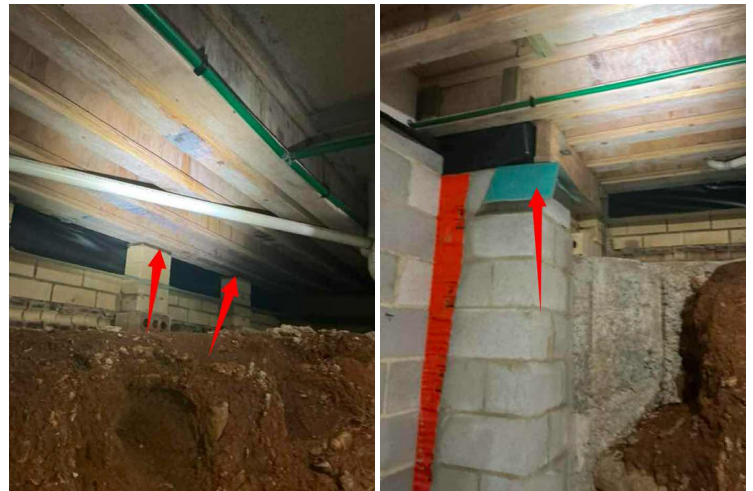
The ant capping is generally considered adequate.
