# Building and Pest Report

## 33 Karalauren Crt, Lennox Head

# Inspection Report

**33 Karalauren Crt , Lennox Head , NSW, 2478**

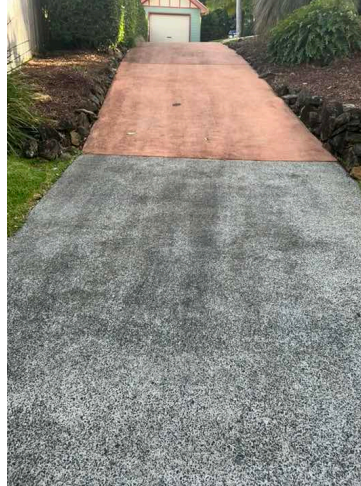
Common cracks were observed on the driveway. Whilst these cracks appeared to be typical at the time of inspection, we strongly recommend you monitor these cracks and if worsening occurs contact a concreter for further advice.

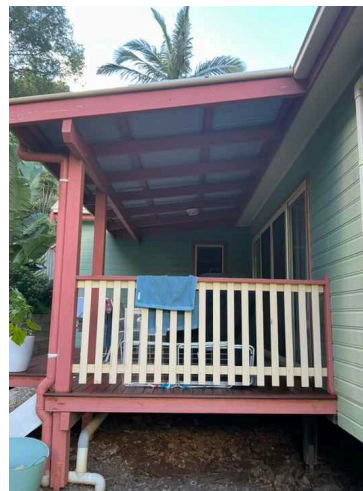
#2. Paint / finish was deteriorated in areas and is in need of maintenance - Sanding back affected areas and painting required.

Upon visual inspection, the fascia board shows signs of peeling paint, indicating potential weather exposure. Recommend sanding and repainting to protect the wood.

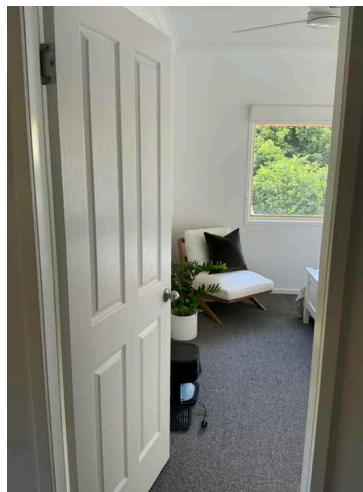
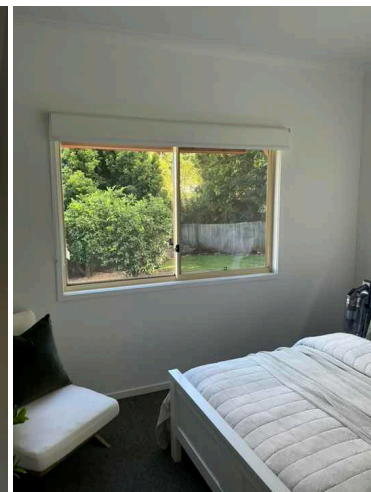
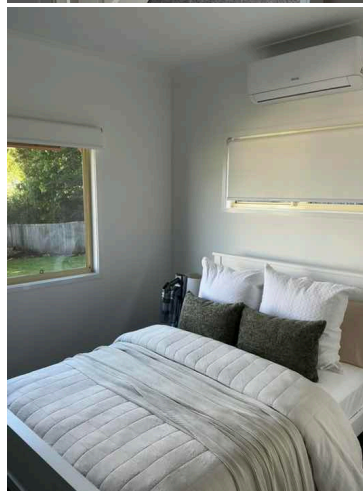
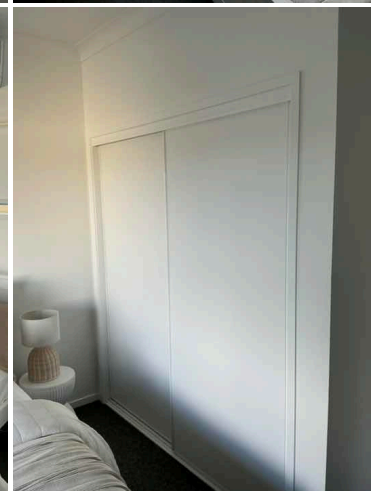
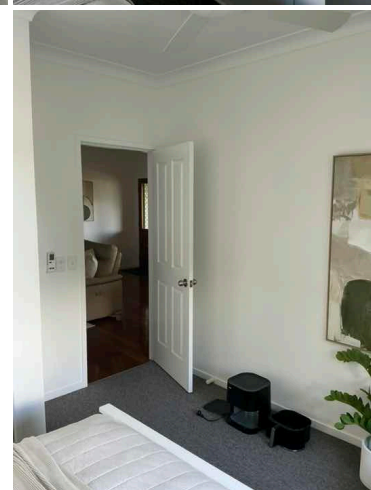
## Bedroom 1

From the visible and accessible areas, this bedroom appears to be in a serviceable condition for the age of the property with no notable structural defects sighted.

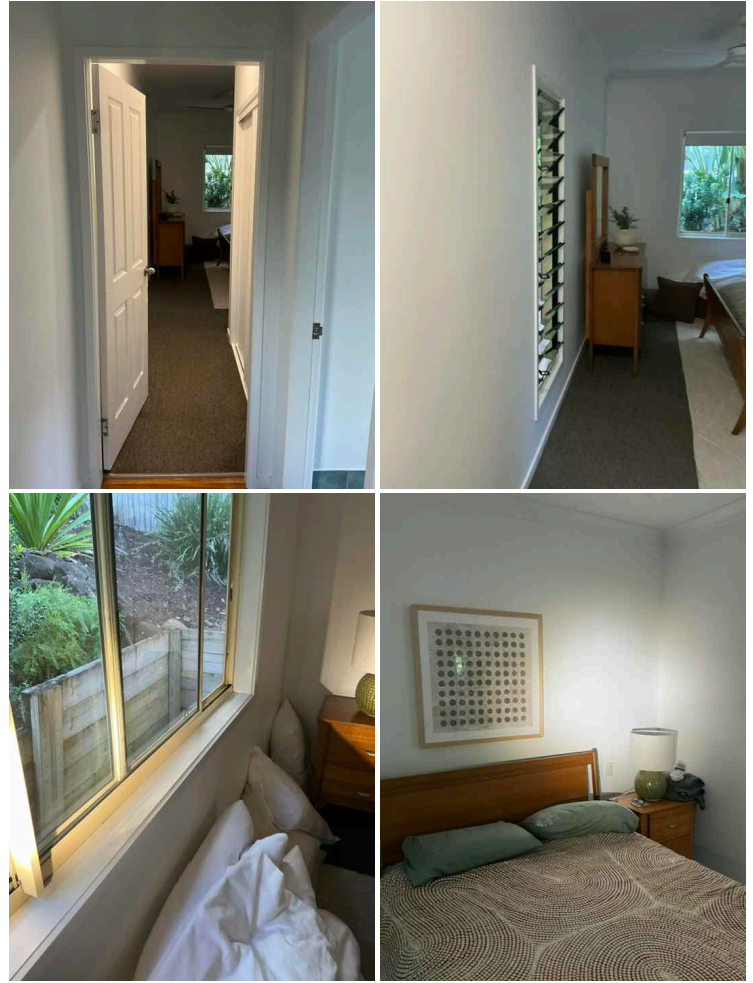
**Bedroom 2****Overall Condition**

From the visible and accessible areas, this bedroom appears to be in a serviceable condition for the age of the property with no notable structural defects sighted.

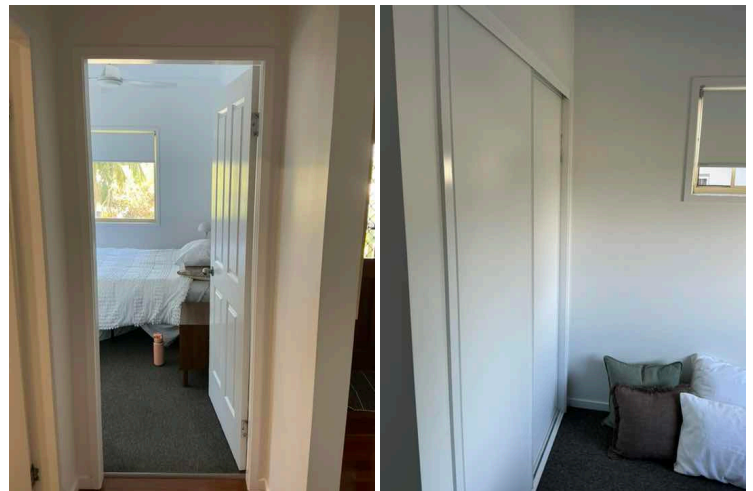
**Bedroom 3****Overall Condition**

From the visible and accessible areas, this bedroom appears to be in a serviceable condition for the age of the property with no notable structural defects sighted.

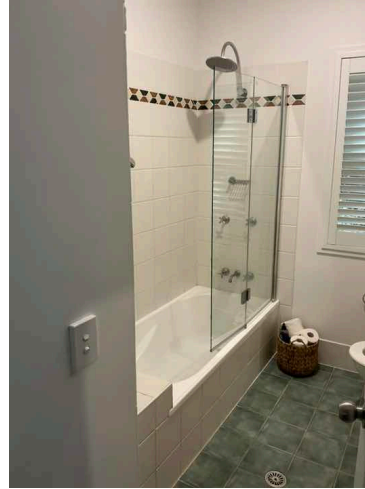
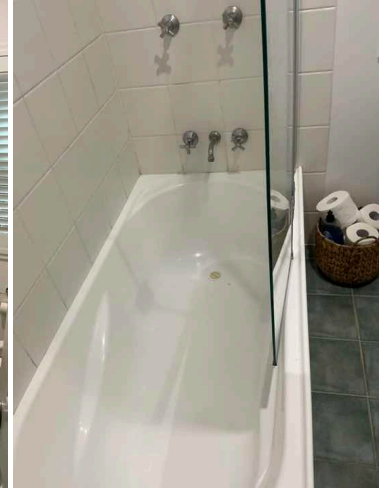
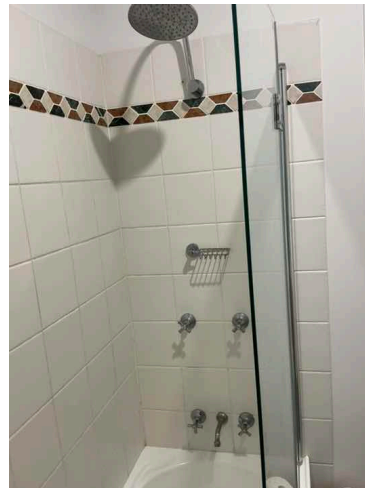
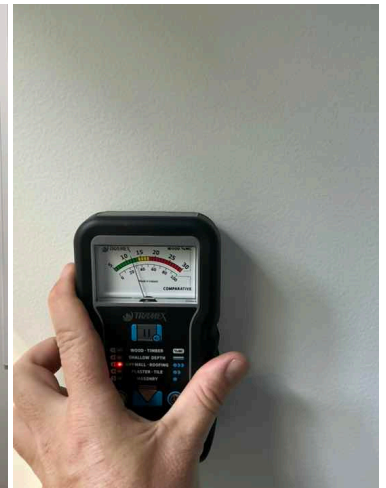
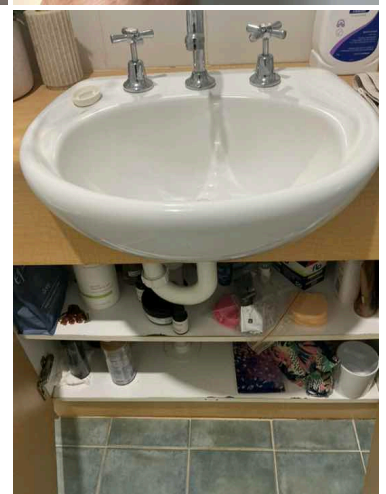
Of the visible areas, the general condition of this bathroom is serviceable or in reasonable condition for age of dwelling.

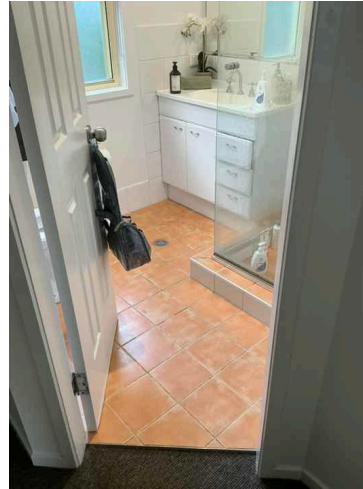
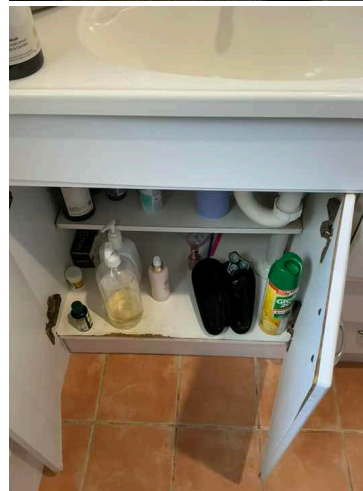
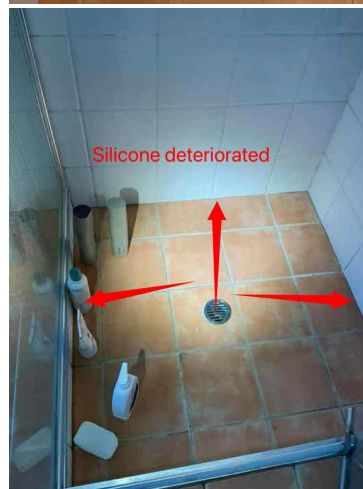
Upon visual inspection, there is water staining on the subfloor indicating a possible leak. It is recommended to have a licensed plumber inspect and repair the plumbing to prevent further water damage. Additionally, assess the surrounding materials for any signs of mold or rot and replace if necessary.

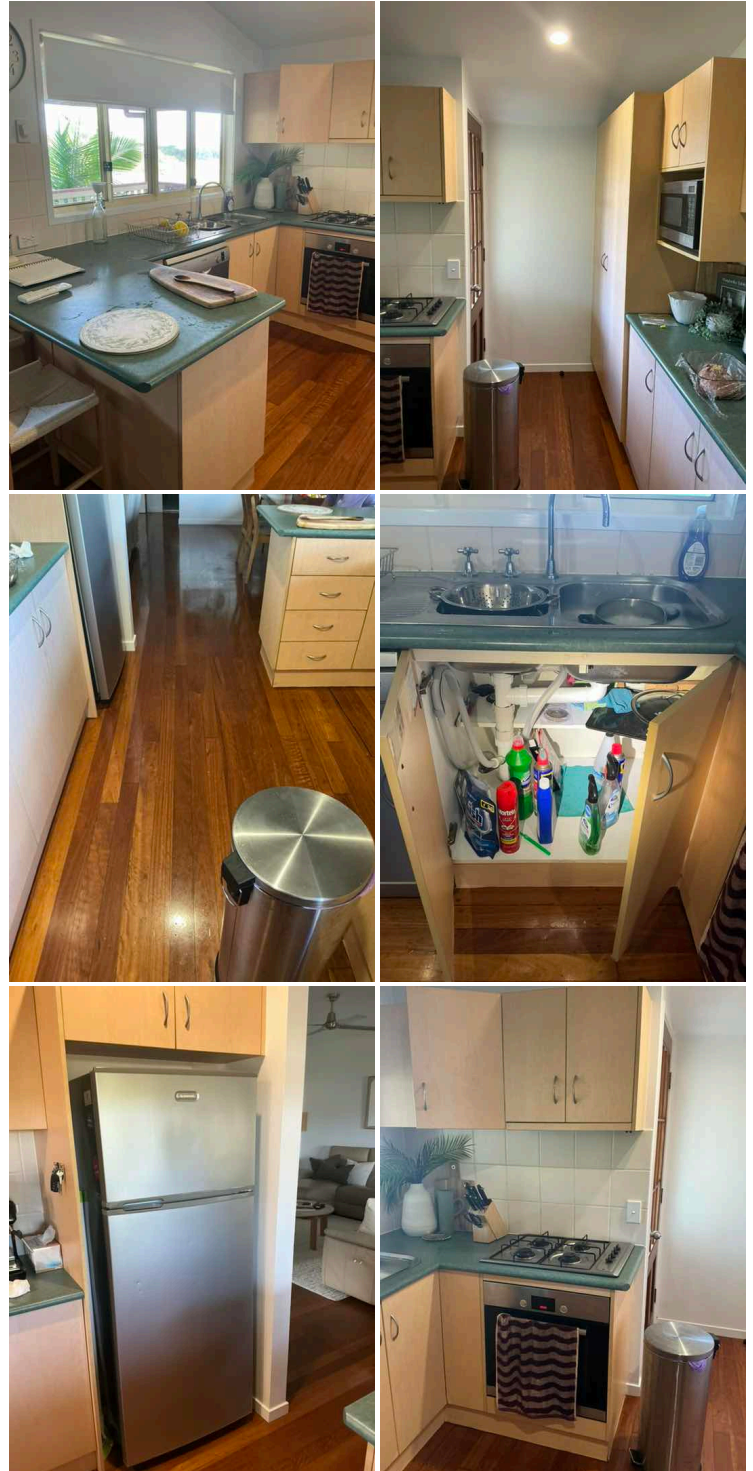
Of the visible areas, the general condition of the kitchen and pantry is serviceable or in reasonable condition for age of dwelling.

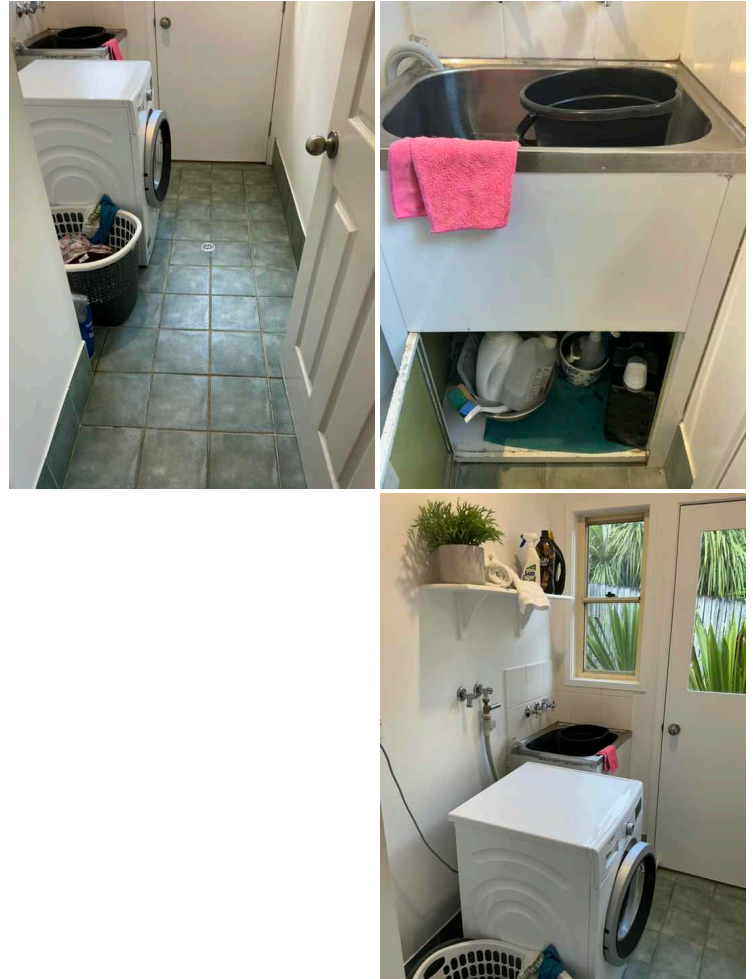
Of the visible areas, the general condition of the laundry is serviceable or in reasonable condition for age of dwelling.

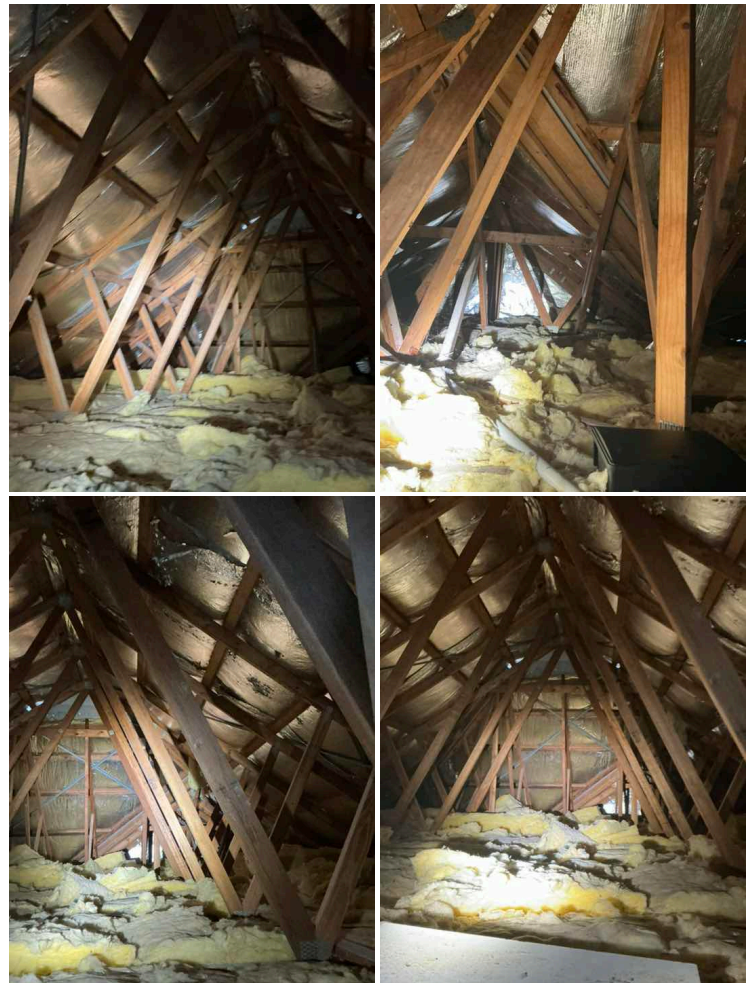
Visible sections of the roof void is in a serviceable condition for age of this dwelling.

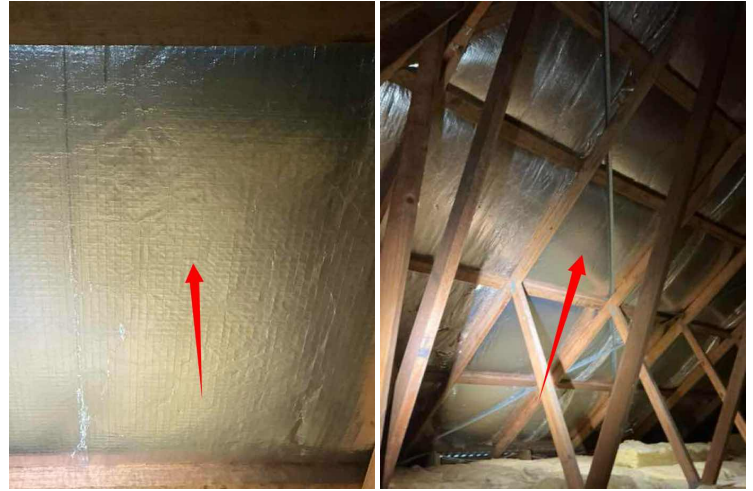
The sarking generally is in a serviceable condition.

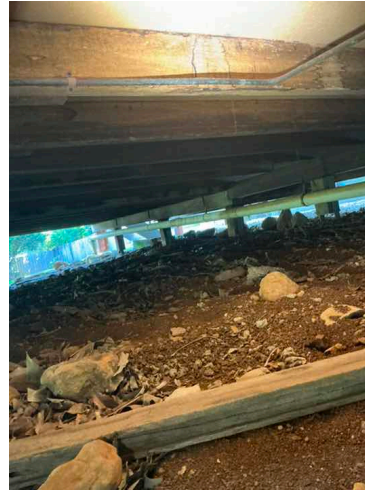
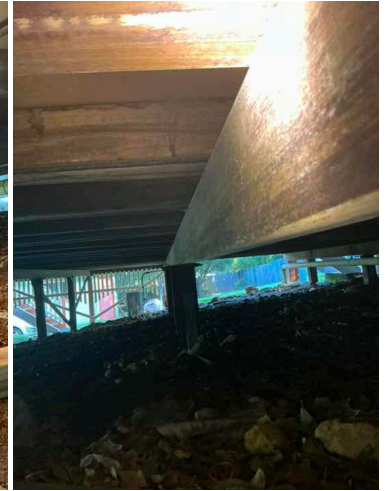
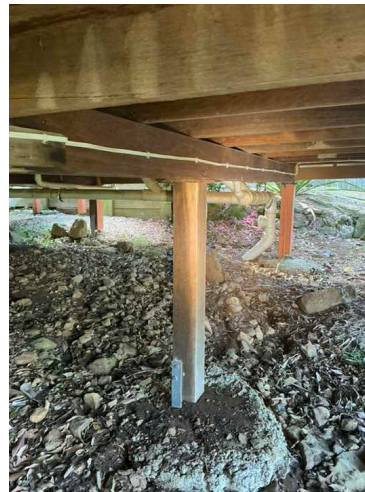
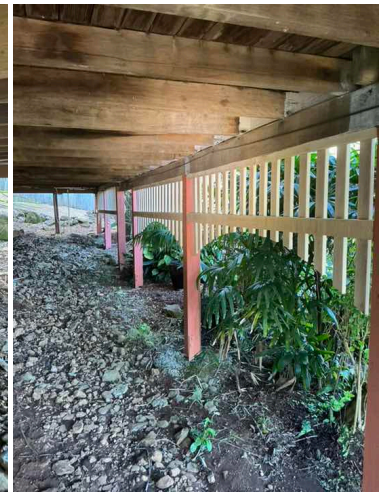
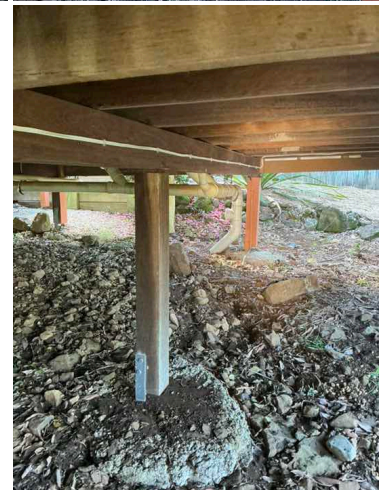
Of areas accessible and visible, the subfloor and components appeared to be in a serviceable condition.

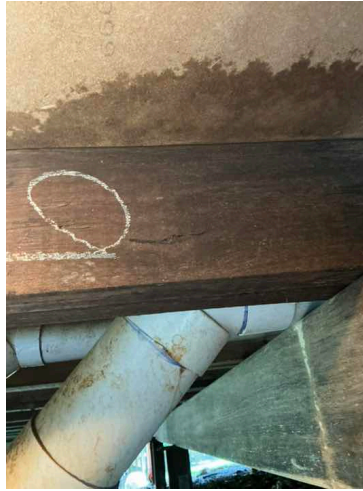
## Floor Timbers

#4. Damp/Moisture damage noted. Possible failed water proof membrane to shower area. Reconstruction of this area may be the best option long term. Contact a licensed builder for further evaluation.

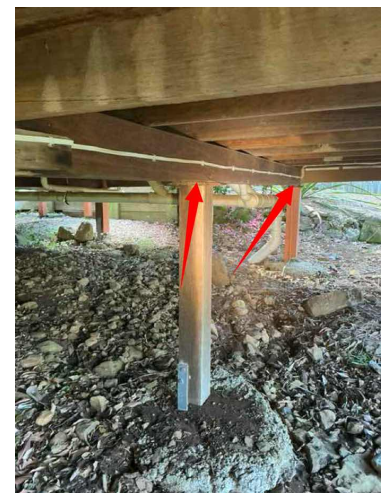
The ant capping is generally considered adequate.
