# PEST AND BUILDING PRE-PURCHASE REPORTS

# Inspection Report

**13 Andrew Pl, Lennox Head, NSW, 2479**

Report/Agreement #	280325101850332
Inspection Date:	28 Mar 2025
Inspection Time:	10:18 am

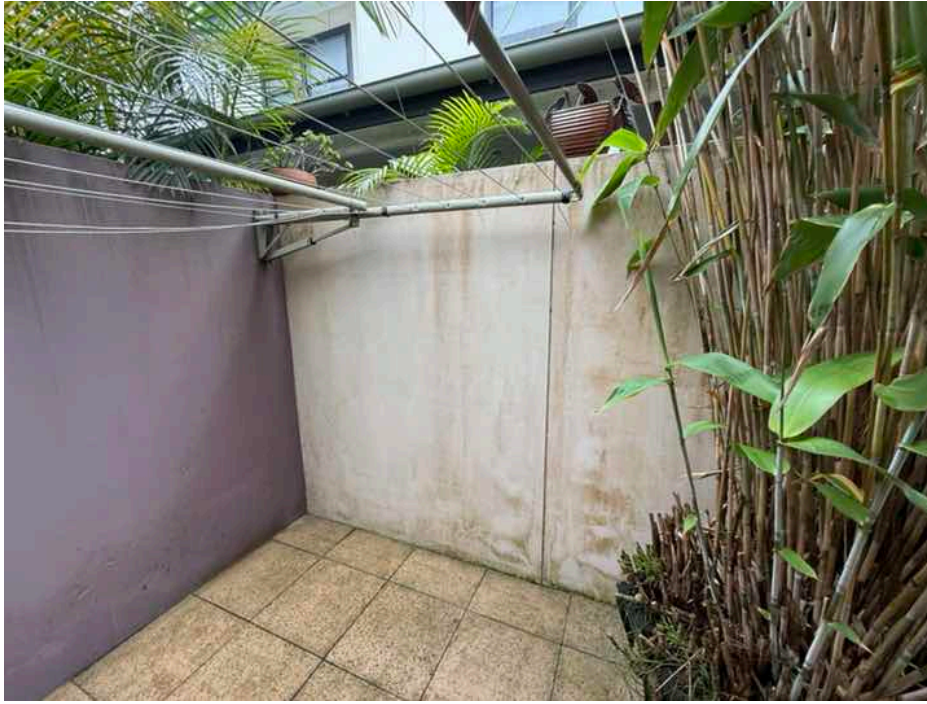
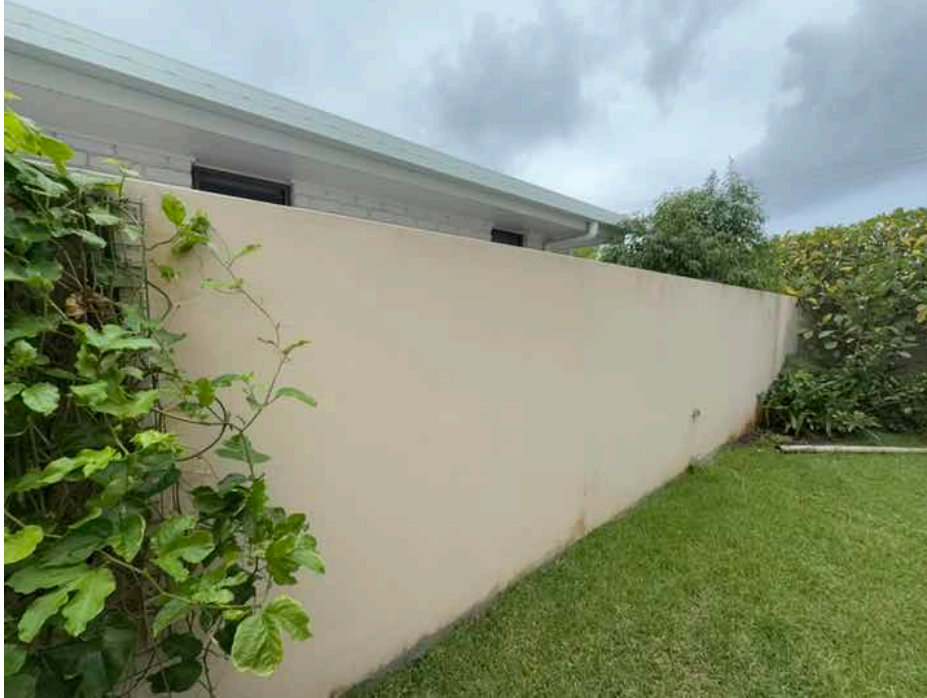
Of the visible areas, the general condition of the fences and gates is serviceable for the age of dwelling.

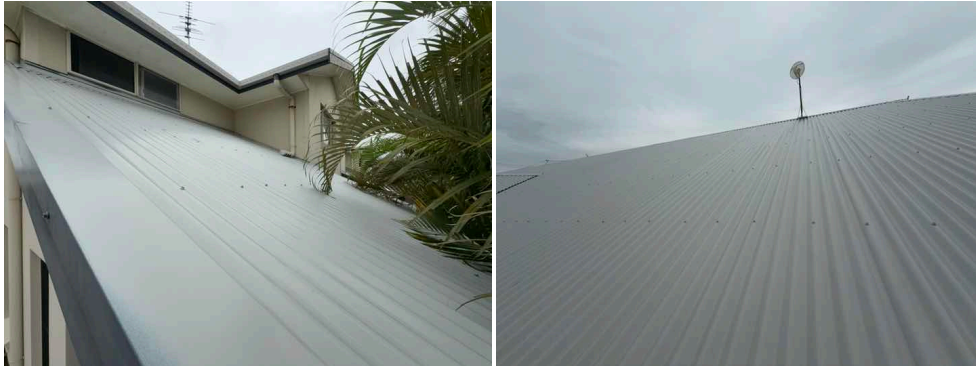
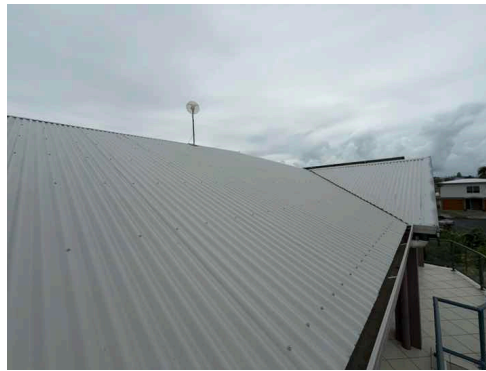
Of the visible areas, the general condition of the roof is in serviceable condition for the age.

Gutter rust/penetrations- The guttering has excessive rust where leaking will occur. The gutters require replacement by a roof plumber.

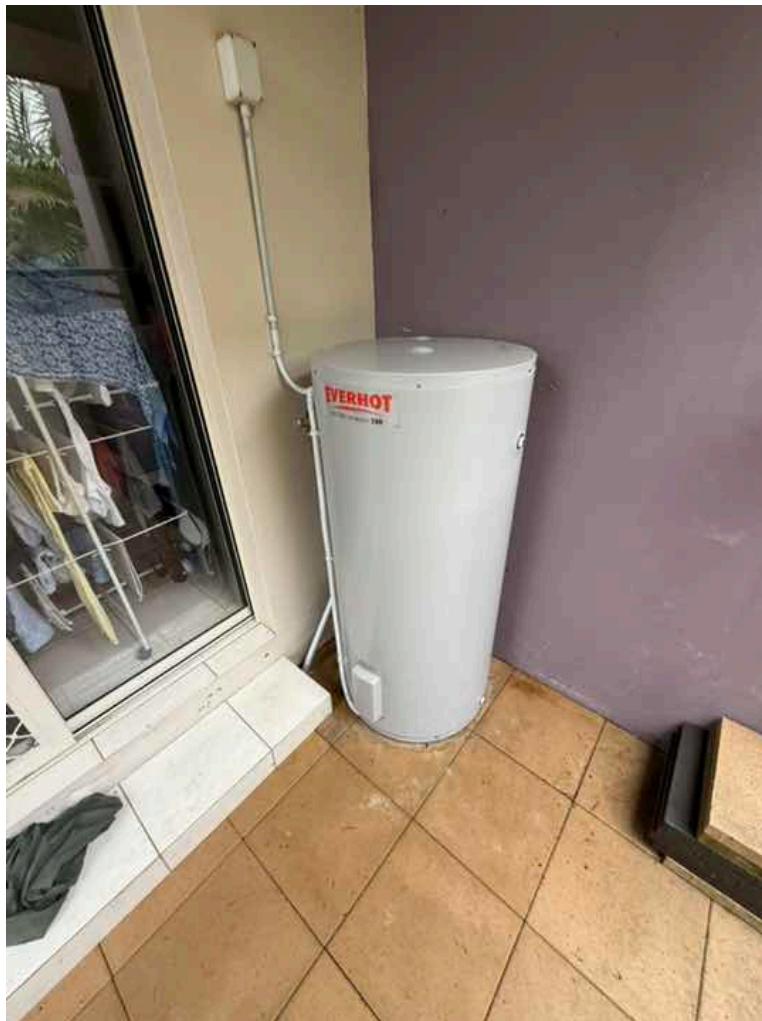
Everhot

General rust deterioration was observed on the hot water unit casing. We recommend you replace the unit.

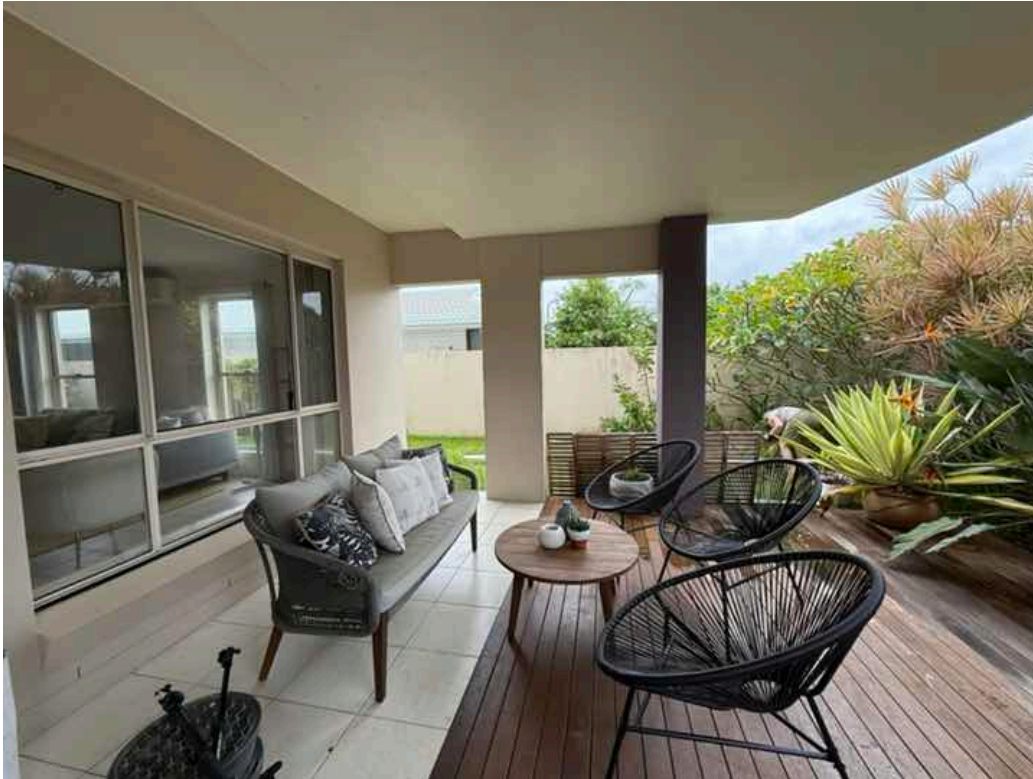
Visible sections of the Alfresco area are serviceable or in reasonable or condition for the age of this dwelling.

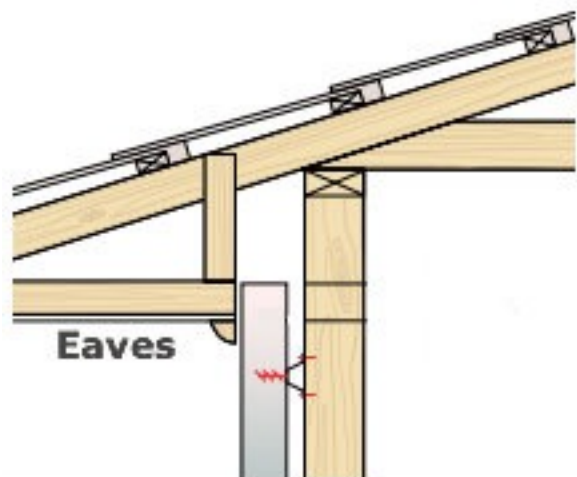
The soffit lining (eaves) are in a serviceable condition with no notable defects.

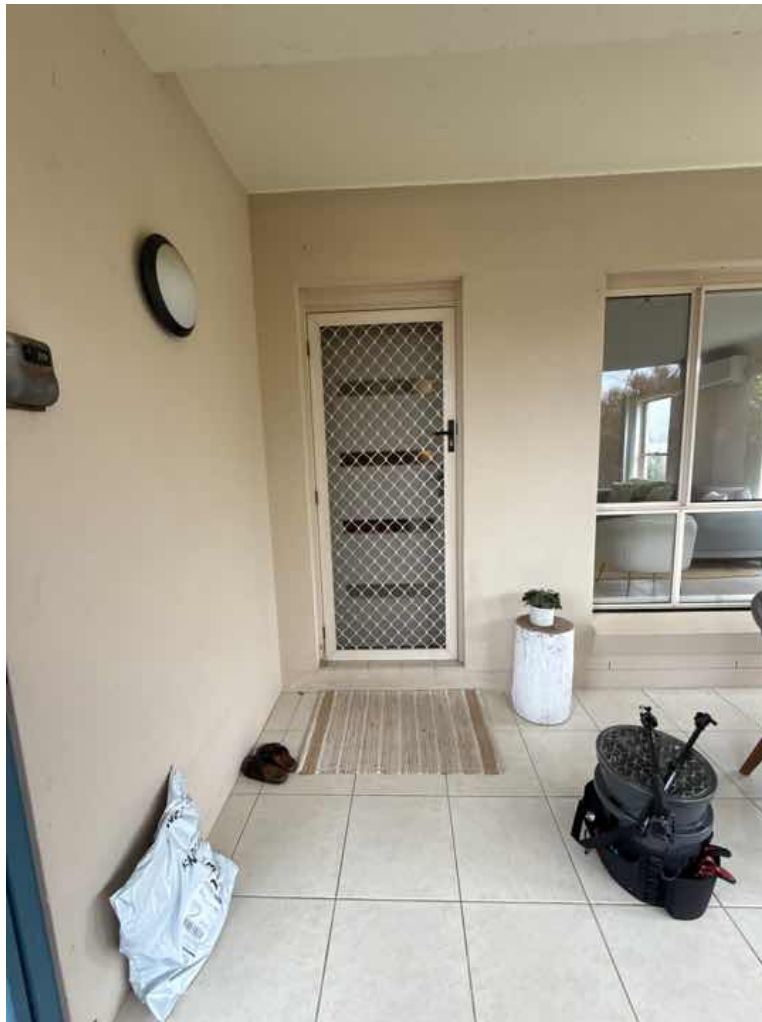
The entry porch serviceable or in reasonable or condition for the age of this dwelling.

Damp damage to door/frame - It appear water has damaged / penetrated areas of the door/framing.

Recommendations: A qualified carpenter should be engaged for advice and recommendations re repair/sealing from weathering.

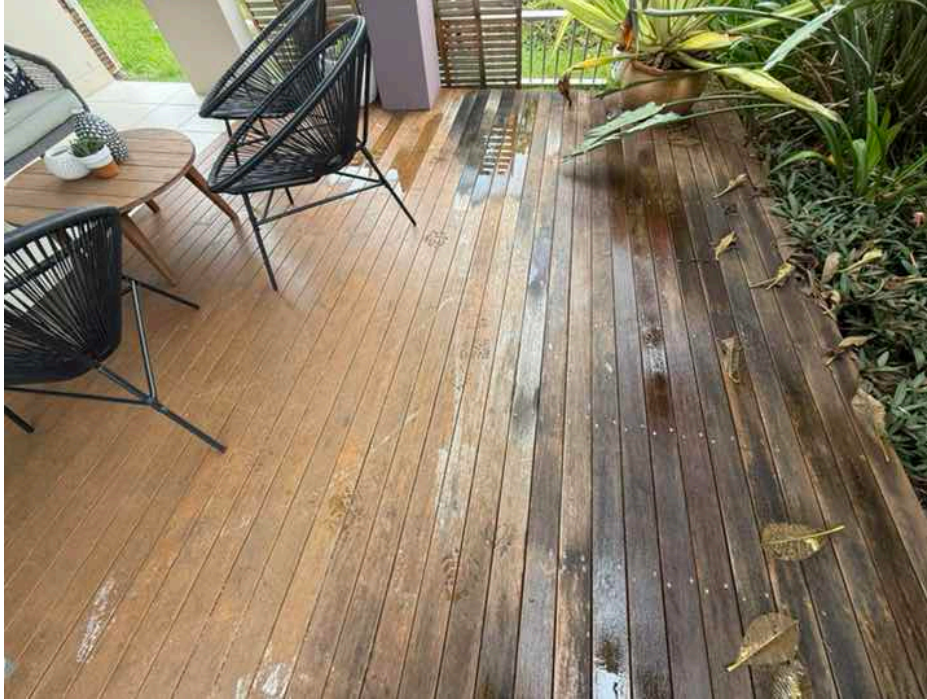
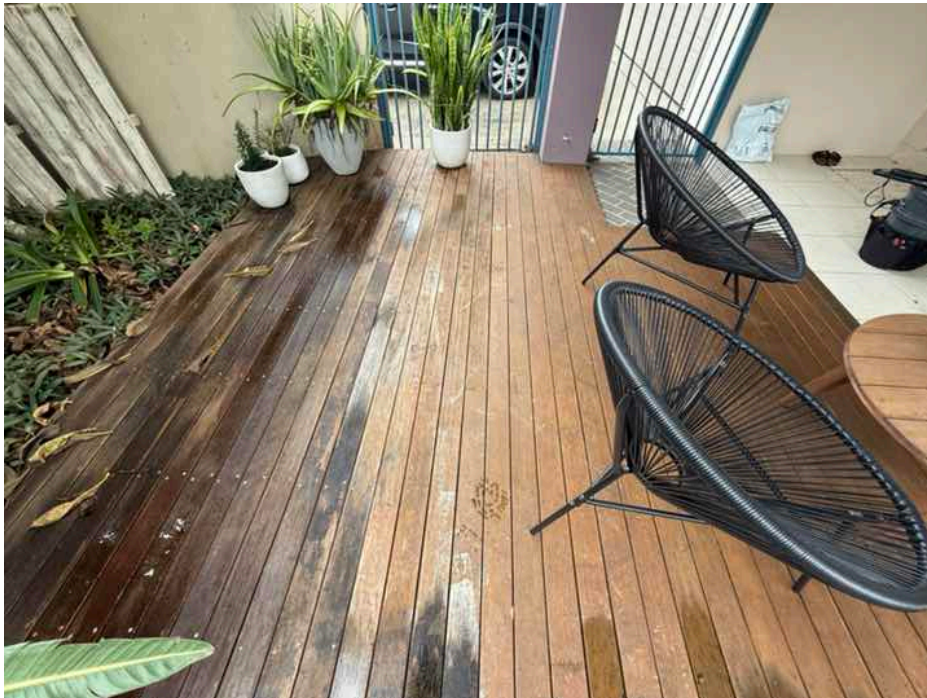
Of areas visible, the decking appears to be in a serviceable condition.

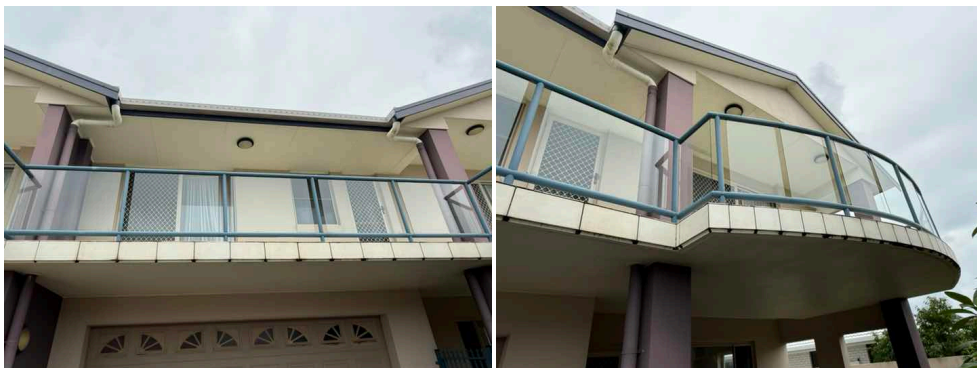
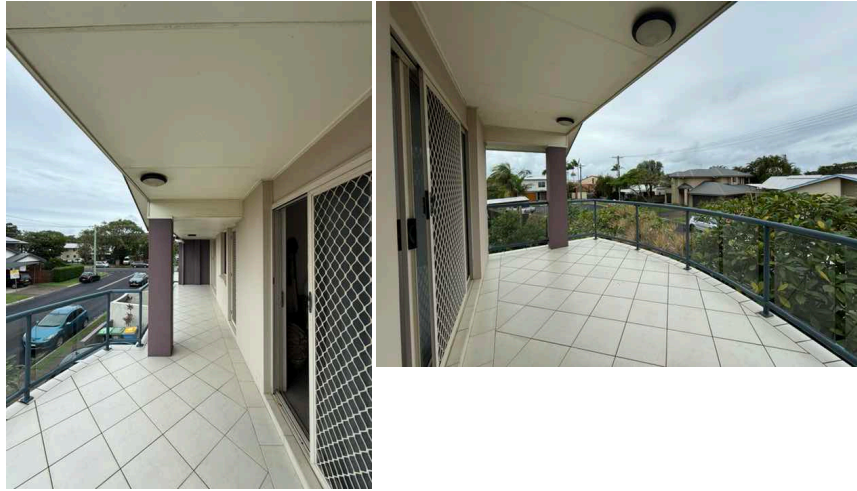
Though we are not structural engineers the balcony/s appear to be in a serviceable condition.

Baluster rail height should be 1 m in height from deck/balcony/patio floor. In some circumstances this regulation was non-existent dependent on the age of the dwelling and technically there is no requirement to rectify. We strongly advise you rectify to comply for safety concerns.

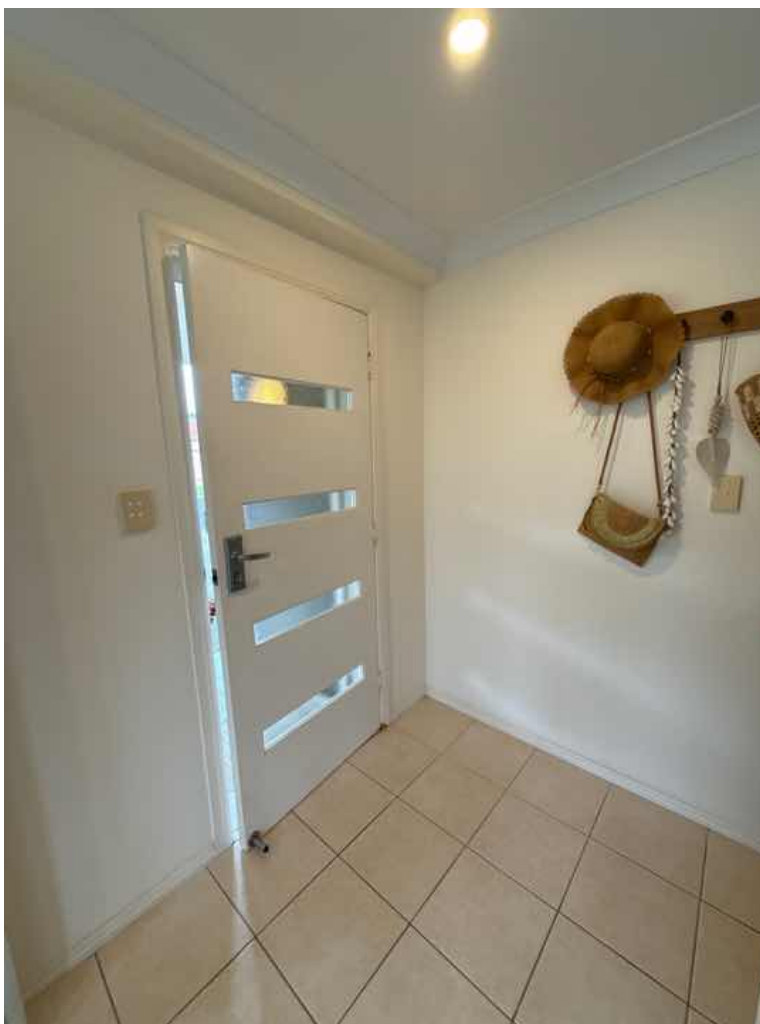
From the visible and accessible areas, this area appears to be in a serviceable condition for the age of the property with no notable structural defects sighted.

Skirting board damage/deterioration. A qualified carpenter should be engaged to replace.

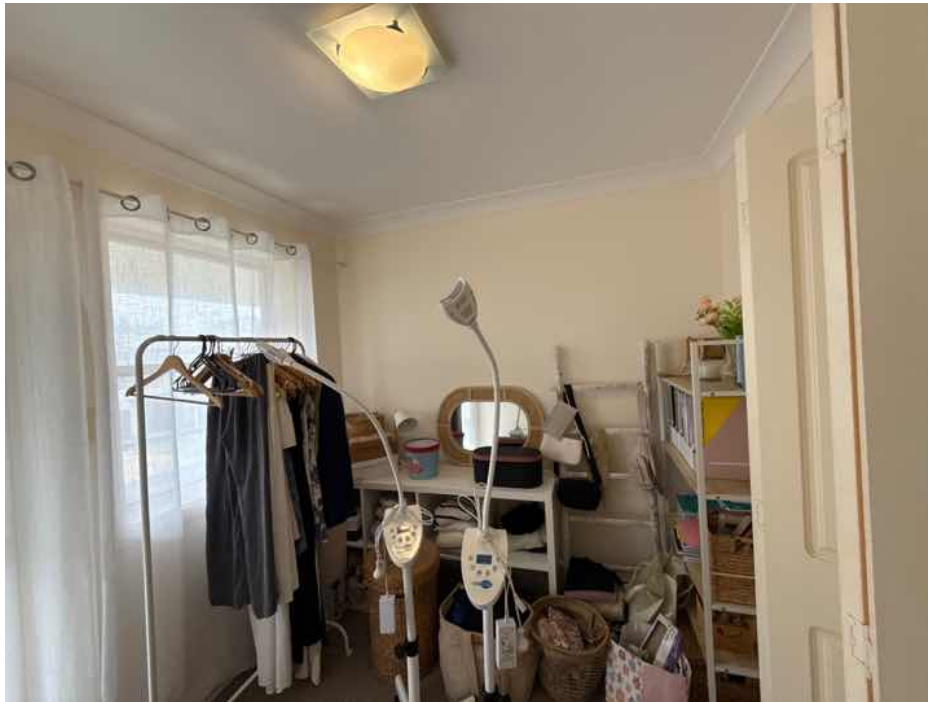
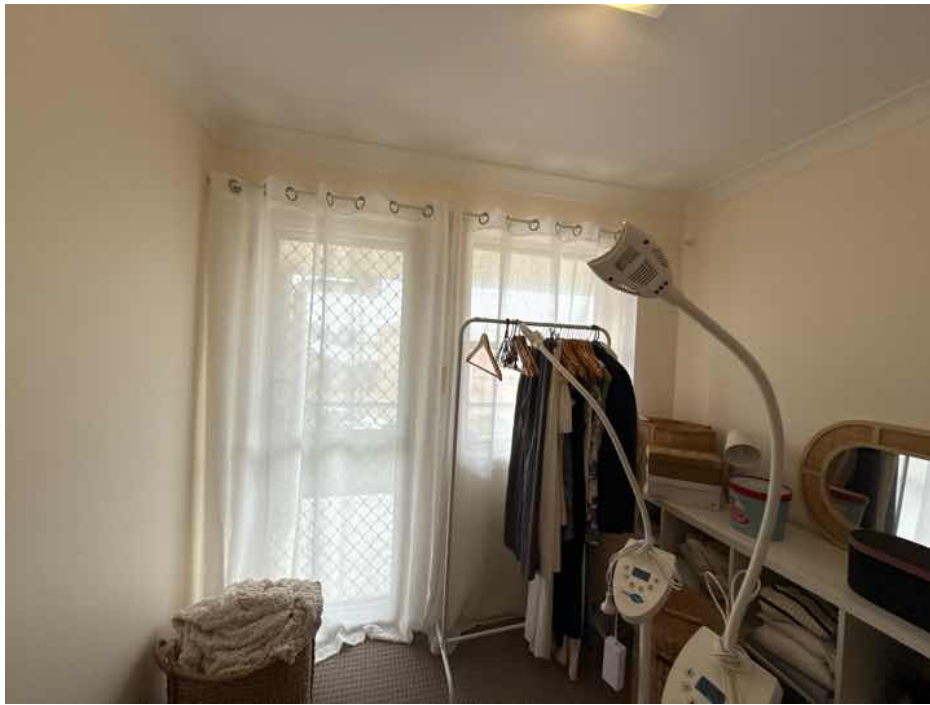
From the visible and accessible areas, this room appears to be in a serviceable condition for the age of the property with no notable structural defects sighted.

Catching on the carpet.

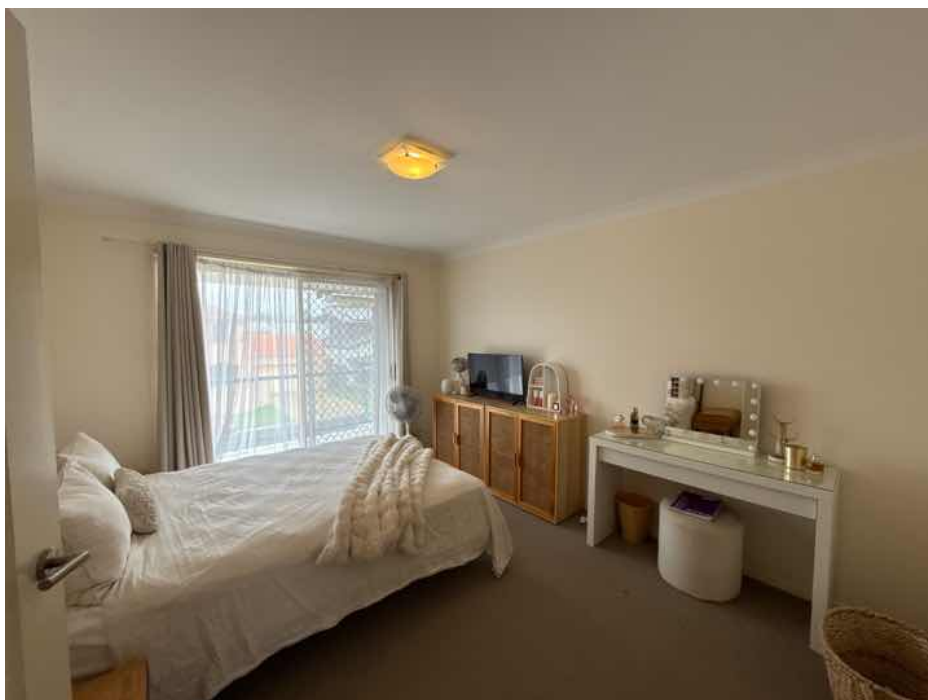
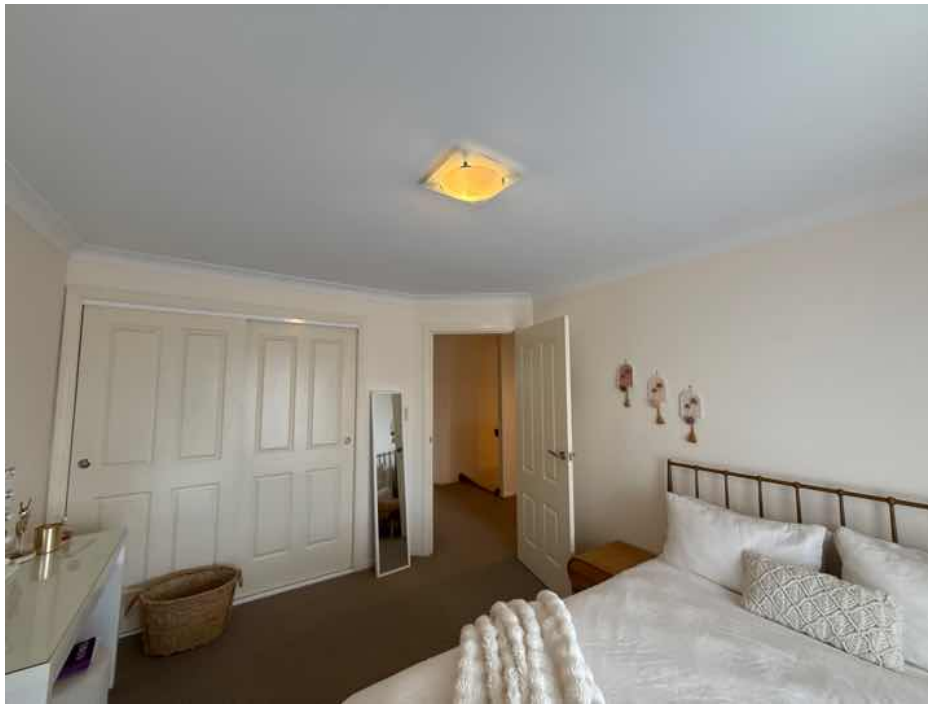
From the visible and accessible areas, this bedroom appears to be in a serviceable condition for the age of the property with no notable structural defects sighted.

Ceiling stains - No moisture readings obtained. These may have been repaired however you will need to monitor after a prolonged period of rainfall. If leaking persists, a qualified plumber should be engaged for advice and recommendations. All water damaged plaster should be replaced.

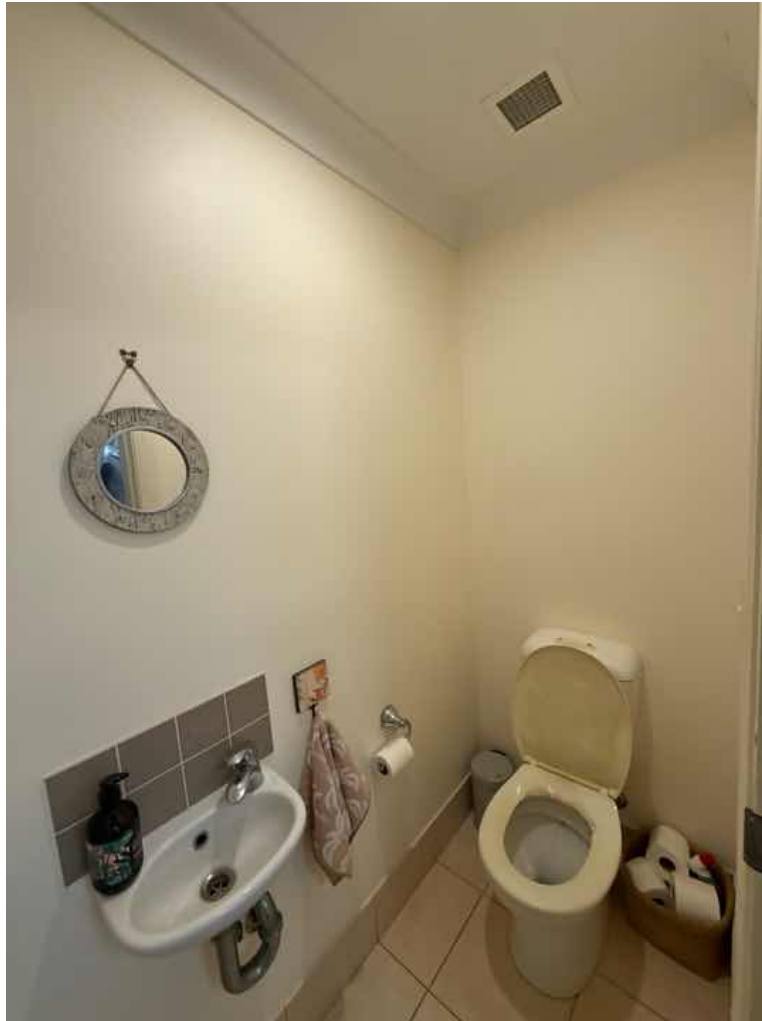
Of the visible areas, the general condition of this bathroom is serviceable or in reasonable condition for age of dwelling.

The rubber bumper off the door stop is missing.

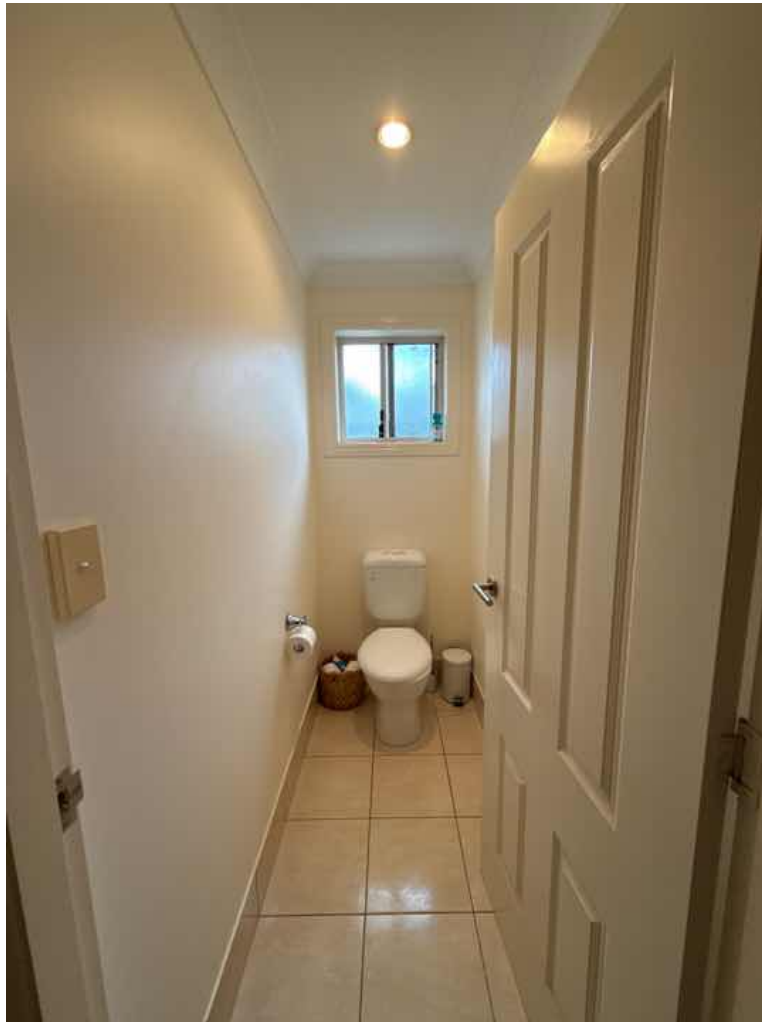
Of the visible areas, the general condition of this bathroom is serviceable or in reasonable condition for age of dwelling.

The door hardware is loose.

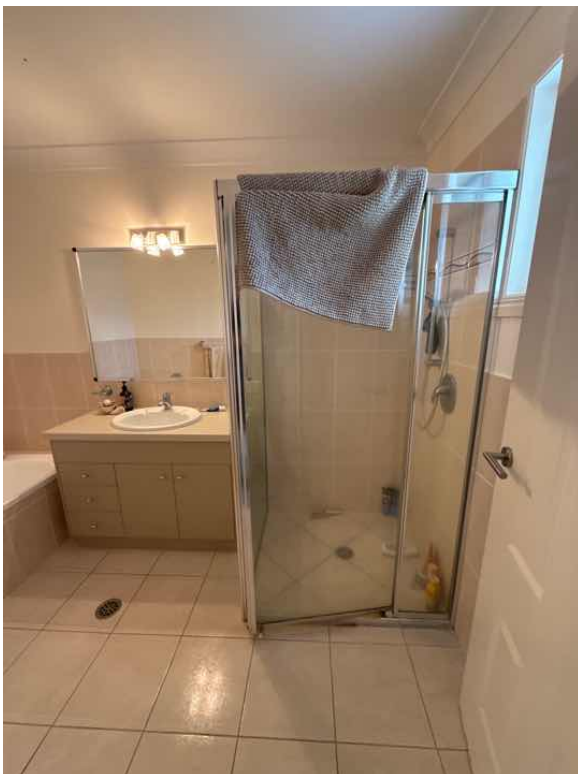
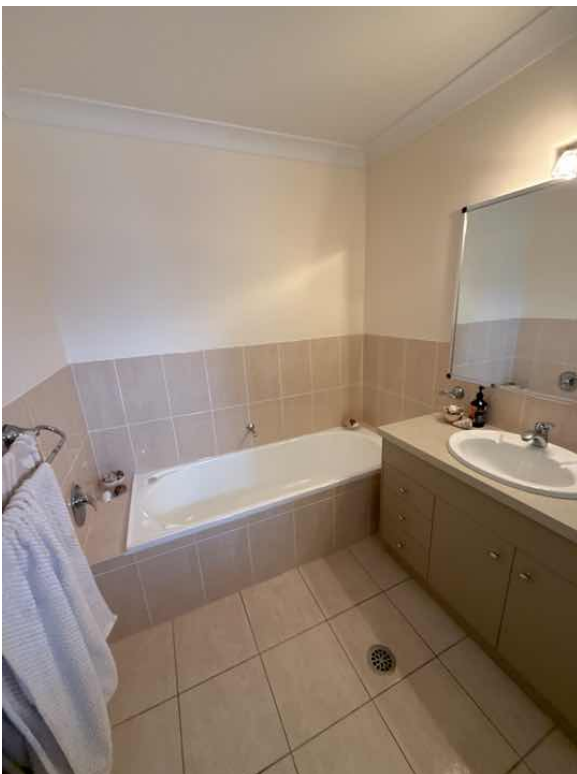
Of the visible areas, the general condition of this bathroom is serviceable or in reasonable condition for age of dwelling.

Water damaged door. Possible due to leak in bathroom. Replacement recommended.

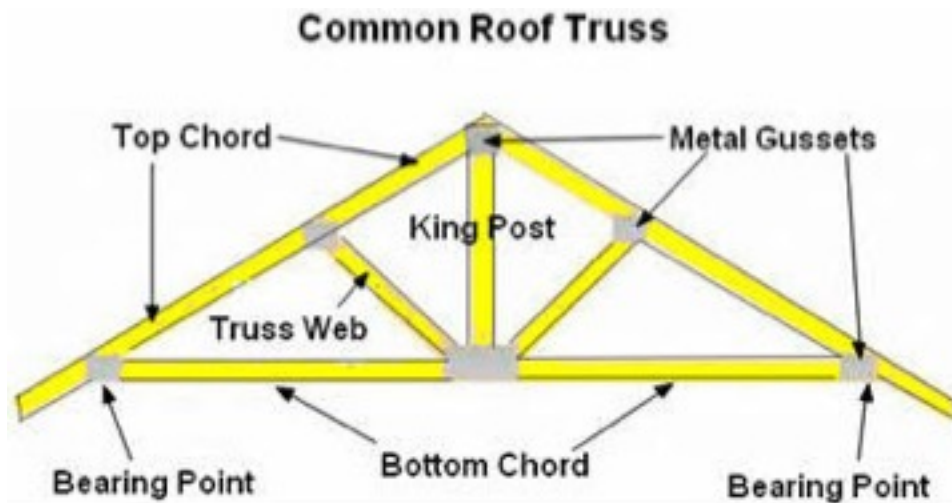
The roof frame is a truss timber frame.

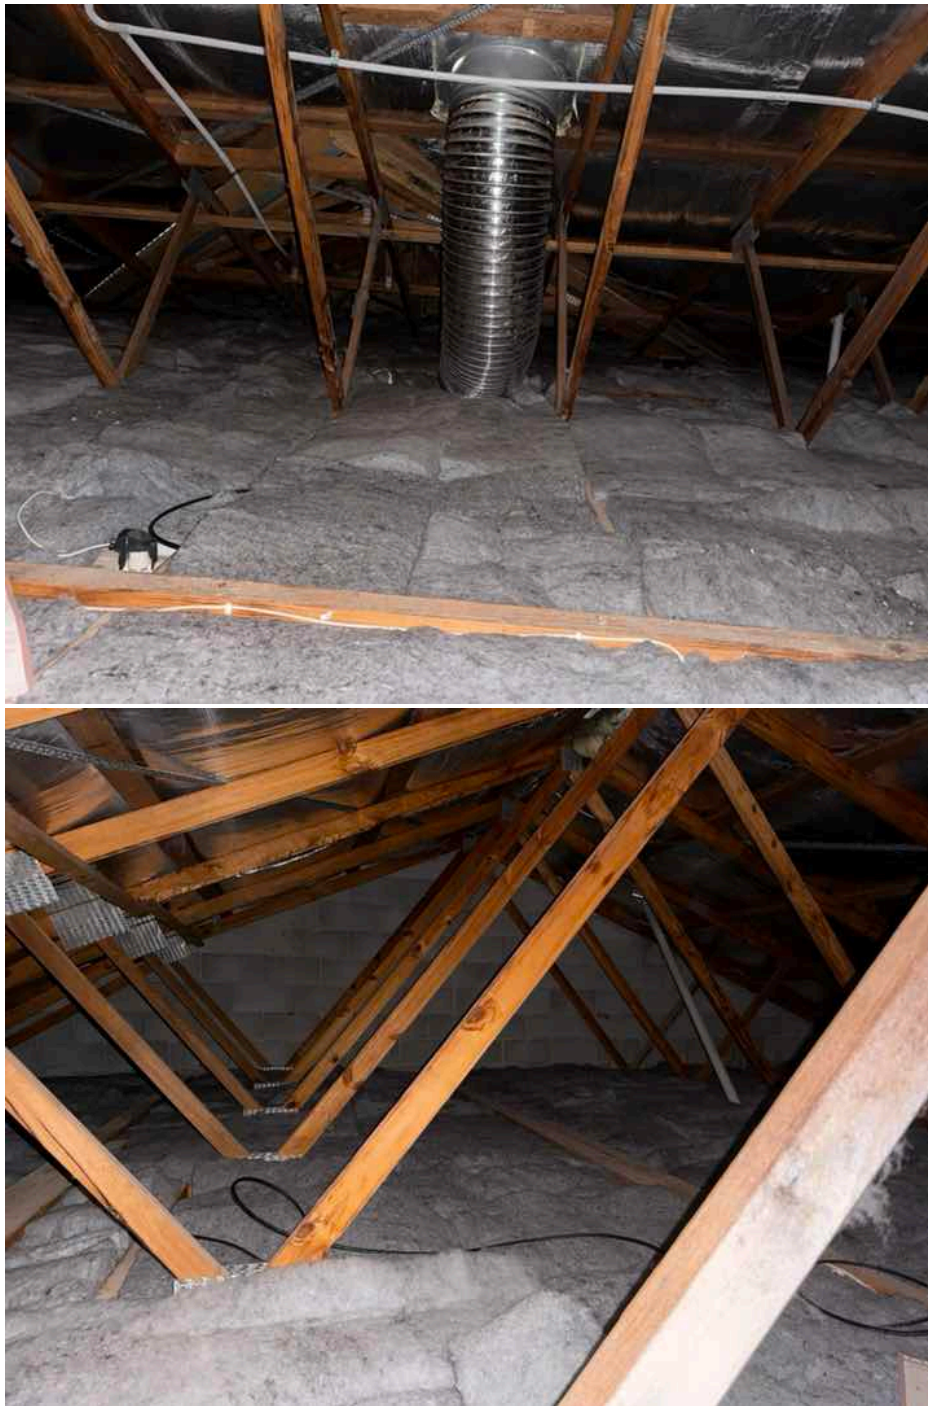
Visible sections of the roof void is in a serviceable condition for age of this dwelling.
