Building and Pest Report

2/28 Kell Mather Drive Lennox Head

Pest And Building Inspection

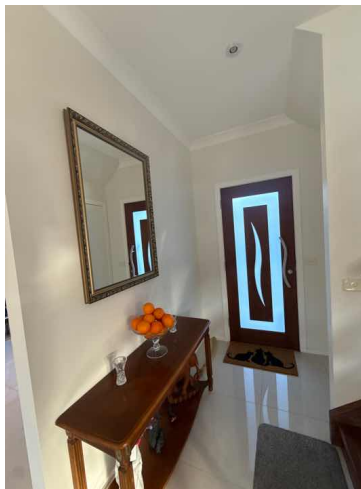
Overall Condition

From the visible and accessible areas, this area appears to be in a serviceable condition for the age of the property with no notable structural defects sighted.

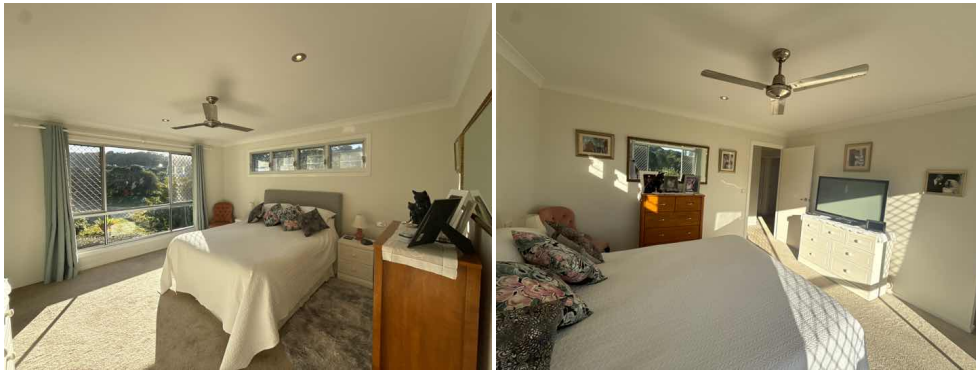
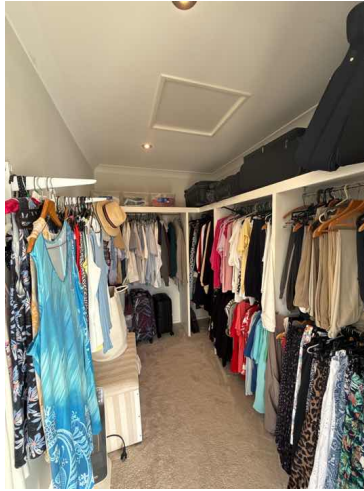
Overall Condition

From the visible and accessible areas, this bedroom appears to be in a serviceable condition for the age of the property with no notable structural defects sighted.

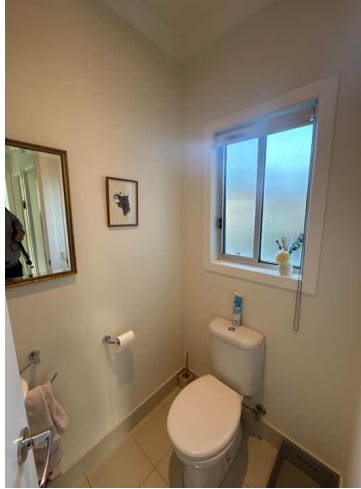
Overall Condition

Of the visible areas, the general condition of this bathroom is serviceable or in reasonable condition for age of dwelling.

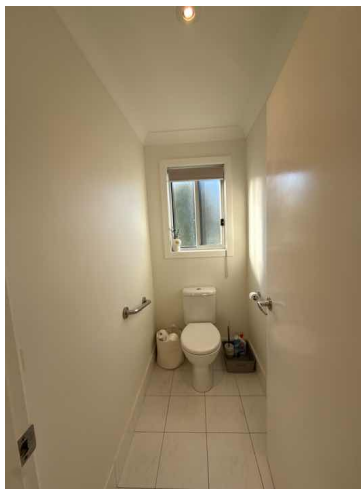
Powder Room(1)

Overall Condition

Of the visible areas, the general condition of this bathroom is serviceable or in reasonable condition for age of dwelling.

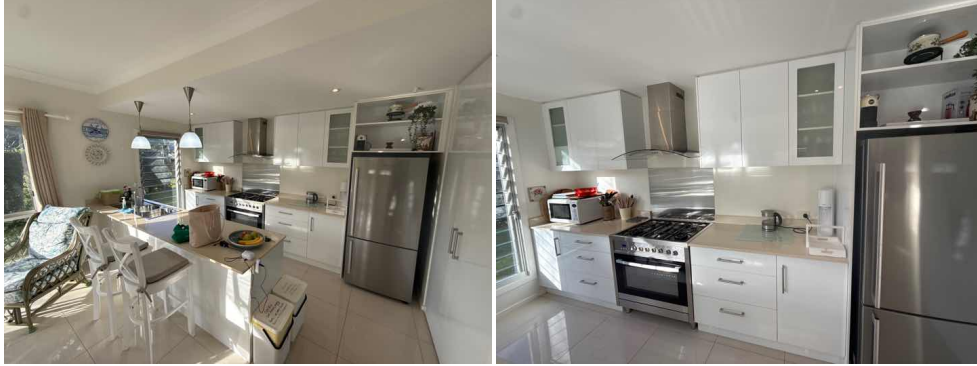
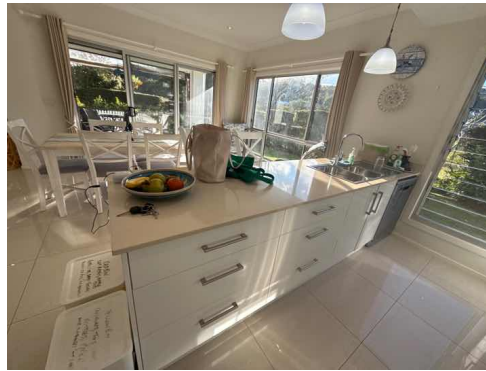
Overall Condition

Of the visible areas, the general condition of the kitchen is serviceable or in reasonable condition for age of dwelling.
