Inspection Report

Naraic Building & Pest Inspections Pty Ltd

32 Lakeview Cct, East Ballina, NSW, 2478

Pest And Building Inspection

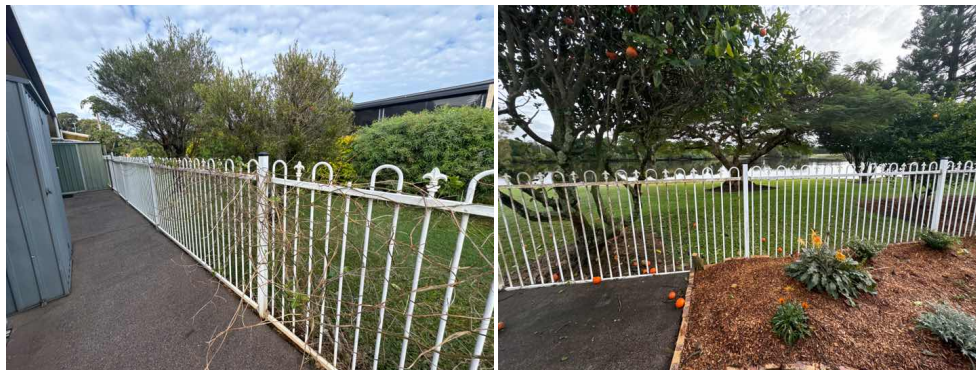
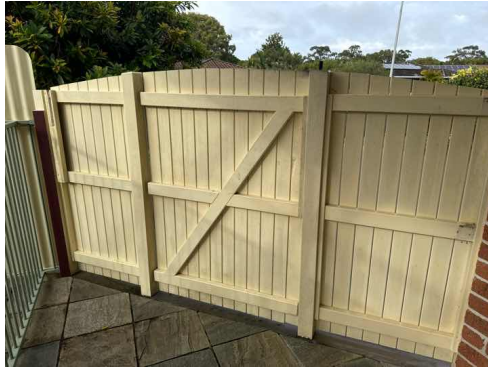
Overall Condition

Of the visible areas, the general condition of the fences and gates is serviceable for the age of dwelling.

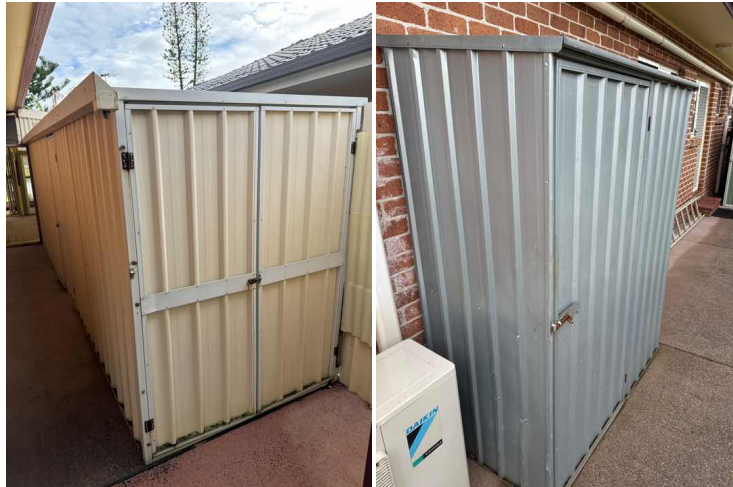
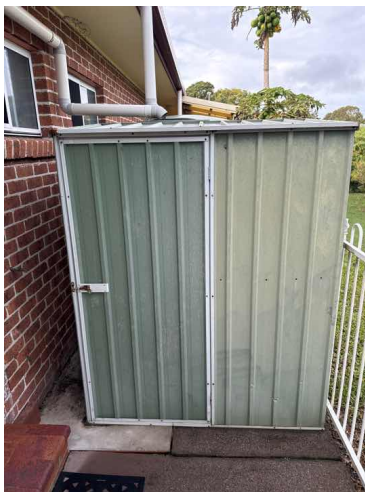
Shed Condition

The shed is in fair usable condition.

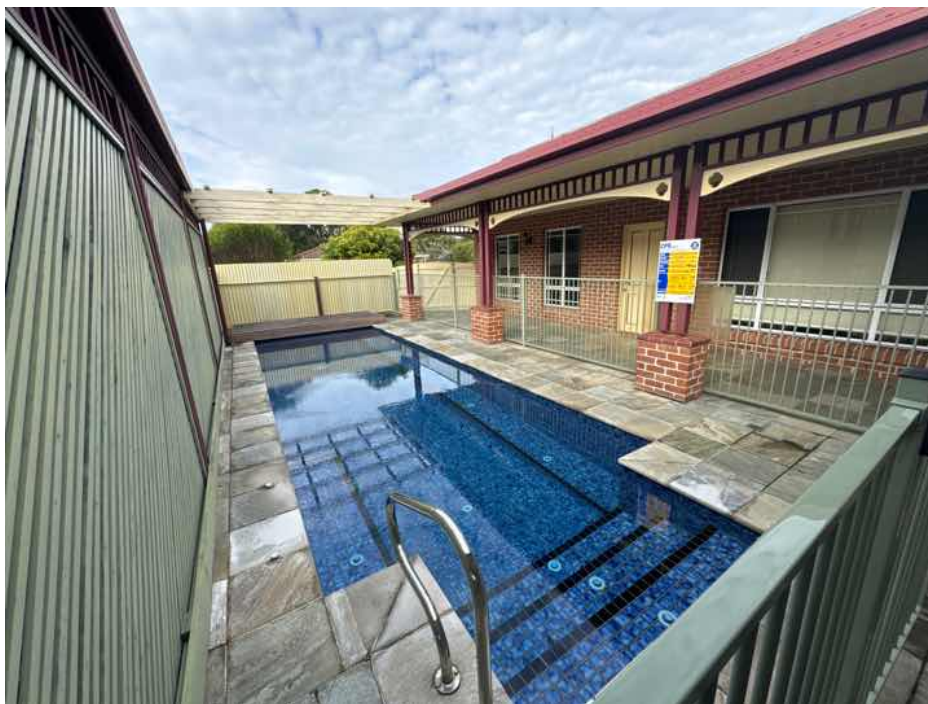
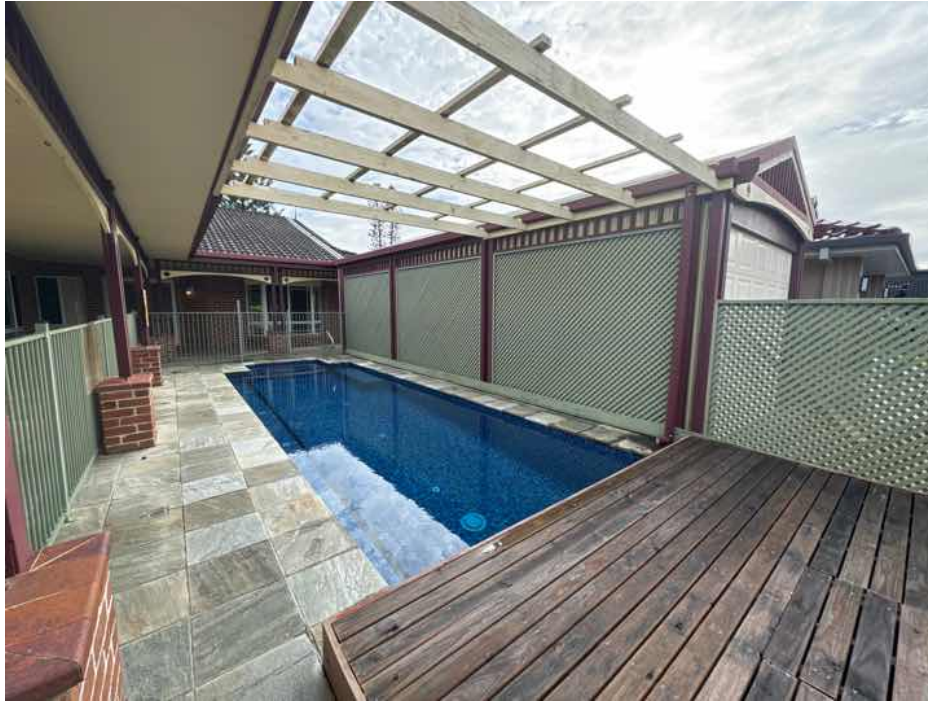
Pool Fence

Pool fence and signage were sighted.

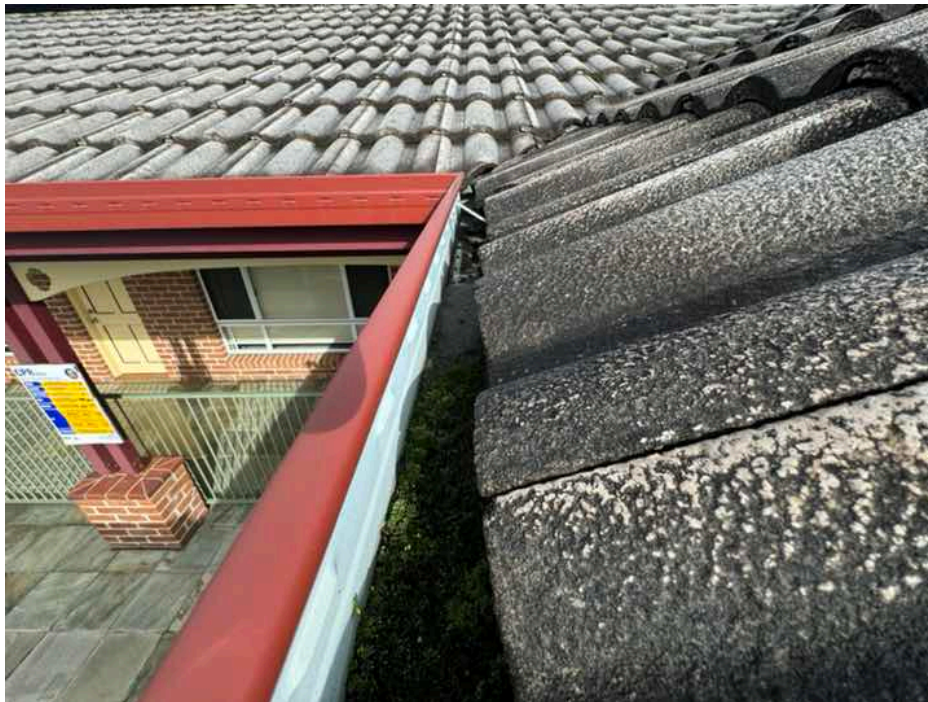
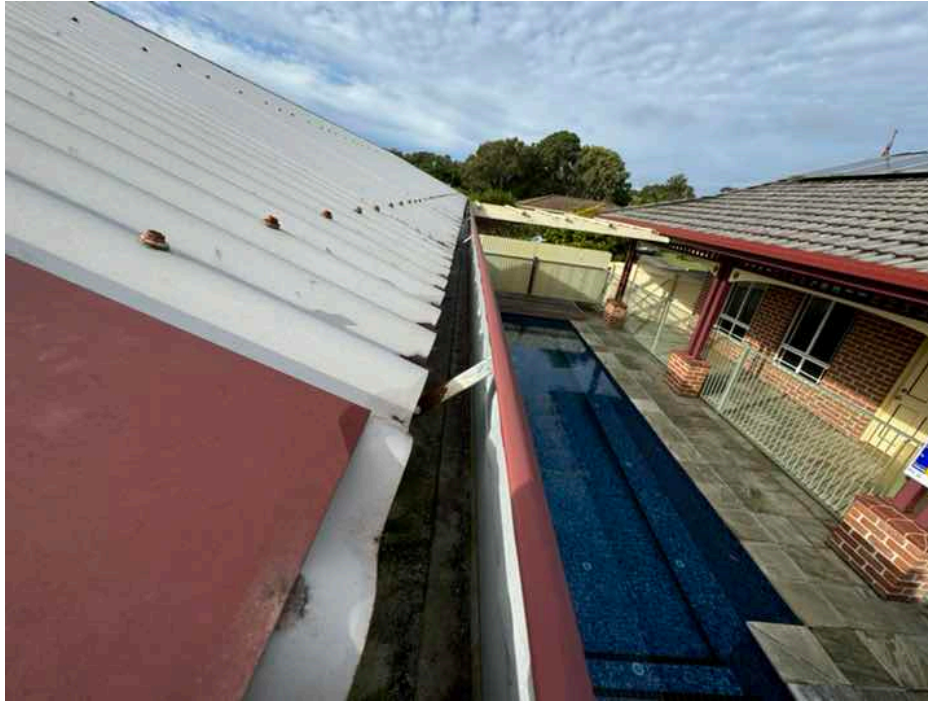
Gutter Findings

All visible and accessible of the physical nature of the guttering system appears to be in a serviceable condition with no apparent defects at the time of inspection. In the absence of prolonged rain fall efficiency of the guttering can not be assessed and you may find that further investigation or repairs maybe required. Note: Periodic maintenance checks should be carried out for rust penetrations and leaks.

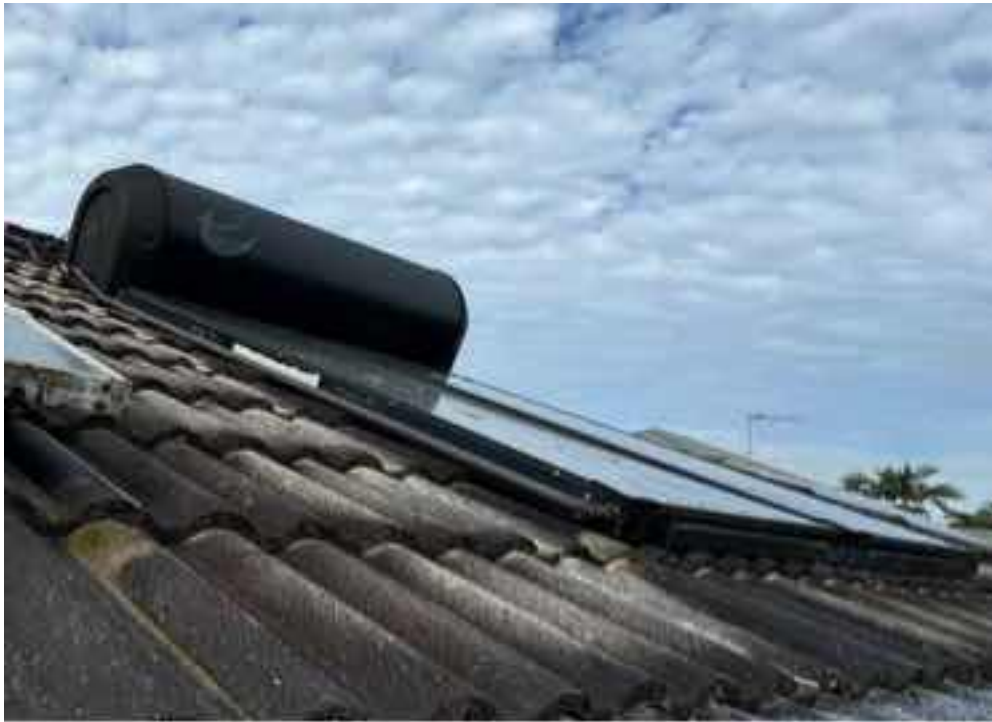
System Make

Edwards

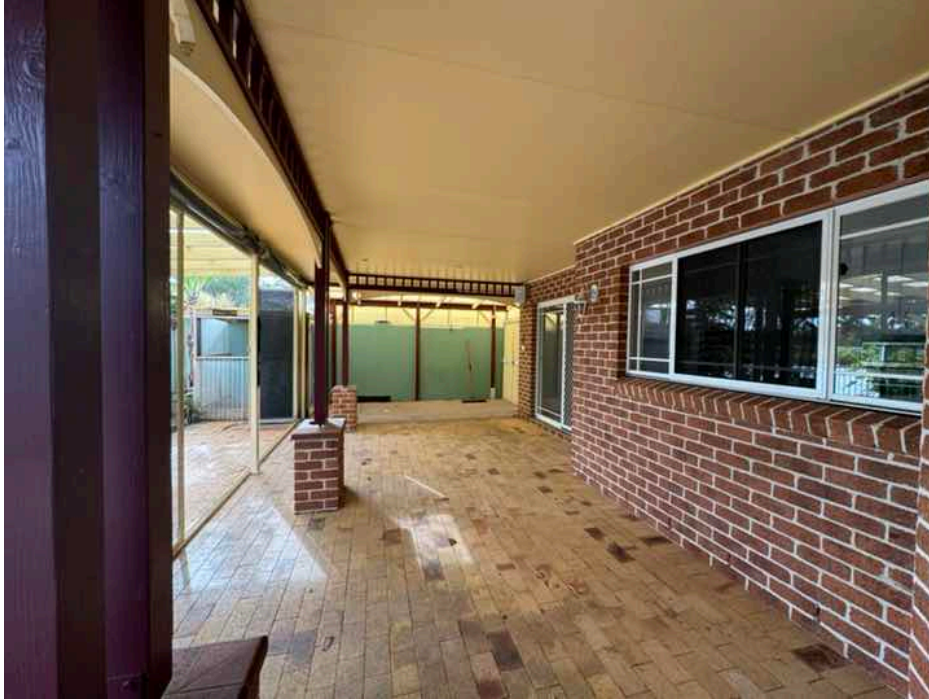
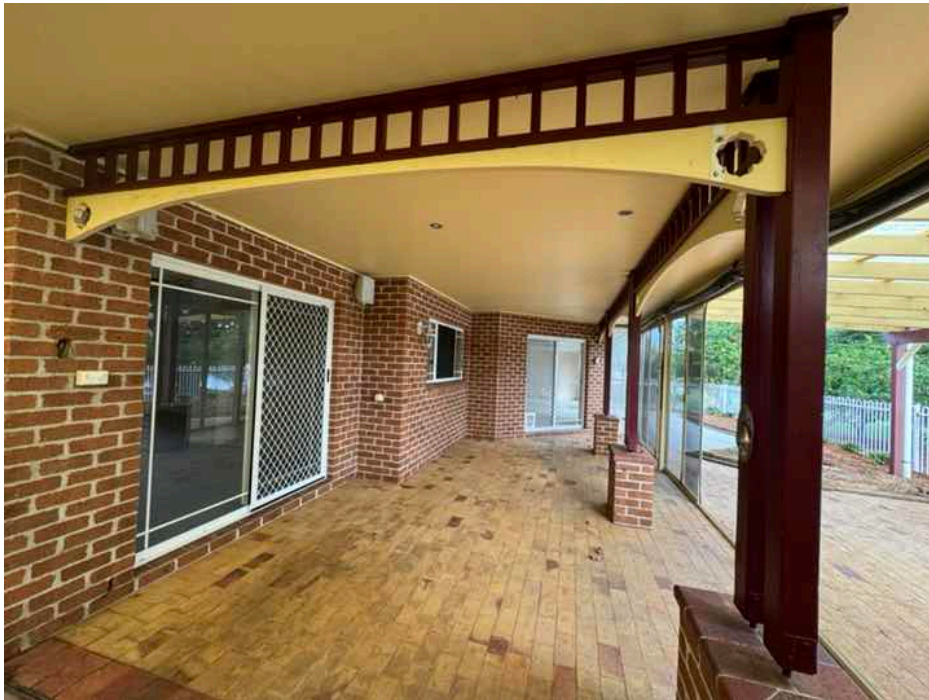
Overall Condition

Visible sections of the Alfresco area are serviceable or in reasonable or condition for the age of this dwelling.

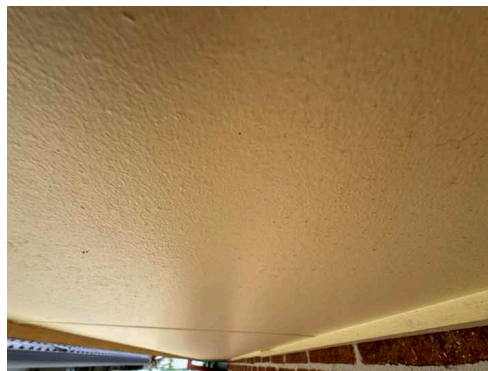
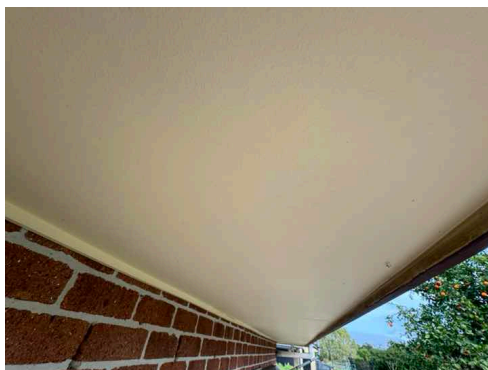
Eave Condition

The soffit lining (eaves) are in a serviceable condition with no notable defects.

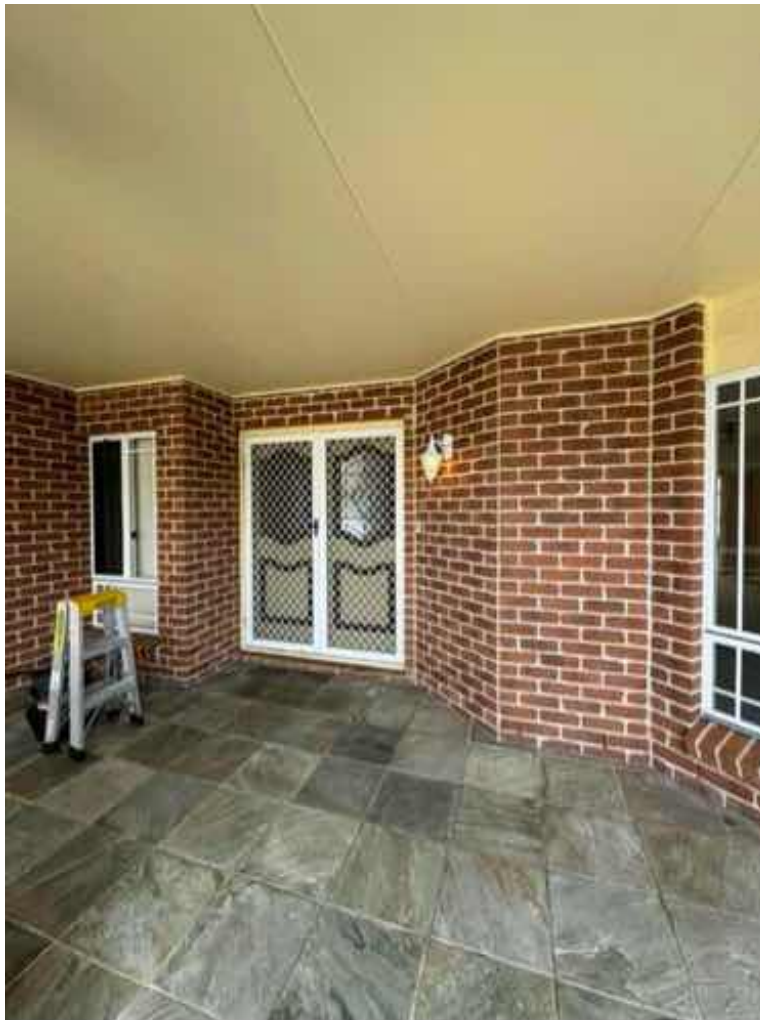
Entry Porch Area

The entry porch serviceable or in reasonable or condition for the age of this dwelling.

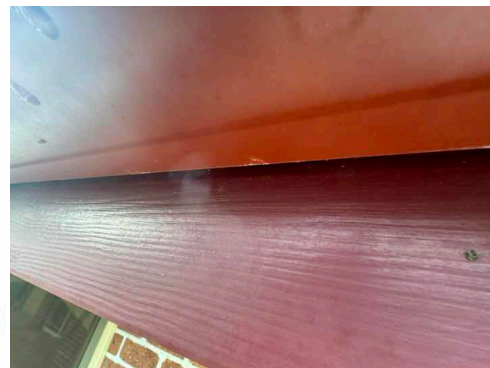
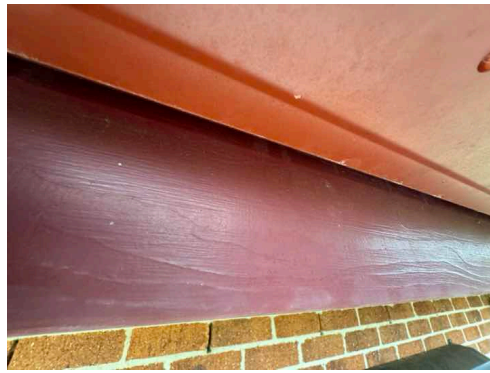
Condition

On visual inspection, the general condition of the fascia/barge boards is serviceable.

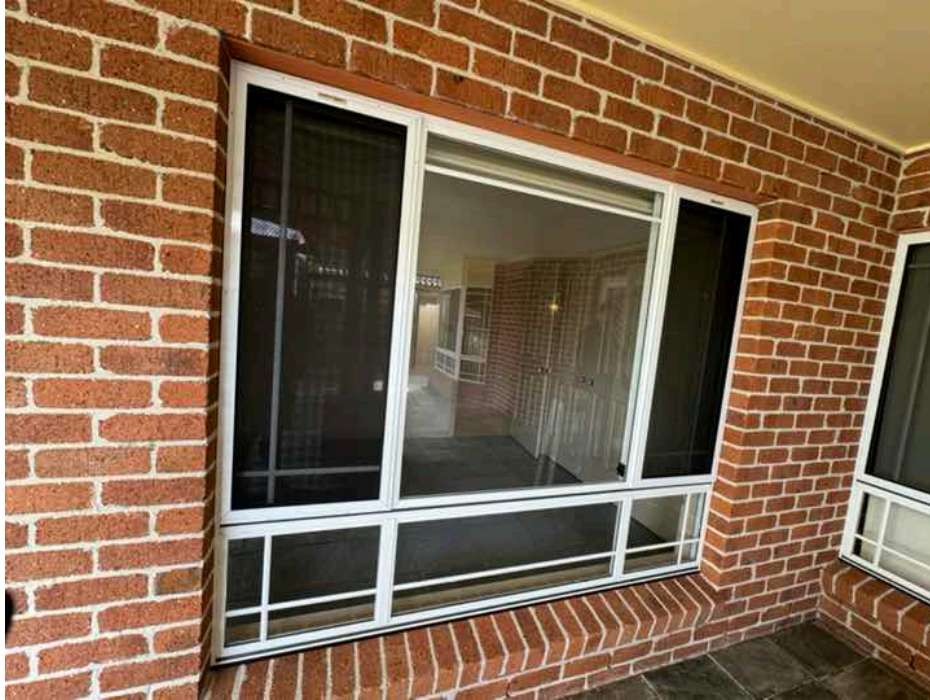
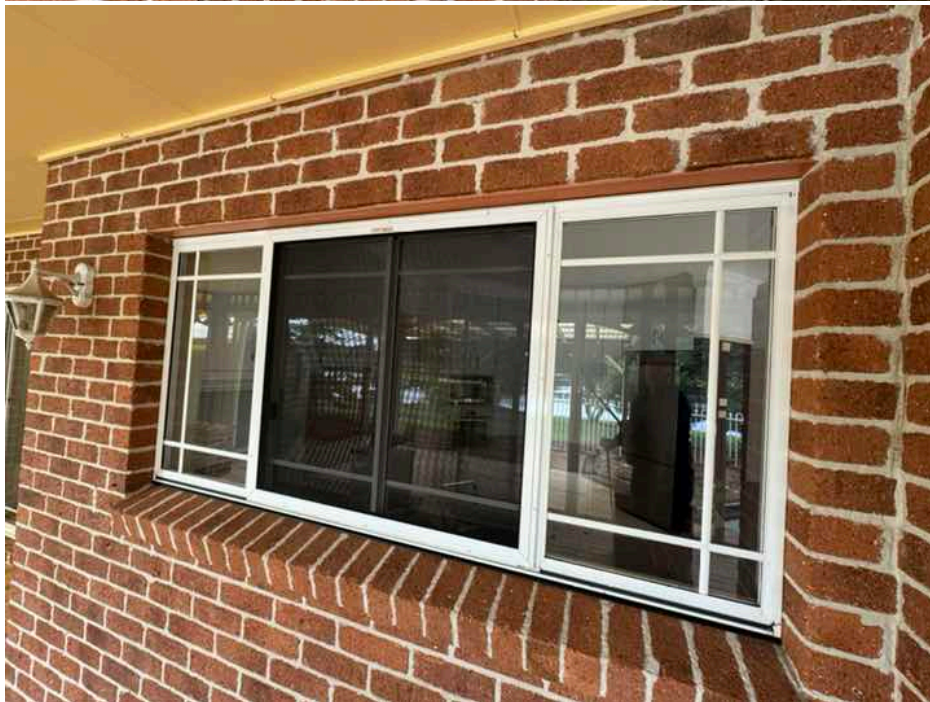
Overall Condition

On visual inspection, the general condition of the windows is serviceable for the age.

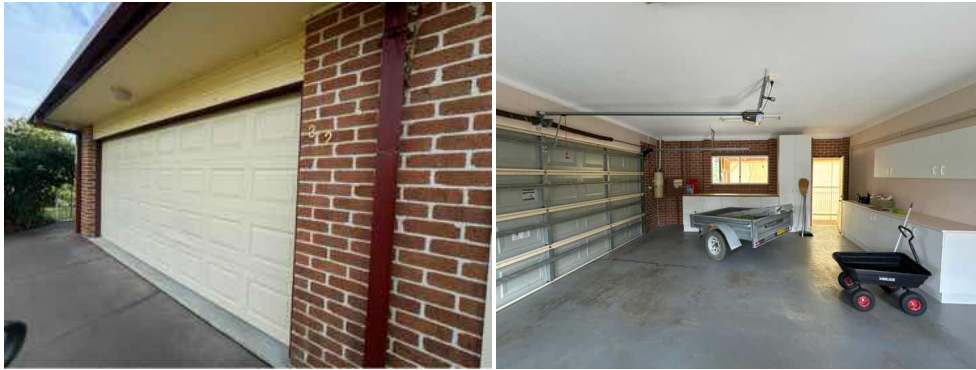
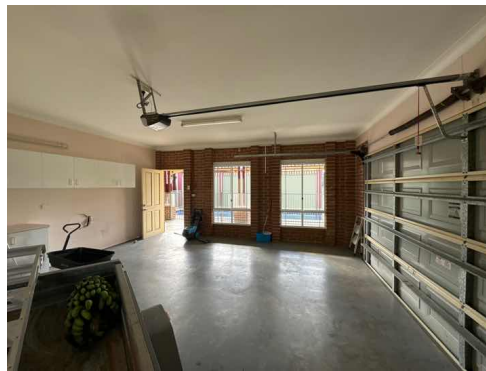
Overall Condition

From the visible and accessible areas, the garage appears to be in a serviceable condition for the age of the property with no notable structural defects sighted.

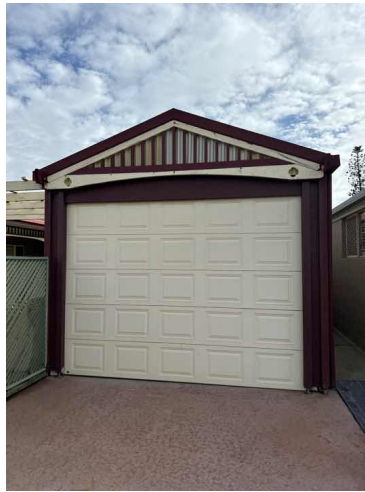
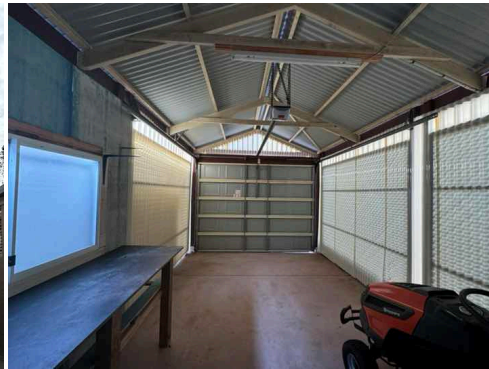
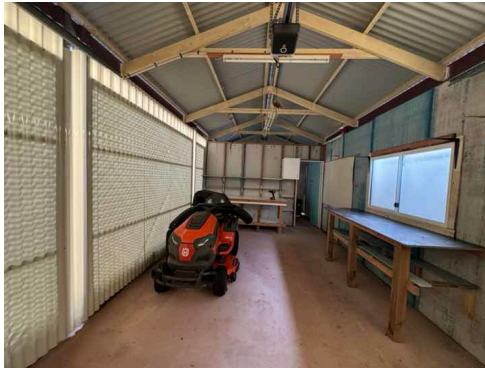
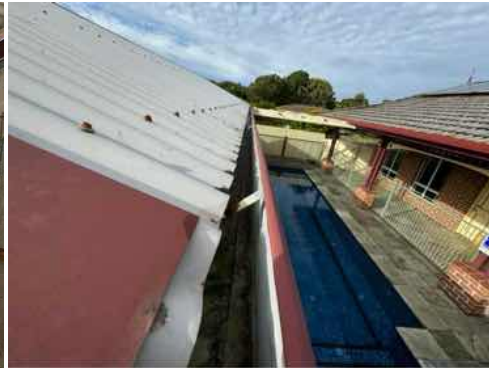
Overall Condition

From the visible and accessible areas, the garage appears to be in a serviceable condition for the age of the property with no notable structural defects sighted.

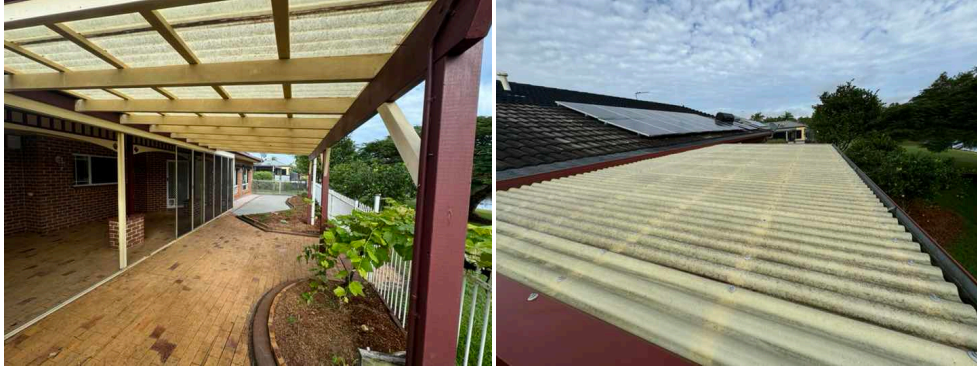
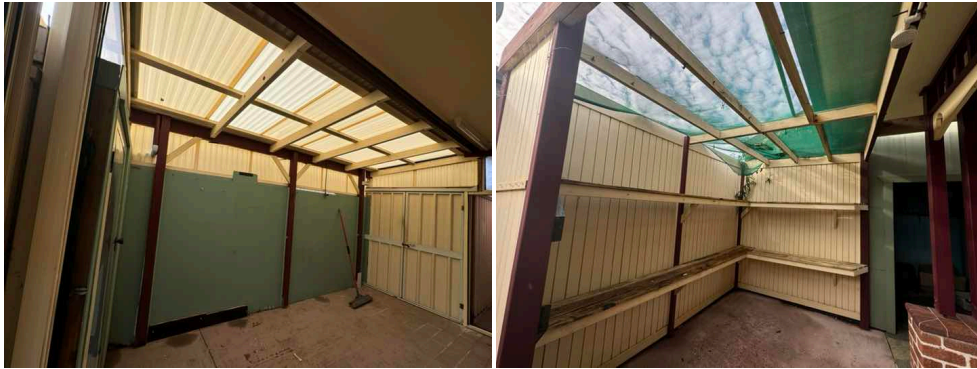
Overall Condition

The Pergola is in a serviceable condition with no notable defects sighted.

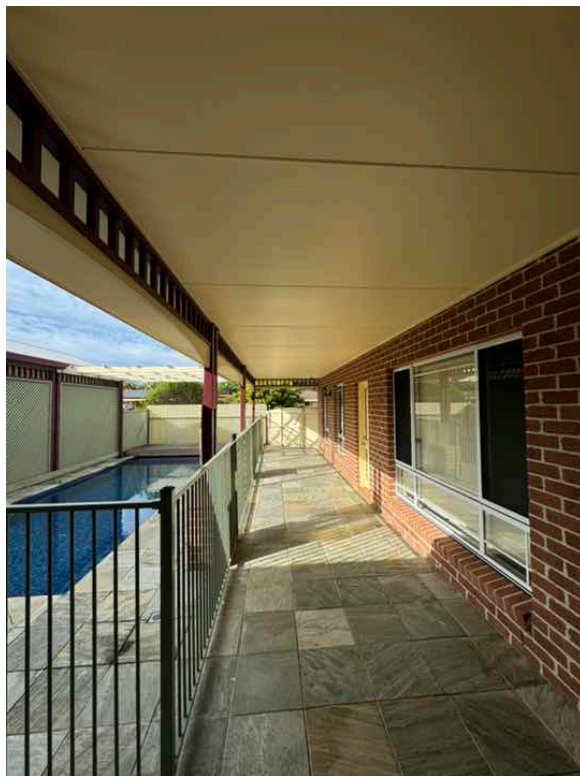
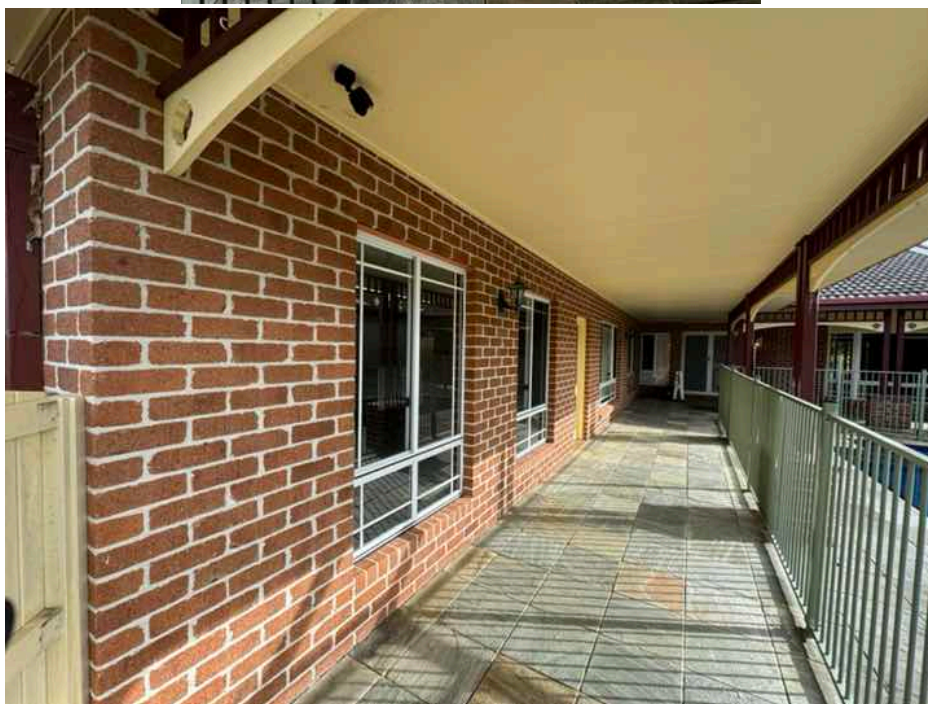
Overall Condition

Though we are not structural engineers the veranda/s appear to be in a serviceable condition.

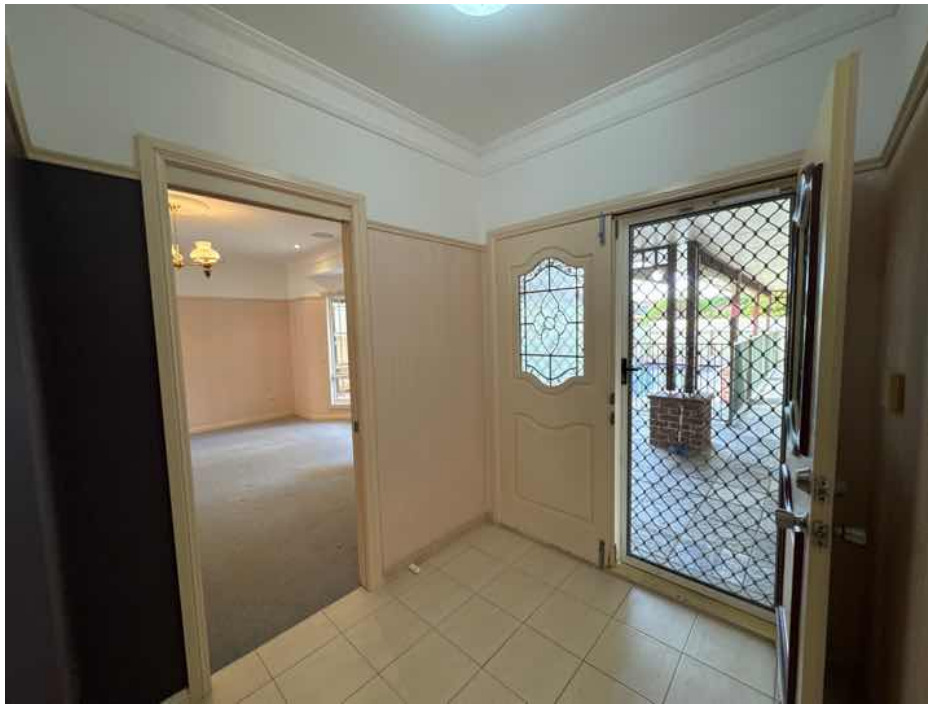
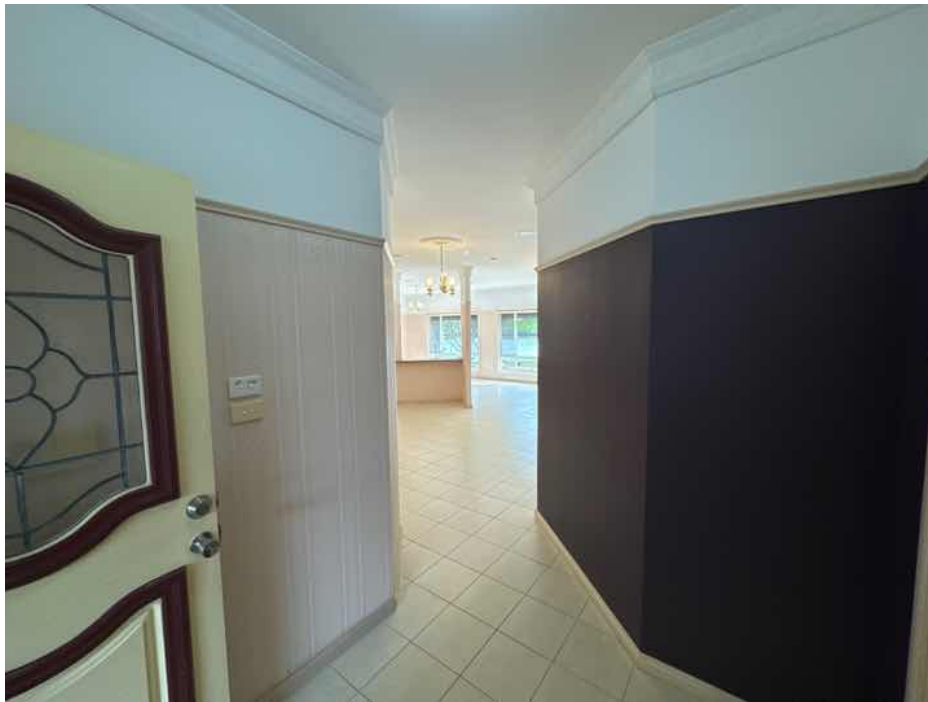
Overall Condition

From the visible and accessible areas, this area appears to be in a serviceable condition for the age of the property with no notable structural defects sighted.

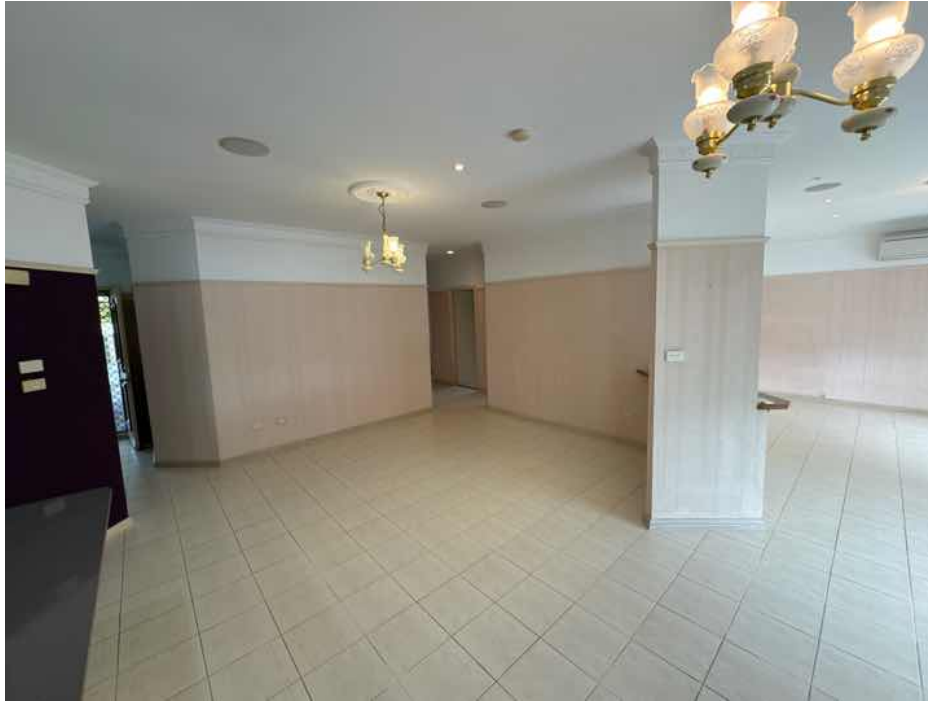
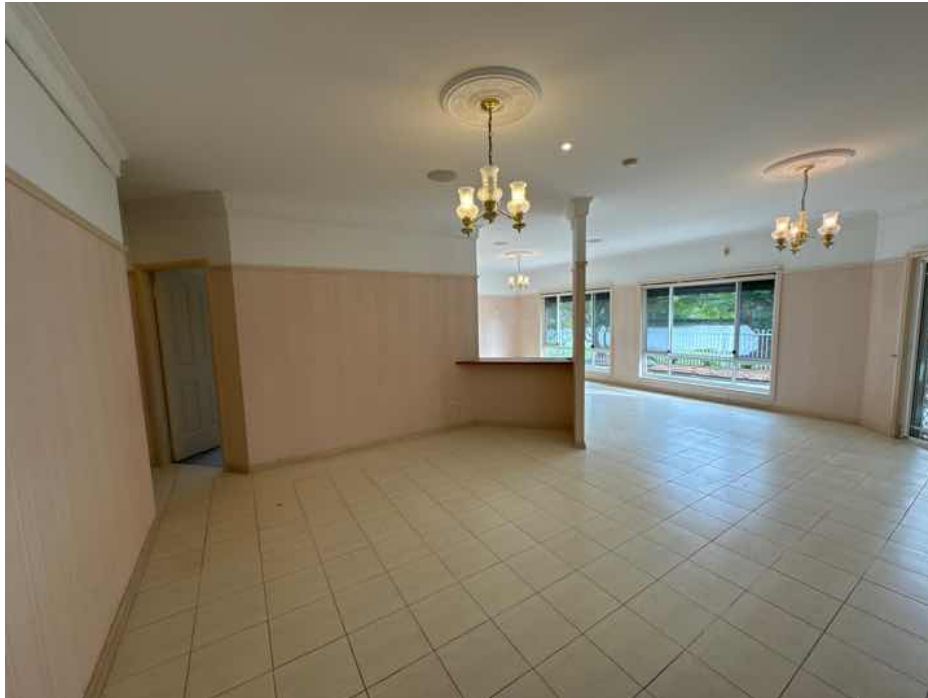
Overall Condition

From the visible and accessible areas, this room appears to be in a serviceable condition for the age of the property with no notable structural defects sighted.

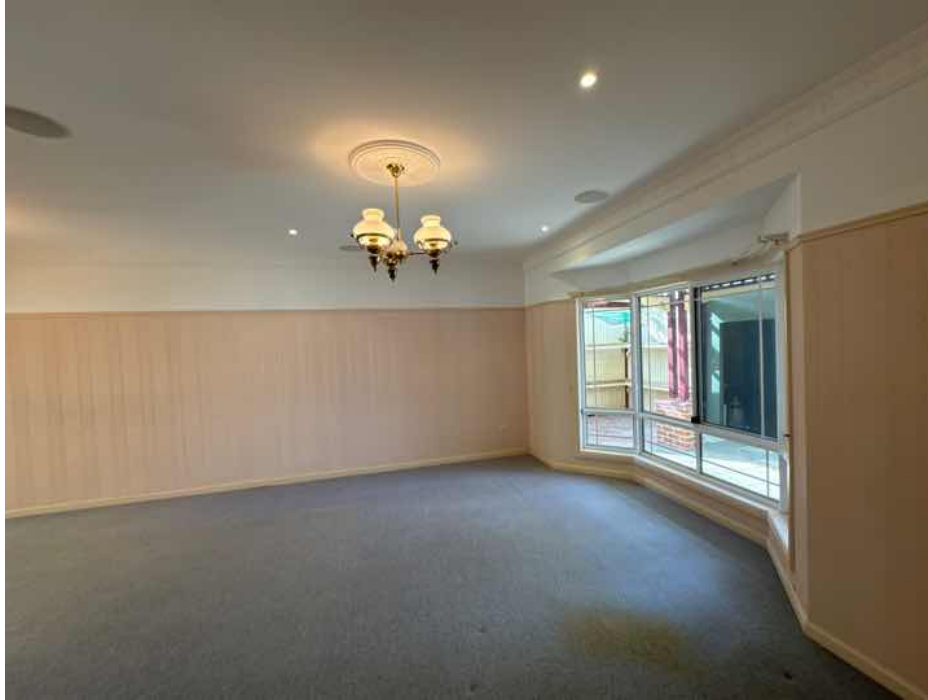
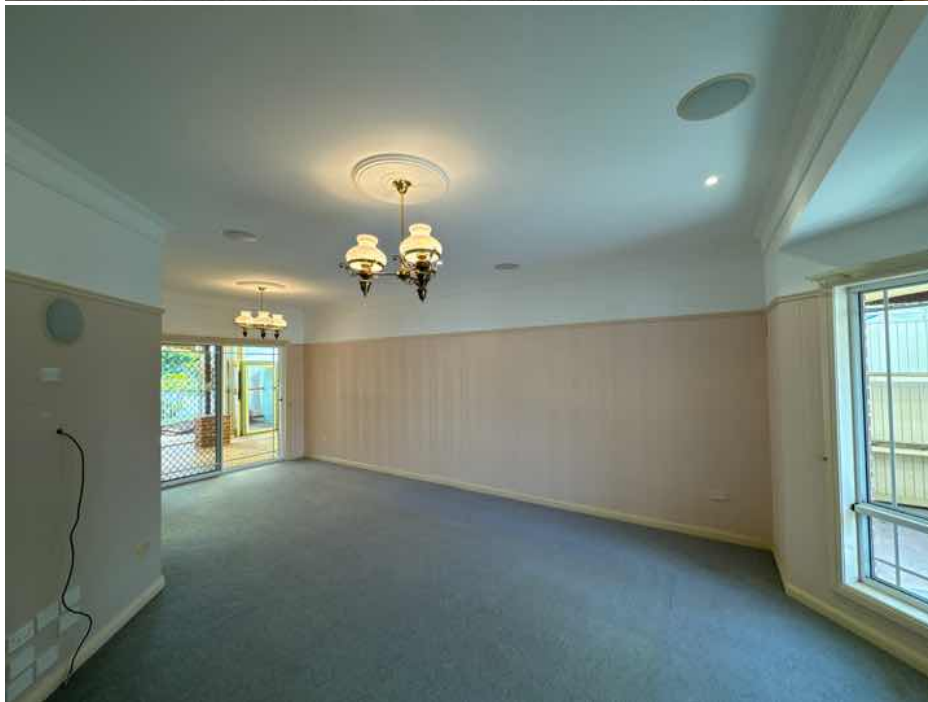
Overall Condition

From the visible and accessible areas, this room appears to be in a serviceable condition for the age of the property with no notable structural defects sighted.

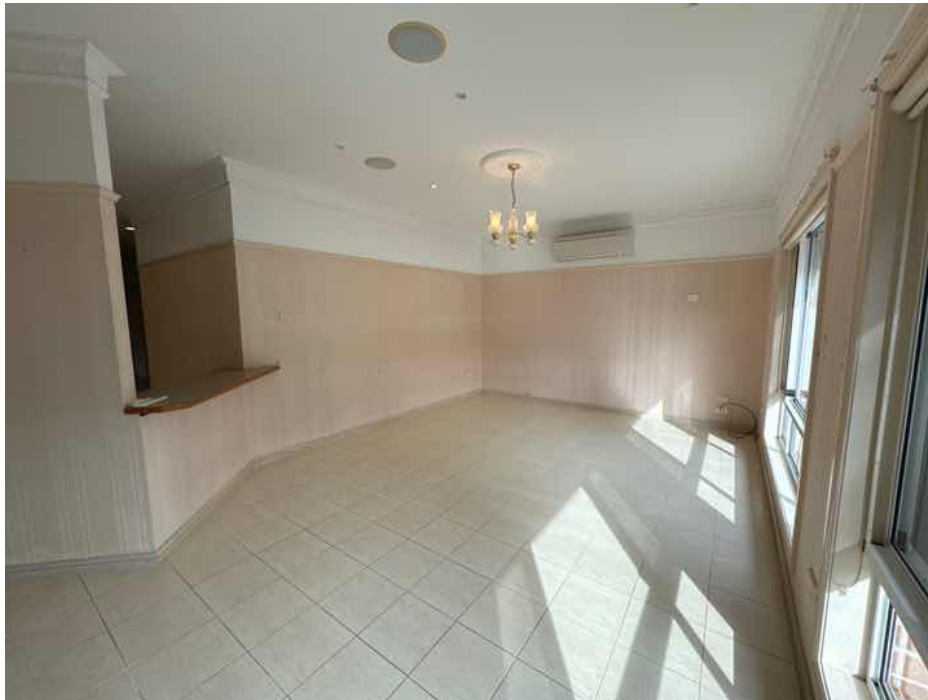
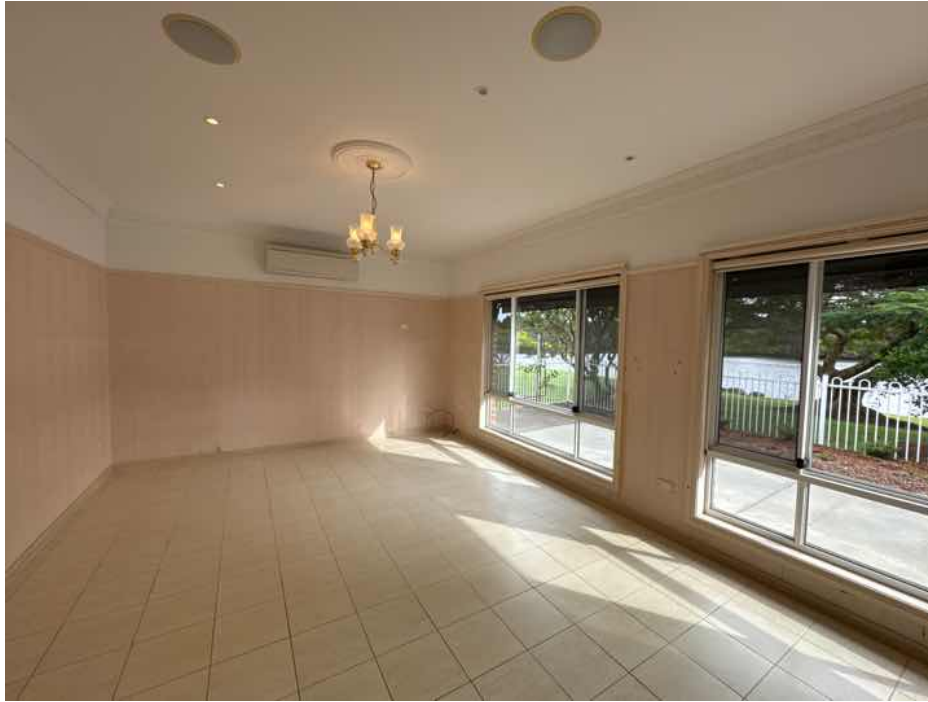
Overall Condition

From the visible and accessible areas, this room appears to be in a serviceable condition for the age of the property with no notable structural defects sighted.

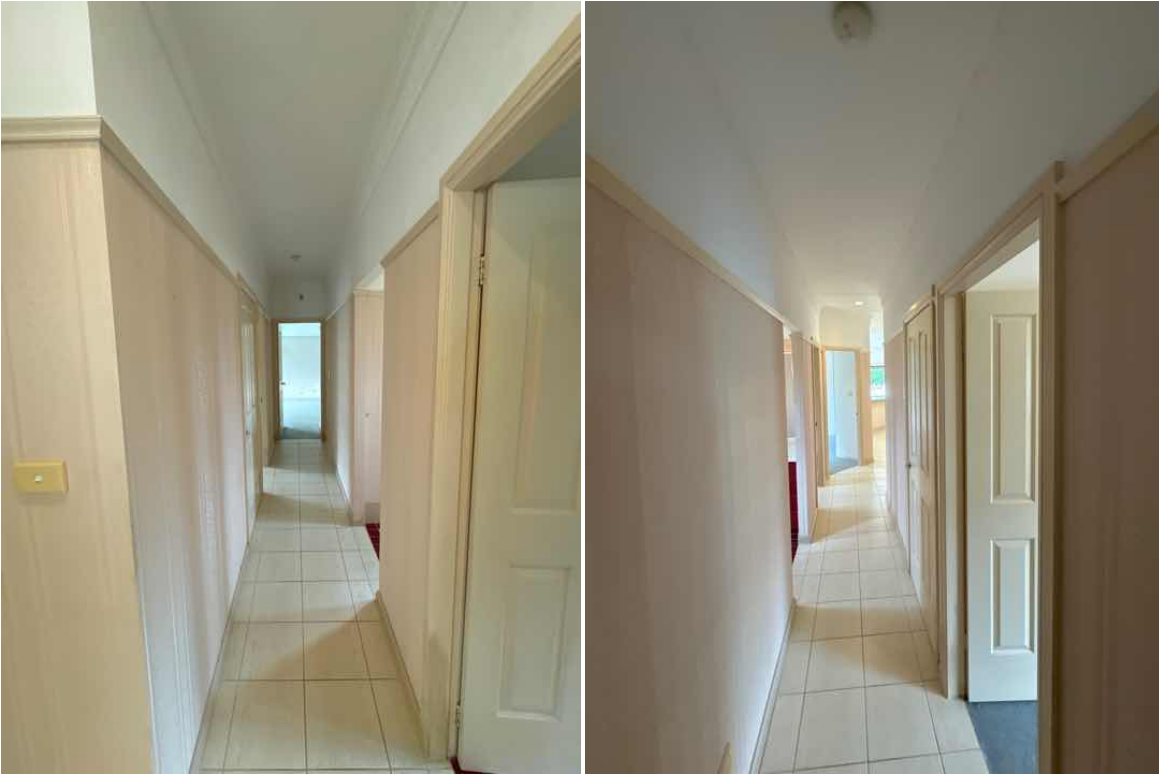
Hallway/s**Overall Condition**

From the visible and accessible areas, the hallway/s appears to be in a serviceable condition for the age of the property with no notable structural defects sighted.

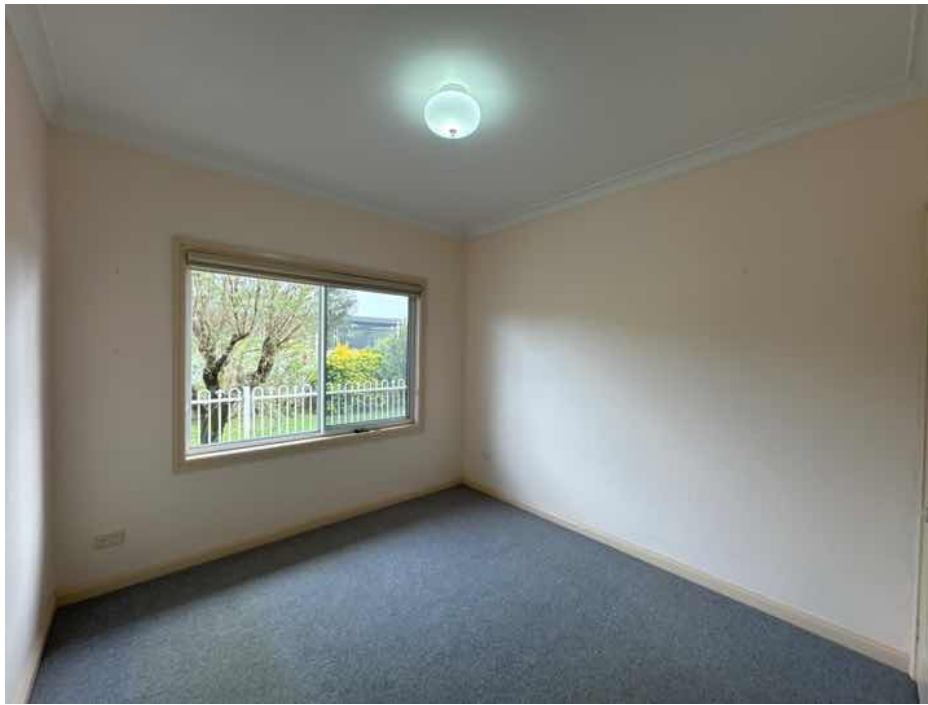
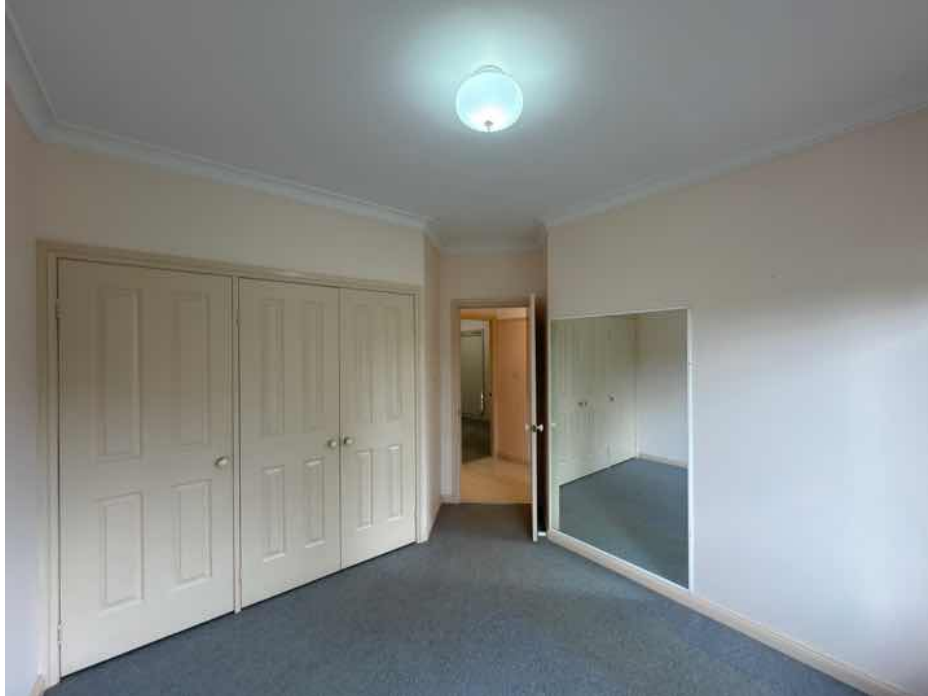
From the visible and accessible areas, this bedroom appears to be in a serviceable condition for the age of the property with no notable structural defects sighted.

Typical cornice separation/detachment observed. I recommend you contact a qualified painter for repairs.

Settlement Cracks Noted. These are typical and generally patch and paint will suffice, however we recommend monitor these cracks and if become wider or longer, you will need to contact a structural engineers to assess.

Stains observed - Steam cleaning may rectify stained areas but they appear entrenched.

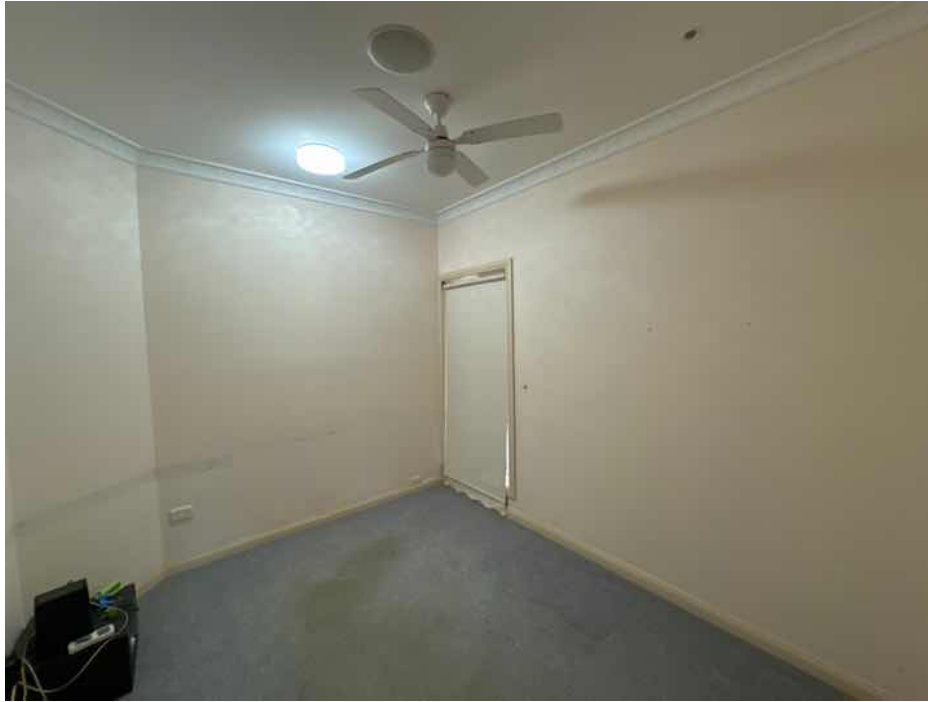
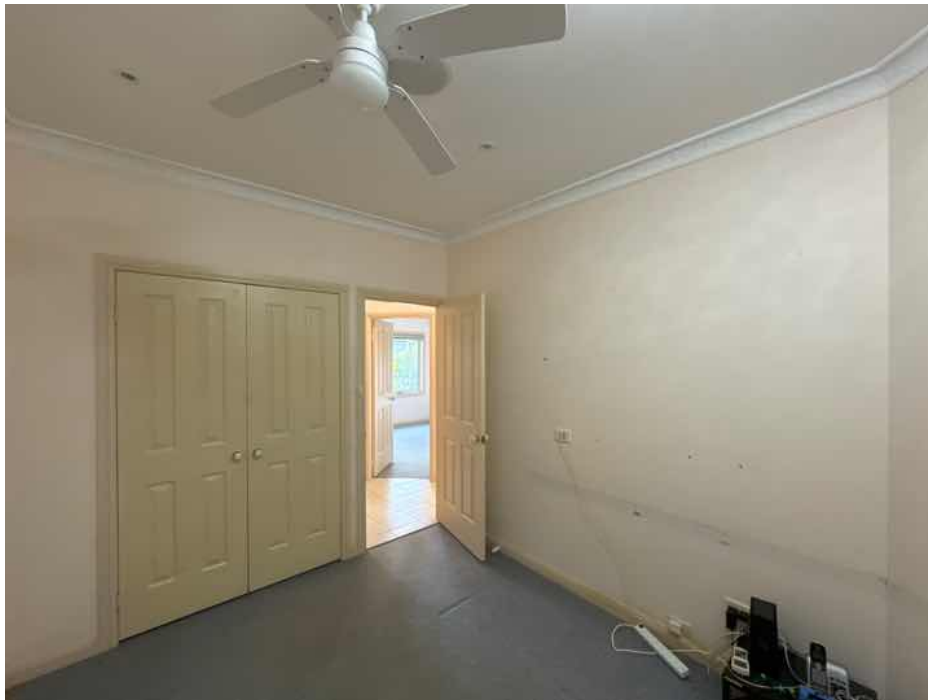
From the visible and accessible areas, this bedroom appears to be in a serviceable condition for the age of the property with no notable structural defects sighted.

Typical cornice separation/detachment observed. I recommend you contact a qualified painter for repairs.

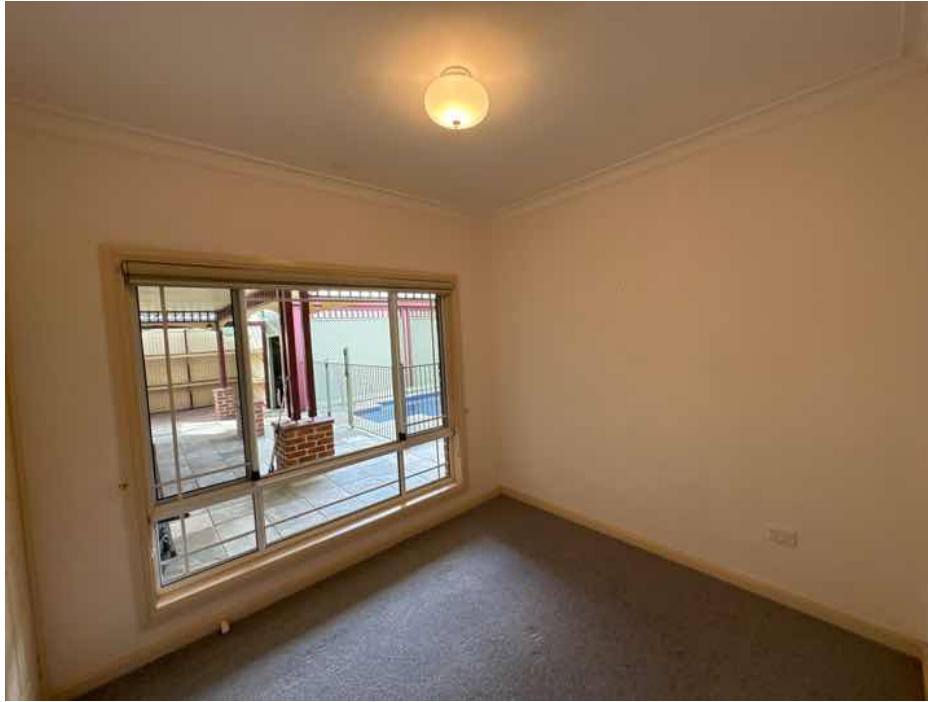
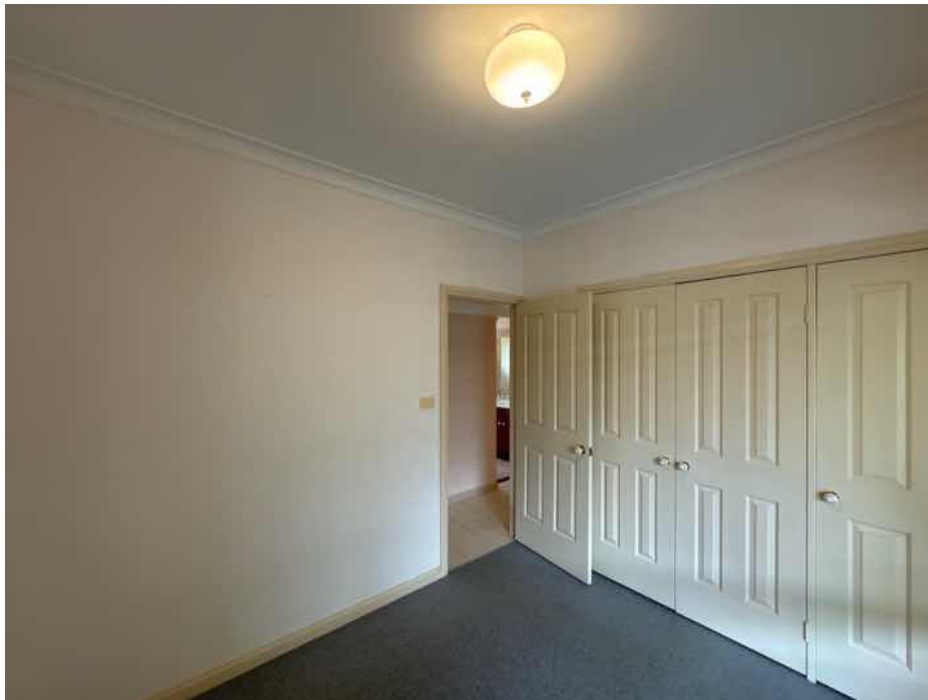
From the visible and accessible areas, this bedroom appears to be in a serviceable condition for the age of the property with no notable structural defects sighted.

Typical cornice separation/detachment observed. I recommend you contact a qualified painter for repairs.

Ceiling stains - No moisture readings obtained. These may have been repaired however you will need to monitor after a prolonged period of rainfall. If leaking persists, a qualified plumber should be engaged for advice and recommendations. All water damaged plaster should be replaced.
