Inspection Report

Naraic Building & Pest Inspections Pty Ltd

32 Lakeview Cct, East Ballina, NSW, 2478

Pest And Building Inspection

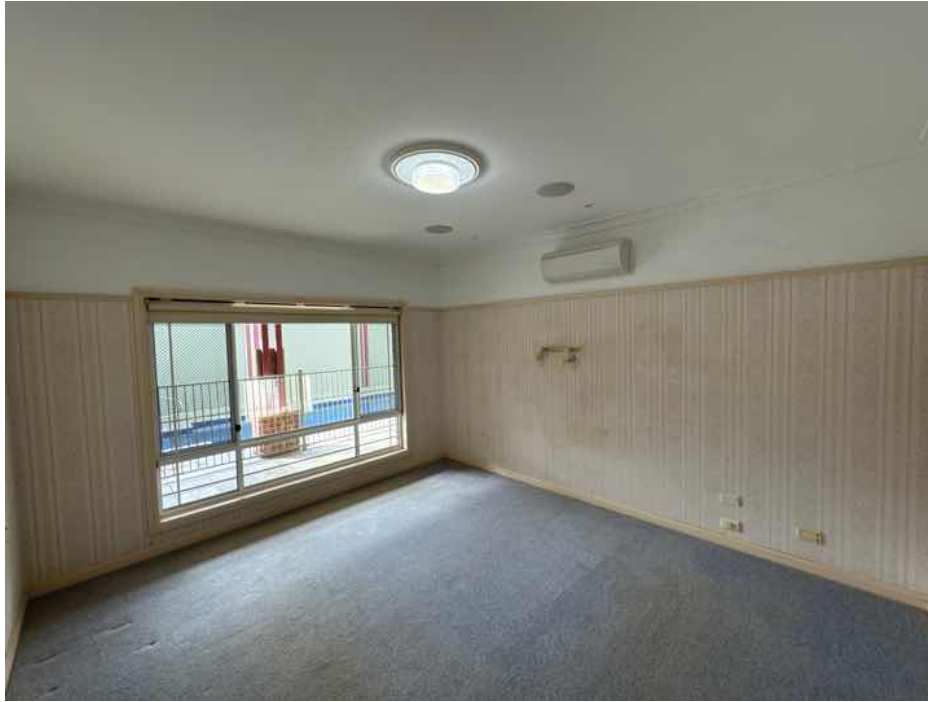
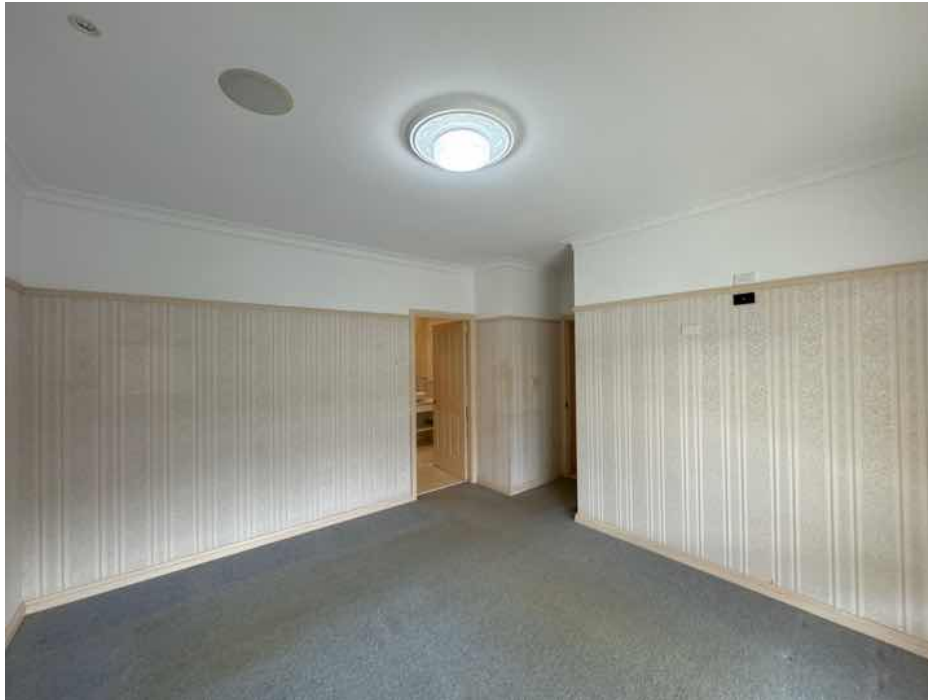
From the visible and accessible areas, this bedroom appears to be in a serviceable condition for the age of the property with no notable structural defects sighted.

Typical cornice separation/detachment observed. I recommend you contact a qualified painter for repairs.

Incomplete Patch/Paint repairs noted. I recommend you contact a qualified painter for repairs.

Stains observed - Steam cleaning may rectify stained areas but they appear entrenched.

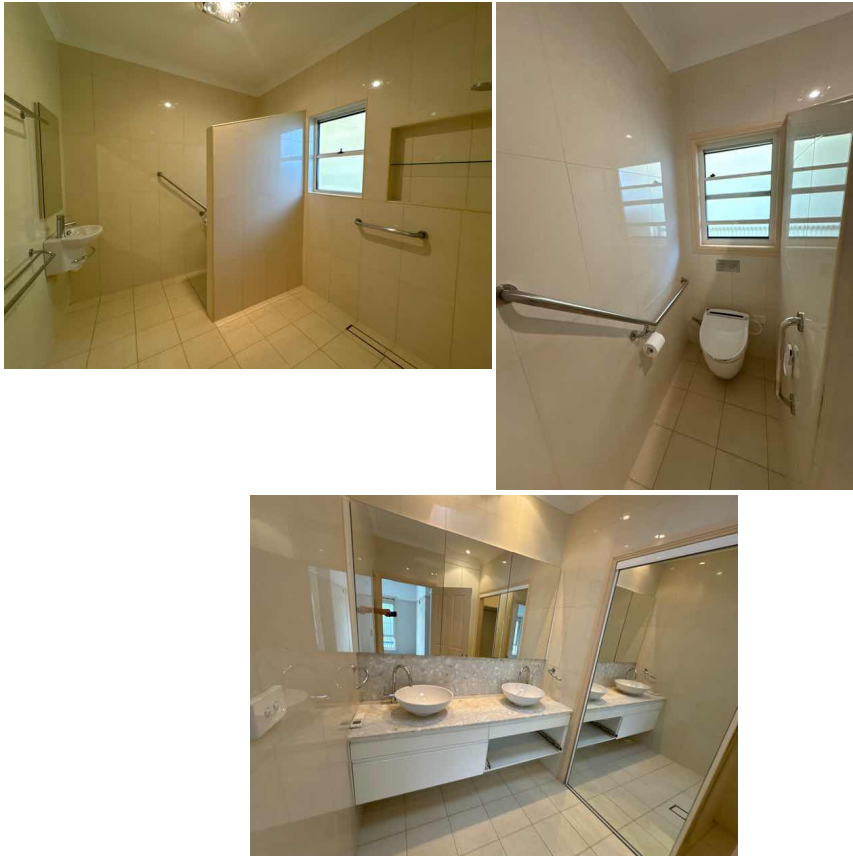
Of the visible areas, the general condition of this bathroom is serviceable or in reasonable condition for age of dwelling.

No lock hardware installed.

Cornice separation. I recommend you contact a licensed plasterer for repairs.

Ceiling paint flake/deterioration is evident. General maintenance / painting as required.

Drummy tiles noted. This needs to be repaired at the earliest as this has the potential to lead to many related issues such as damp, water ingress to other areas and cracked tiles. Contact a qualified tiler for repairs and recommendation

The vanity mirror is desilvering at edges. Replacement recommended.

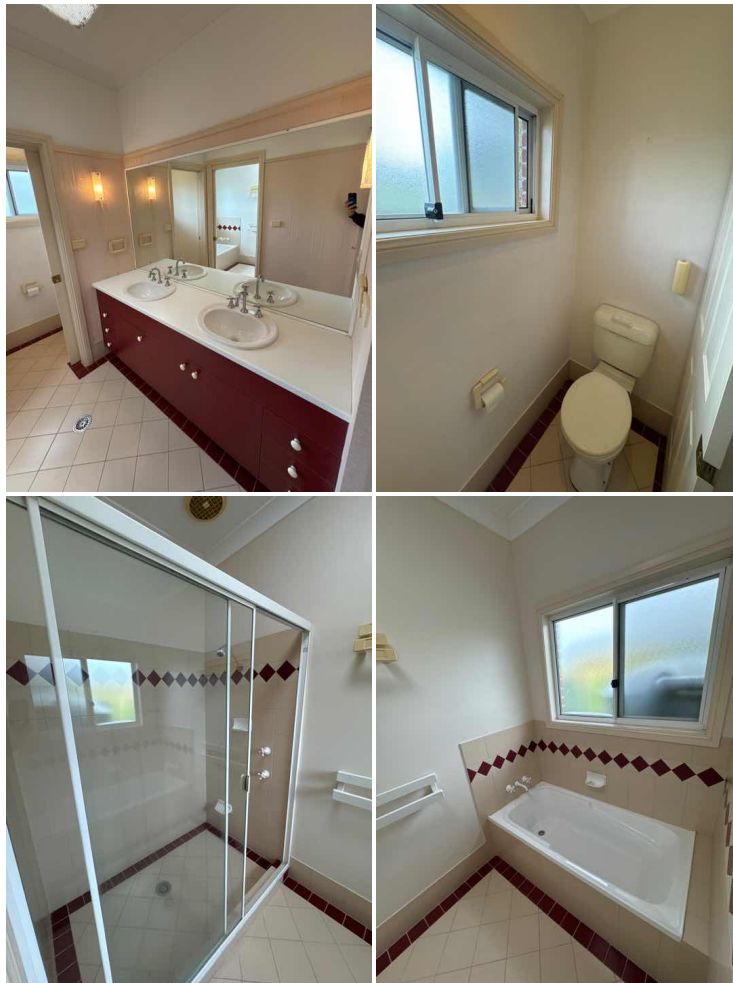
Of the visible areas, the general condition of this bathroom is serviceable or in reasonable condition for age of dwelling.

Cornice separation. I recommend you contact a licensed plasterer for repairs.

Ceiling paint flake/deterioration is evident. General maintenance / painting as required.

Settlement Cracks Noted . These are typical and generally patch and paint will suffice, however Monitoring these cracks advised for 12 months and if become wider or longer, you will need to contact a structural engineers to assess.

Loose tap at sink. Maintenance as required.

Poor water pressure from taps. A qualified plumber should be engaged for advice and recommendations.

Tap screws are missing. Replace as required.

The cistern is leaking and should be repaired. Contact a qualified plumber for repairs.

Pan cone leaking when flushing the toilet. This is a small rubber seal on the rear of the pan and the cistern sleeve connecting fresh water to the pan during flushing. Though a maintenance issue I recommend You contact a qualified plumber for repairs.

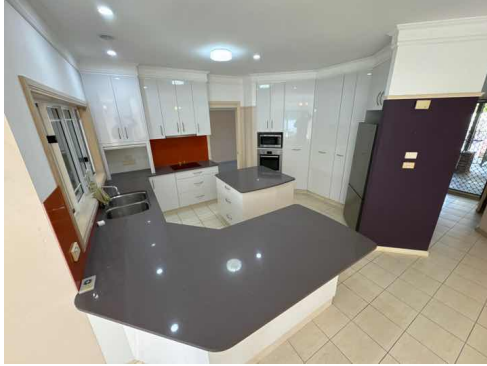
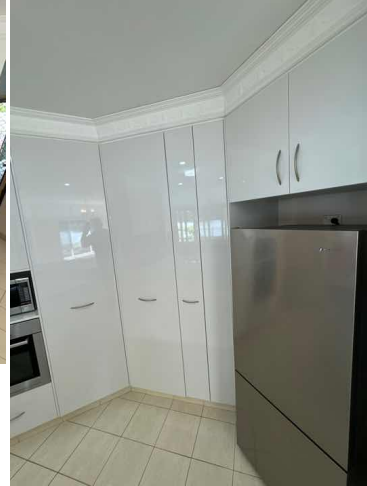
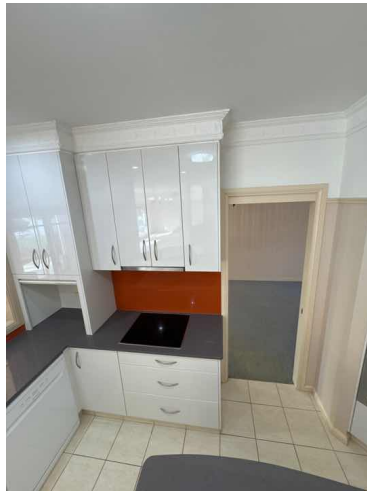
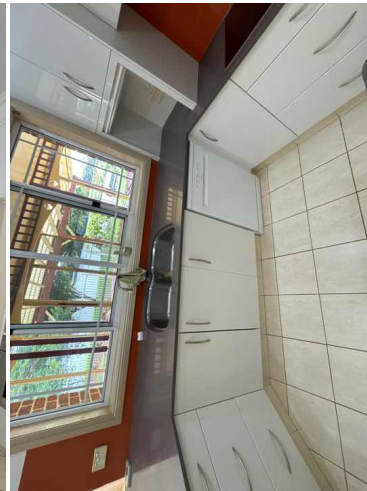
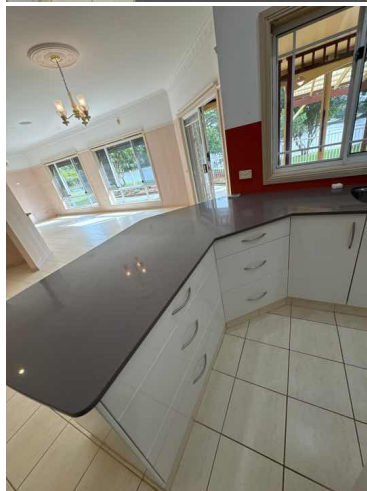
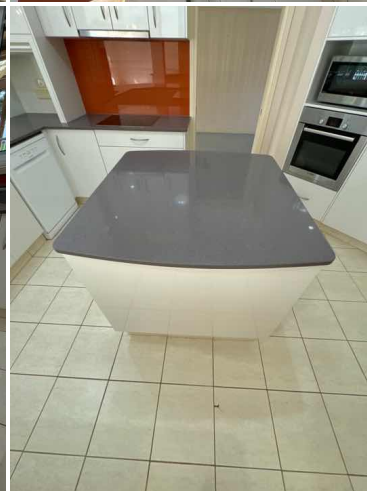
Of the visible areas, the general condition of the kitchen and pantry is serviceable or in reasonable condition for age of dwelling.

Cornice separation. I recommend you contact a licensed painter for repairs.

Drummy tiles noted. This needs to be repaired at the earliest as this has the potential to lead to many related issues such as damp, water ingress to other areas and cracked tiles. Contact a qualified tiler for repairs and recommendation.

Adjustment to cabinet doors required, in some instance hinges may need to be replaced.

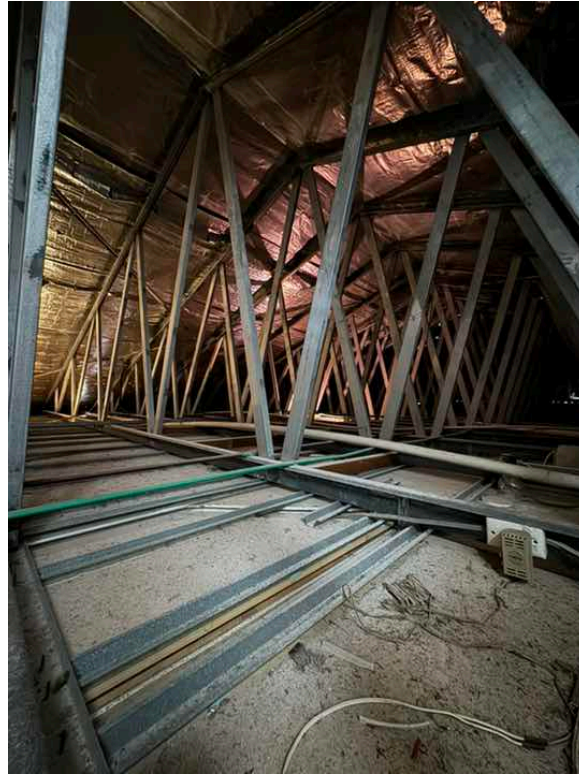
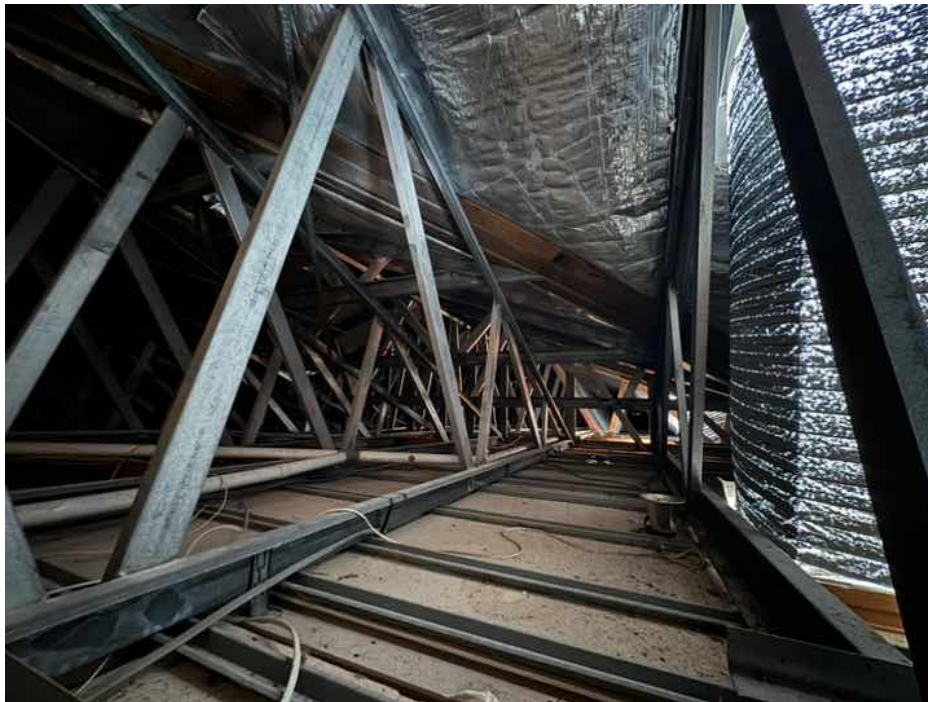
Visible sections of the roof void is in a serviceable condition for age of this dwelling.

No insulation installed. Recommendations: Engage insulation contractor to assess.

Sarking deteriorated/ damaged / aged in some sections. A qualified roofing contractor should be engaged for advice and recommendations.
