PEST AND BUILDING PRE-PURCHASE REPORTS

BUILDING & PEST INSPECTIONS

45 Fox Valley Way
Lennox Head

BPI - INSPECTION REPORT

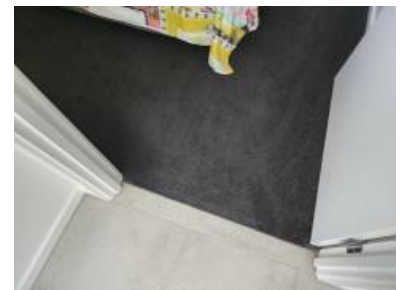
Type and Covering
Carpet & Tiles.

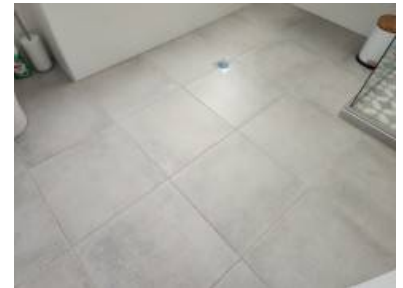
Restrictions
The concrete slabs were covered by flooring coverings and no inspection of the concrete surfaces could be carried out.

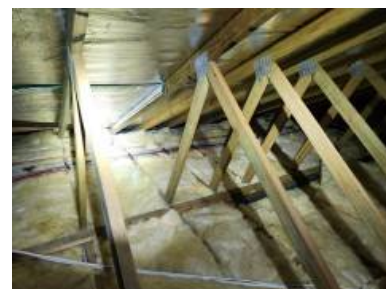
Inspection over the eaves was restricted due to the low pitch and construction allowing only a limited visual inspection from a distance of some areas to be carried out.

Clearance within sections of the roof was too low to allow body access. Outer top wall plates and framing timbers were not inspected due to the area being too low to allow body access. This allows only a limited visual inspection from a distance of some areas to be carried out.

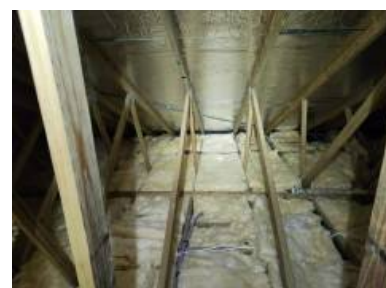
Insulation is present in the roof cavity. This restricted inspection to some roofing members and various wall top plates. Removal of insulation is not within the scope of a standard building inspection report.

Sarking paper covered roofing battens restricting inspection. Removal of sarking paper is not within the scope of a standard building inspection report.

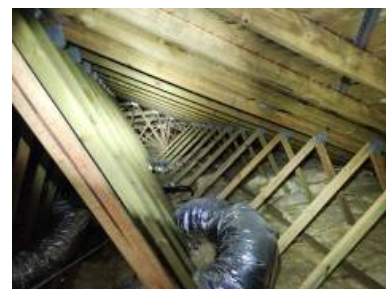
The roof framing is in satisfactory / typical condition for the age / construction date.

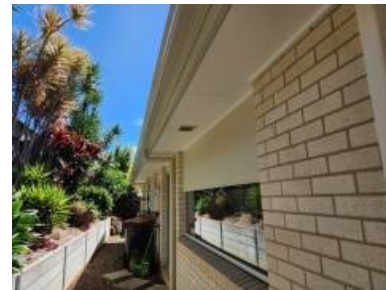
Condition:
The external paintwork / finish to the external surfaces and timberwork is generally in good condition. There may be sections / areas that require touching up / repainting.

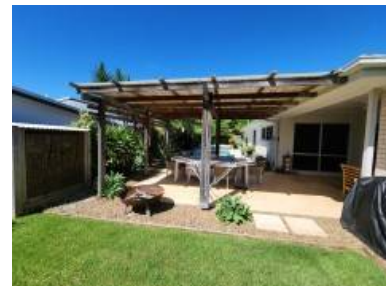
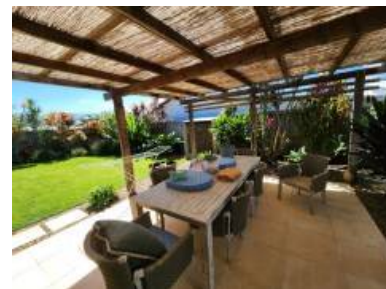
Condition:
Satisfactory.

Please be aware that it is common for patio / main residence joins to leak during raining conditions. As it was not raining at the time of the inspection, we strongly recommend that the flashing joins be monitored and a plumber be engaged immediately if a leak is present during raining conditions.

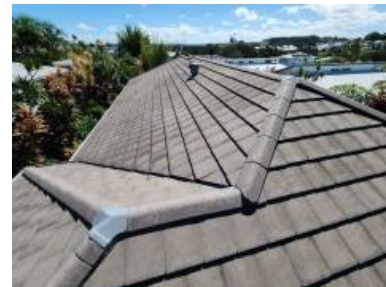
Solar Panels are present to the Roof Exterior and restricted the inspection of the roofing material beneath. Concealed damage may be present but not identified in the report.

We recommend that a qualified roofer be engaged to inspect & detail the condition of the roof exterior, gutters, downpipes & stormwater pipes and any rectification required prior to making a final purchase decision.

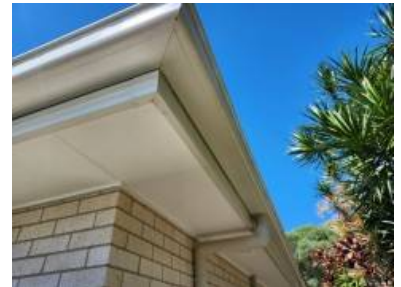
Restrictions:
No inspection can be made of the concealed stormwater pipes. I recommend the gutters, downpipes & stormwater be further inspected by a qualified plumber to ensure that they are functional, clear of blockages / damage / cracks and are adequate for the situation.

Condition:
Satisfactory.

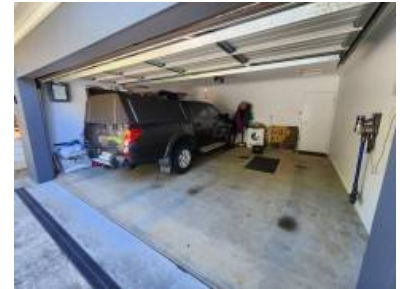
As part of / attached to the residence:
Yes.

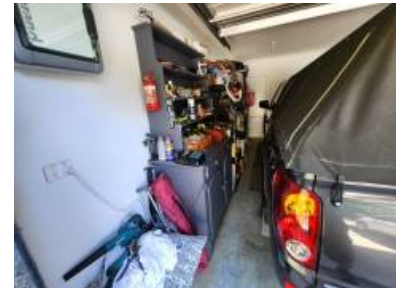
Some wall and floor areas were covered by stored goods and were inaccessible.

Further inspection of these areas is strongly recommended once access has been obtained.

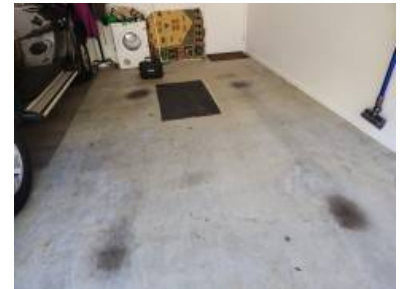
Condition:

Satisfactory.

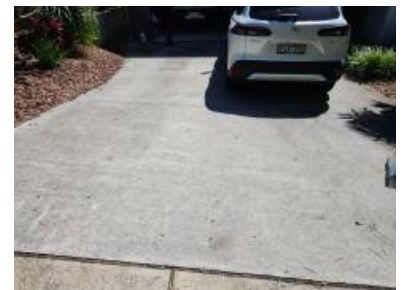
PATHS & DRIVEWAYS

Satisfactory.

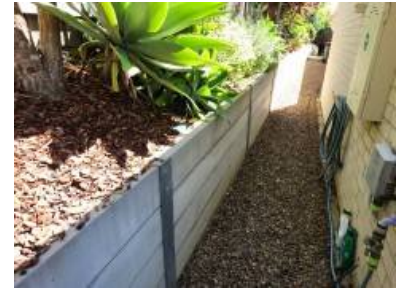
RETAINING WALLS

Condition:
Satisfactory.

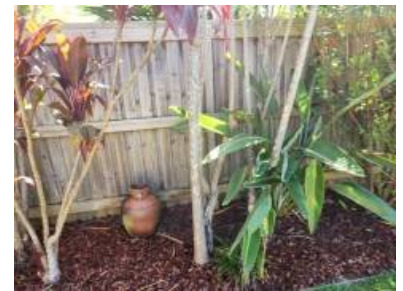
FENCING

Restrictions:
Various fencing is covered in foliage which restricted the inspection of the fencing. There may be damage / defects where access cannot be achieved.

Condition:
Satisfactory.
