Building and Pest Report

698 Uralba Road, Lynwood

Report/Agreement #	140125085905125
Inspection Date:	14 Jan 2025
Inspection Time:	08:59 am

Pest And Building Inspection

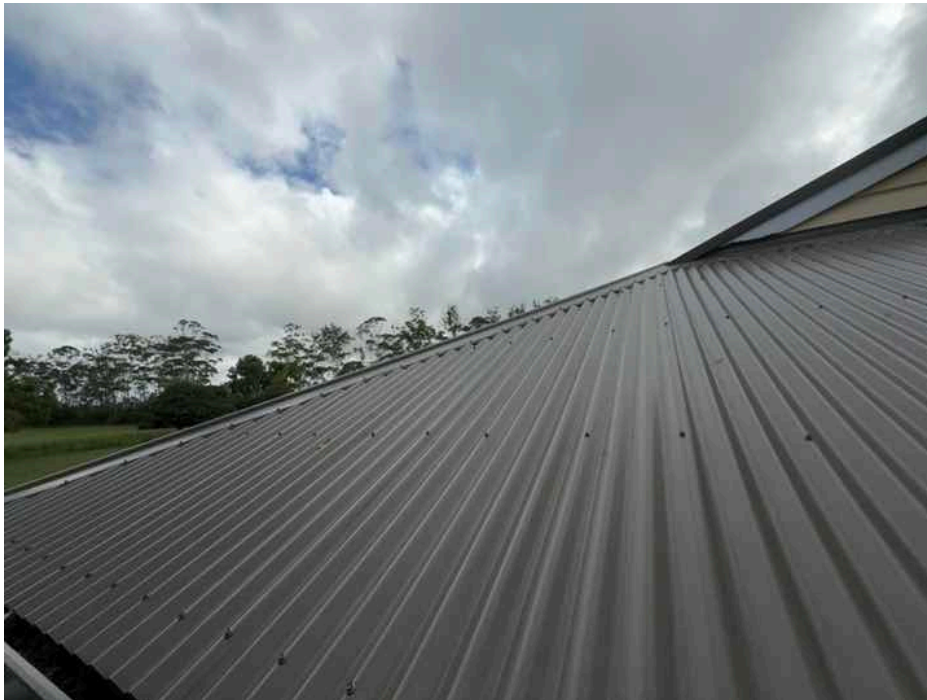
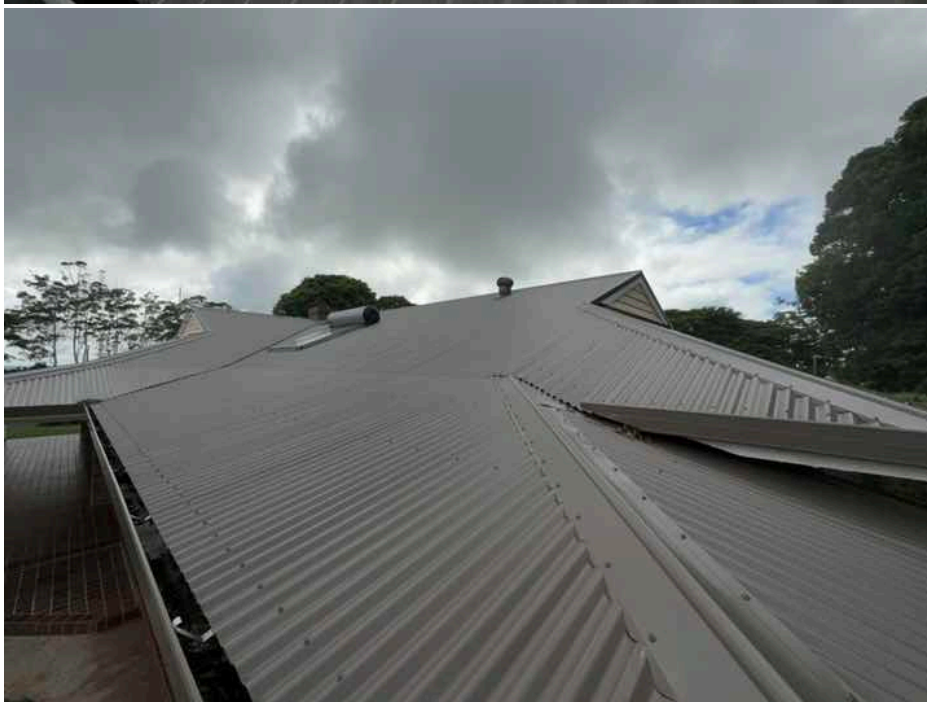
Of the visible areas, the general condition of the roof is in serviceable condition for the age.
Note: In the absence of rainfall there is no guarantee that the roof won't leak.

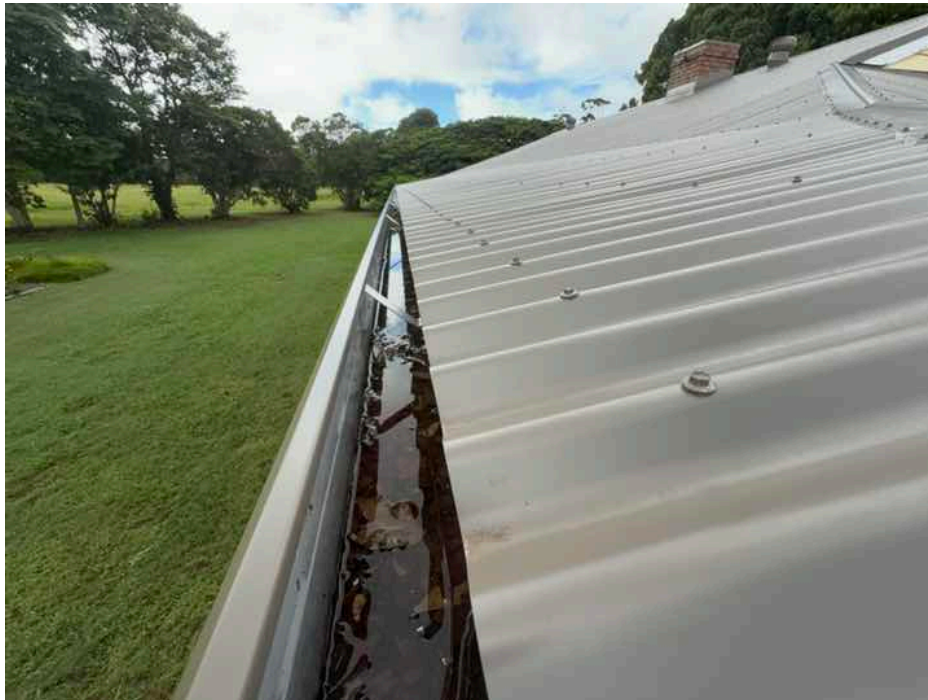
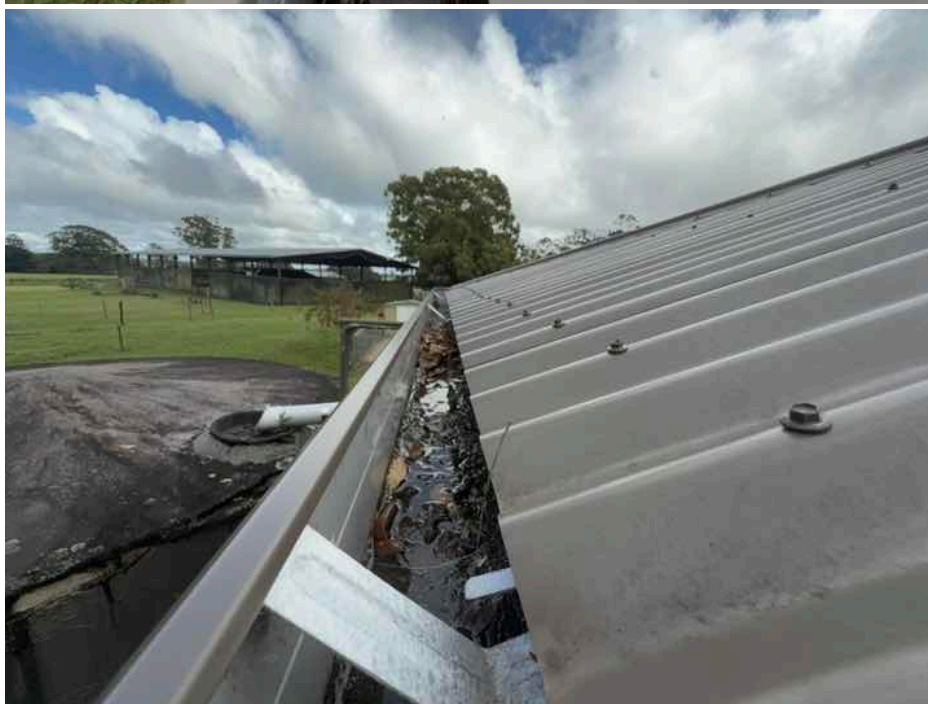
Gutter Findings

All visible and accessible of the physical nature of the guttering system appears to be in a serviceable condition with no apparent defects at the time of inspection. In the absence of prolonged rain fall efficiency of the guttering can not be assessed and you may find that further investigation or repairs maybe required. Note: Periodic maintenance checks should be carried out for rust penetrations and leaks.

Gutter ponding - This can relate to poor fall, inadequate down pipes, gutter or debris build up. If debris presence has been noted above clean same out and re-assess for any ponding. If clean guttering is ponding it can be a blocked down pipe or the guttering fall is inadequate. A qualified roof plumber should be engaged for advice and recommendations.

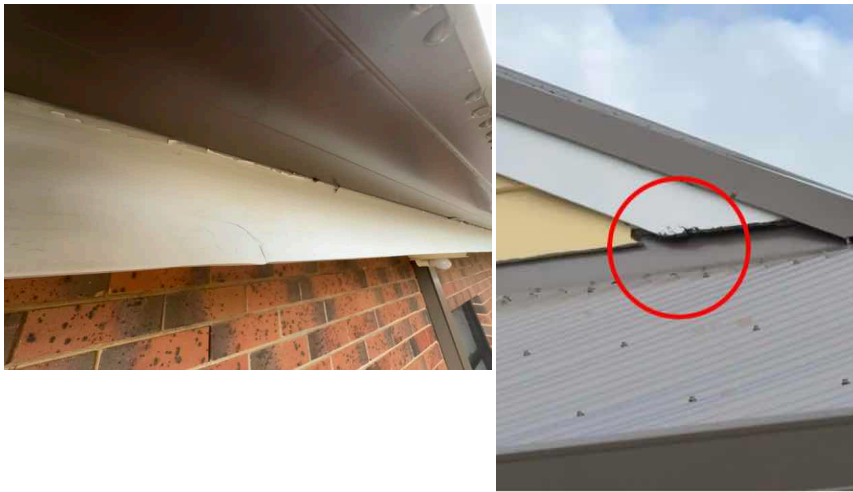
On visual inspection, the general condition of the fascia/barge boards is serviceable.

Timber fungal decay (rot) visible. Recommendations: A qualified carpenter should be engaged to replace all affected timbers.

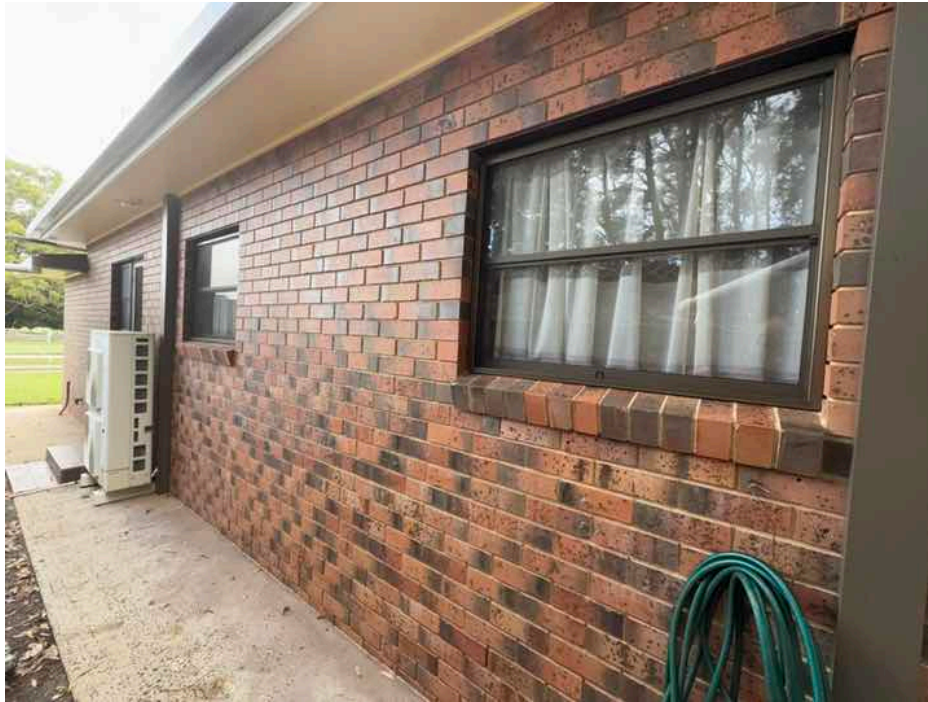
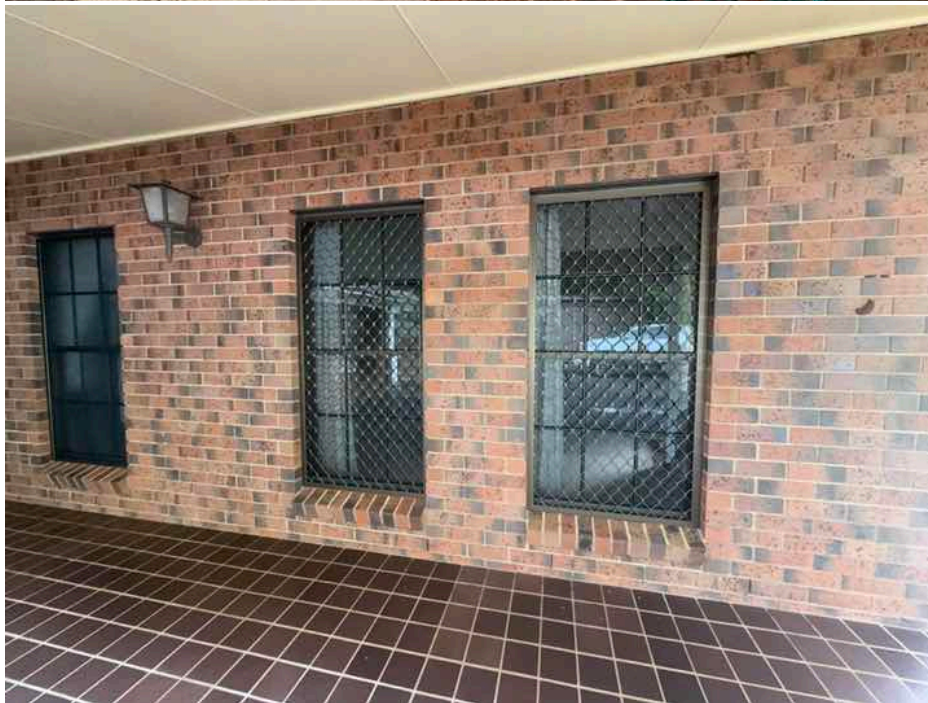
Windows

On visual inspection, the general condition of the windows is serviceable for the age.

Deterioration of sections of window rubber seals was observed. A qualified glazier should be engaged for advice and recommendations.

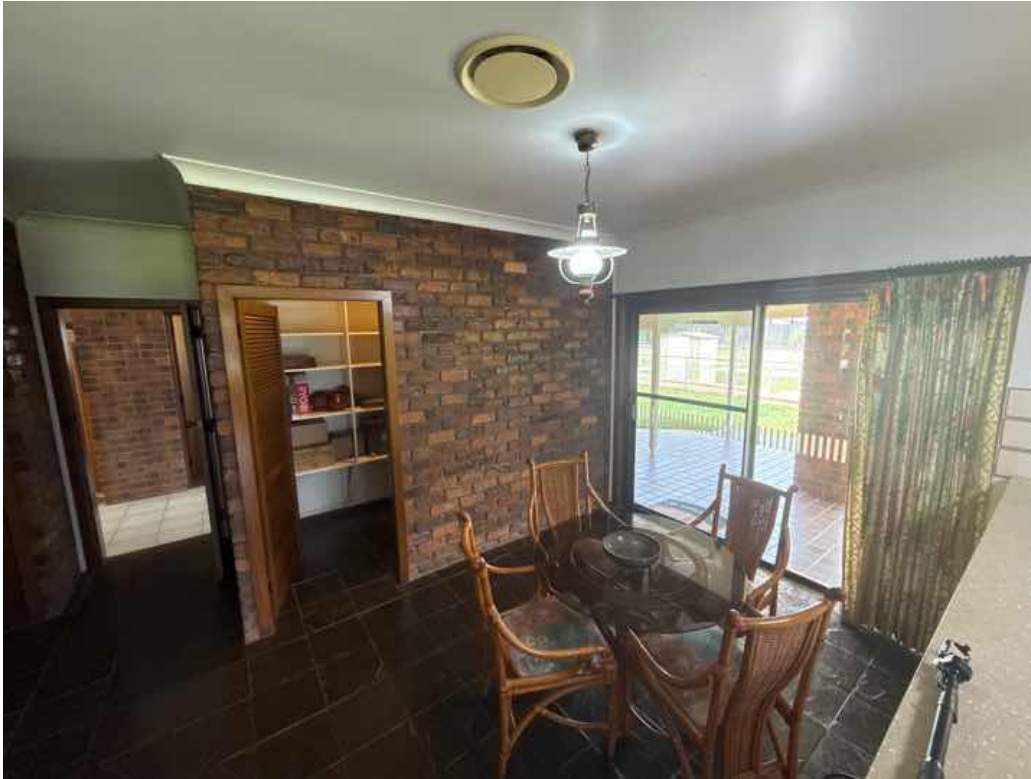
Ceiling

Settlement Cracks Noted. These are typical and generally patch and paint will suffice, however monitoring these cracks is advised for 12 months and if they become worse, further investigation by a suitably qualified professional is advised.

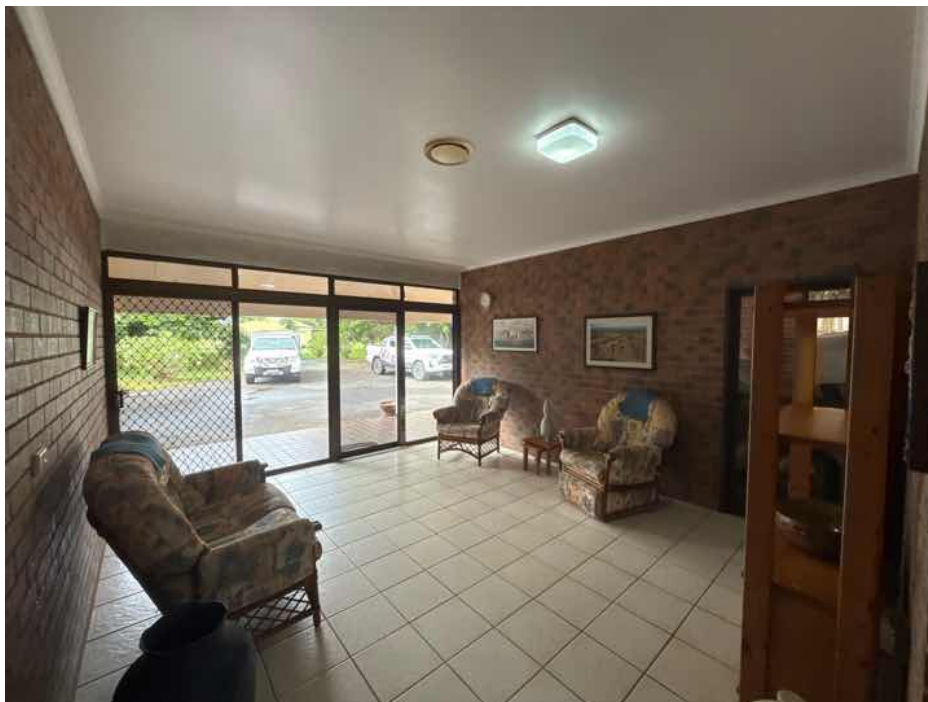
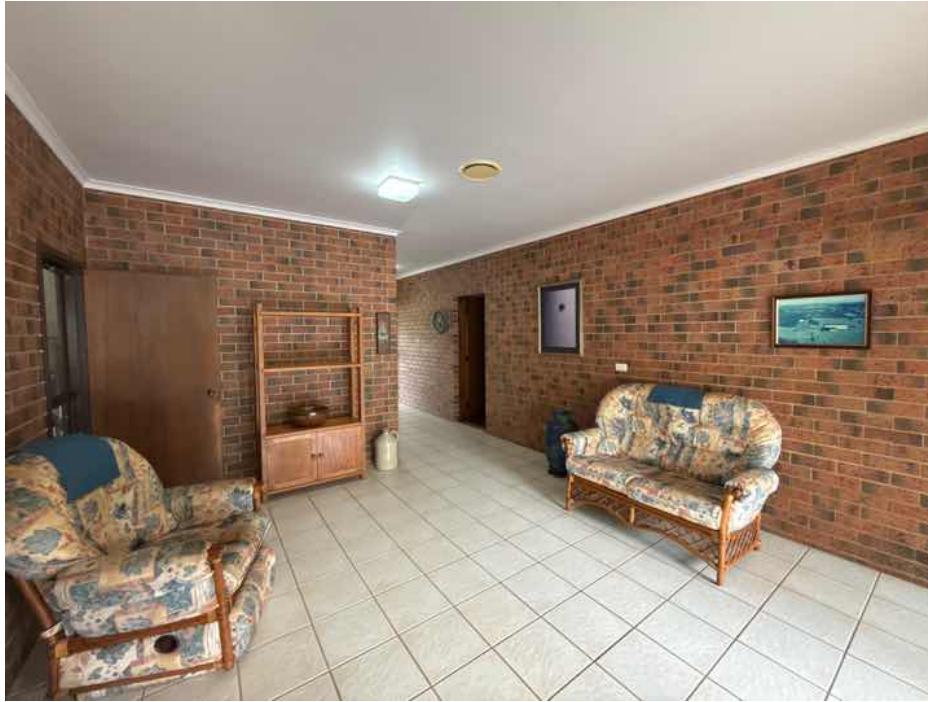
Ceiling

Settlement Cracks Noted. These are typical and generally patch and paint will suffice, however monitoring these cracks is advised for 12 months and if they become worse, further investigation by a suitably qualified professional is advised.

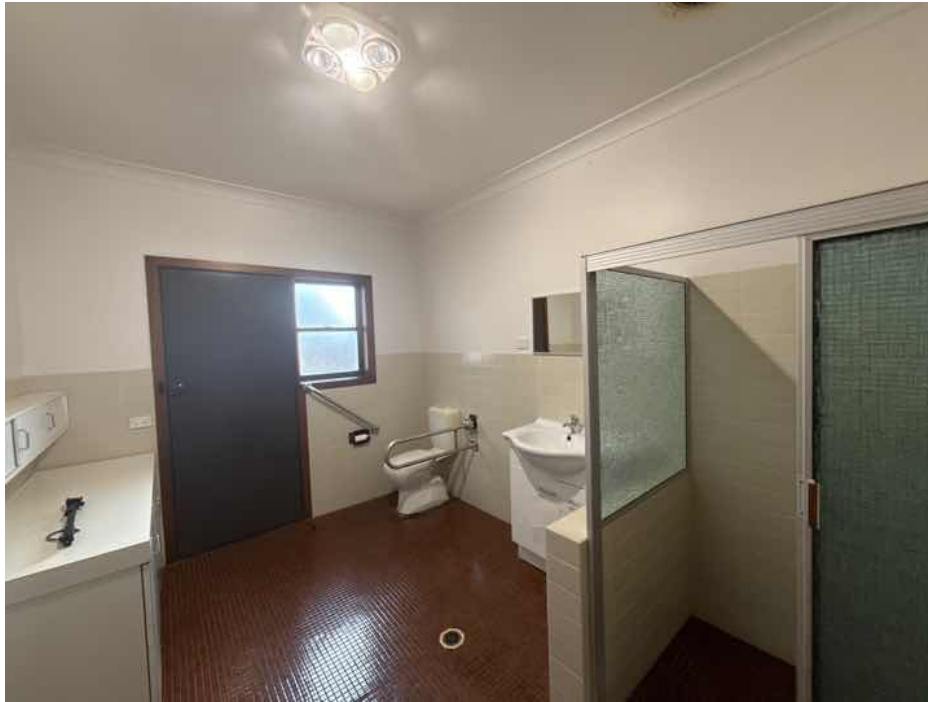
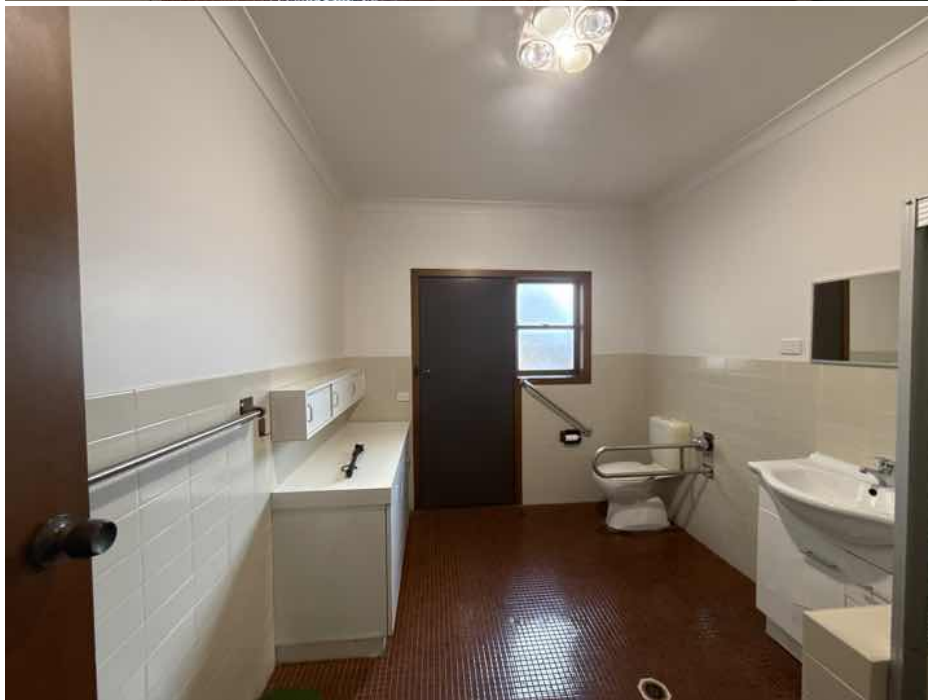
Flooring

Drummy tiles noted. This needs to be repaired at the earliest as this has the potential to lead to many related issues such as damp, water ingress to other areas and cracked tiles. Contact a qualified tiler for repairs and recommendation

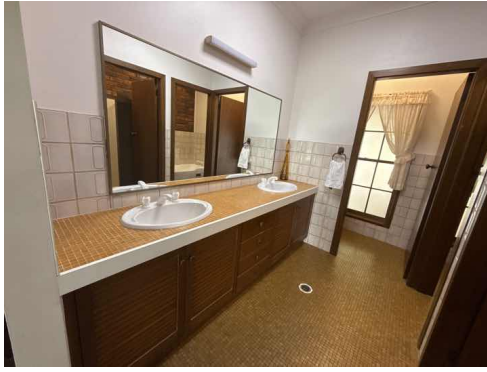
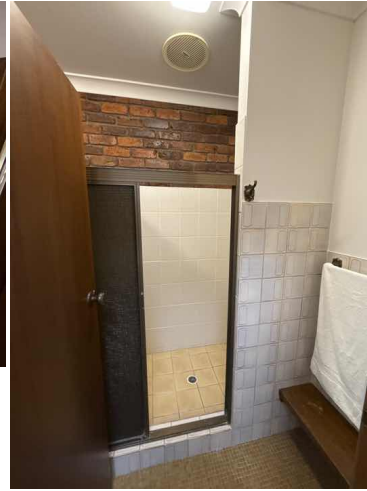
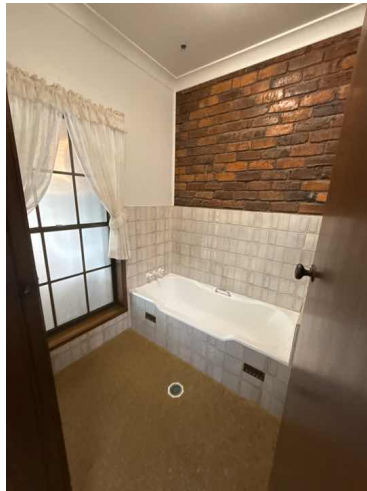
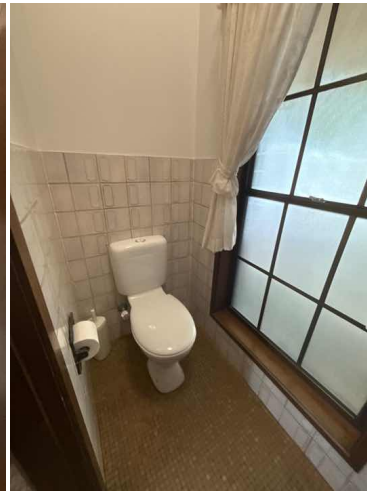
Ceiling

Settlement Cracks Noted. These are typical and generally patch and paint will suffice, however monitoring these cracks advised for 12 months and if become wider or longer, you will need to contact a structural engineers to assess.

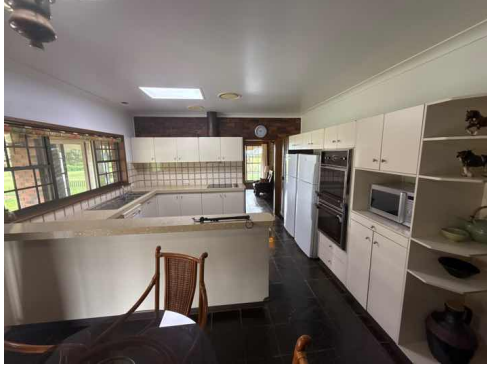
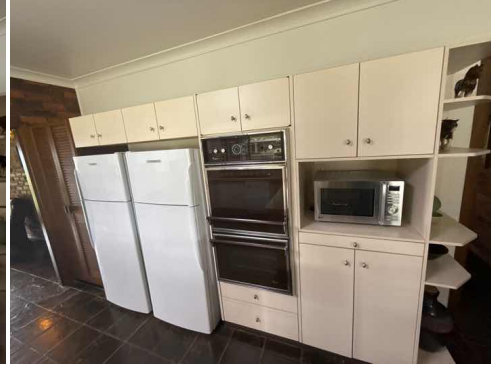
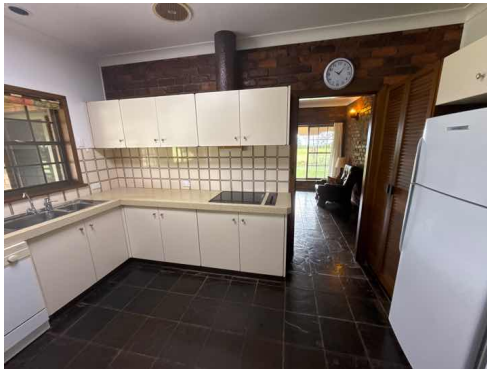
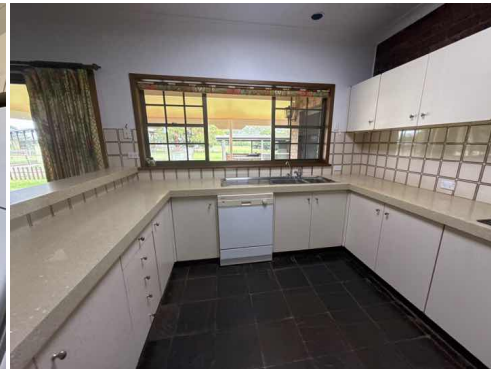
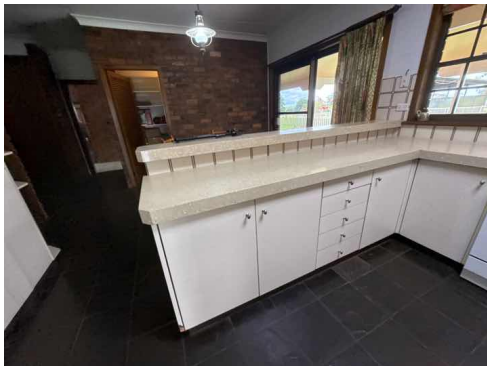
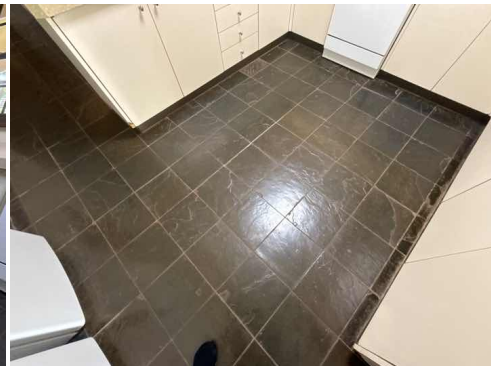
Cupboards And Bench Tops

These components appear to be in a serviceable condition

Adjustment to cabinet doors required, in some instance hinges may need to be replaced.

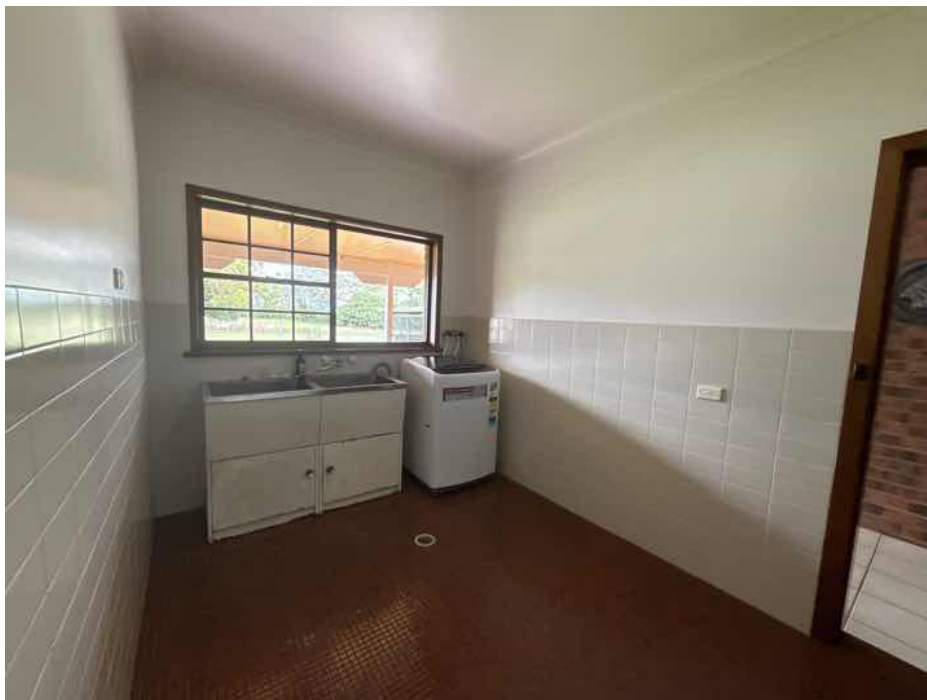
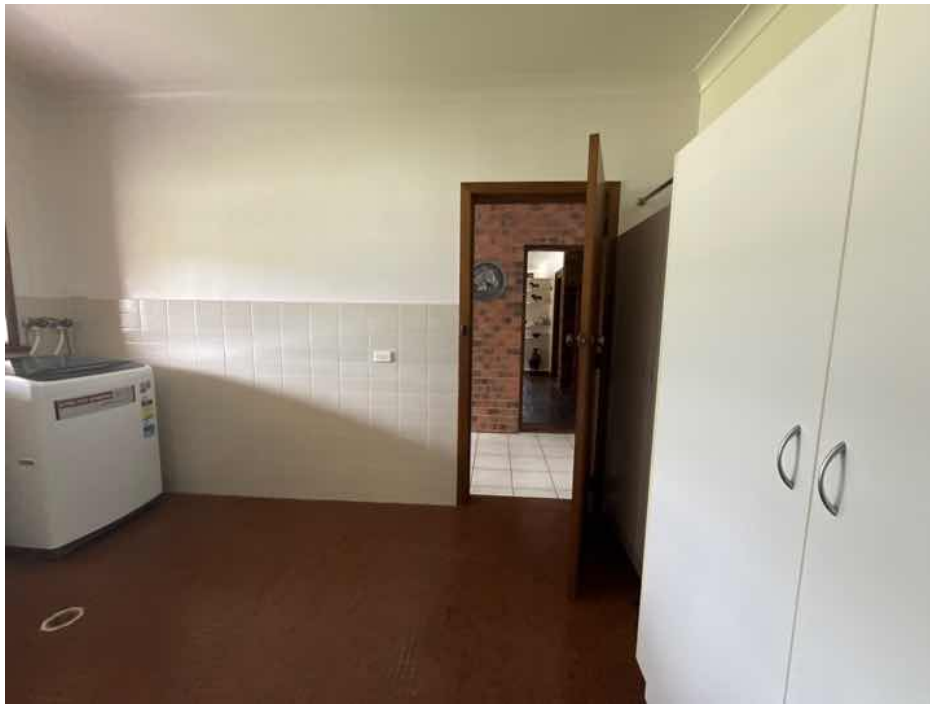
Of the visible areas, the general condition of the laundry is serviceable or in reasonable condition for age of dwelling.

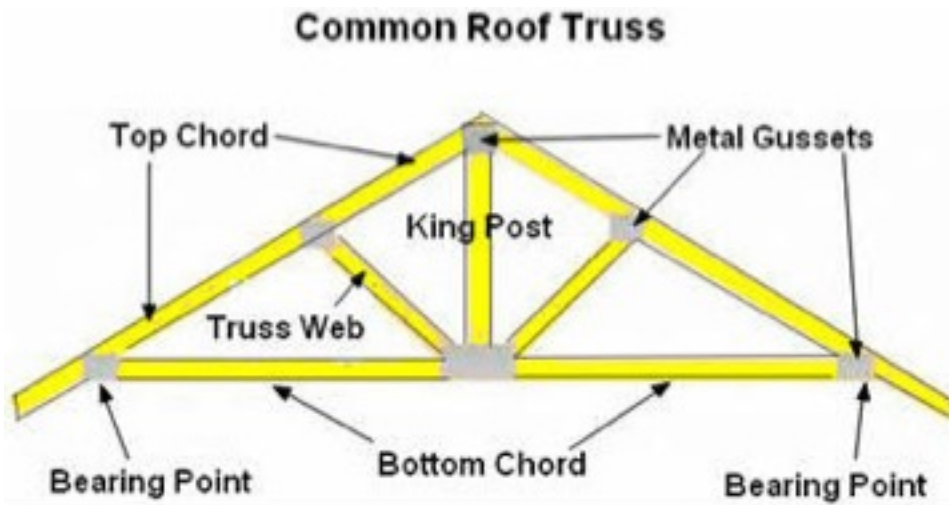
The roof frame is a truss timber frame.

Visible sections of the roof void is in a serviceable condition for age of this dwelling.

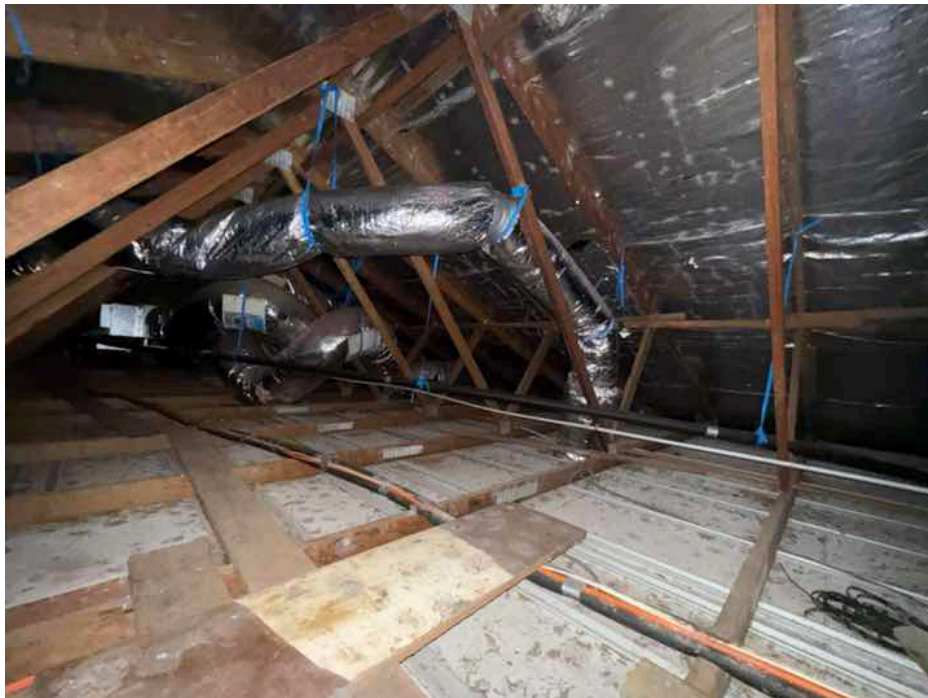
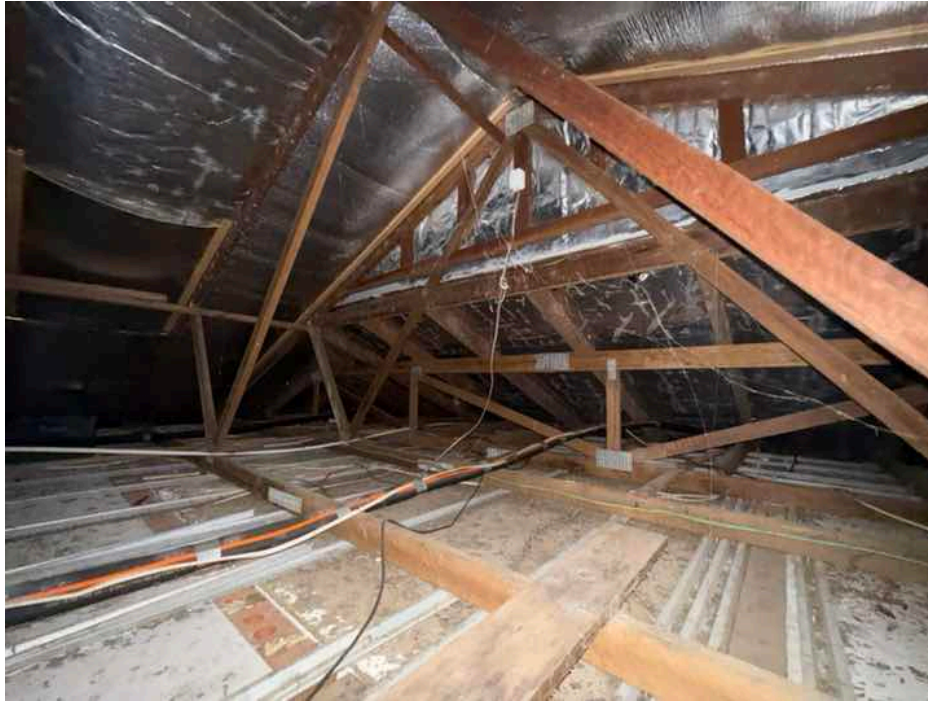
Insulation

Where visible and accessible, the insulation appears to be in a serviceable condition.
