# Building and Pest Report

## 15 Outrigger Road Lennox Head

Report/Agreement #	170725115953573
Inspection Date:	17 Jul 2025
Inspection Time:	11:59 am

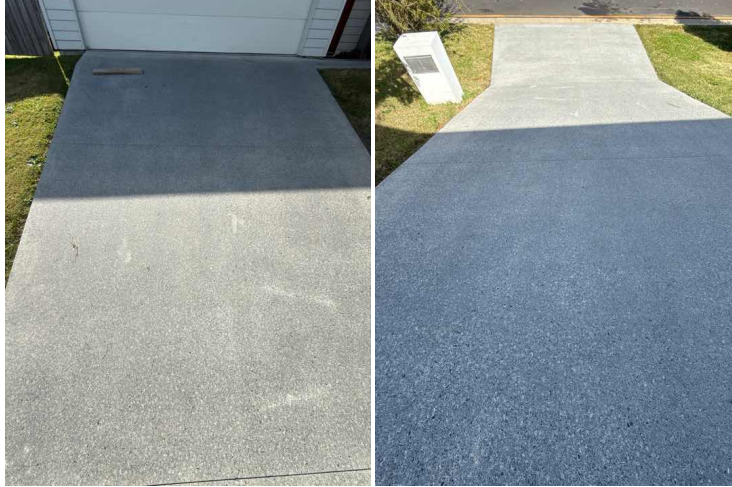
#### **Driveway Condition**

On visual inspection, the general condition of the driveway is serviceable.

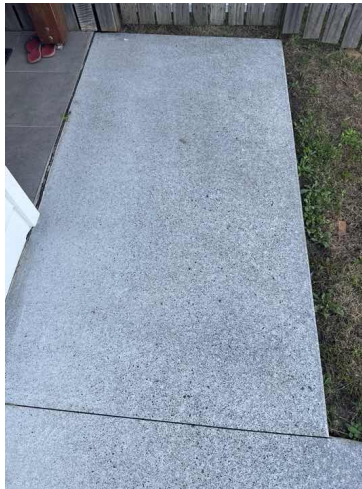
#### **Pathways Condition**

The paths around the home are in a serviceable condition for the age of this dwelling with no major defects visible.

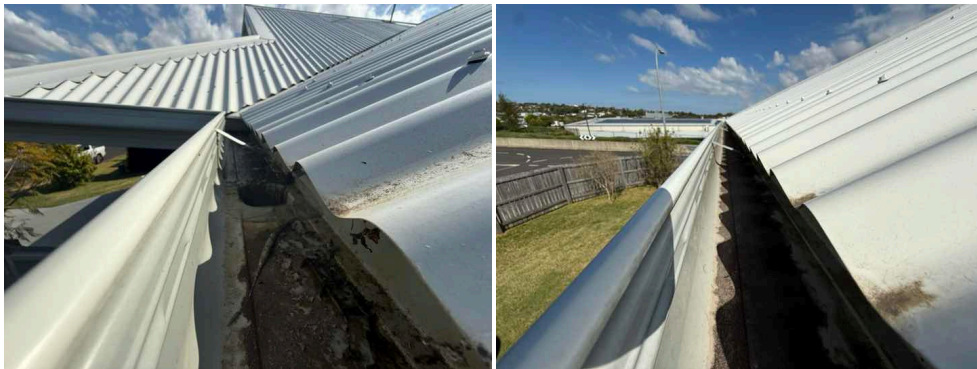
#### Gutter Findings

All visible and accessible of the physical nature of the guttering system appears to be in a serviceable condition with no apparent defects at the time of inspection. In the absence of prolonged rain fall efficiency of the guttering can not be assessed and you may find that further investigation or repairs maybe required. Note: Periodic maintenance checks should be carried out for rust penetrations and leaks.

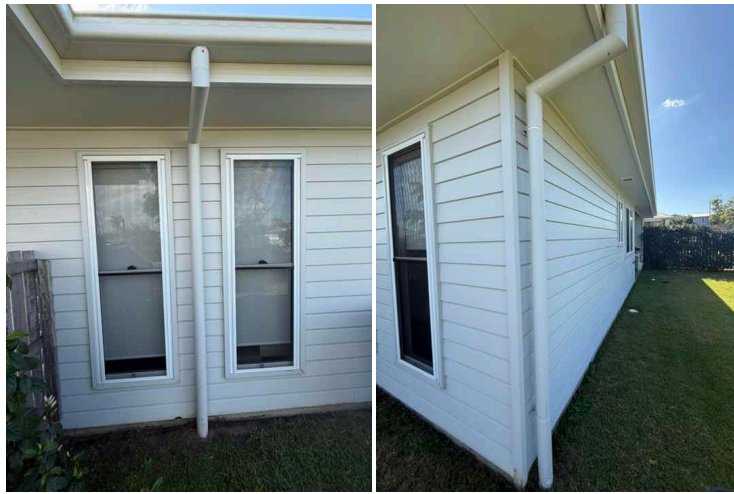
#### Downpipe Findings

On visual inspection no apparent defects were noted to the down pipes and are considered serviceable, however no comment can be made with regard to blockages or connections to stormwater or functionality in the absence of rain. Note: Periodic maintenance checks should be carried out for rust penetrations and leaks.

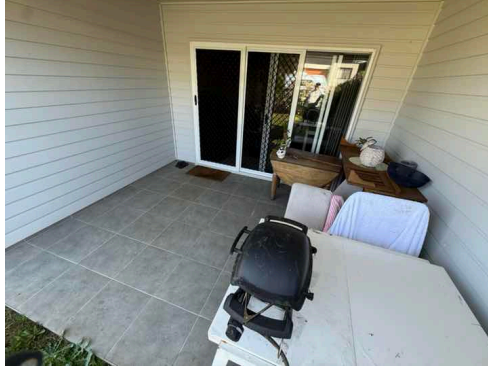
Visible sections of the Alfresco area are serviceable or in reasonable or condition for the age of this dwelling.

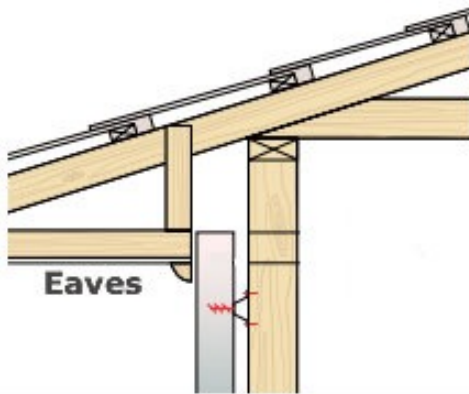
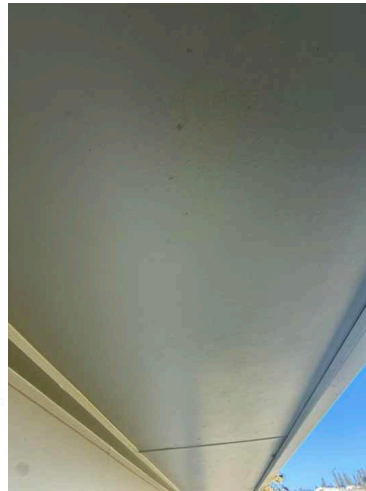
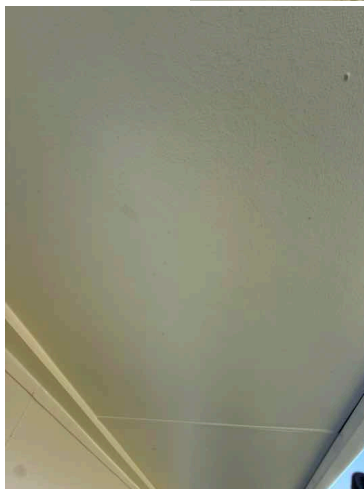
#### Eave Condition

The soffit lining (eaves) are in a serviceable condition with no notable defects.

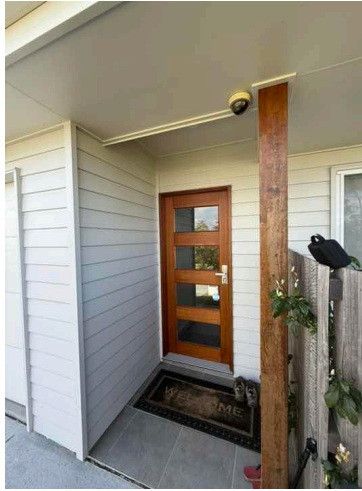
## Entry Porch Area

The entry porch serviceable or in reasonable or condition for the age of this dwelling.

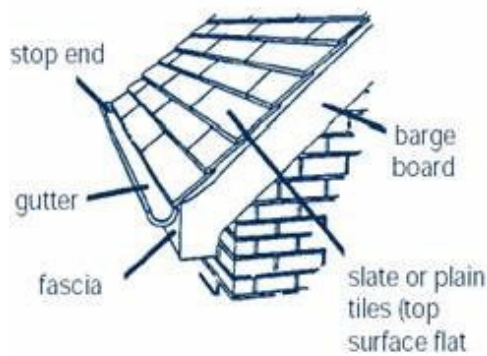
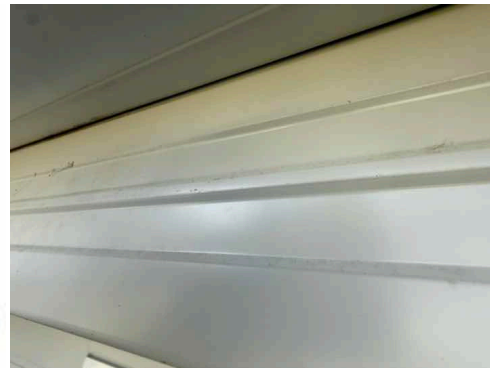
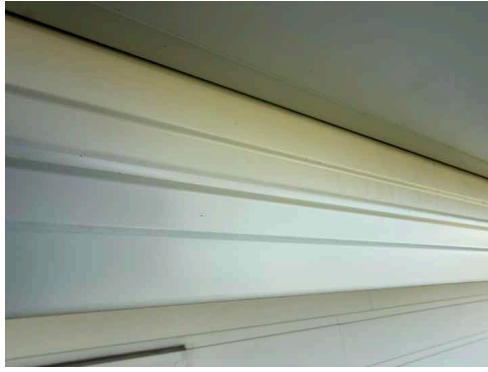
On visual inspection, the general condition of the fascia/barge boards is serviceable.

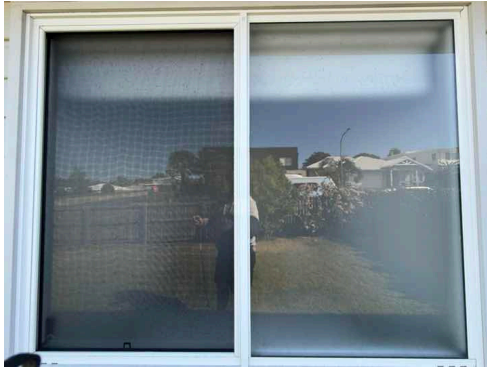
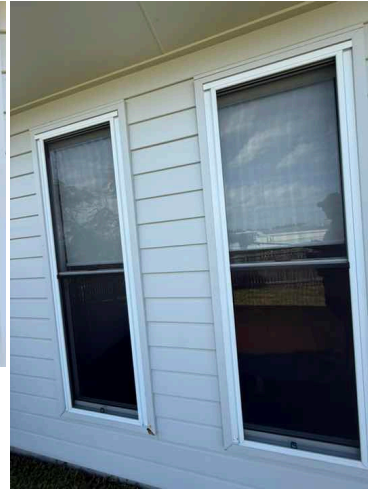
On visual inspection, the general condition of the windows is serviceable for the age.

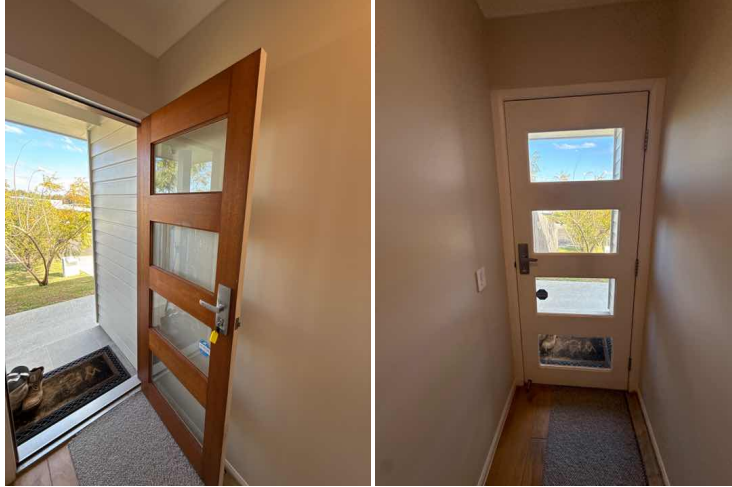
#### **Front Entry Doors**

The doors are in serviceable condition with no notable defects observed.

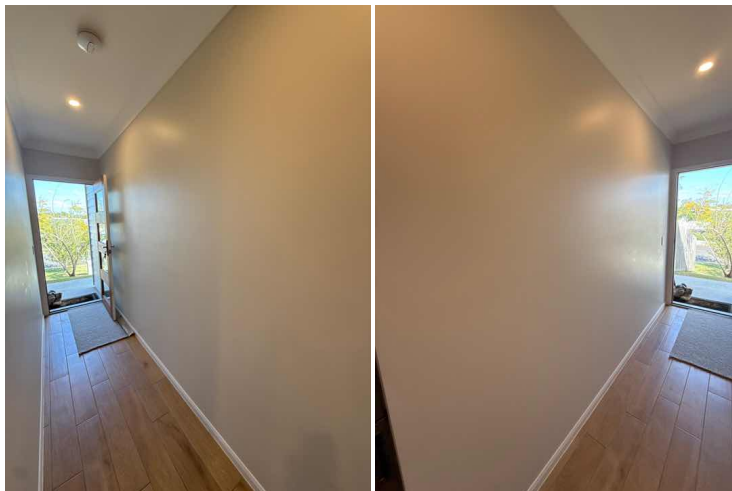
From the visible and accessible areas, this area appears to be in a serviceable condition for the age of the property with no notable structural defects sighted.

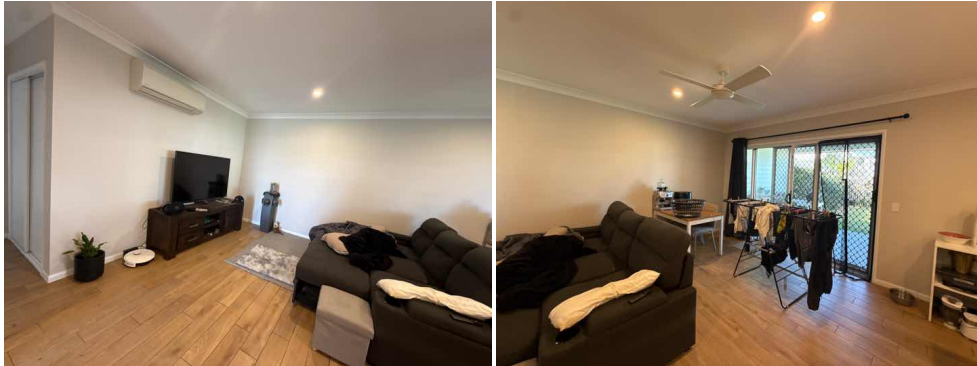
## Combined Living & Dining

From the visible and accessible areas, this room appears to be in a serviceable condition for the age of the property with no notable structural defects sighted.

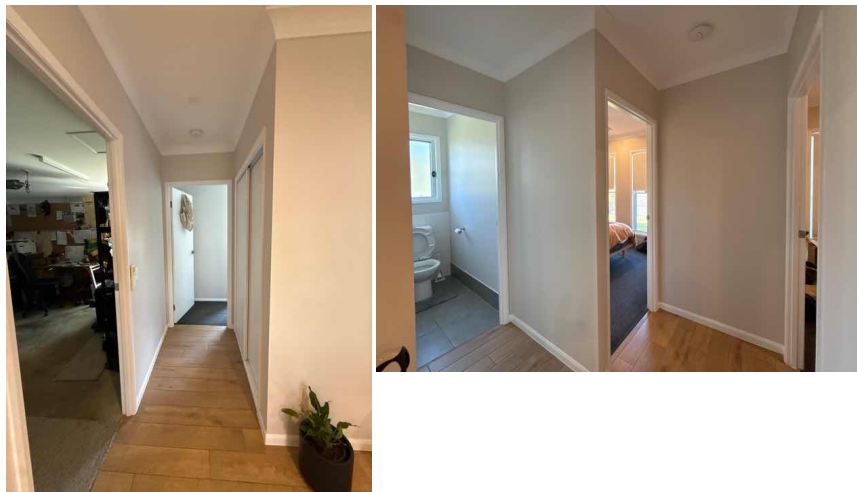
## Hallway/s

From the visible and accessible areas, the hallway/ appears to be in a serviceable condition for the age of the property with no notable structural defects sighted.

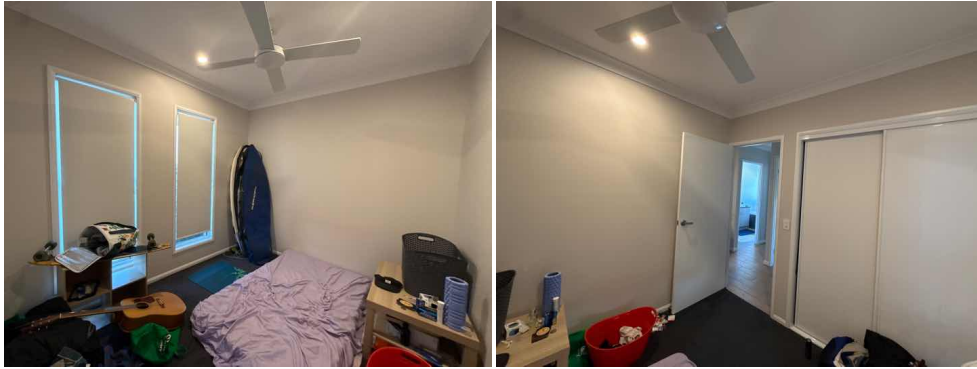
From the visible and accessible areas, this bedroom appears to be in a serviceable condition for the age of the property with no notable structural defects sighted.

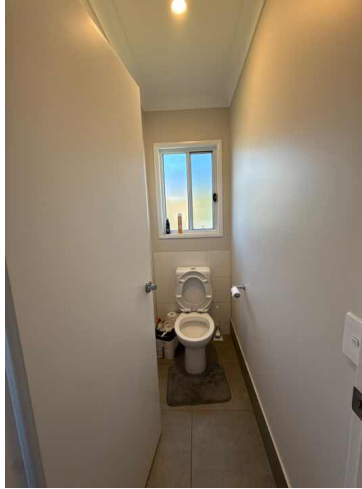
Of the visible areas, the general condition of this bathroom is serviceable or in reasonable condition for age of dwelling.

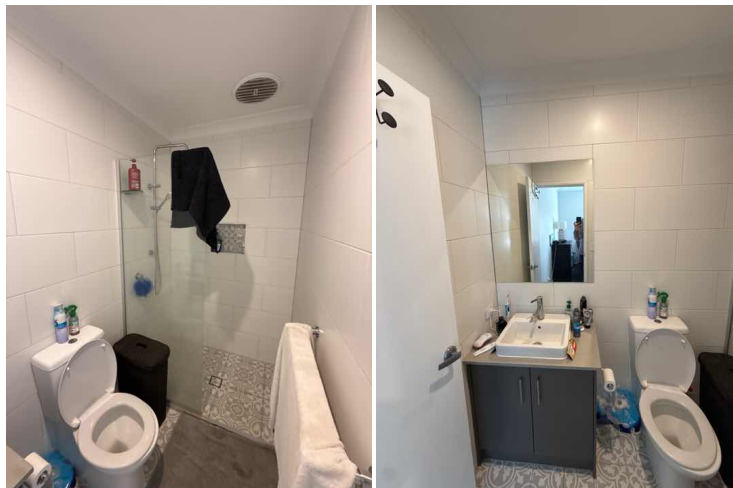
Of the visible areas, the general condition of this bathroom is serviceable or in reasonable condition for age of dwelling.

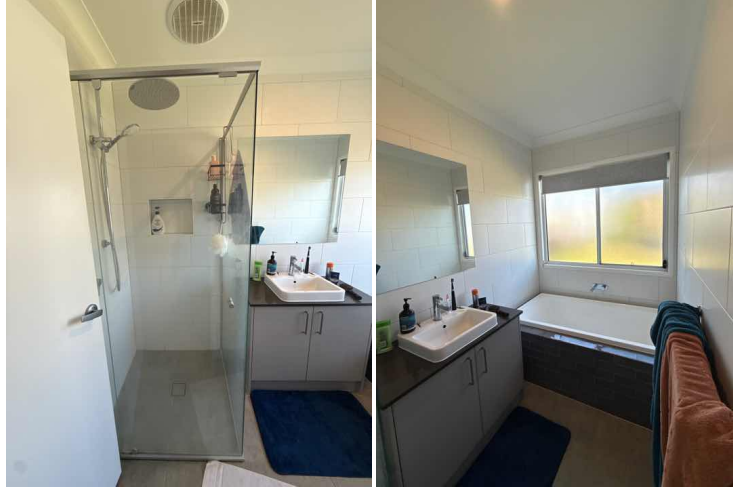
Of the visible areas, the general condition of this bathroom is serviceable or in reasonable condition for age of dwelling.

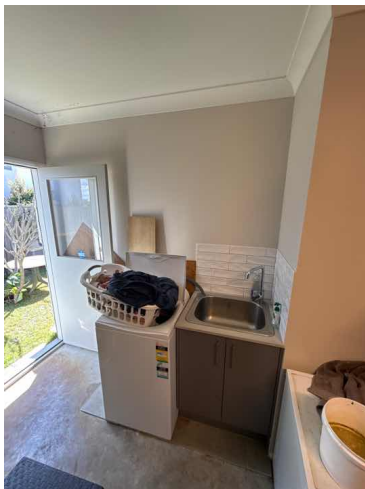
Of the visible areas, the general condition of the laundry is serviceable or in reasonable condition for age of dwelling.

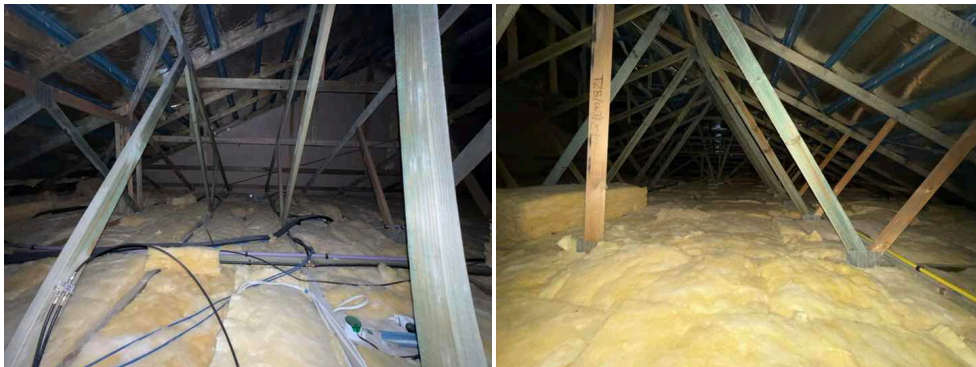
Visible sections of the roof void is in a serviceable condition for age of this dwelling.
