Building and Pest Report

3/20 Byron Street
Lennox Head

Inspection Report

3/20 Byron Street , Lennox Head , NSW , 2478

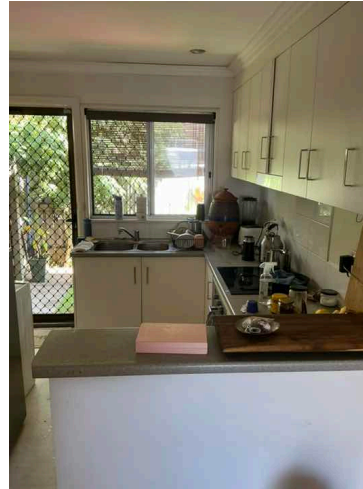
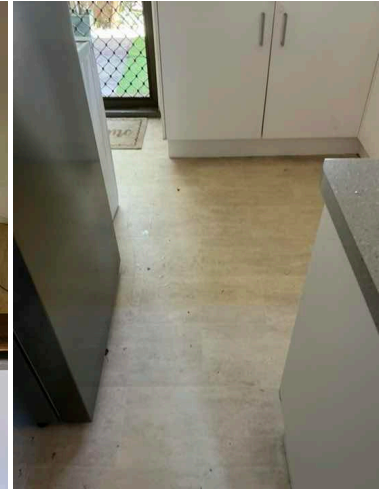
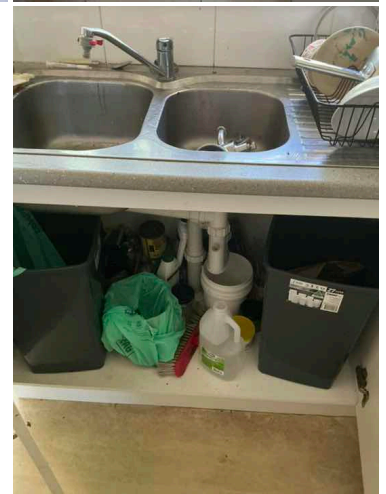
Of the visible areas, the general condition of the kitchen is serviceable or in reasonable condition for age of dwelling.

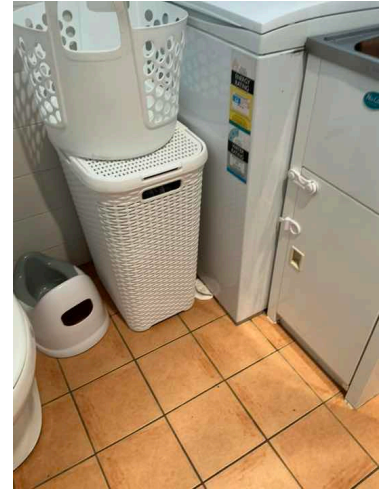
Of the visible areas, the general condition of the laundry is serviceable or in reasonable condition for age of dwelling.
