# Building and Pest Report

## 9 Outrigger Road, Lennox Head

# Inspection Report

**9 Outrigger Rd, Lennox Head, NSW, 2478**

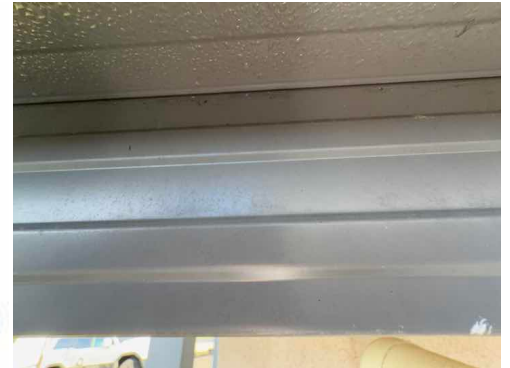
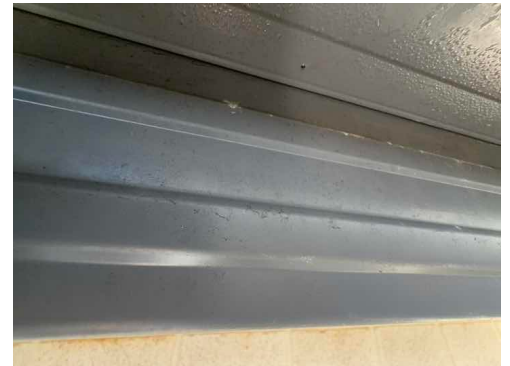
Salt residue on lower external wall visible - Salt residue can be associated with rising damp problems. Further investigation by a specialist in this field is recommended.

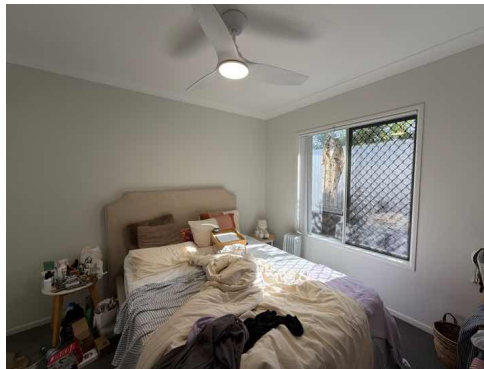
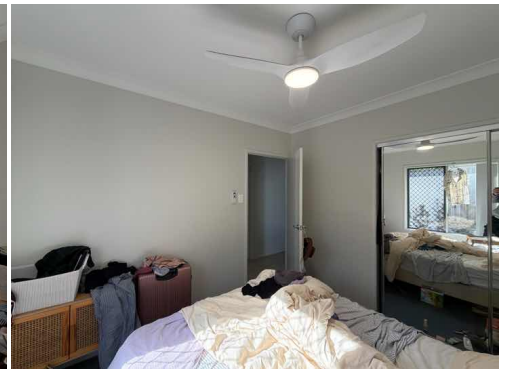
Stains observed - Steam cleaning may rectify stained areas but they appear entrenched.

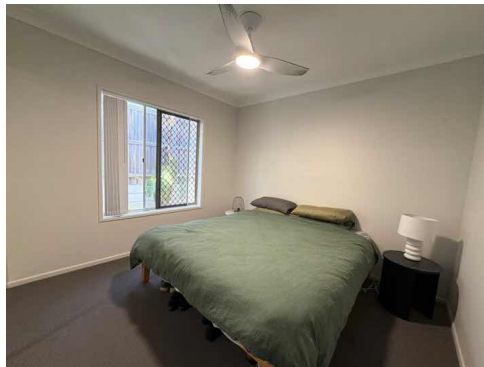
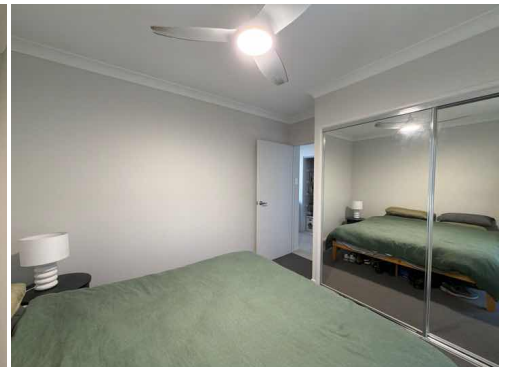
Stains observed - Steam cleaning may rectify stained areas but they appear entrenched.

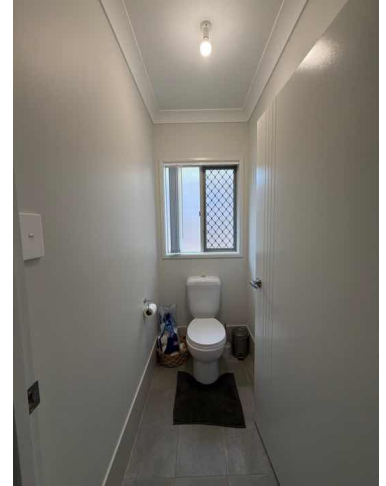
No exhaust fan is installed - Recommend having one installed.

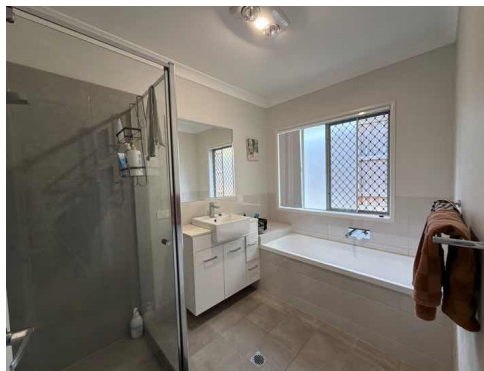
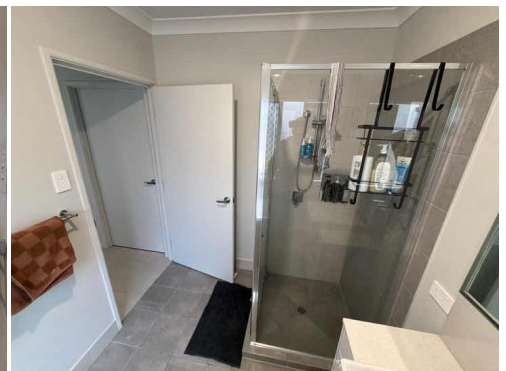
On inspection, defects were present that will require further assessing and recommendations by licensed and qualified trades persons, please read below for details.

Though reporting on mould does not form part of this inspection it's worth noting that mould growth is noted. Due to health risks we strongly recommend that a expert in the field of mould treatment be engaged for further advise and recommendations.

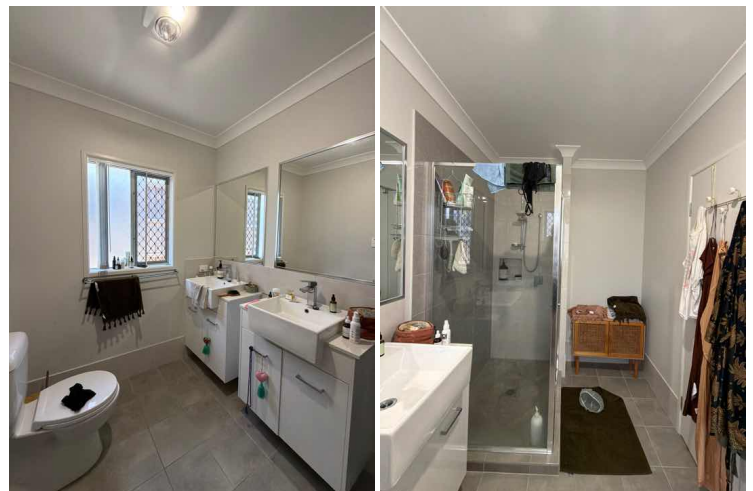
Of the visible areas, the general condition of this bathroom is serviceable or in reasonable condition for age of dwelling.

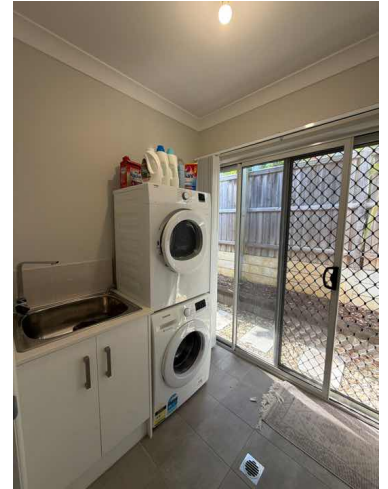
Of the visible areas, the general condition of the laundry is serviceable or in reasonable condition for age of dwelling.

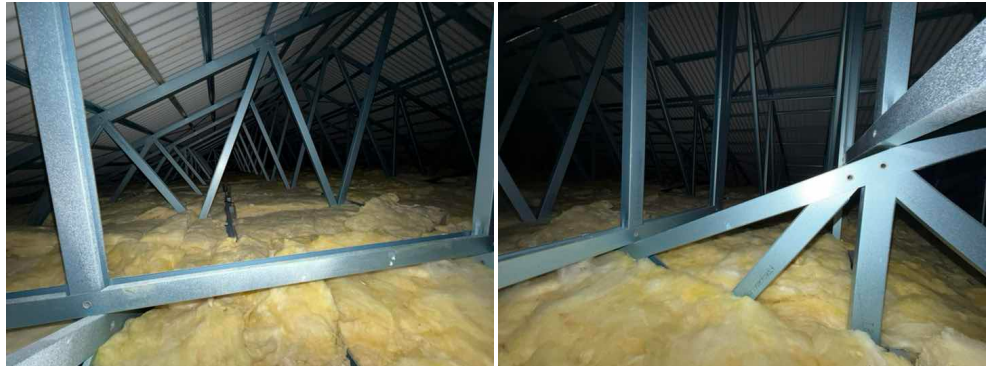
Visible sections of the roof void is in a serviceable condition for age of this dwelling.
