# Building and Pest Report

## 3 Claremont Place Lennox Head

# Inspection Report

**3 Claremont Place , Lennox Head , NSW, 2478**

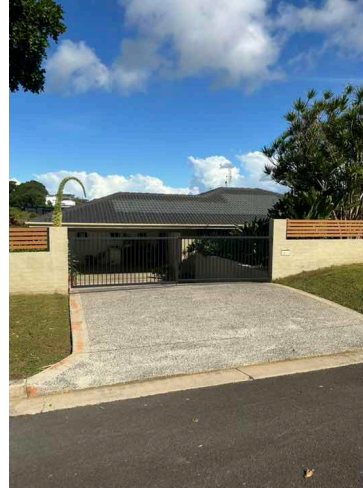
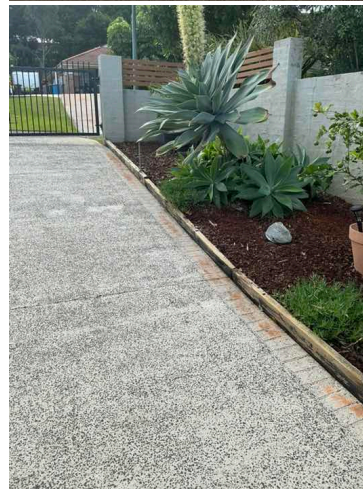
#### Driveway Condition

Common cracks were observed on the driveway. Whilst these cracks appeared to be typical at the time of inspection, we strongly recommend you monitor these cracks and if worsening occurs contact a concreter for further advice.

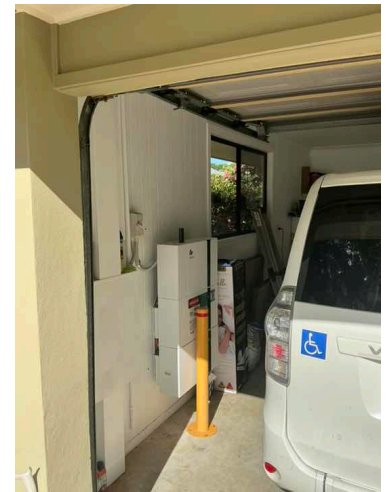
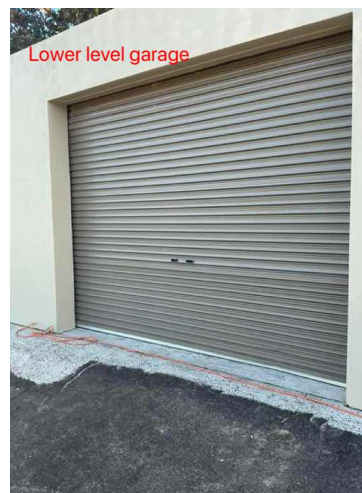
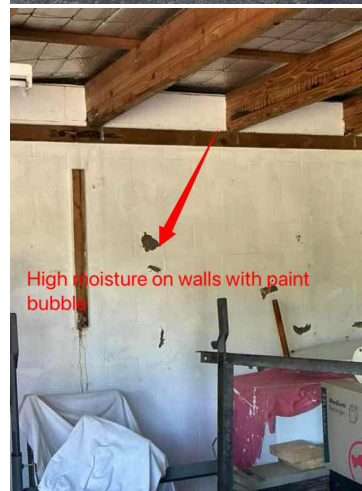
Upon visual inspection, the wall shows signs of moisture damage, with visible peeling and discoloration. Recommend engaging a licensed tradesperson to assess and repair the affected areas, ensuring proper sealing and waterproofing to prevent future issues.

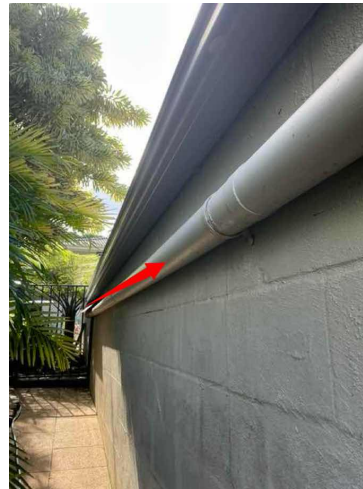
### Downpipe Findings

| Section | Location | Name | Comment |
|---|---|---|--|
| GARAGE - CARPORT | Carport | Downpipe Findings | #3. Down pipe is not connected to storm water. Contact a roof plumber for repairs |

#3. Down pipe is not connected to storm water.  
Contact a roof plumber for repairs

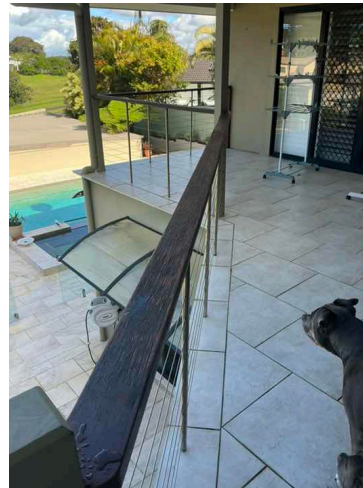
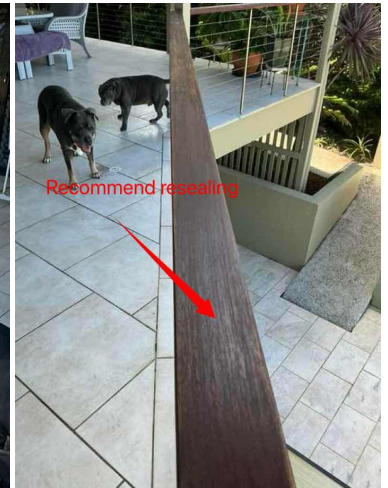
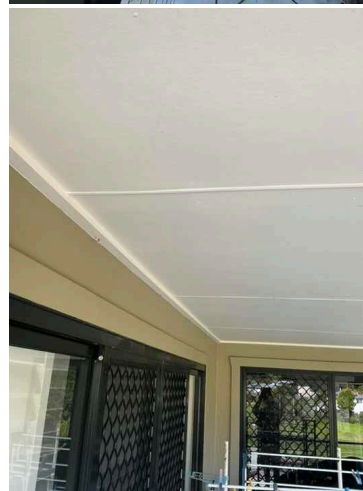
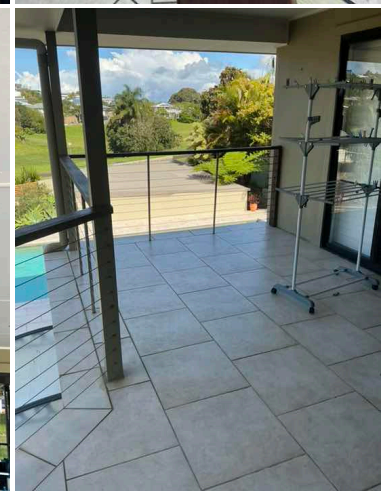
Though we are not structural engineers the balcony/s appear to be in a serviceable condition.

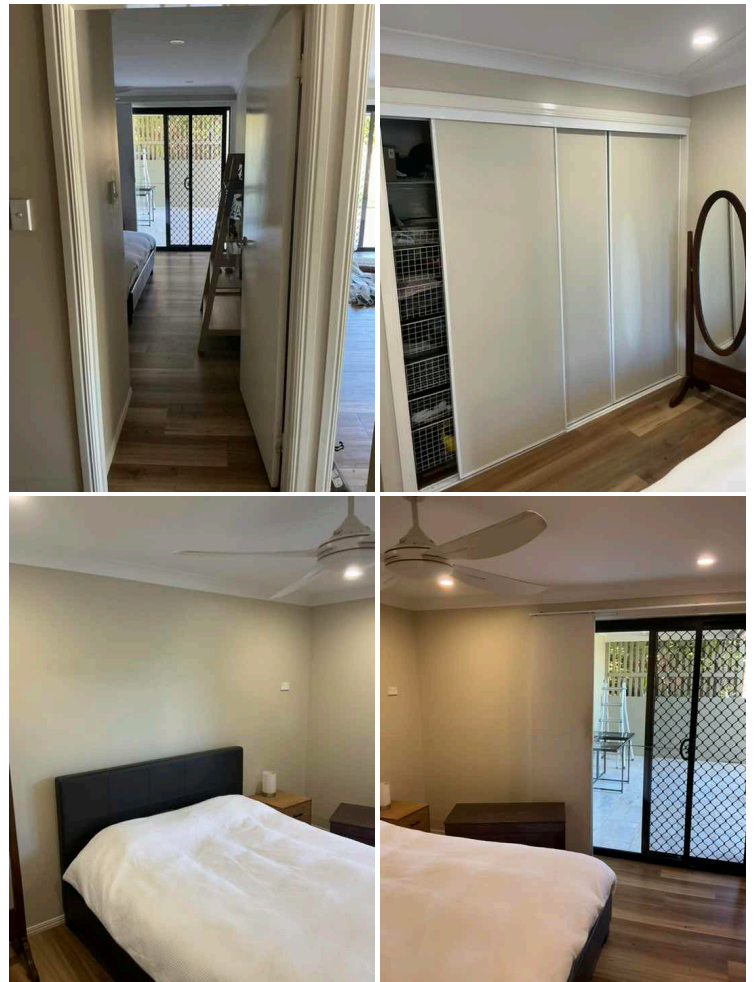
## **Bedroom 5**

Upon visual inspection, the moisture meter indicates elevated moisture levels in the wall. It is recommended to engage a licensed plumber to investigate potential leaks or water ingress. Additionally, a licensed builder should assess any structural implications and ensure proper remediation to prevent further moisture-related issues.

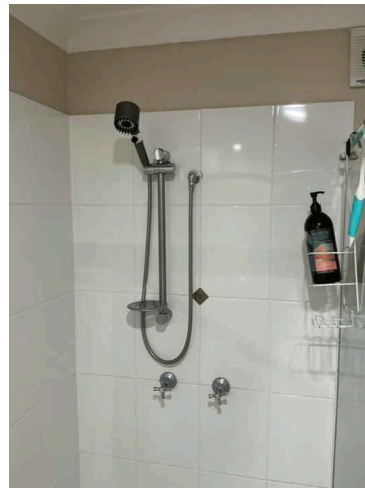
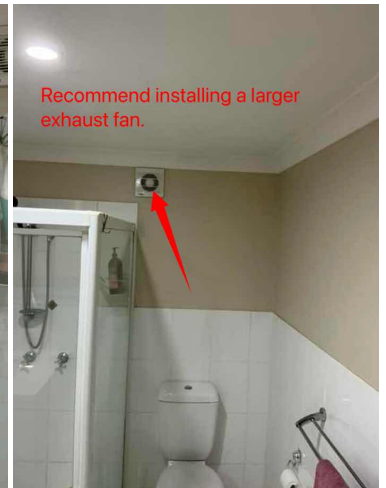
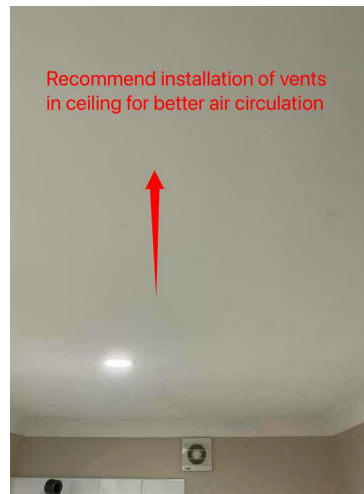
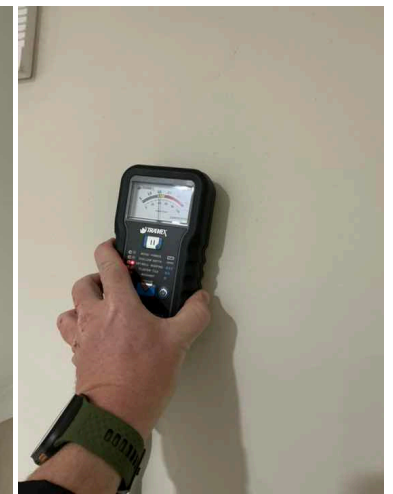
On inspection, defects were present that will require further assessing and recommendations by licensed and qualified trades persons, please read below for details.see photos attached.
