Building and Pest Report

39 Gibbon Street, Lennox Head

Inspection Report

39 Gibbon Street, Lennox Head , NSW, 2478

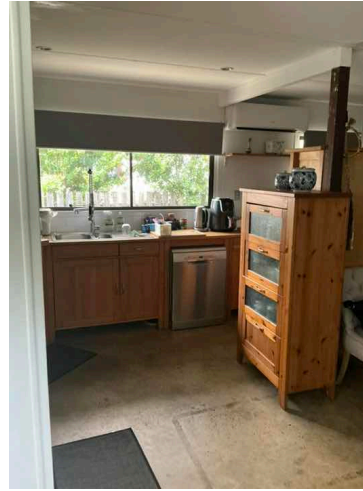
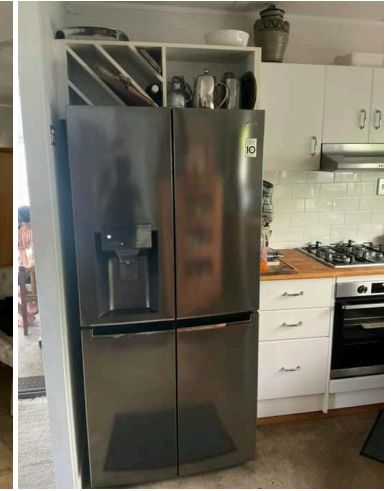
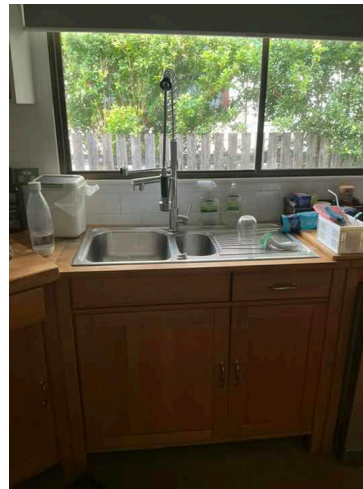
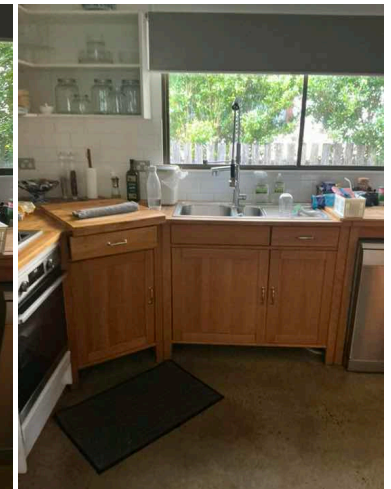
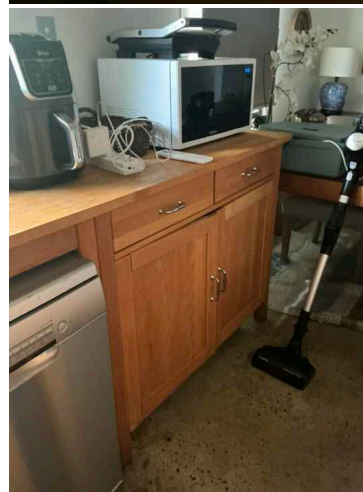
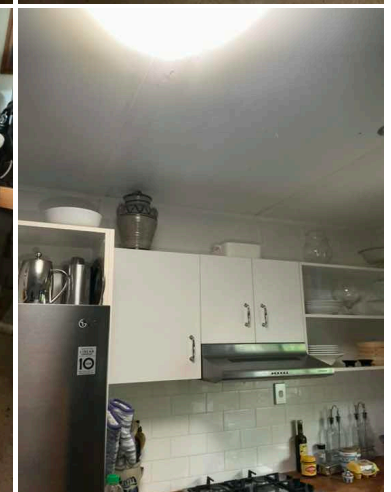
Of the visible areas, the general condition of the kitchen is serviceable or in reasonable condition for age of dwelling.

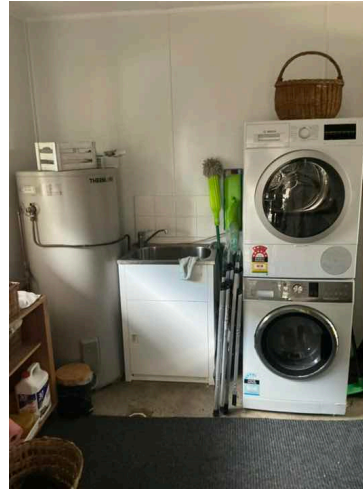
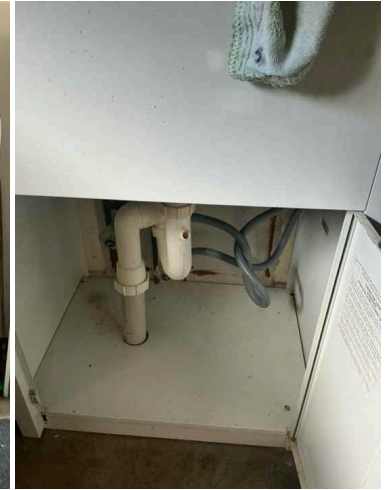
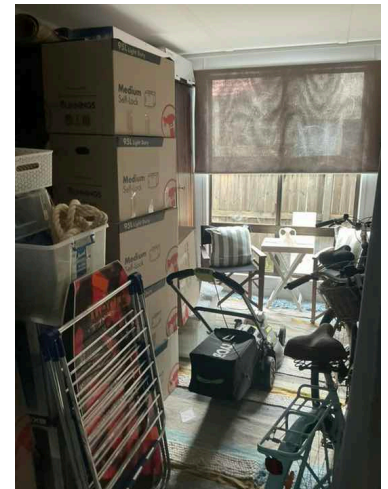
Of the visible areas, the general condition of the laundry is serviceable or in reasonable condition for age of dwelling.
