# Building and Pest Report

## 74A Stoneyhurst Drive Lennox Head

| Inspection Date: | 19 May 2025 |

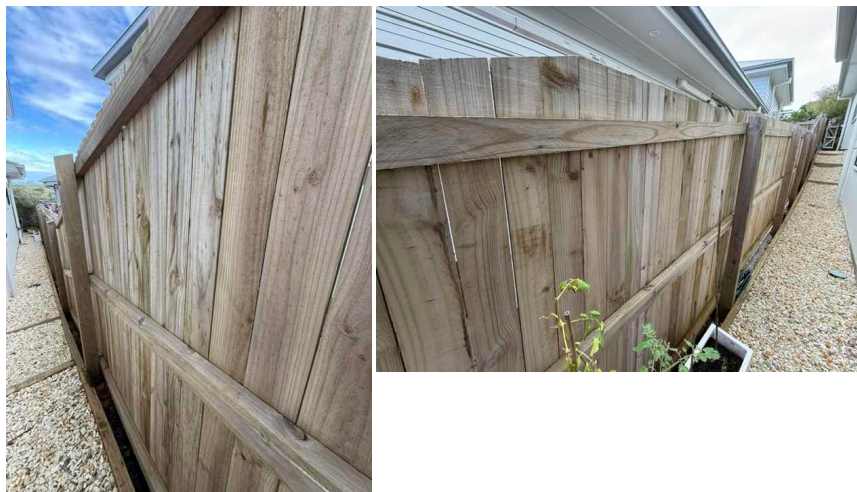
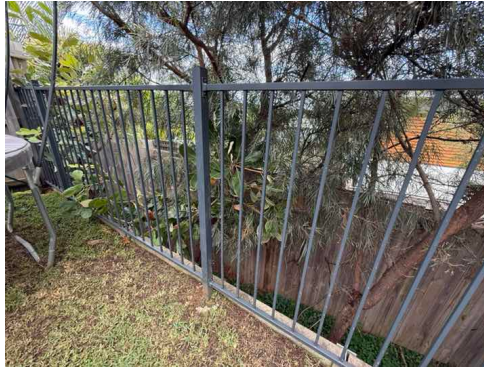
Of the visible areas, the general condition of the fences and gates is serviceable for the age of dwelling.

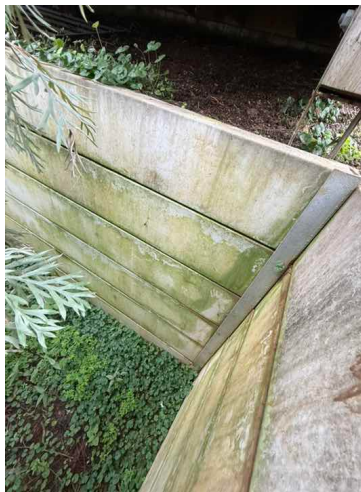
Of the visible areas, the general condition is serviceable or in reasonable condition for age of dwelling.

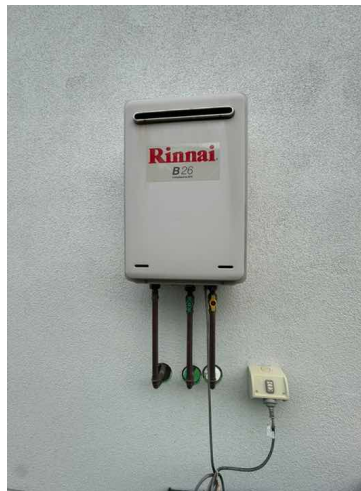
The make of the hot water unit is rinnai.

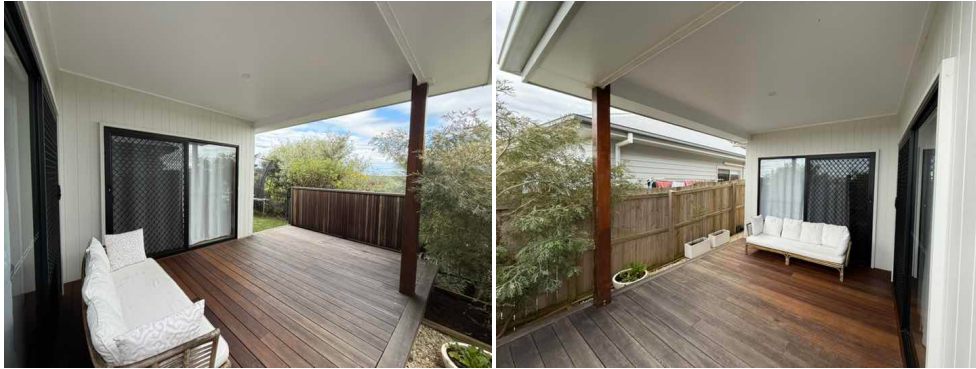
Visible sections of the Alfresco area are serviceable or in reasonable or condition for the age of this dwelling.

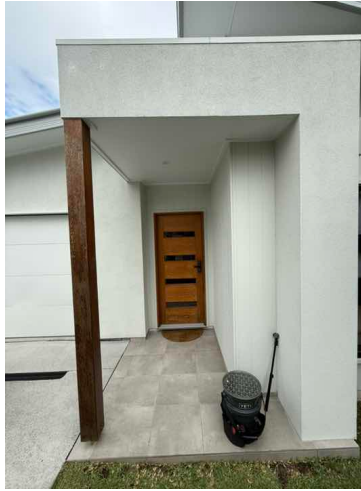
The entry porch serviceable or in reasonable or condition for the age of this dwelling.

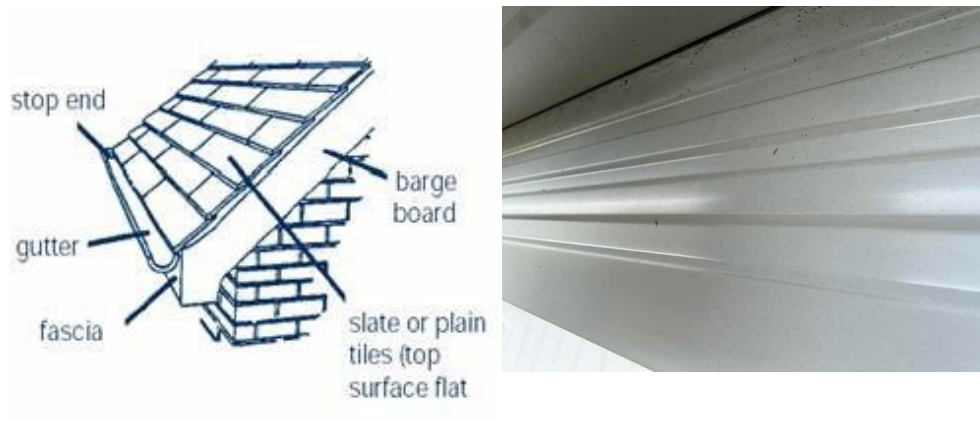
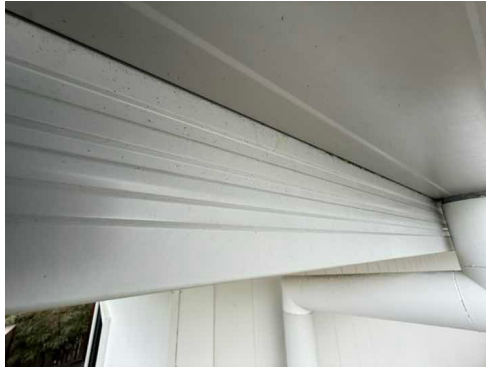
On visual inspection, the general condition of the fascia/barge boards is serviceable.

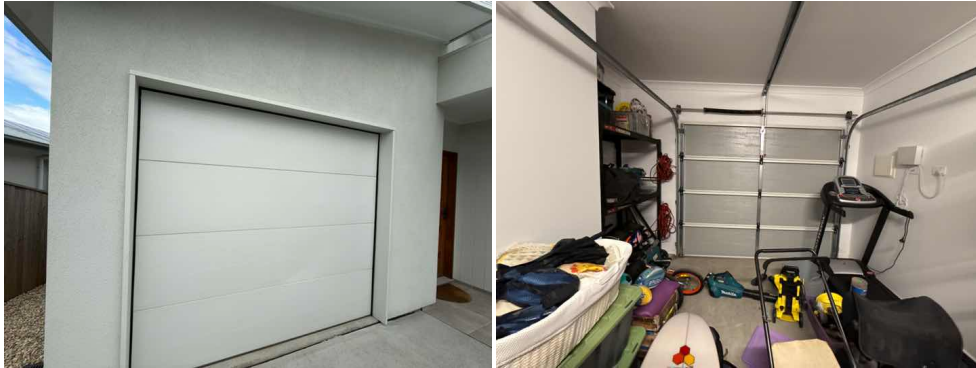
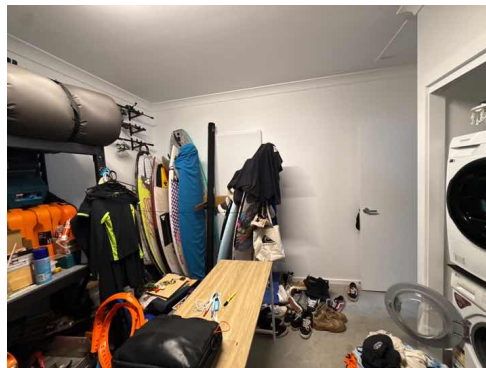
From the visible and accessible areas, the garage appears to be in a serviceable condition for the age of the property with no notable structural defects sighted.

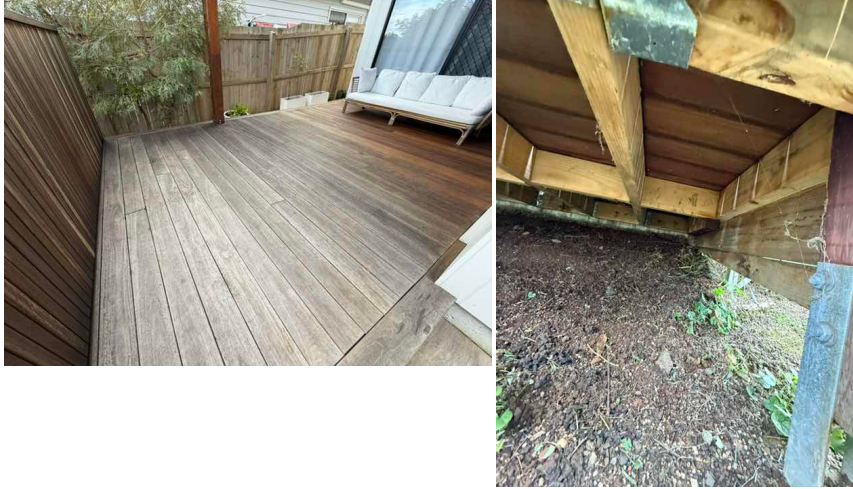
Of areas visible, the decking appears to be in a serviceable condition.

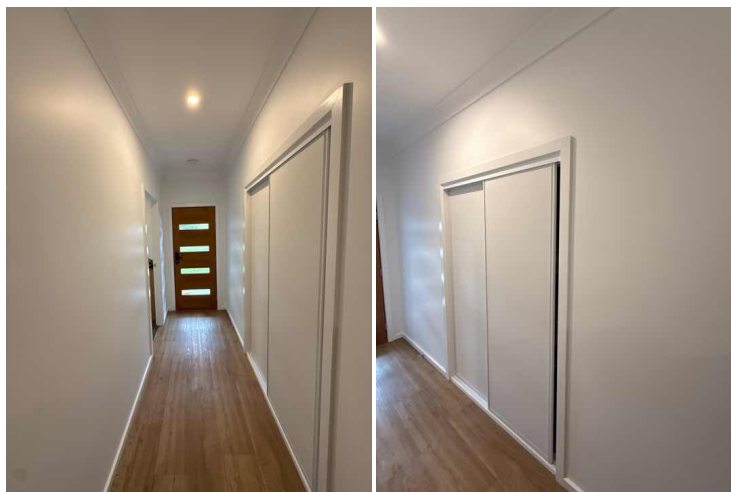
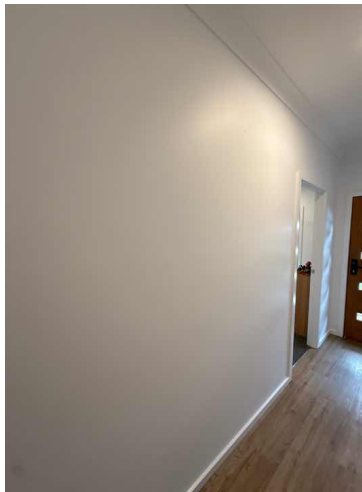
From the visible and accessible areas, this area appears to be in a serviceable condition for the age of the property with no notable structural defects sighted.

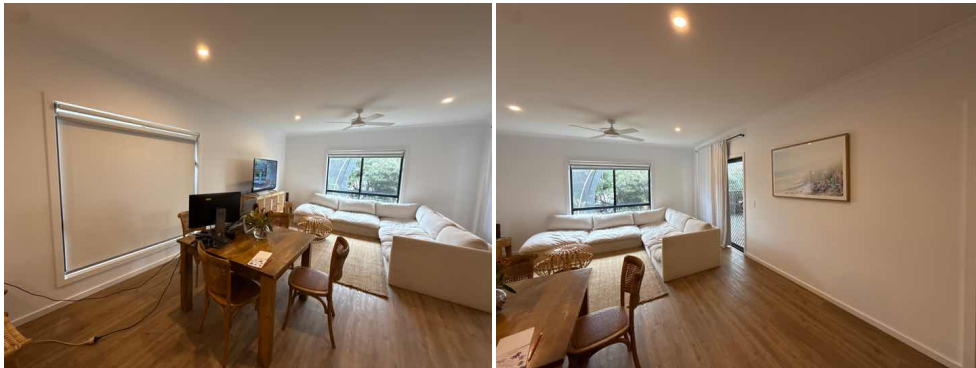
From the visible and accessible areas, this room appears to be in a serviceable condition for the age of the property with no notable structural defects sighted.

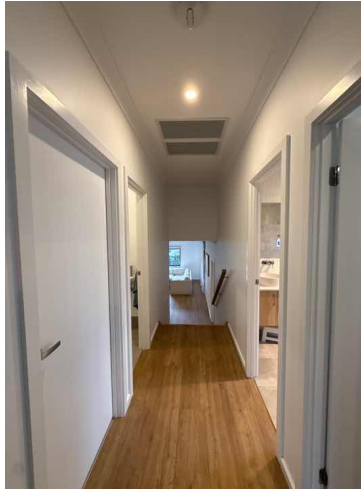
From the visible and accessible areas, the hallway/s/ appears to be in a serviceable condition for the age of the property with no notable structural defects sighted.

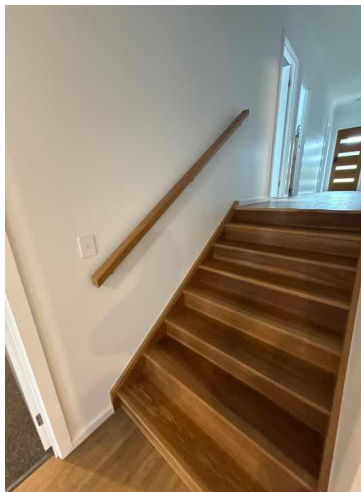
The internal staircase and components appear to be in a serviceable condition for the age with no notable defects sighted.

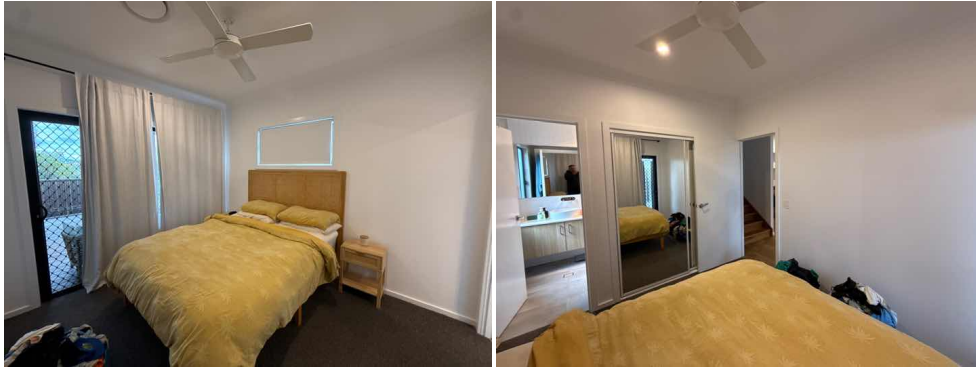
From the visible and accessible areas, this bedroom appears to be in a serviceable condition for the age of the property with no notable structural defects sighted.

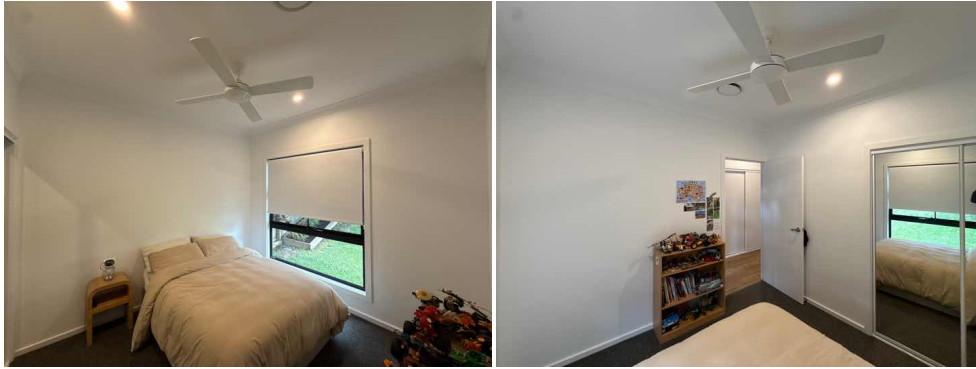
From the visible and accessible areas, this bedroom appears to be in a serviceable condition for the age of the property with no notable structural defects sighted.

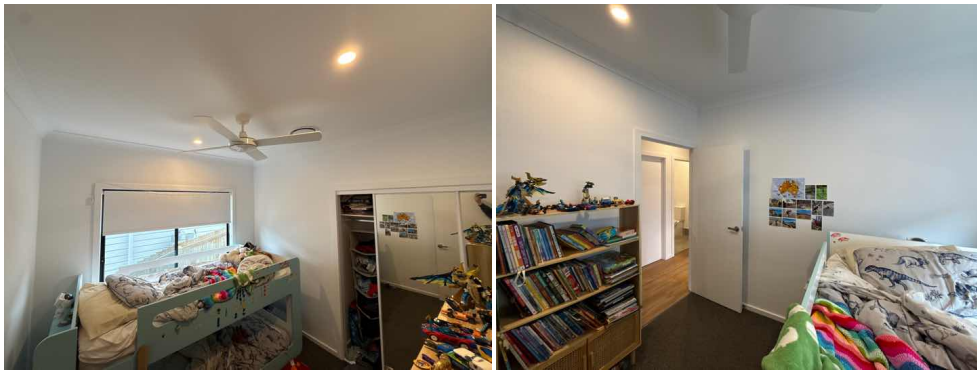
From the visible and accessible areas, this bedroom appears to be in a serviceable condition for the age of the property with no notable structural defects sighted.

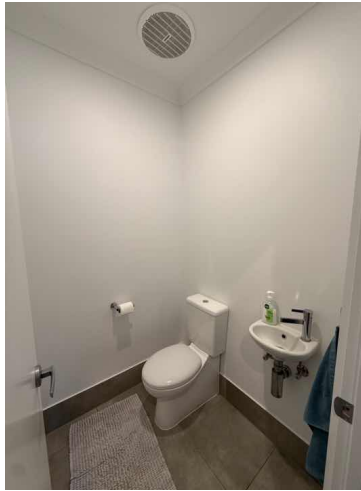
Of the visible areas, the general condition of this bathroom is serviceable or in reasonable condition for age of dwelling.

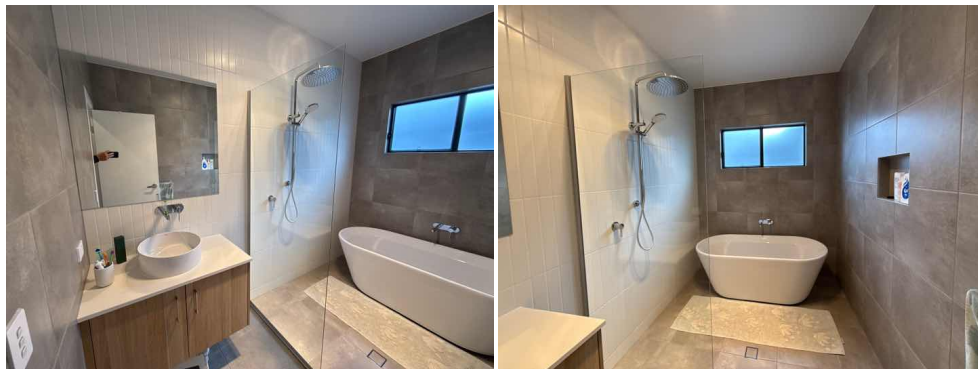
Of the visible areas, the general condition of this bathroom is serviceable or in reasonable condition for age of dwelling.

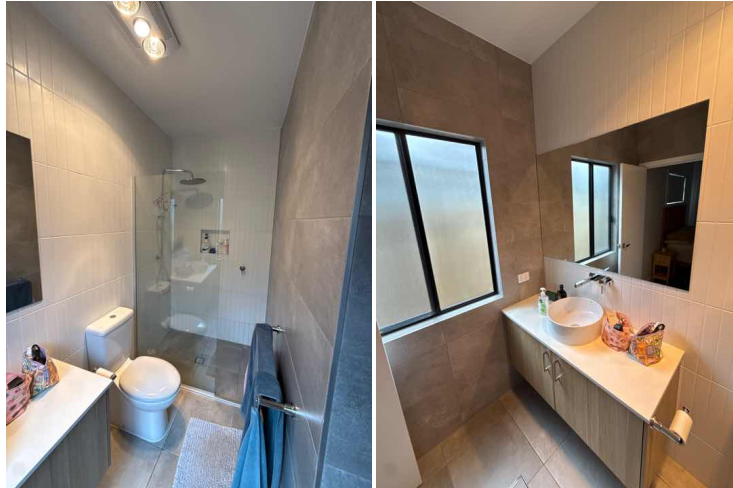
Of the visible areas, the general condition of this bathroom is serviceable or in reasonable condition for age of dwelling.

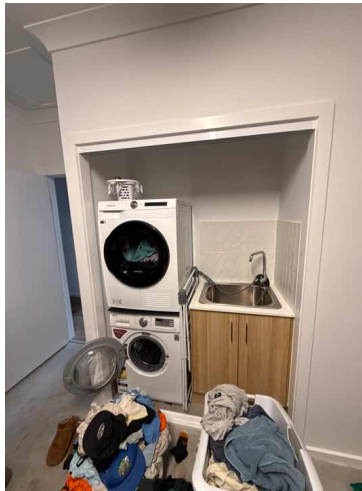
Of the visible areas, the general condition of the laundry is serviceable or in reasonable condition for age of dwelling.

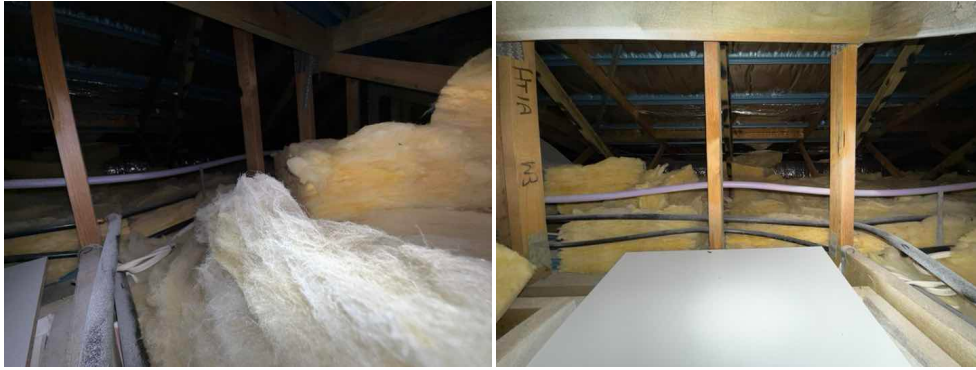
Visible sections of the roof void is in a serviceable condition for age of this dwelling.
