PEST AND BUILDING PRE-PURCHASE REPORTS

46 Sunray Crescent
Lennox Head

BPI - INSPECTION REPORT

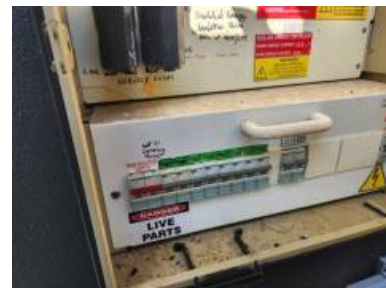
ELECTRICIAL SAFETY SWITCH:

Whilst not an electrician, it appears that an electrical safety switch is present.

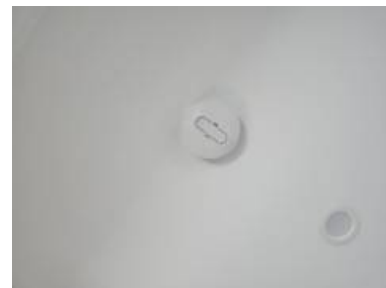
SMOKE DETECTORS / ALARMS:

Present - Hall, Bottom of Stairs, Top of Stairs.

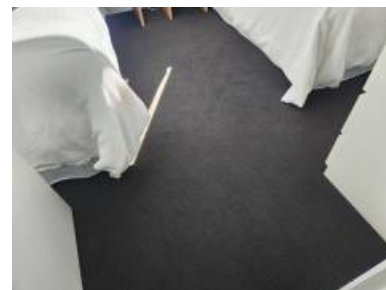
Type and Covering
Carpet & Tiles.

Restrictions
The Timber floors were covered by flooring coverings and no inspection of the timber floor surfaces could be carried out.

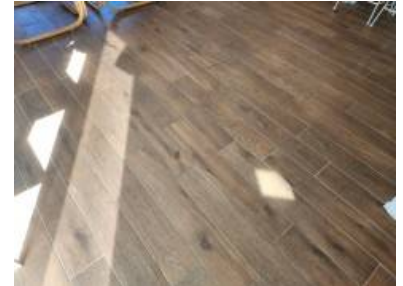
The concrete slabs were covered by flooring coverings and no inspection of the concrete surfaces could be carried out.

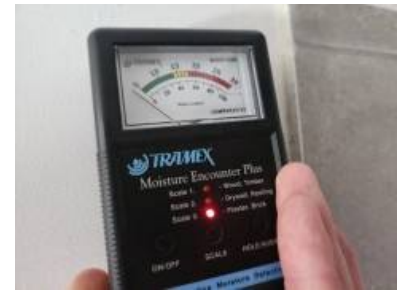
At the time of inspection no moisture was detected to the wall/s to the rear or side of the shower(s).

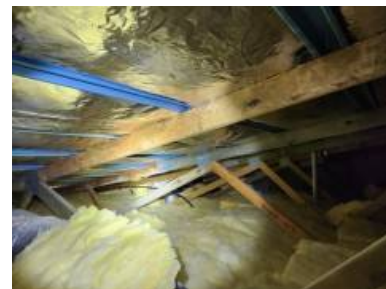
Inspection over the eaves was restricted due to the low pitch and construction allowing only a limited visual inspection from a distance of some areas to be carried out.

Clearance within sections of the roof was too low to allow body access. Outer top wall plates and framing timbers were not inspected due to the area being too low to allow body access. This allows only a limited visual inspection from a distance of some areas to be carried out.

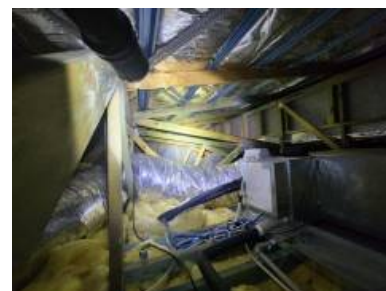
Insulation is present in the roof cavity. This restricted inspection to some roofing & ceiling members and wall top plates. Removal of insulation is not within the scope of a standard building inspection report. Foil Blanket Insulation (fibreglass batts covered in foil) is present in the roof cavity. This restricted inspection to some roofing members. Removal of the Foil Blanket is not within the scope of a standard building inspection. Ducting associated with air-conditioning or heating restricted the inspection. Removal of ducting is not within the scope of a standard building inspection report.

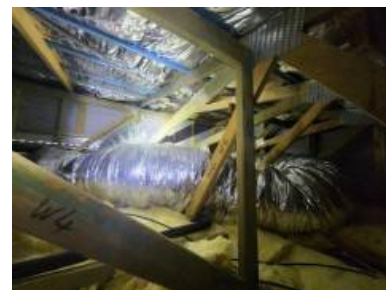
Roof Void & Framing - Condition

The roof framing is in satisfactory / typical condition for the age / construction date.

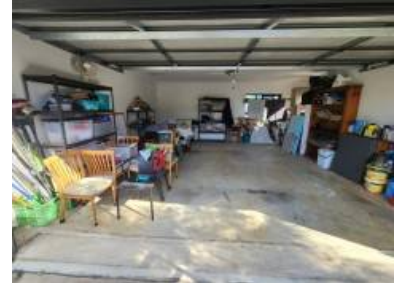
Some wall and floor areas were covered by stored goods and were inaccessible.

Further inspection of these areas is strongly recommended once access has been obtained.

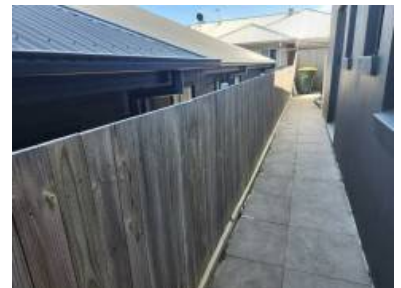
Condition:

Satisfactory.

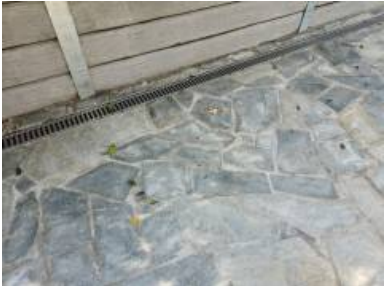
SURFACE WATER DRAINAGE

Whilst not a plumber it appears that at the time of the inspection, drainage seems generally adequate.

No inspection & comment can be made of concealed stormwater pipes and their functionality. I recommend the drainage systems / stormwater be further inspected by a qualified plumber to ensure that they are functional, clear of blockages / damage / cracks and are adequate for the situation.

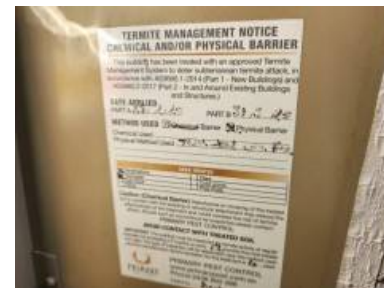
Physical barriers or visual inspection zones have been used as part of the termite treatment / protection.

A termite barrier / treatment notice in the Meter Box / Kitchen Cupboard indicates that the slab penetrations and perimeters are protected from termite activity by physical barriers. We strongly recommend you obtain all barrier paperwork & warranty information. These barriers were installed in 2020.
