Building and Pest Report

20A Killarney Cres Lennox Head

Pest And Building Inspection

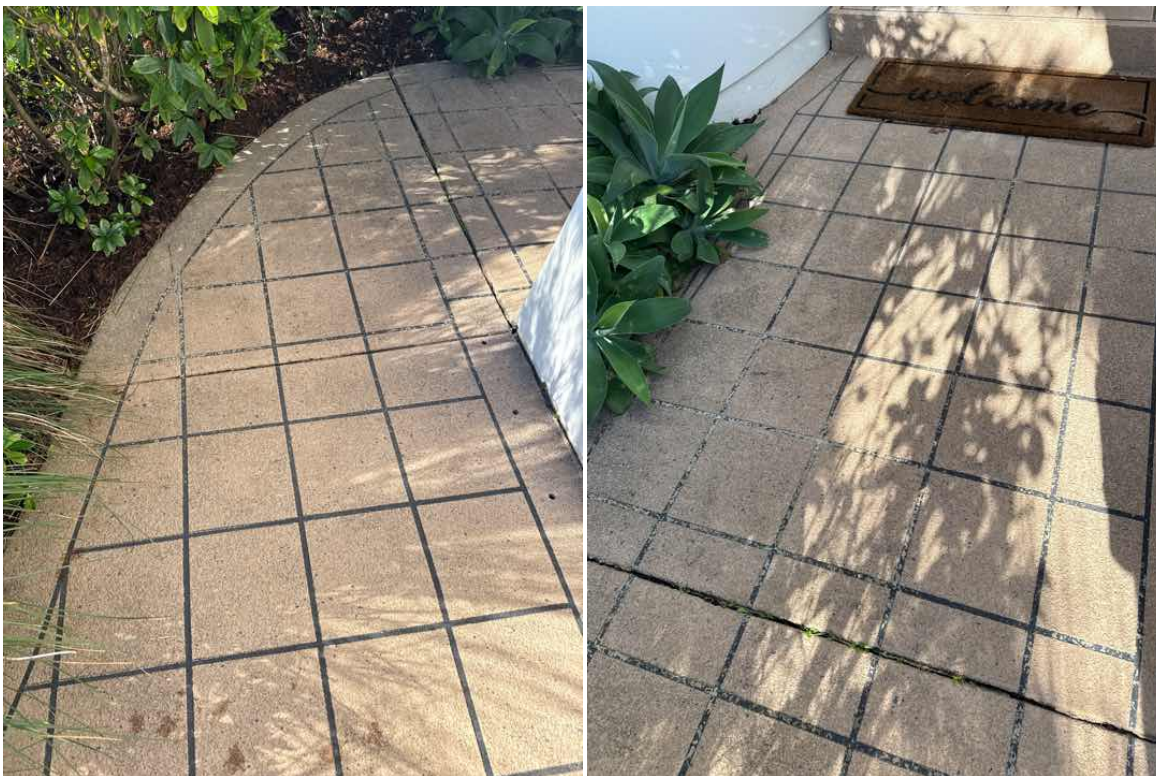
Pathways Condition

The paths around the home are in a serviceable condition for the age of this dwelling with no major defects visible.

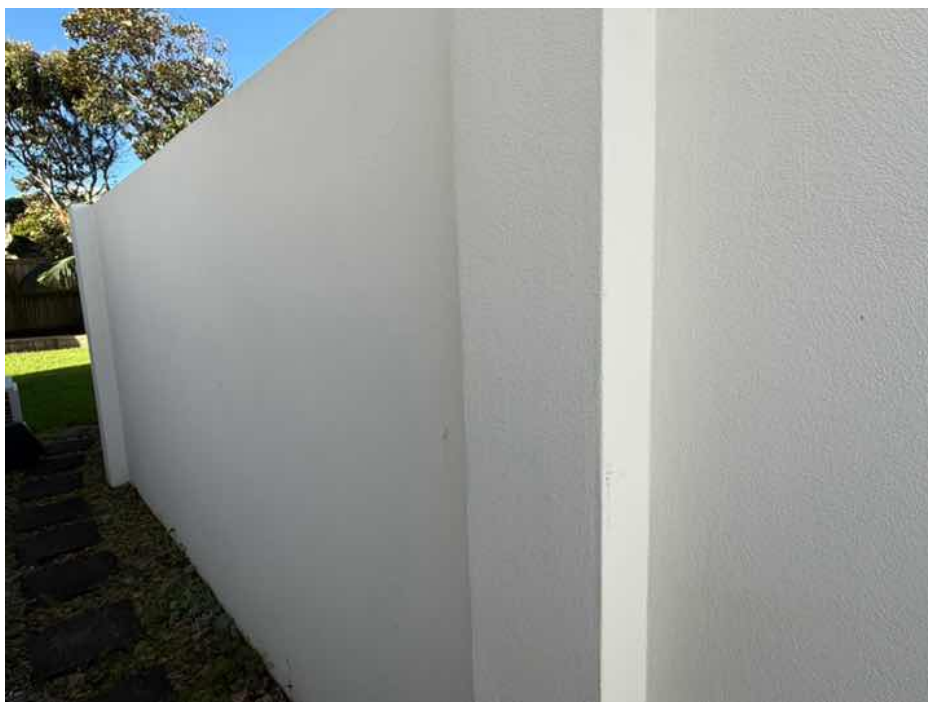
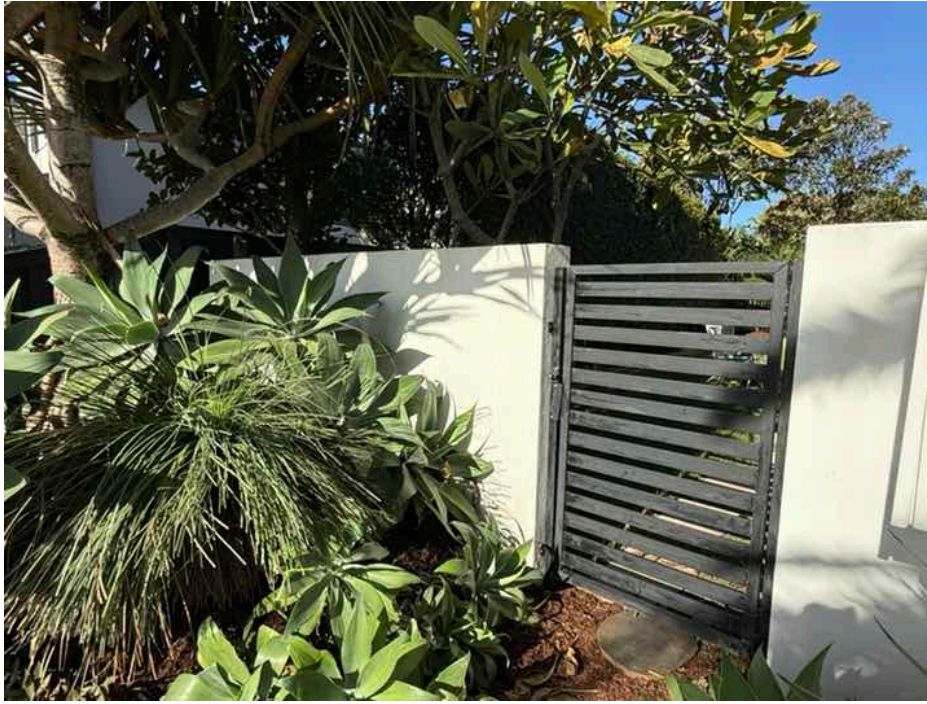
Fences & Gates

Of the visible areas, the general condition of the fences and gates is serviceable for the age of dwelling.

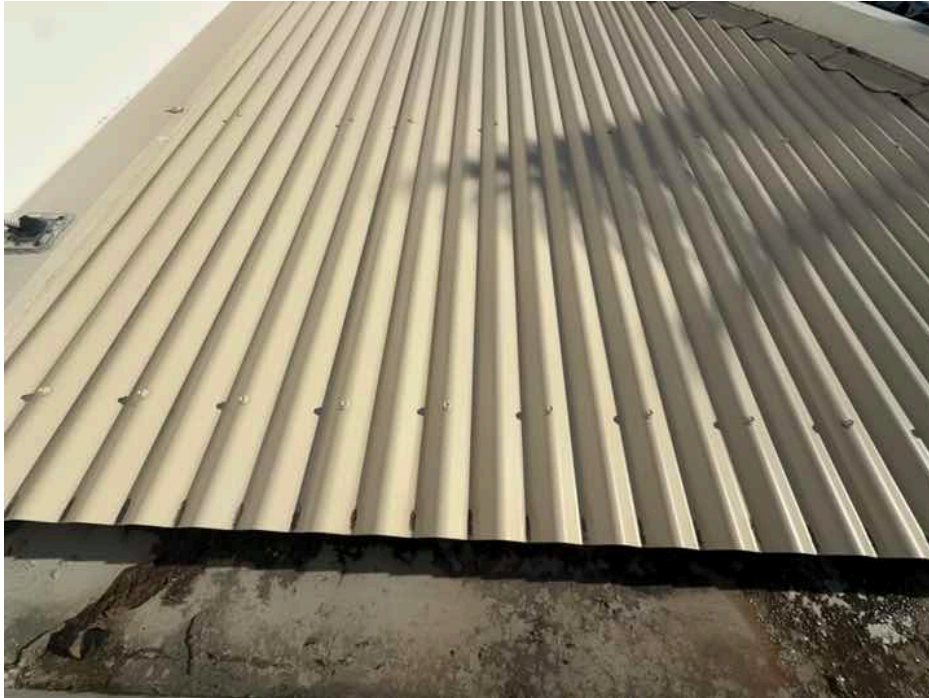
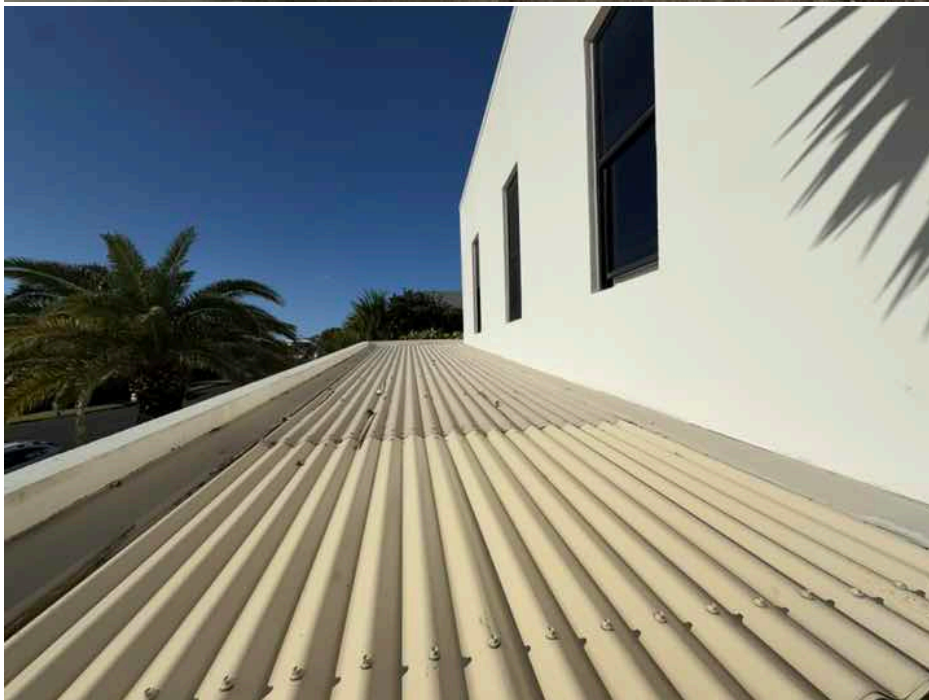
Of the visible areas, the general condition of the roof is in serviceable condition for the age.
Note: In the absence of rainfall there is no guarantee that the roof won't leak.

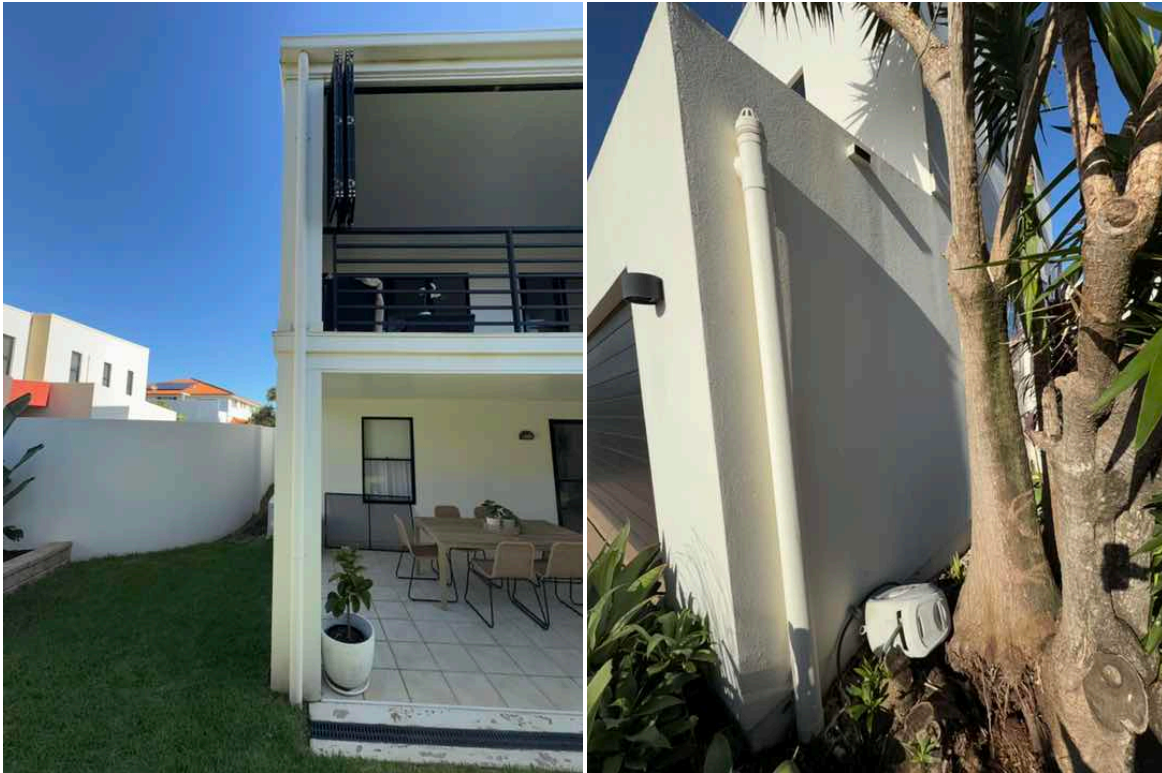
Downpipe Findings

On visual inspection no apparent defects were noted to the down pipes and are considered serviceable, however no comment can be made with regard to blockages or connections to stormwater or functionality in the absence of rain. Note: Periodic maintenance checks should be carried out for rust penetrations and leaks.

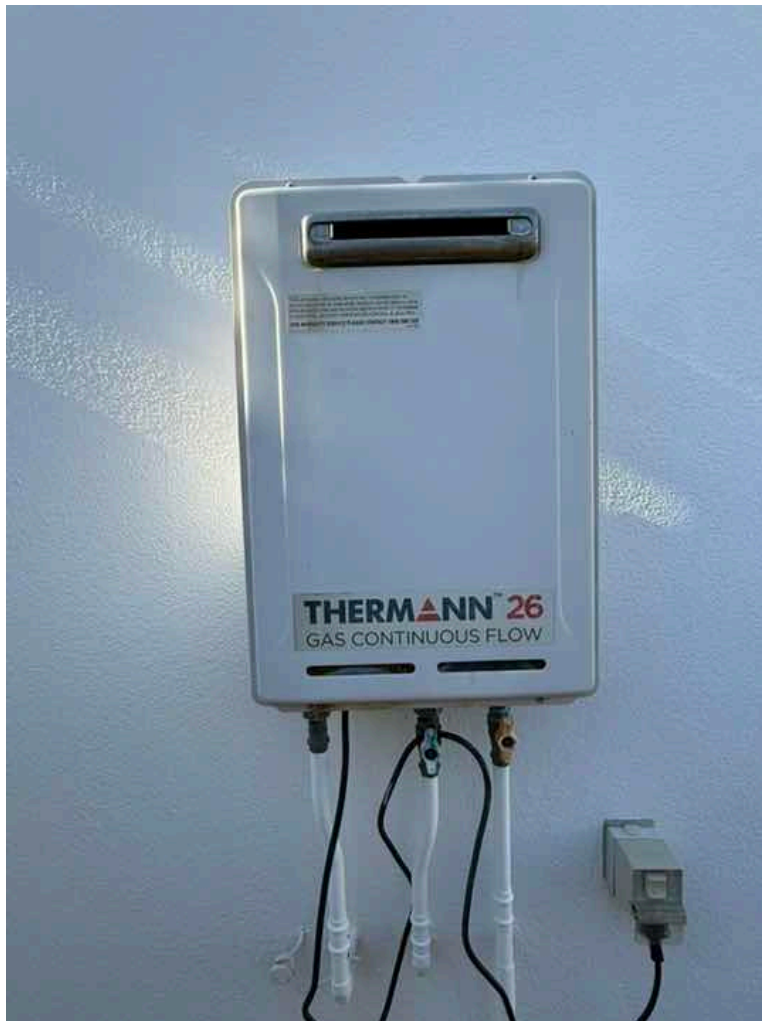
System Make

Thermann

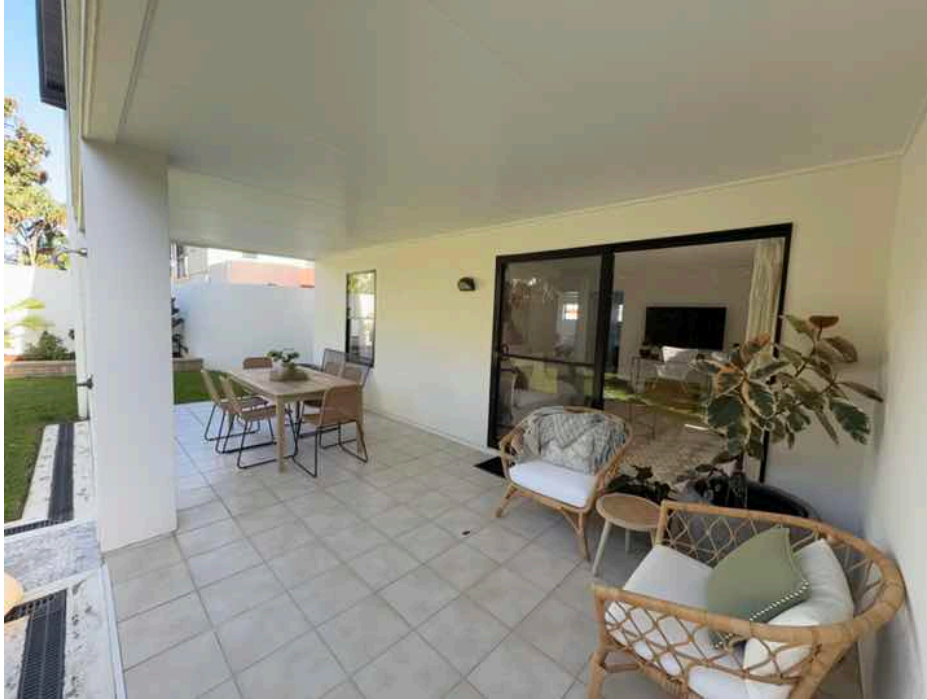
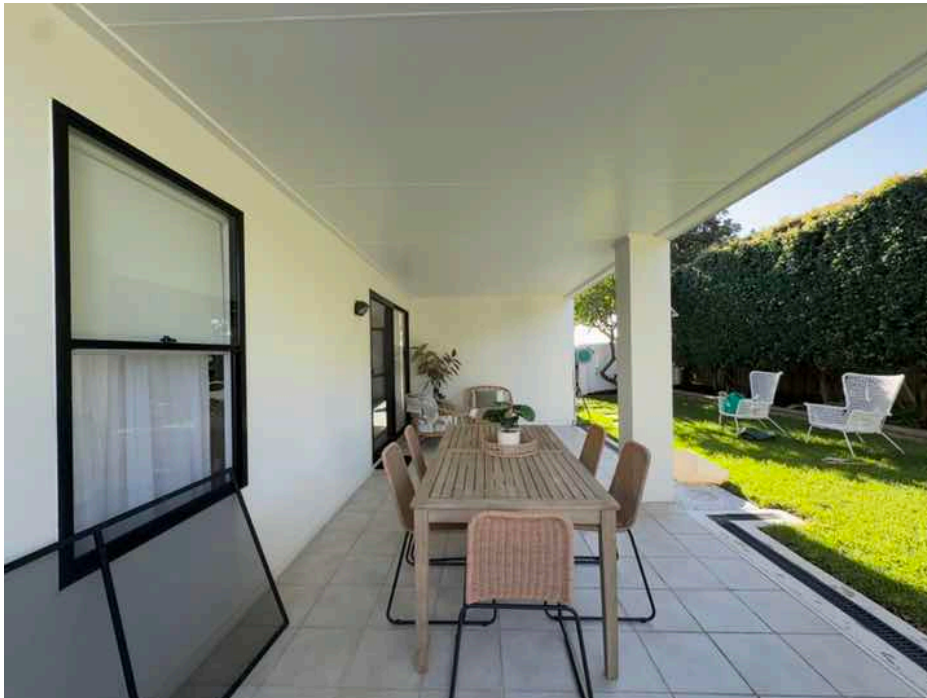
Visible sections of the Alfresco area are serviceable or in reasonable or condition for the age of this dwelling.

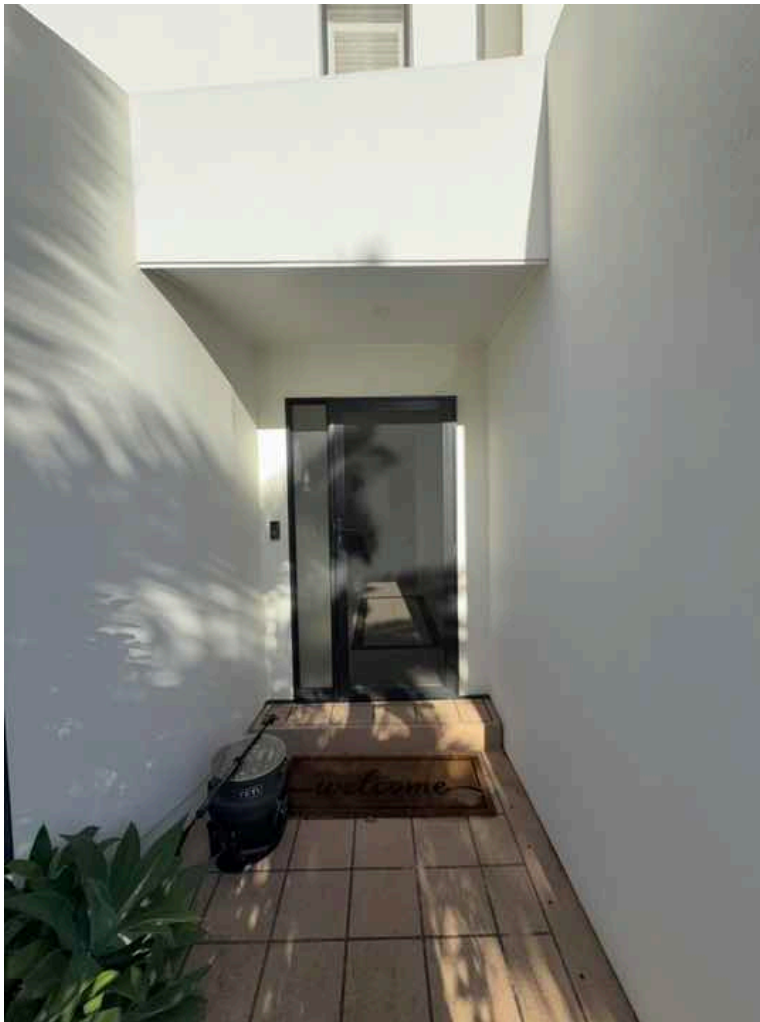
Entry Porch Area

The entry porch serviceable or in reasonable or condition for the age of this dwelling.

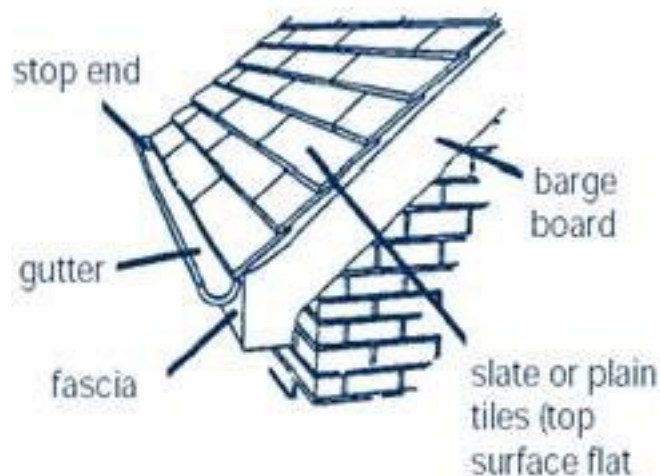
On visual inspection, the general condition of the fascia/barge boards is serviceable.

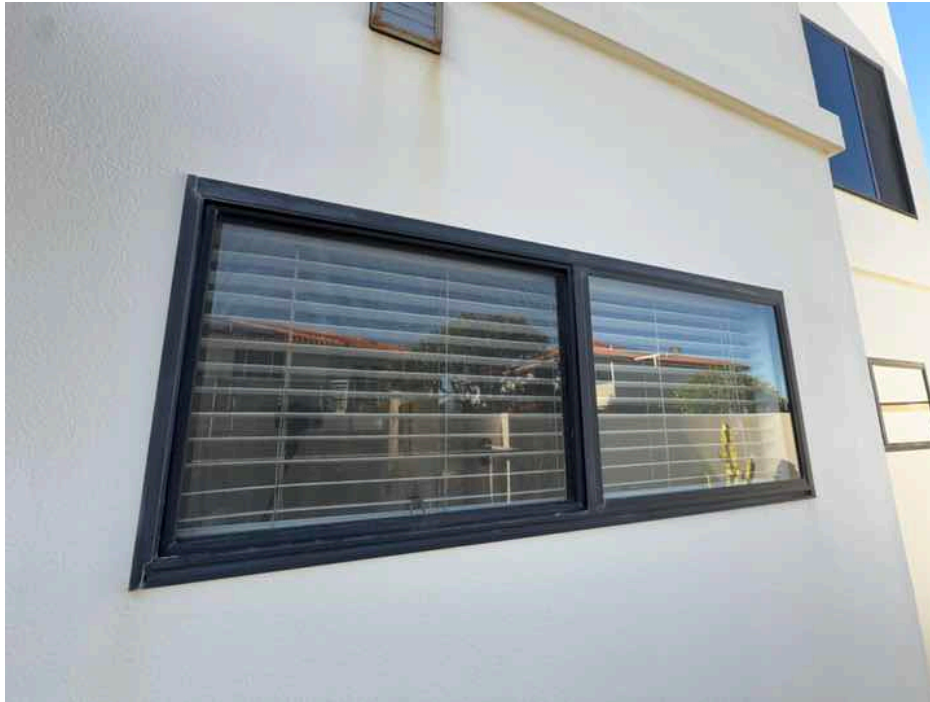
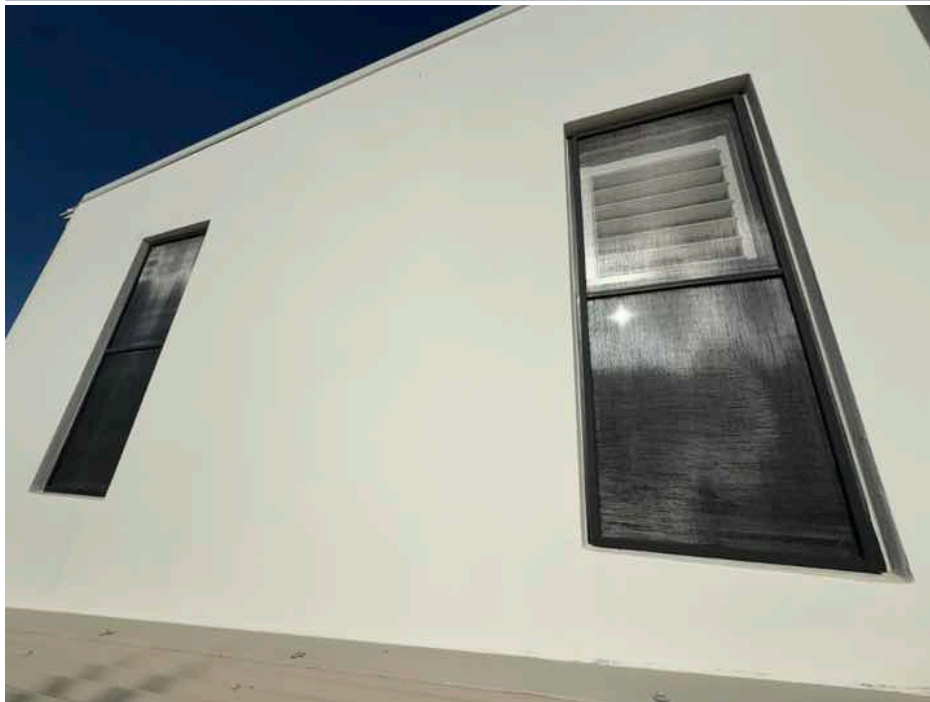
On visual inspection, the general condition of the windows is serviceable for the age.

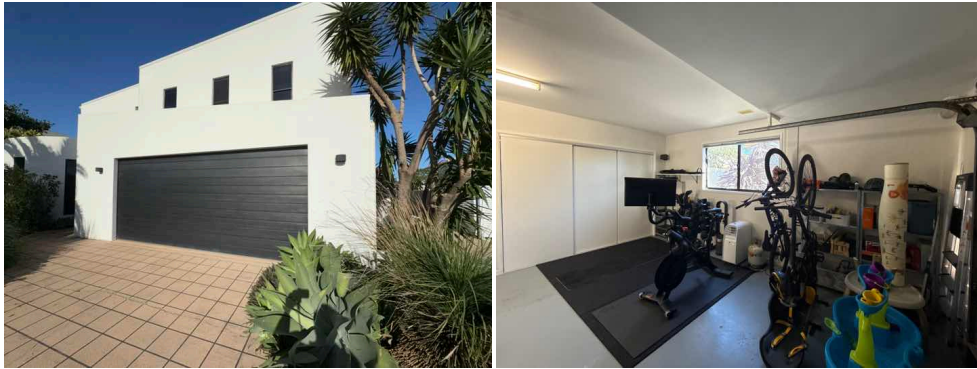
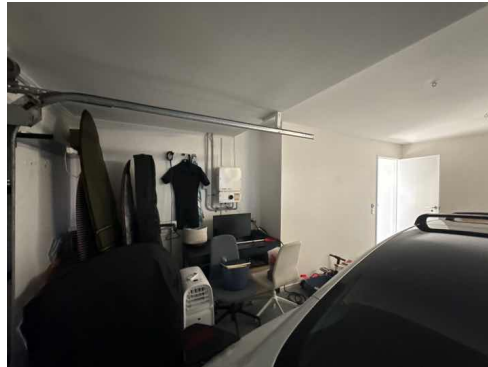
From the visible and accessible areas, the garage appears to be in a serviceable condition for the age of the property with no notable structural defects sighted.

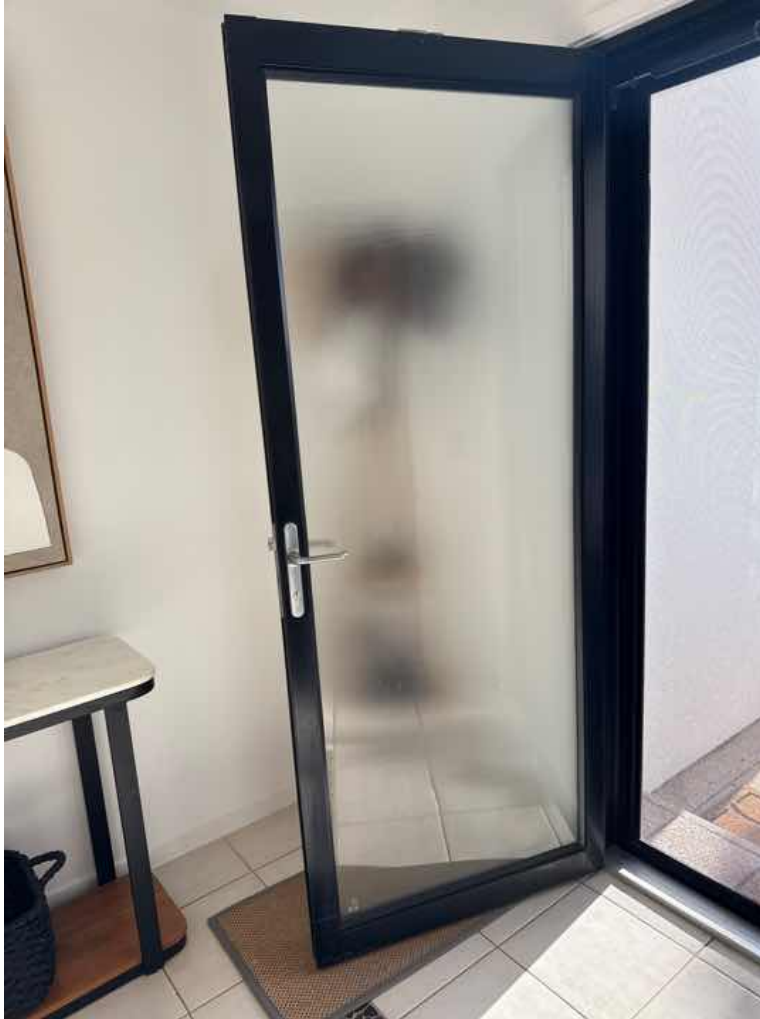
Front Entry Doors

The doors are in serviceable condition with no notable defects observed.

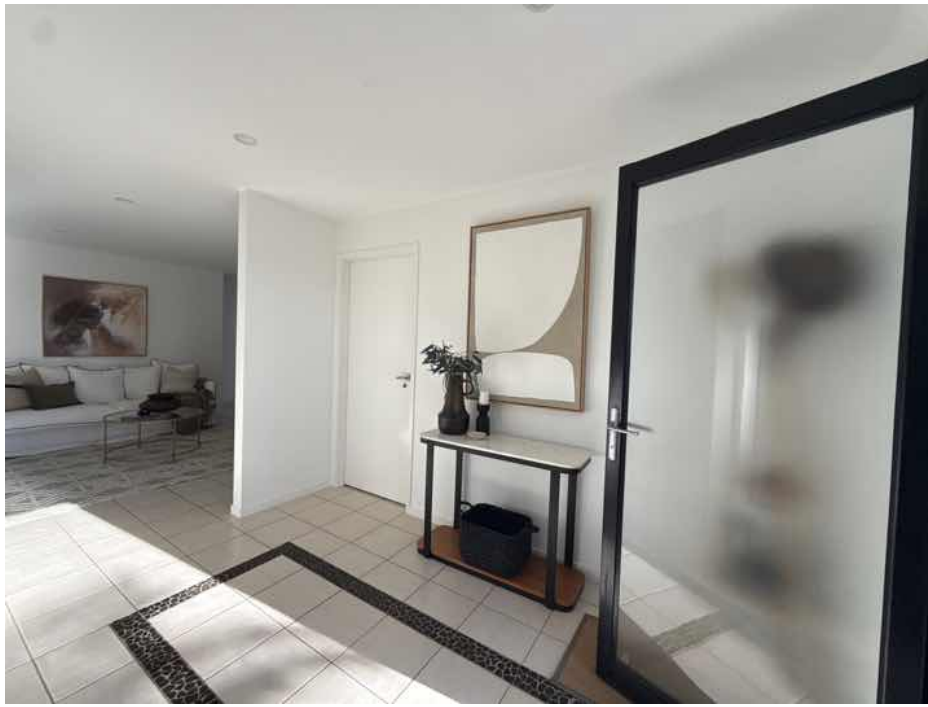
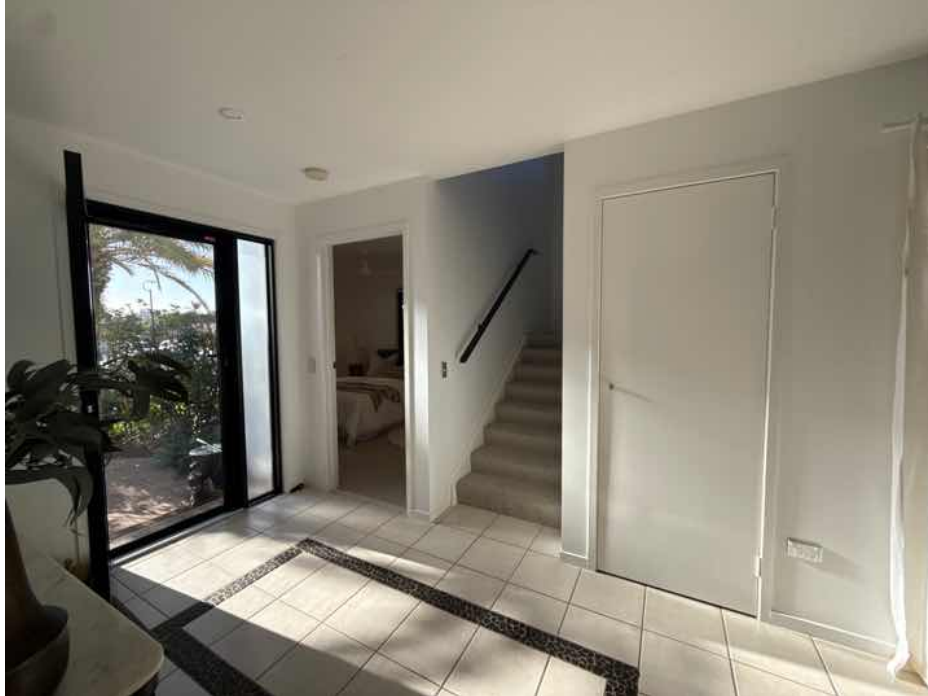
From the visible and accessible areas, this area appears to be in a serviceable condition for the age of the property with no notable structural defects sighted.

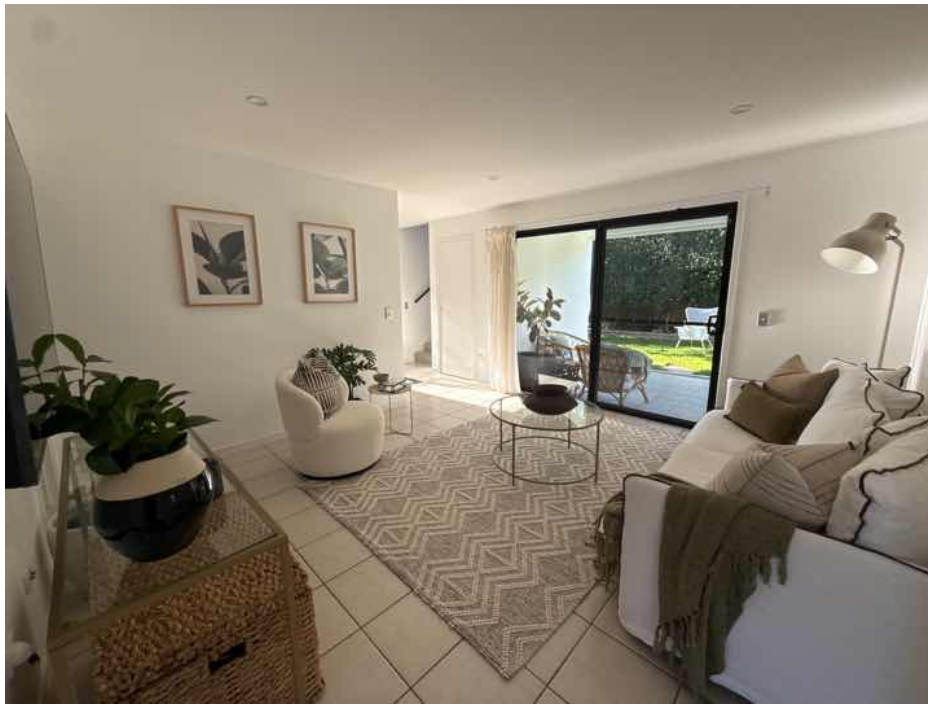
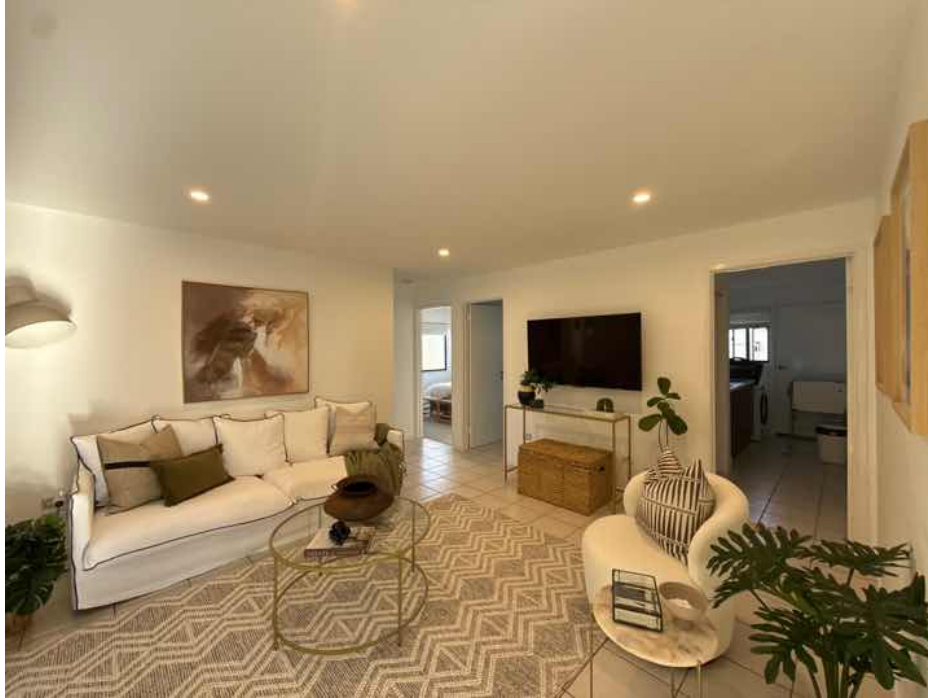
Living Room

From the visible and accessible areas, this room appears to be in a serviceable condition for the age of the property with no notable structural defects sighted.

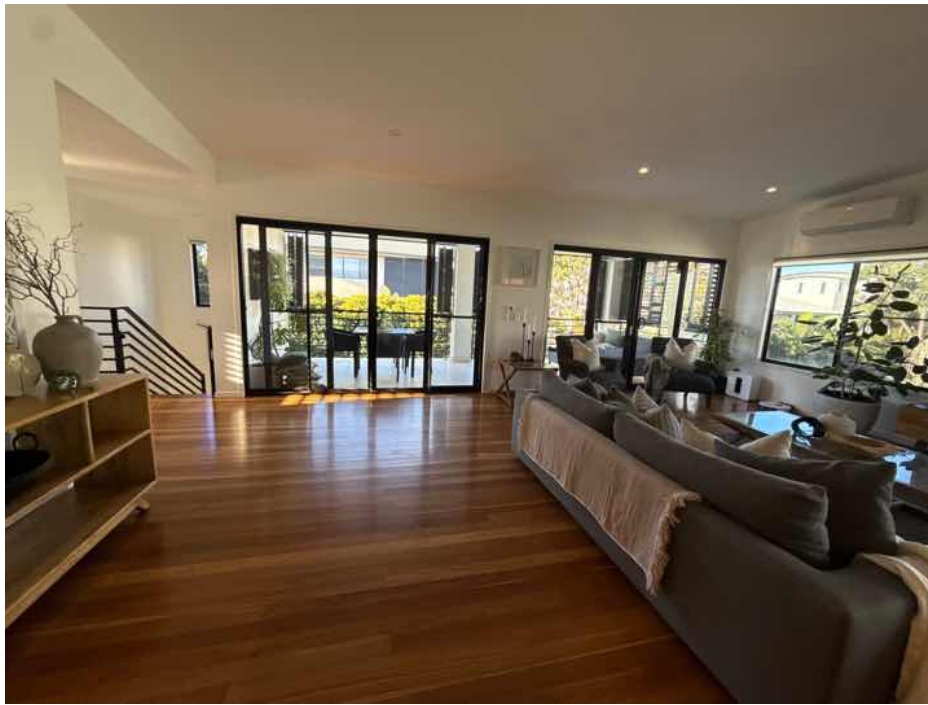
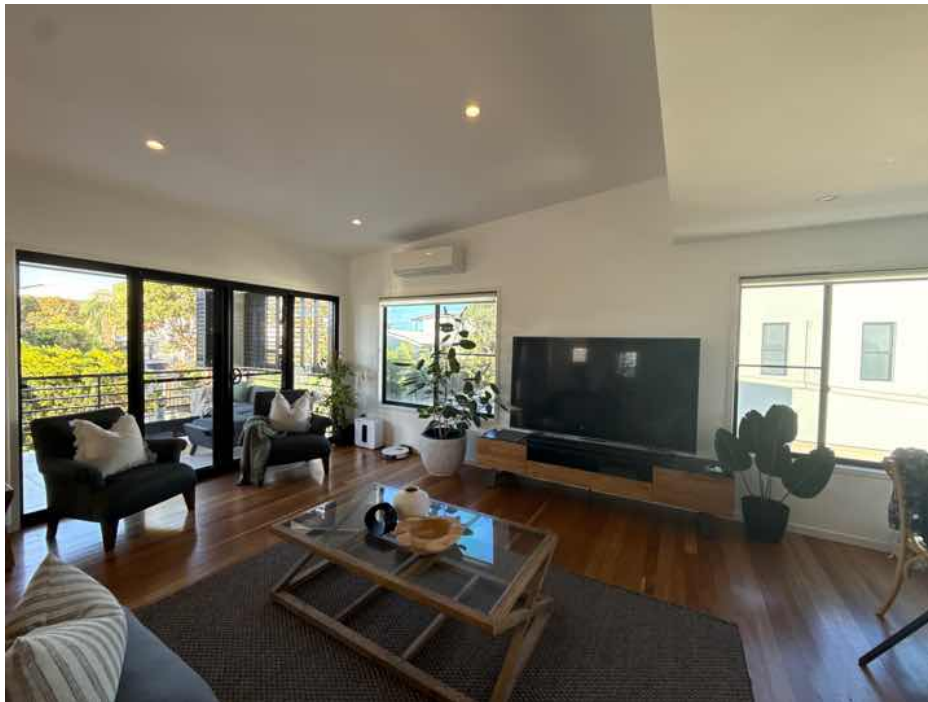
Combined Living & Dining

From the visible and accessible areas, this room appears to be in a serviceable condition for the age of the property with no notable structural defects sighted.

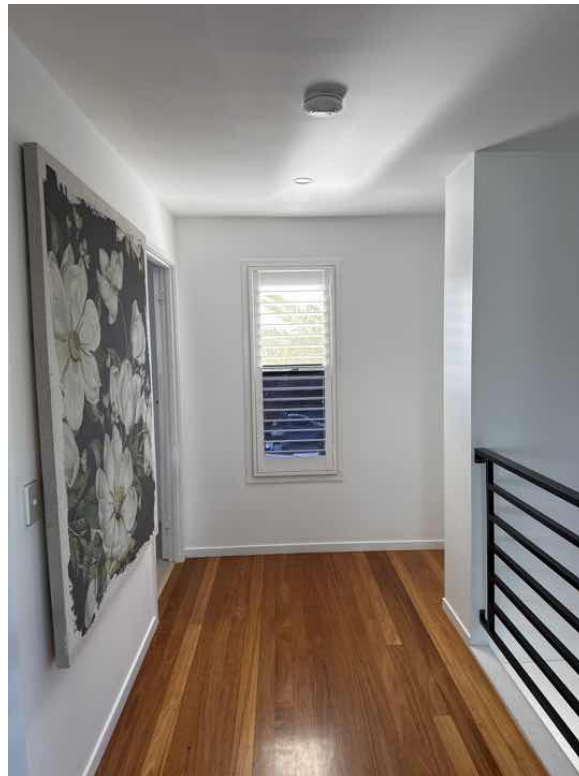
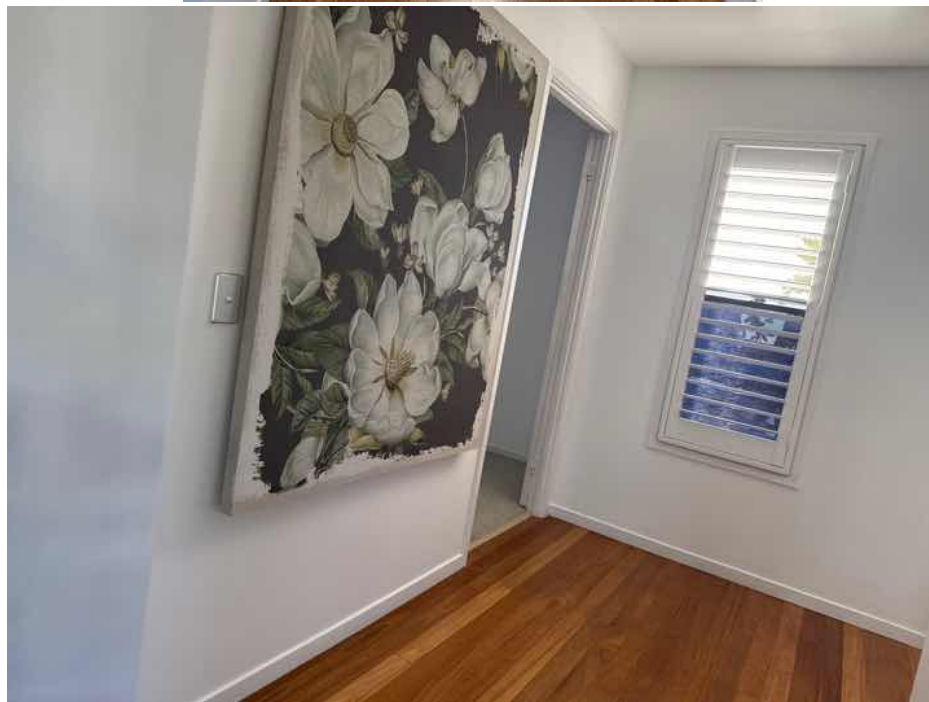
Hallway/s

From the visible and accessible areas, the hallway/s/ appears to be in a serviceable condition for the age of the property with no notable structural defects sighted.

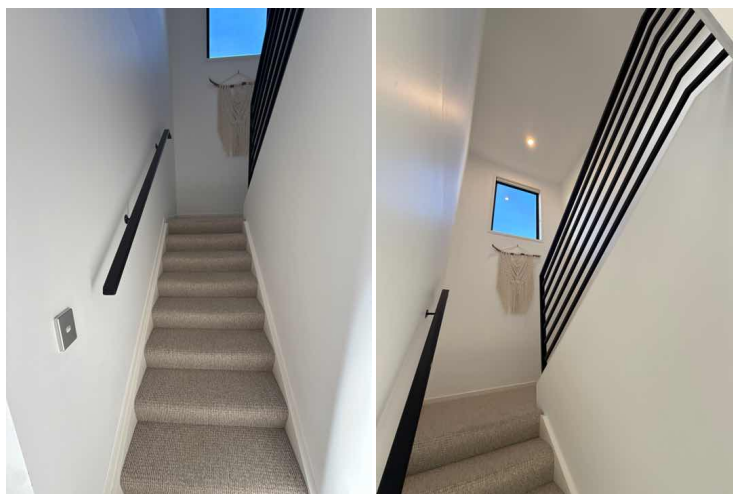
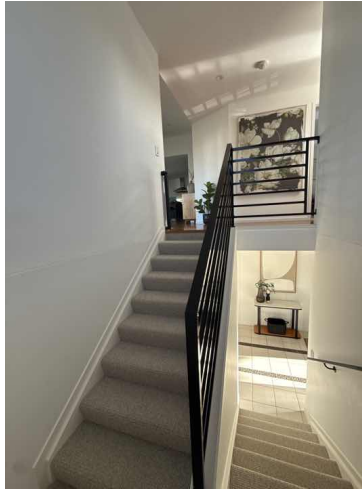
The internal staircase and components appear to be in a serviceable condition for the age with no notable defects sighted.

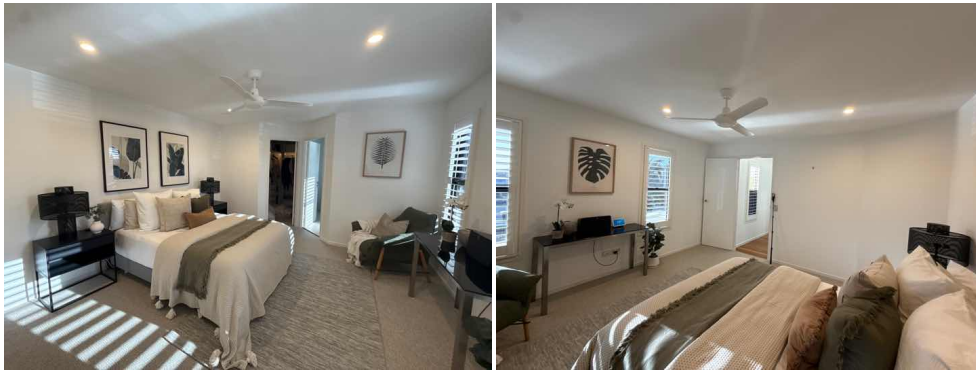
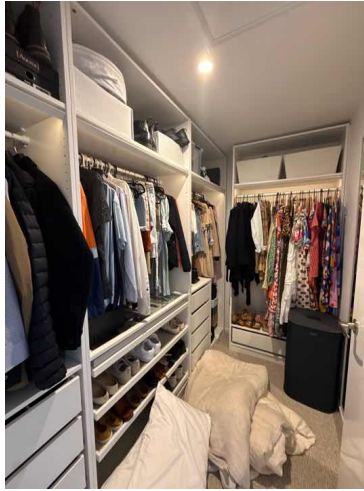
From the visible and accessible areas, this bedroom appears to be in a serviceable condition for the age of the property with no notable structural defects sighted.

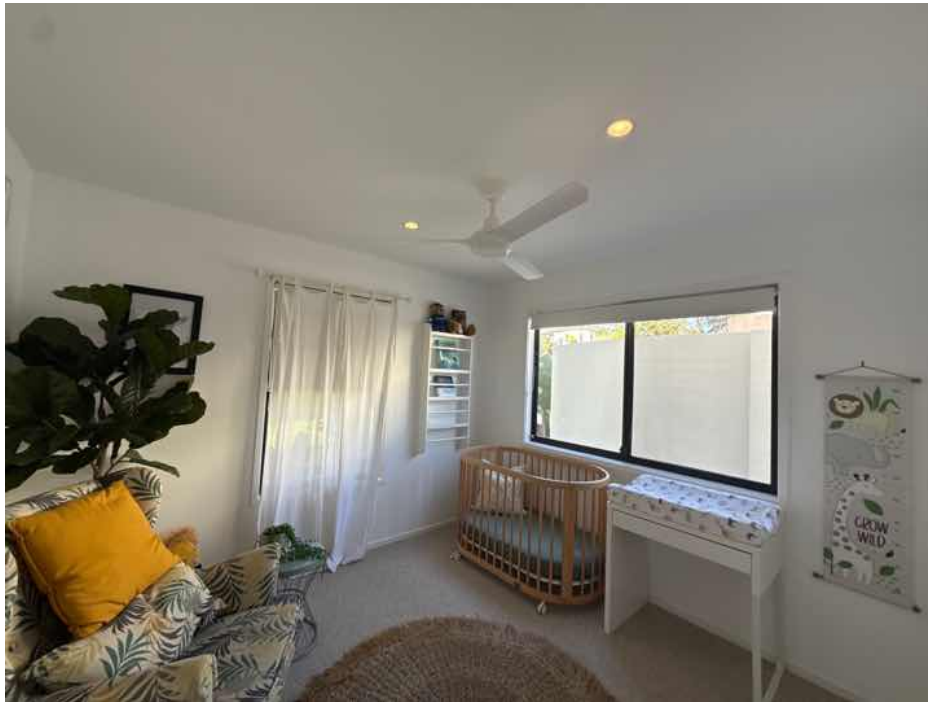
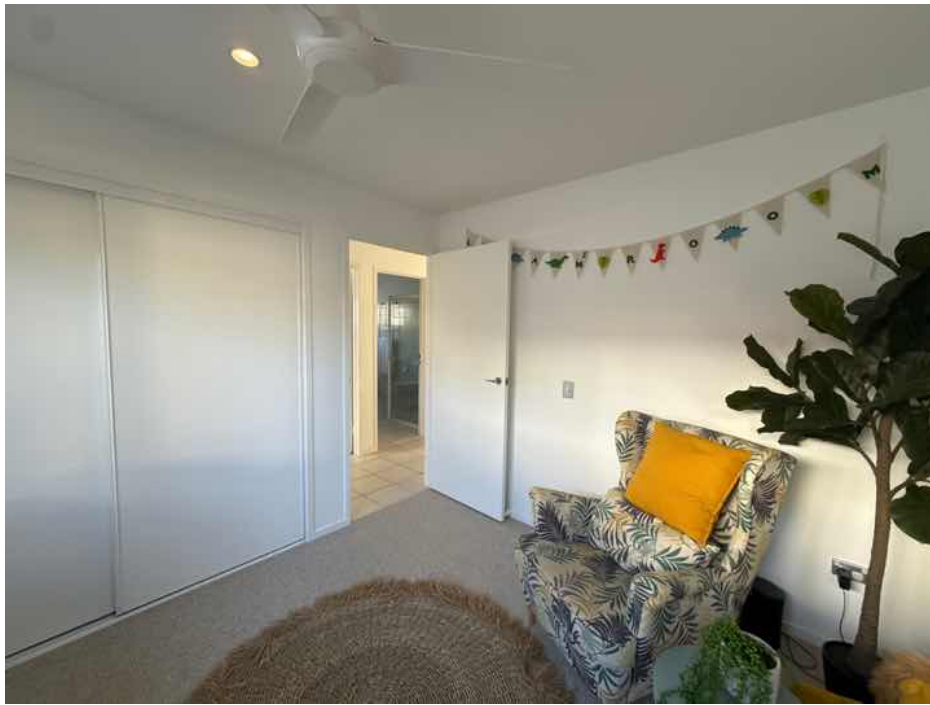
Bedroom 2

From the visible and accessible areas, this bedroom appears to be in a serviceable condition for the age of the property with no notable structural defects sighted.

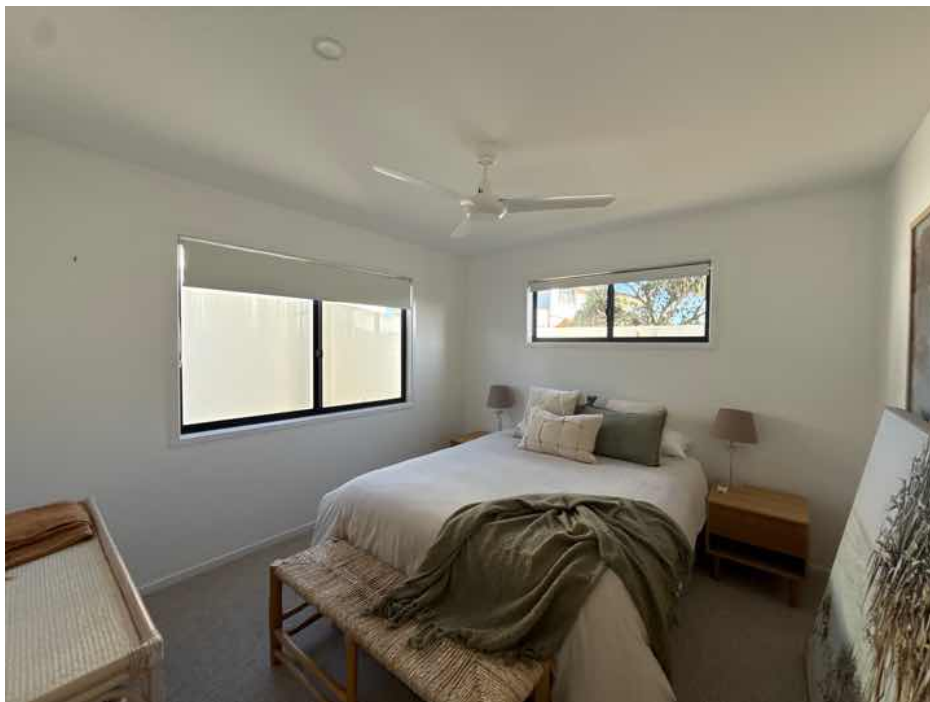
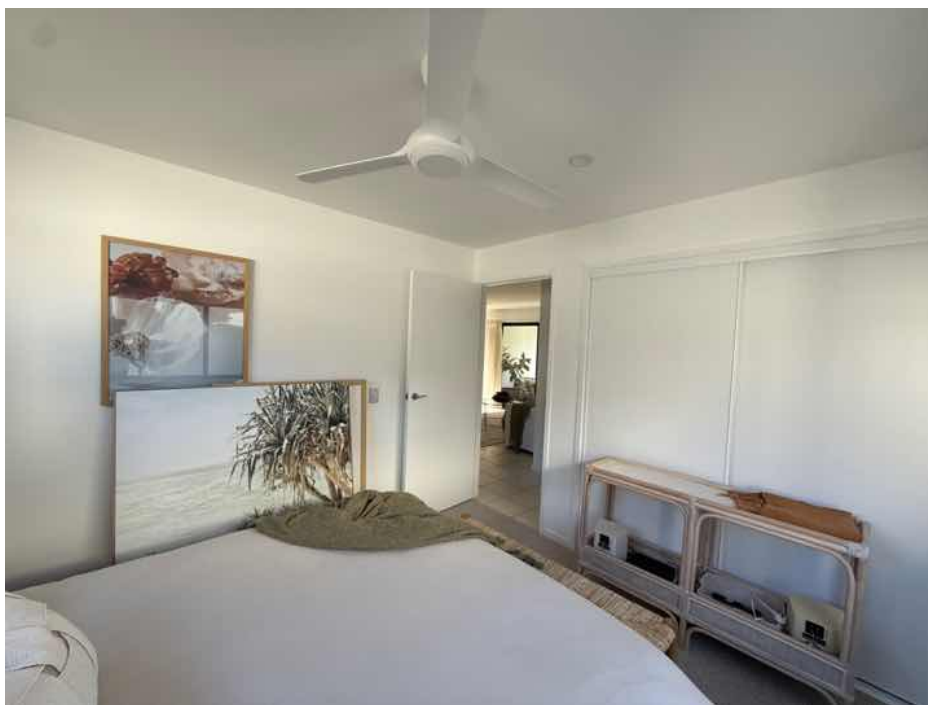
Bedroom 3

From the visible and accessible areas, this bedroom appears to be in a serviceable condition for the age of the property with no notable structural defects sighted.

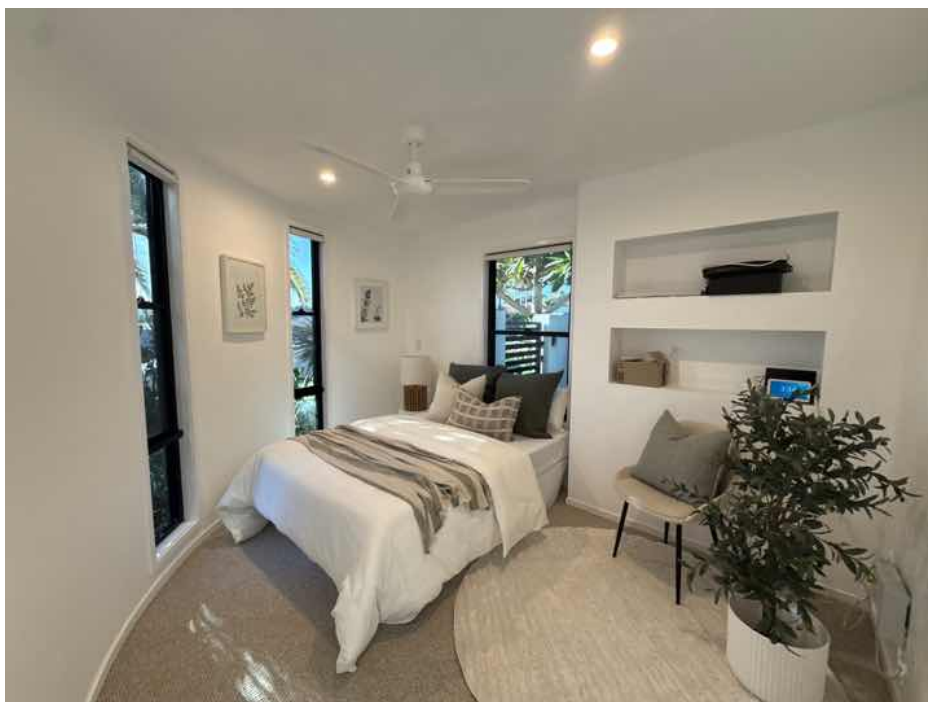
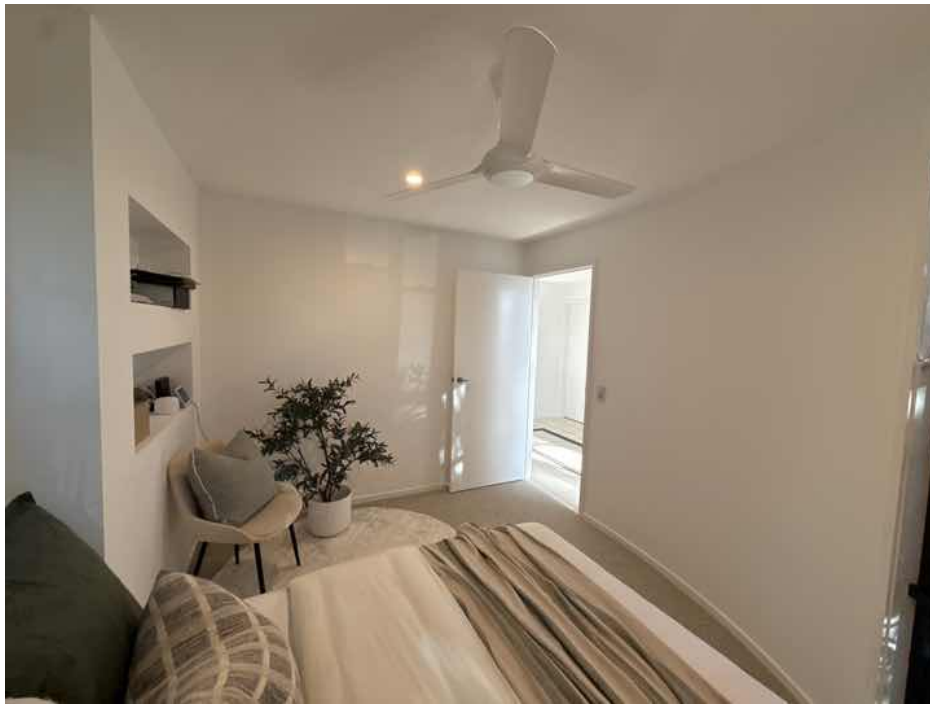
Bedroom 4

From the visible and accessible areas, this bedroom appears to be in a serviceable condition for the age of the property with no notable structural defects sighted.

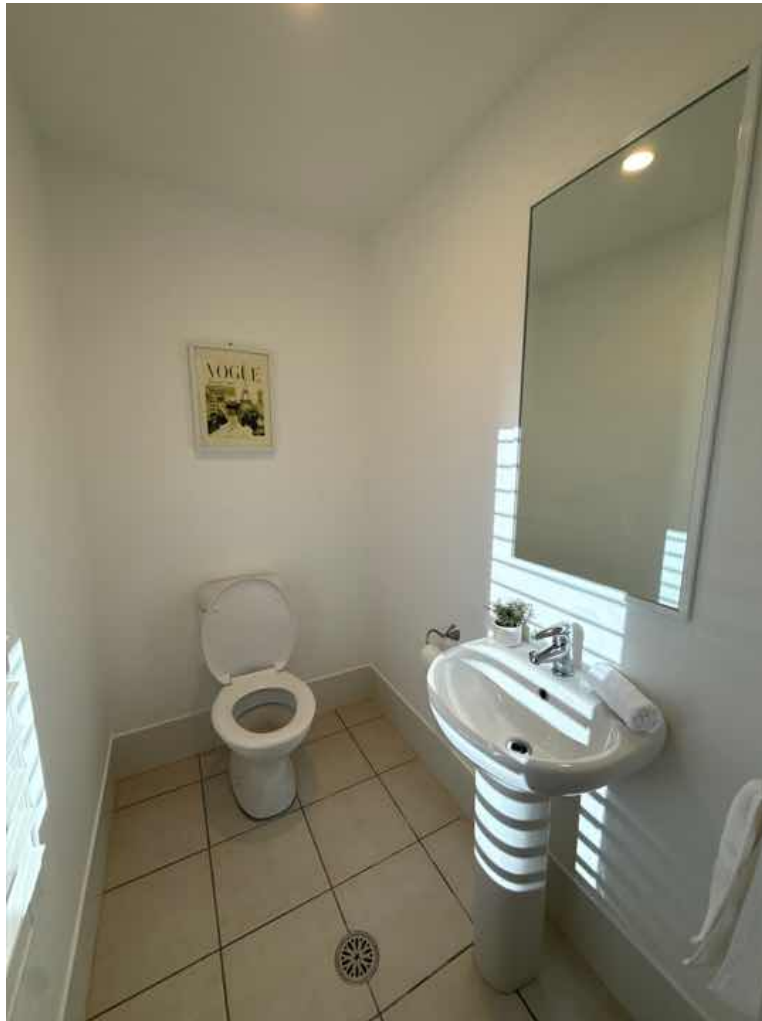
Of the visible areas, the general condition of this bathroom is serviceable or in reasonable condition for age of dwelling.

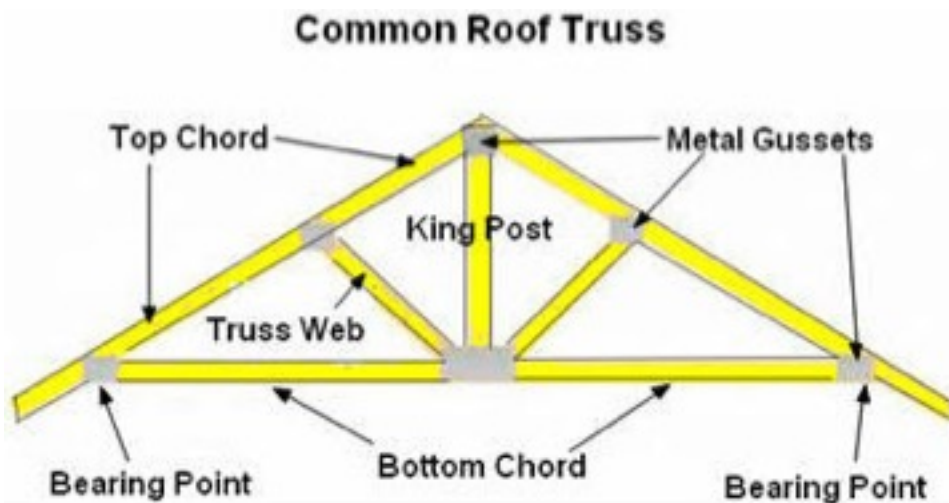
Roof Frame Type

The roof frame is a truss timber frame.
