Building and Pest Report

20A Killarney Cres Lennox Head

Pest And Building Inspection

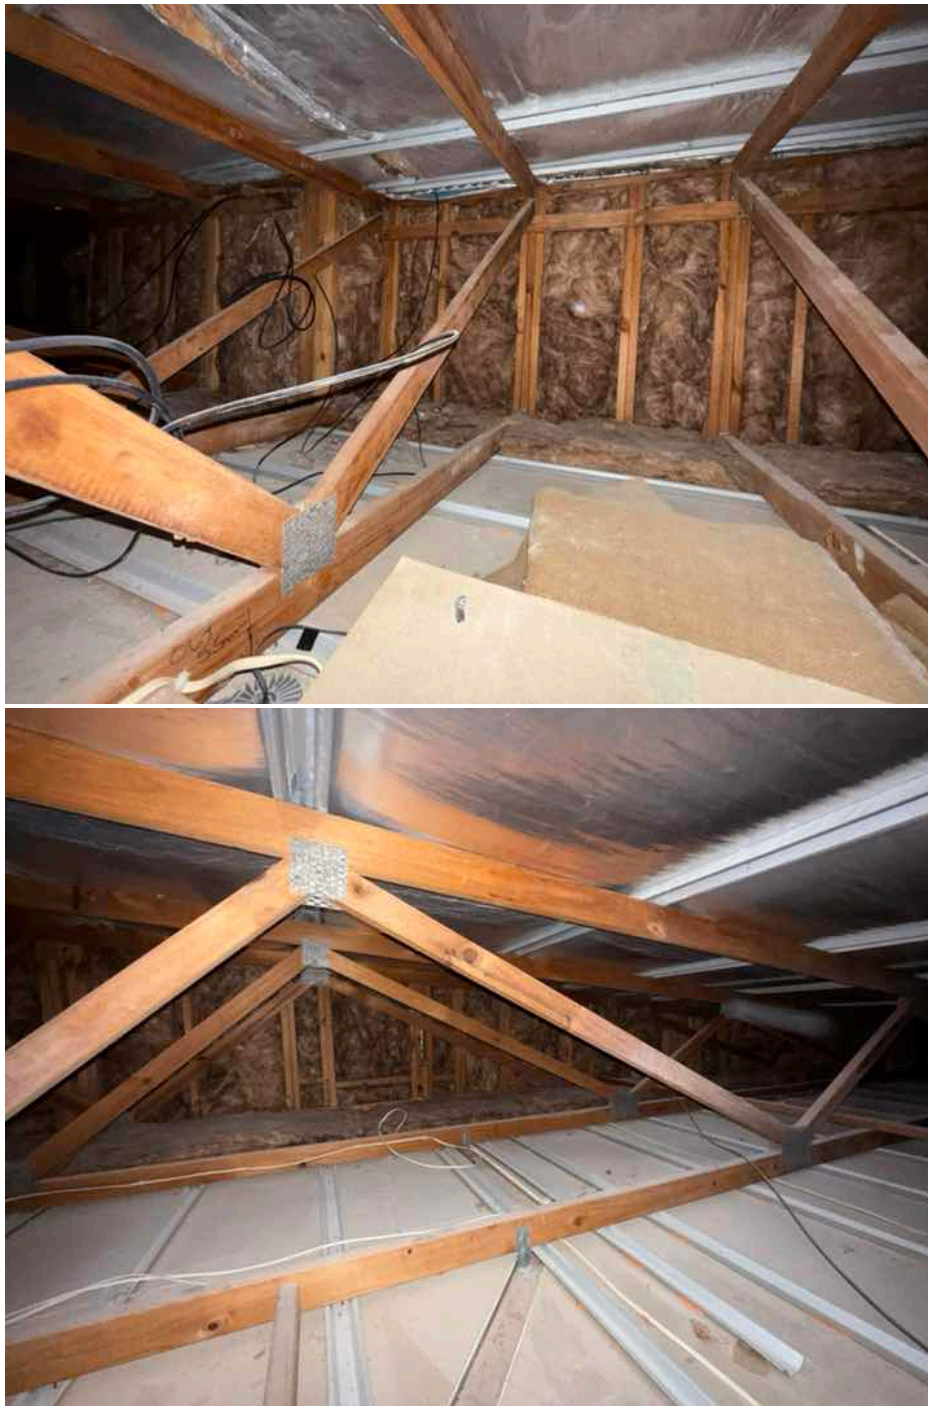
Visible sections of the roof void is in a serviceable condition for age of this dwelling.
