# PEST AND BUILDING PRE-PURCHASE REPORTS

# BPI BUILDING & PEST INSPECTIONS

137 Stewart Street  
Clunes

# BPI - INSPECTION REPORT

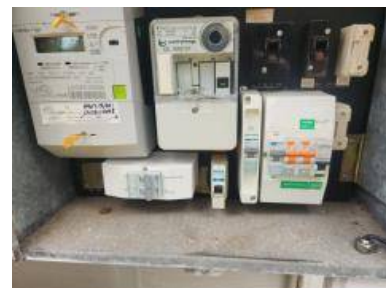
Whilst not an electrician, it appears that an electrical safety switch is present.

The checking of any electrical items is outside the scope of a standard building inspection report & our expertise. We recommend all electrical components, wiring, meter box, smoke detectors and appliances be inspected / tested by a qualified & insured electrician.

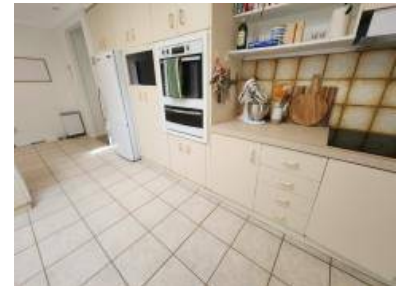
Some edge stripping laminate is damaged / peeling.

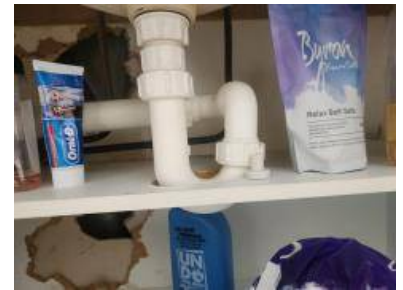
Junctions of Bathroom vanity and wall tiles require resealing with silicone.

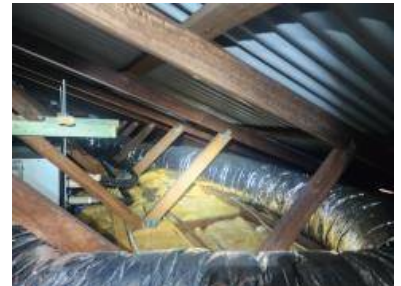
Inspection over the eaves was restricted due to the low pitch and construction allowing only a limited visual inspection from a distance of some areas to be carried out.

Clearance within sections of the roof was too low to allow body access. Outer top wall plates and framing timbers were not inspected due to the area being too low to allow body access. This allows only a limited visual inspection from a distance of some areas to be carried out.

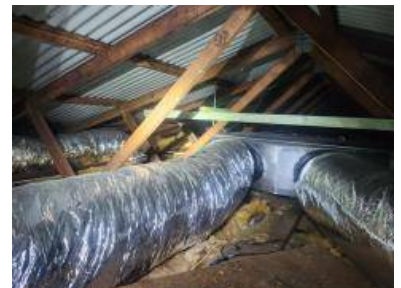
Insulation is present in the roof cavity. This restricted inspection to some roofing & ceiling members and wall top plates. Removal of insulation is not within the scope of a standard building inspection report. Ducting associated with air-conditioning or heating restricted the inspection. Removal of ducting is not within the scope of a standard building inspection report.

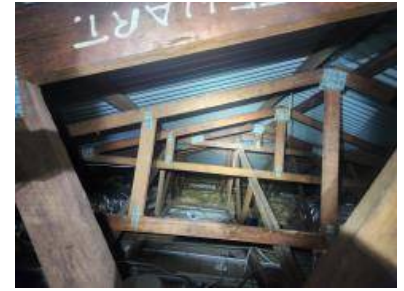
Older roof frames do not comply with current wind ratings. The roof framing is in satisfactory / typical condition for the age / construction date.

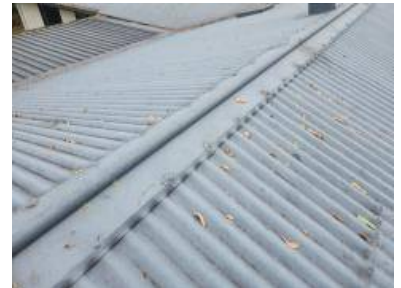
The roof exterior has been painted. No comment can be made on the condition of the concealed roof surfaces beneath the paint.

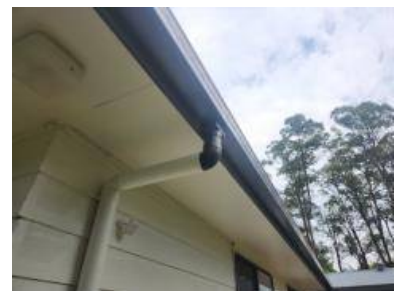
**Restrictions:**  
No inspection can be made of the concealed stormwater pipes. I recommend the gutters, downpipes & stormwater be further inspected by a qualified plumber to ensure that they are functional, clear of blockages / damage / cracks and are adequate for the situation.

**Condition:**  
Satisfactory.
