# PEST AND BUILDING PRE-PURCHASE REPORTS

# Inspection Report

**16 Survey St, Lennox Head, NSW, 2478**

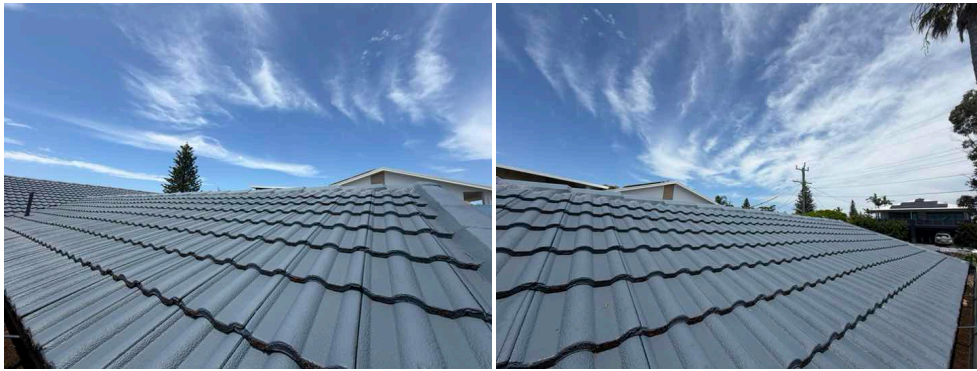
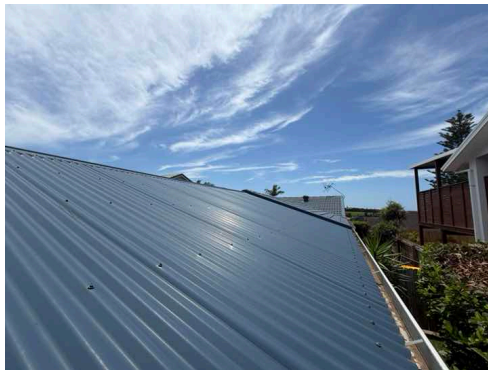
Of the visible areas, the general condition of the roof is in serviceable condition for the age.

Visible section of The roof cladding appeared in a serviceable condition for the age of this dwelling. Annual maintenance inspection recommended.

Corrosion noted to the screw fixings of the metal roof. Have these checked and replaced by qualified roofing contractor.

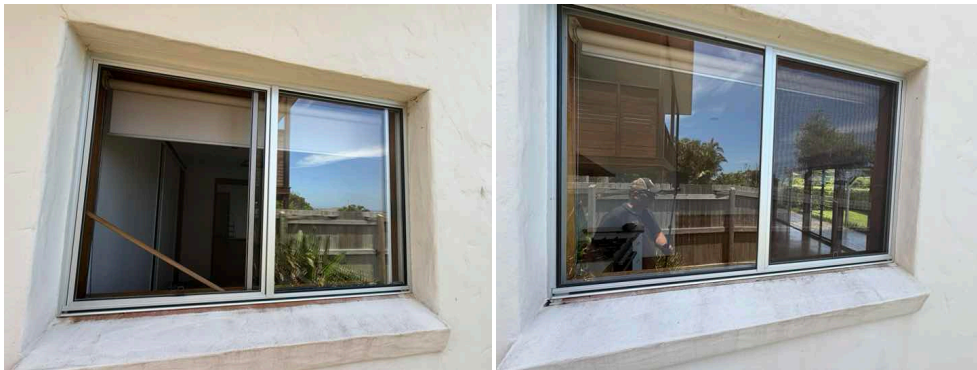
Upon visual inspection, weep holes were found to be rendered over, potentially causing moisture buildup and structural damage. It is recommended to engage a licensed tradesperson to carefully remove the render obstructing the weep holes, ensuring proper ventilation and drainage. Regular maintenance checks should be scheduled to prevent future blockages and maintain the integrity of the building's moisture management system.

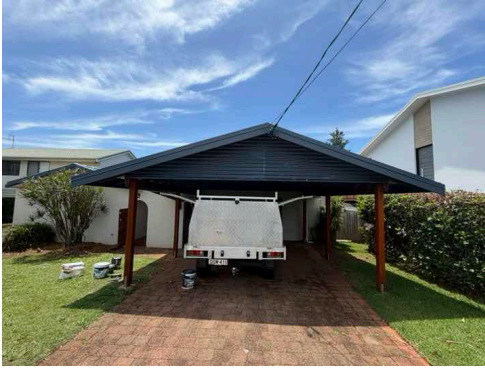
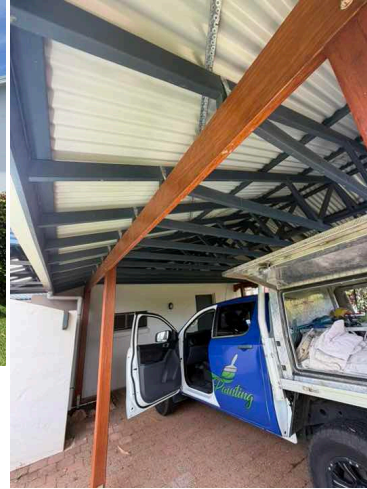
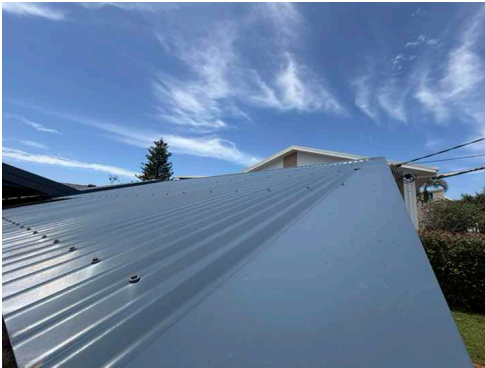
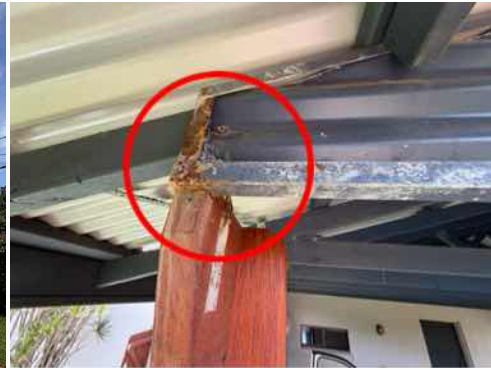
The overall condition of the carport is serviceable for the age.

Corrosion noted to the metal frame. Replacement recommended.

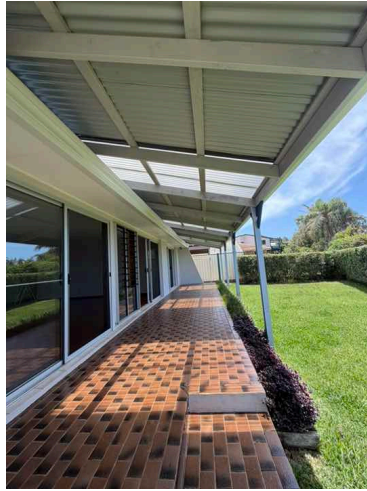
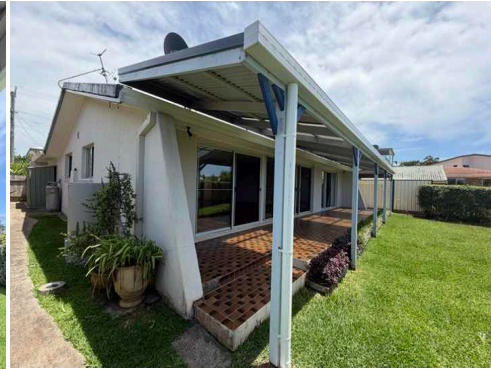
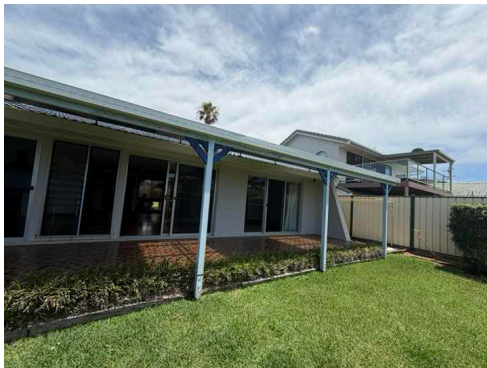
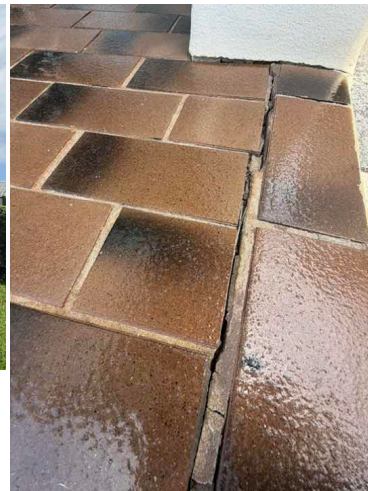
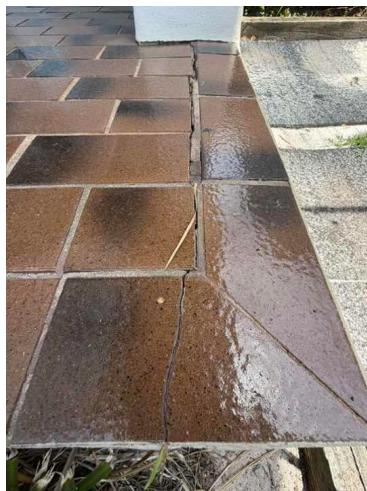
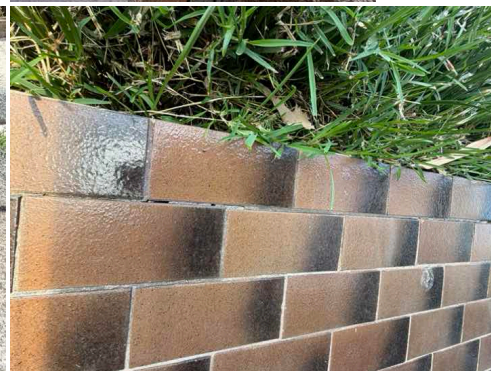
Though we are not structural engineers the balcony/s appear to be in a serviceable condition.

Tiles are drummy and loose. This needs to be fixed by a qualified tiler to eliminate any water penetration issues.

Tile grout deterioration. A qualified tiler should be engaged for advice and recommendations. Grout deterioration may cause leaking and water penetration.

Tile cracking observed. A qualified tiler should be engaged for advice and recommendations. This may cause leaking and water penetration.

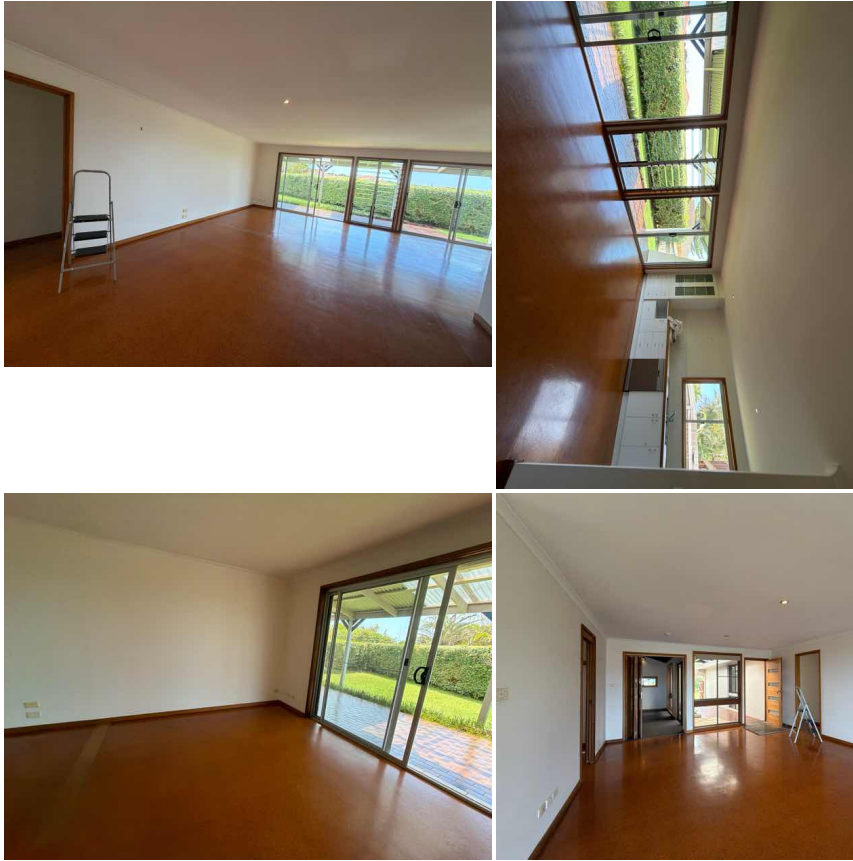
From the visible and accessible areas, this room appears to be in a serviceable condition for the age of the property with no notable structural defects sighted.

Incomplete patch/paint repairs noted. I recommend you contact a qualified painter for repairs.

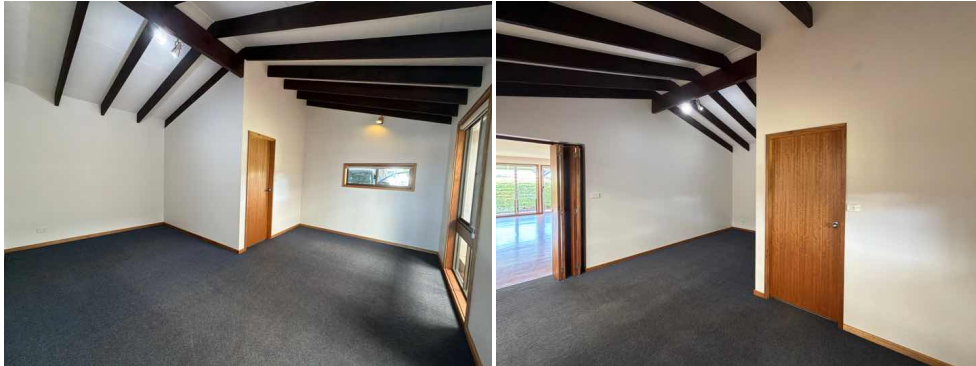
Stains observed - Steam cleaning may rectify stained areas but they appear entrenched.

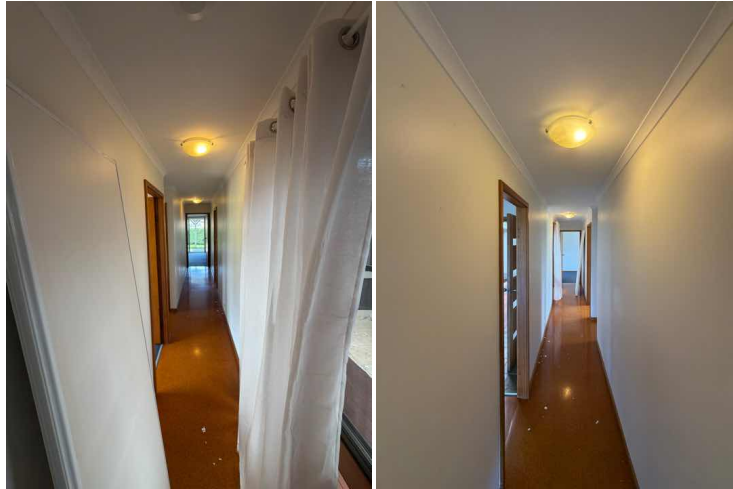
Skirting board damage/deterioration. A qualified carpenter should be engaged to replace.

Skirting board damage. Possibly bath/shower recess leak related. Have bathroom/shower assessed by a qualified plumber for leaks and maintenance/replace skirting boards as required.

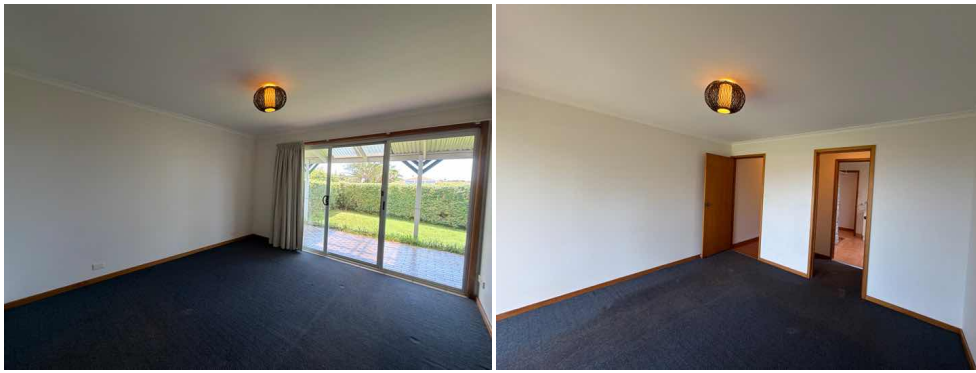
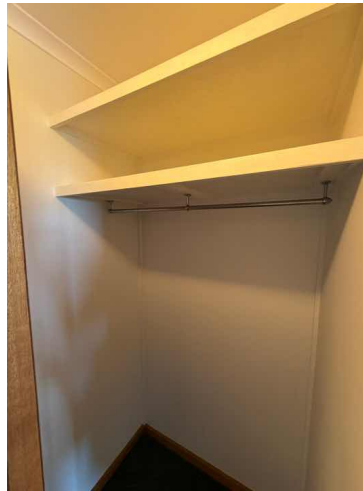
Settlement Cracks Noted. These are typical and generally patch and paint will suffice, however monitoring these cracks is advised for 12 months and if they become worse, further investigation by a suitably qualified professional is advised.

Stains observed - Steam cleaning may rectify stained areas but they appear entrenched.

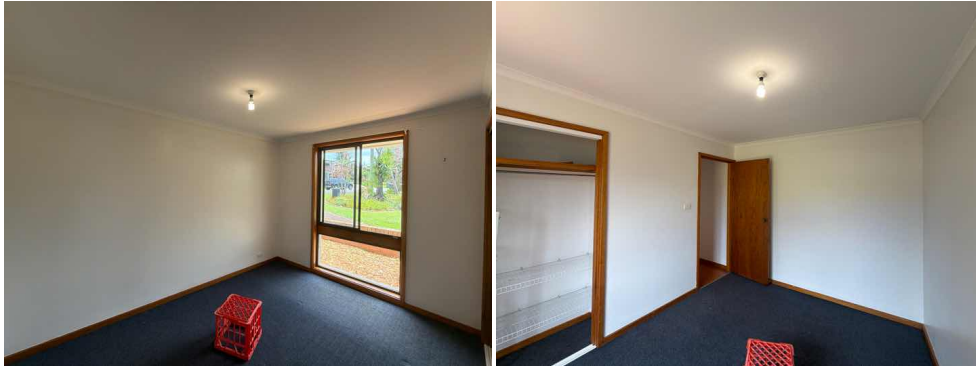
Uneven / out of square door causing binding. A qualified carpenter should be engaged to refit.

Upon visual inspection, the window sill shows signs of moisture staining, indicating potential water intrusion. This may lead to wood rot or mold growth if not addressed. It is recommended to have a licensed contractor assess the source of moisture, repair any leaks, and replace or treat the affected sill to prevent further damage and ensure structural integrity.

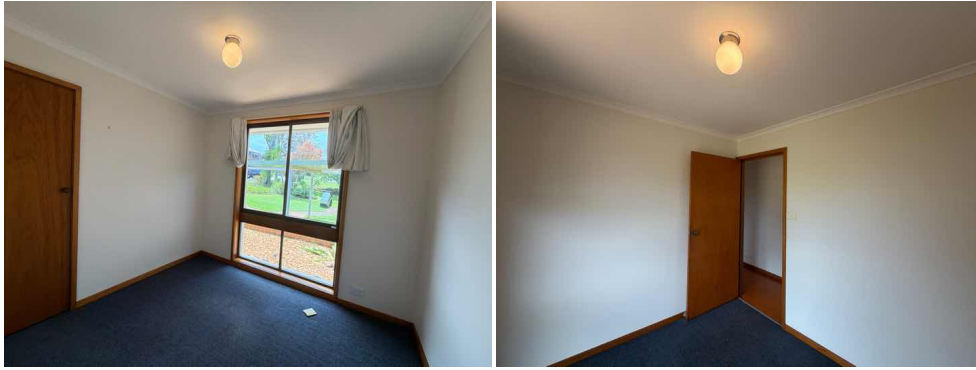
Uneven / out of square door causing binding. A qualified carpenter should be engaged to refit.

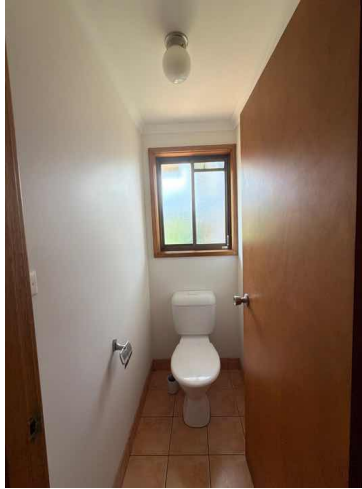
No exhaust fan is installed - Recommend having one installed.

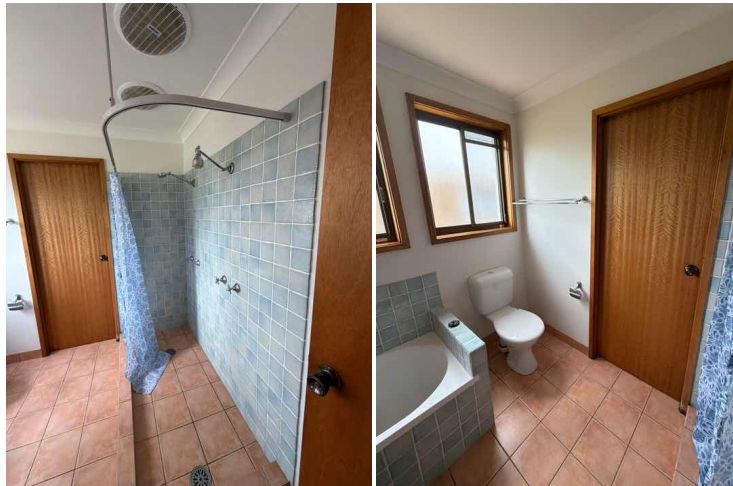
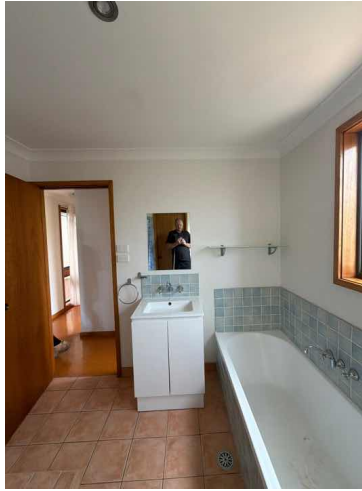
Water damaged door. Possible due to leak in bathroom. Replacement recommended.

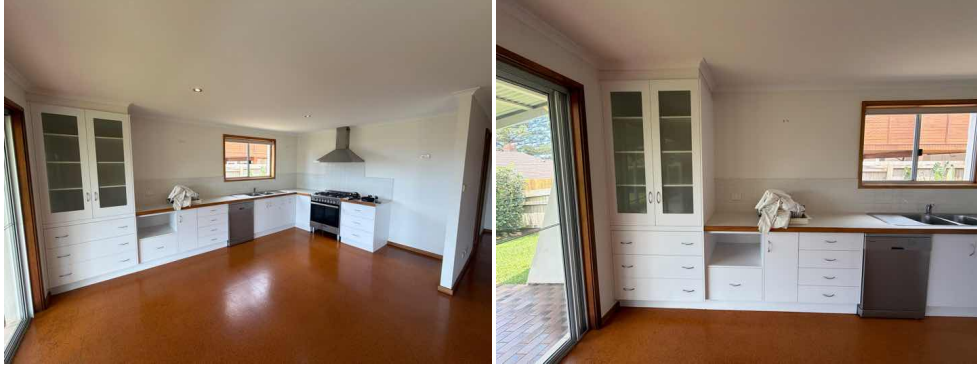
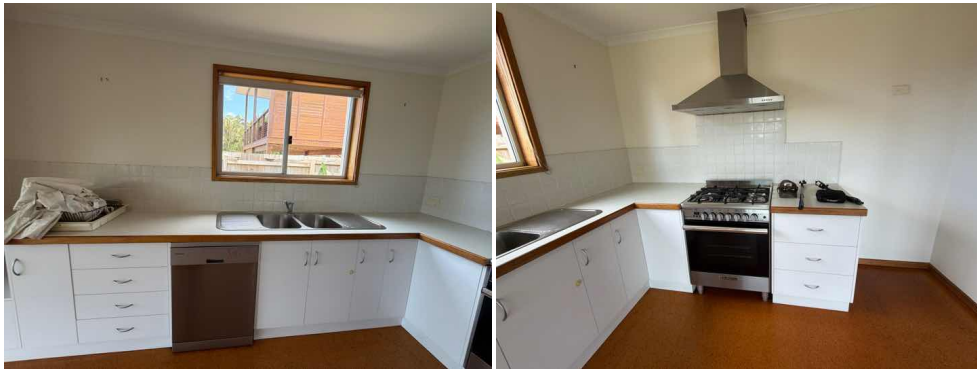
Cornice separation. I recommend you contact a licensed painter for repairs.
