Inspection Report

36 Killarney Cr, Skennars Head, NSW, 2478

Pest And Building Inspection

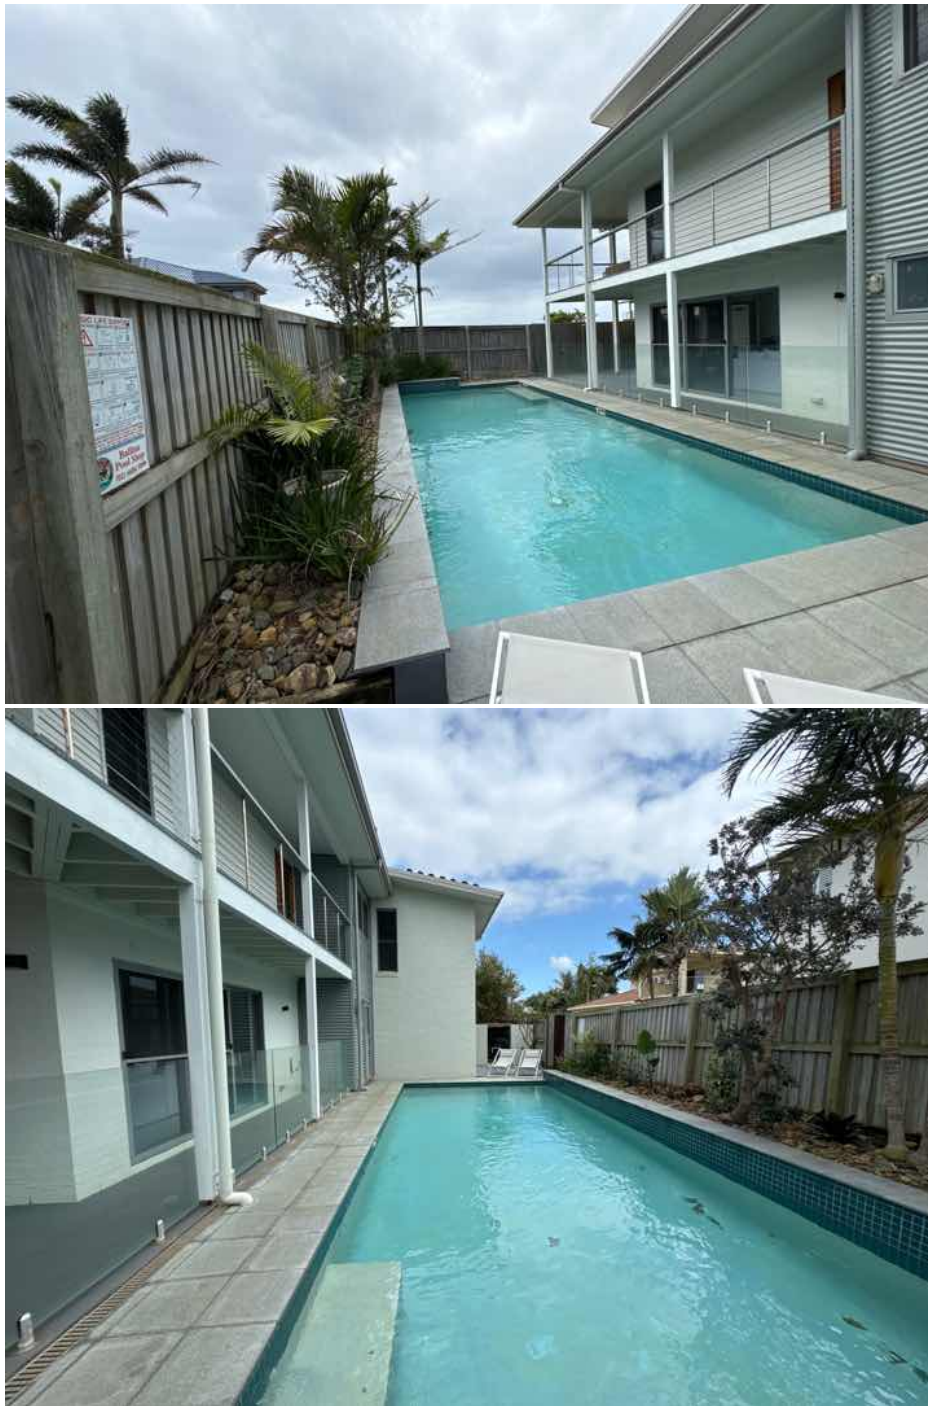
Trees are close to the dwelling. These currently do not appear to have caused any defects/wall cracking.
Recommendations: Engage a qualified arborist to carry out an assessment on potential issues.

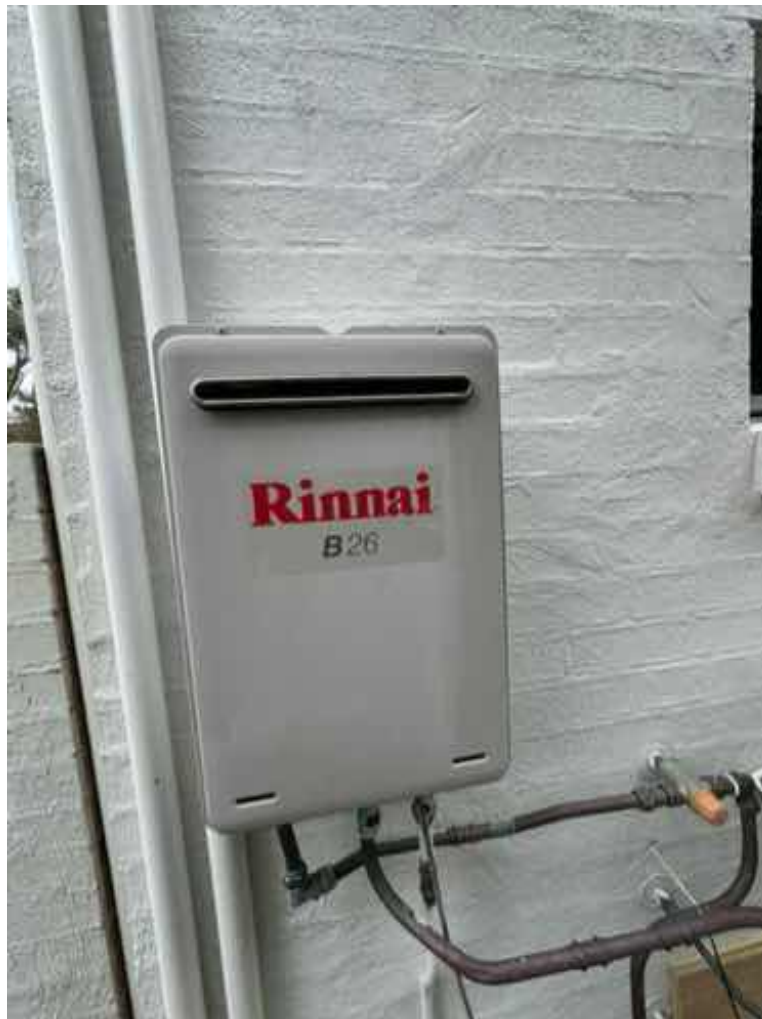
The make of the hot water unit is rinnai.

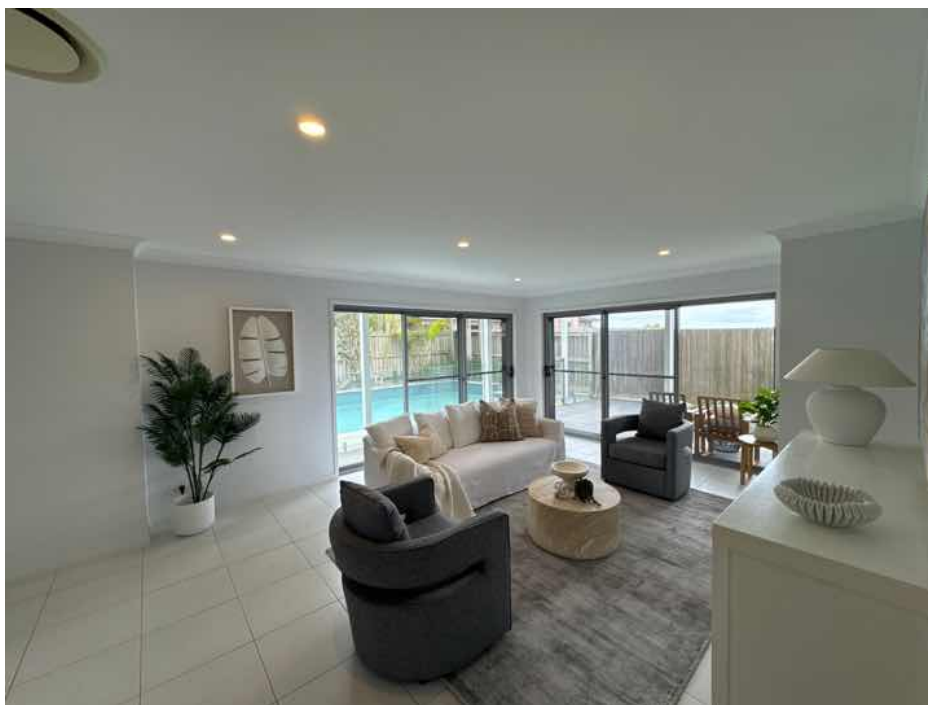
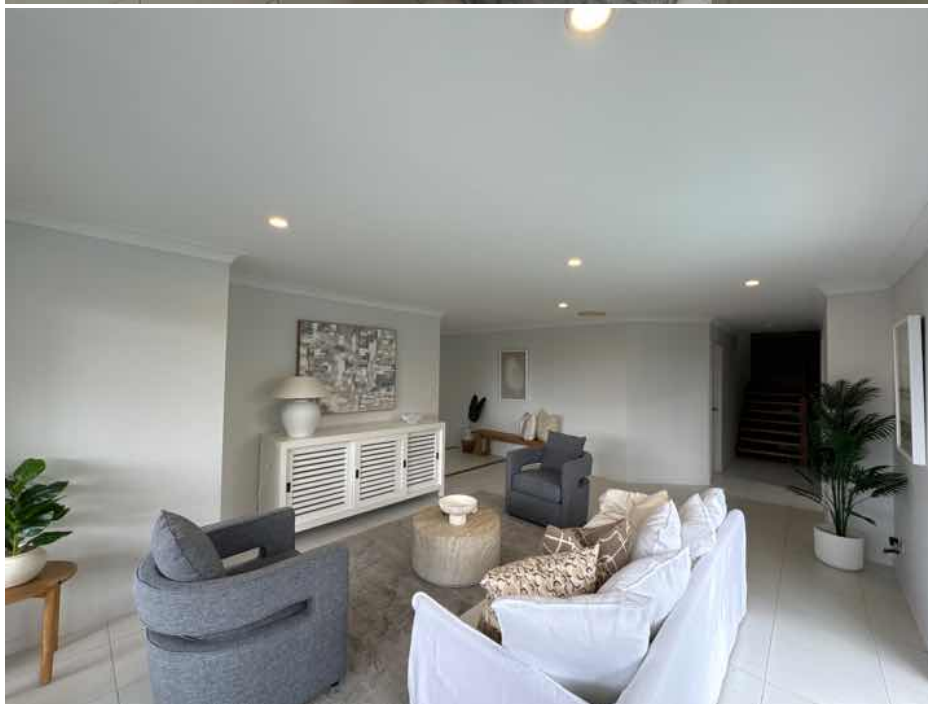
Cracked floor tiles noted. A qualified tiler should be engaged for repairs.

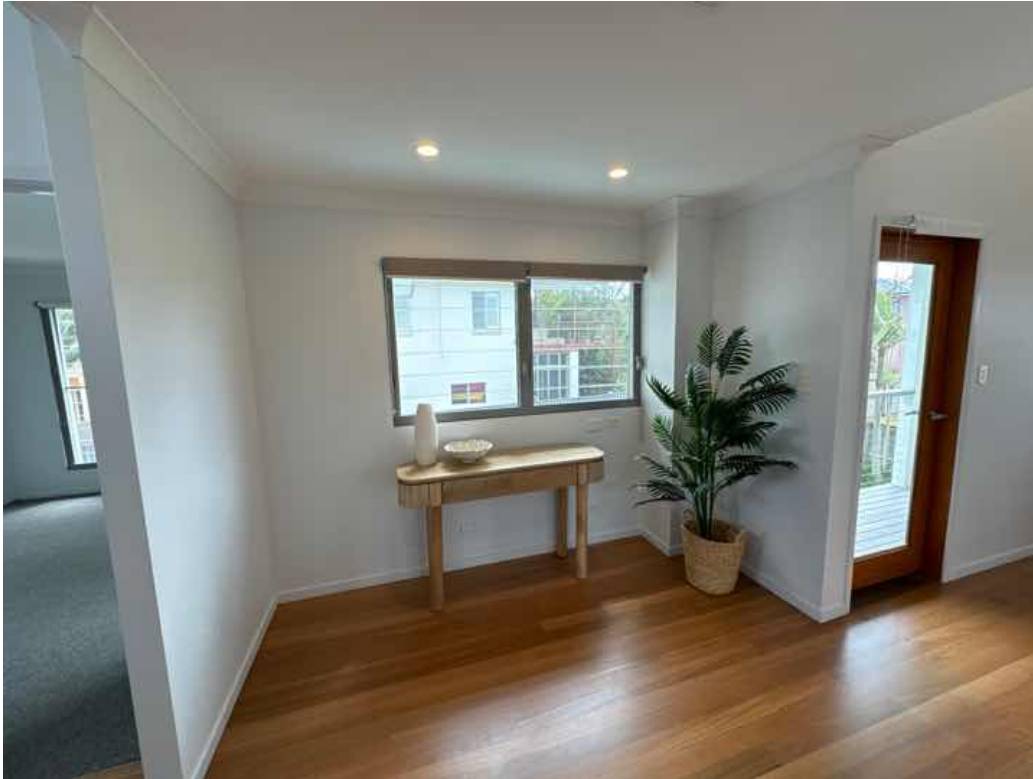
Incomplete patch/paint repairs noted. I recommend you contact a qualified painter for repairs.

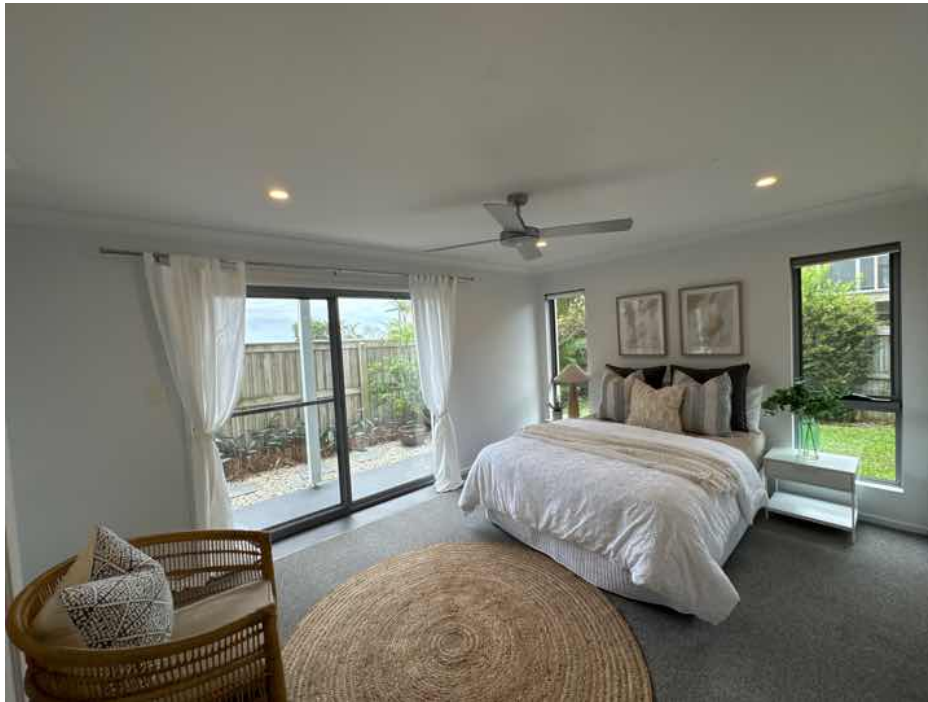
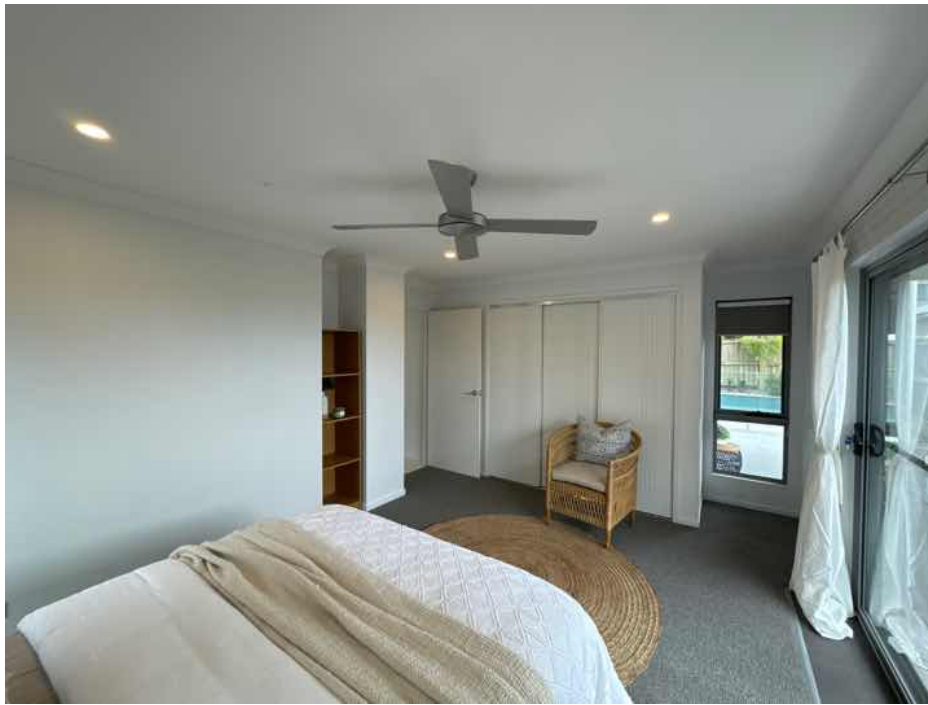
Ceiling stains - No moisture readings obtained. These may have been repaired however you will need to monitor after a prolonged period of rainfall. If leaking persists, a qualified plumber should be engaged for advice and recommendations. All water damaged plaster should be replaced.

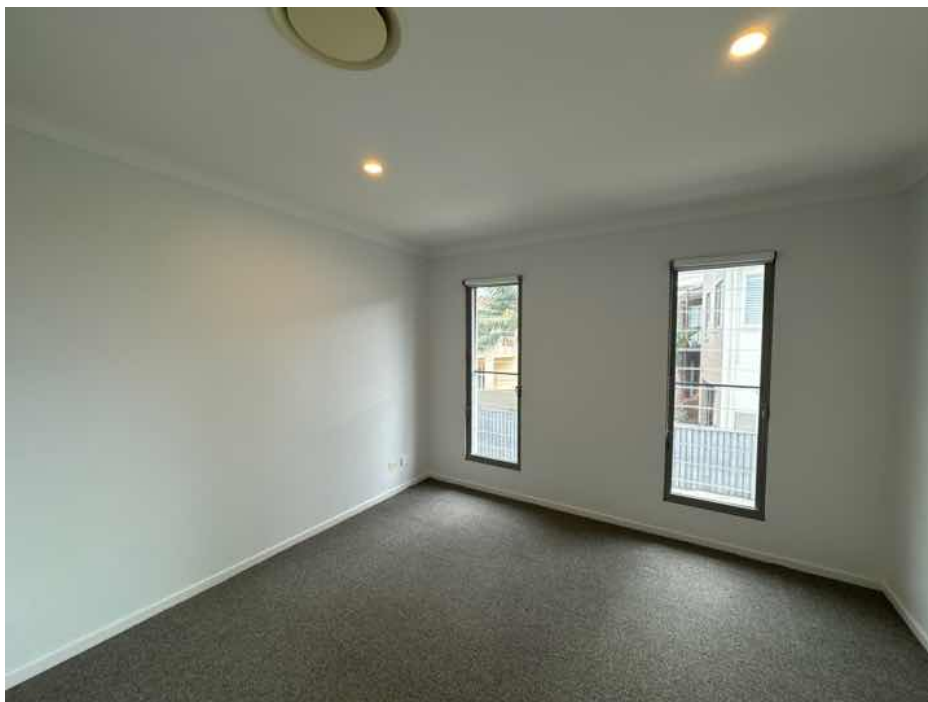
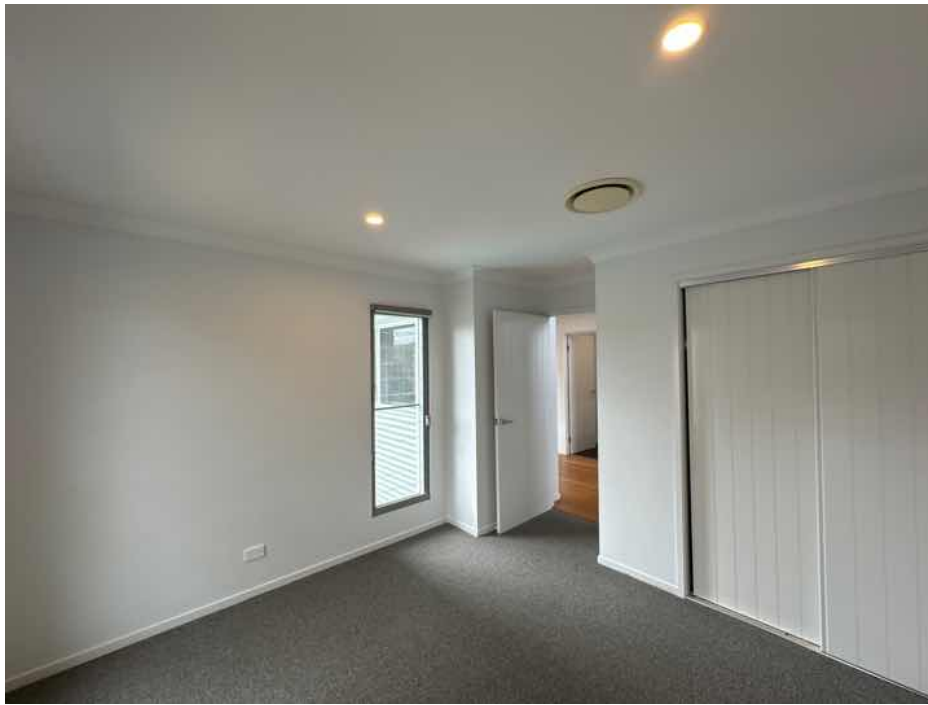
Upon visual inspection, a paint flake was observed on the interior wall surface. The defect appears to be due to inadequate surface preparation or moisture ingress. It is recommended that the affected area be scraped, sanded, primed, and repainted with a suitable high-quality paint to ensure adhesion and durability. A licensed painter should be engaged to assess and carry out the necessary repairs to prevent further deterioration.

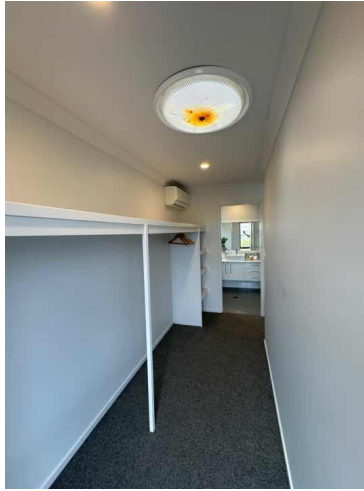
Ceiling

The skylight fitting is rusty

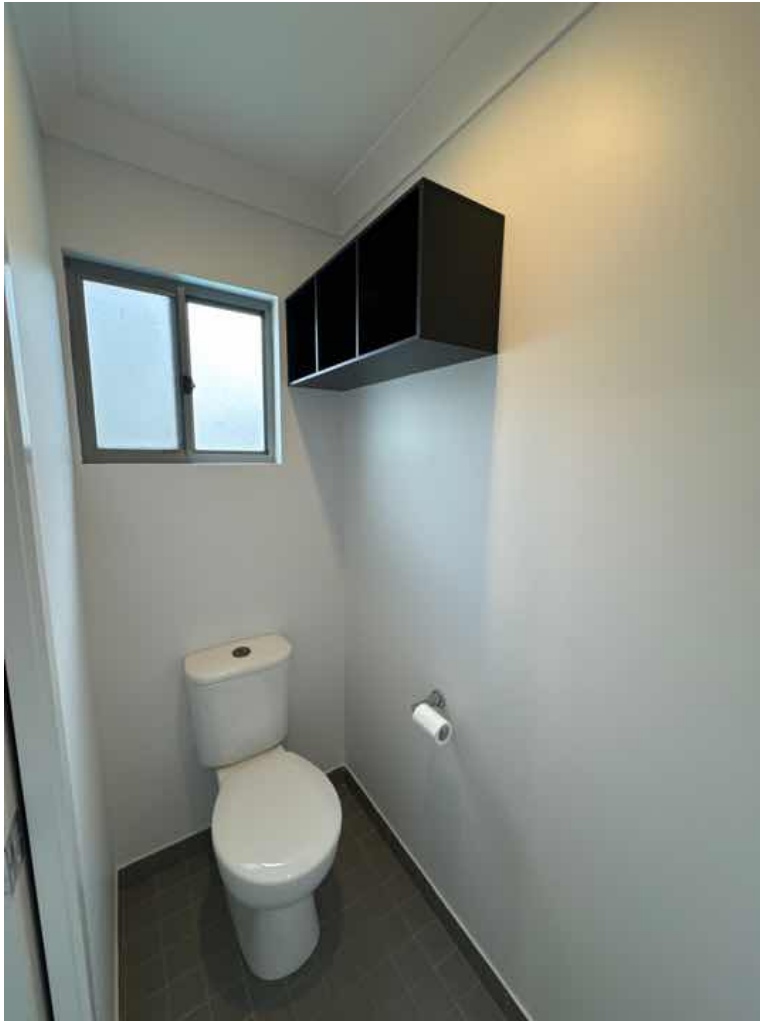
Ceiling

Cornice separation. I recommend you contact a licensed plasterer for repairs.

No exhaust fan is installed - Recommend having one installed.

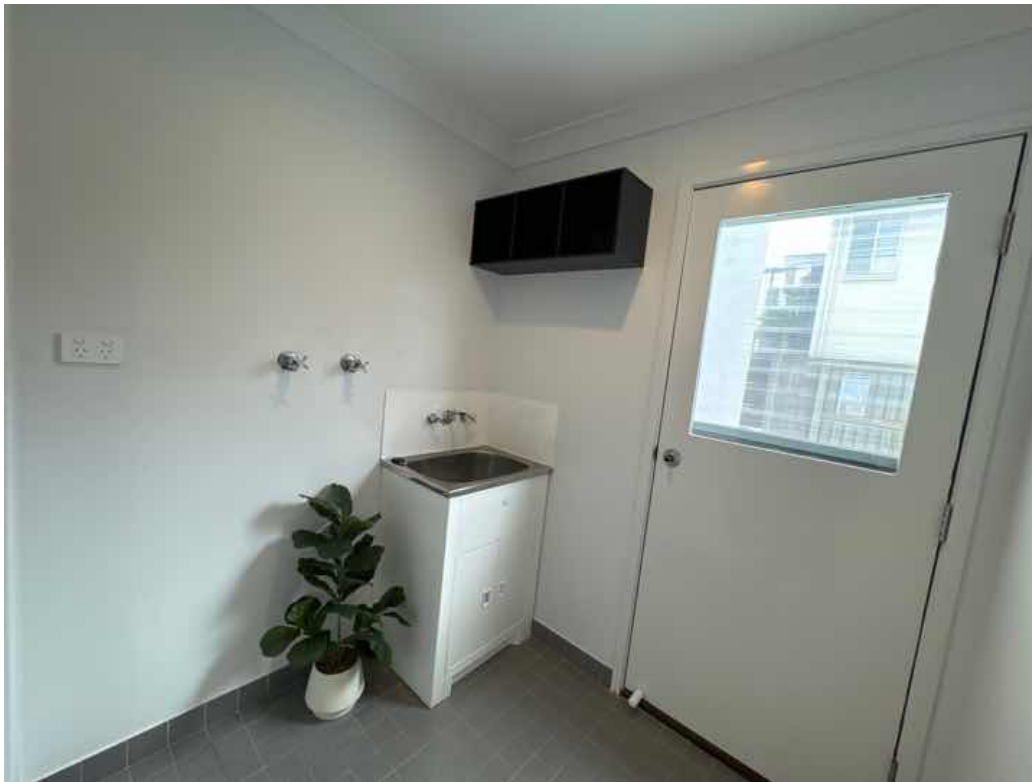
Doors

Upon visual inspection, a door handle was found to be missing. To ensure proper function and security, it is recommended that a replacement handle be installed by a licensed carpenter or locksmith. The new handle should match the existing hardware for consistency and aesthetic purposes. Immediate attention is advised to maintain the door's integrity and usability.
