Building and Pest Report

2 Sunhaven Ave Skennars Head

Report/Agreement #	120226095828115
Inspection Date:	12 Feb 2026
Inspection Time:	09:00 am

Pest And Building Inspection

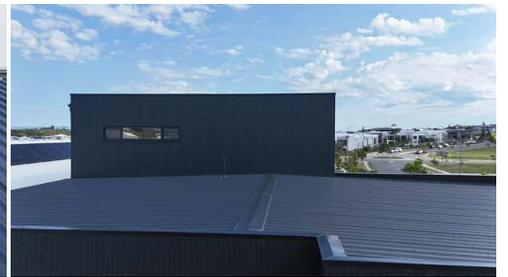
Guttering

All visible and accessible of the physical nature of the guttering system appears to be in a serviceable condition with no apparent defects at the time of inspection. In the absence of prolonged rain fall efficiency of the guttering can not be assessed and you may find that further investigation or repairs maybe required. Note: Periodic maintenance checks should be carried out for rust penetrations and leaks.

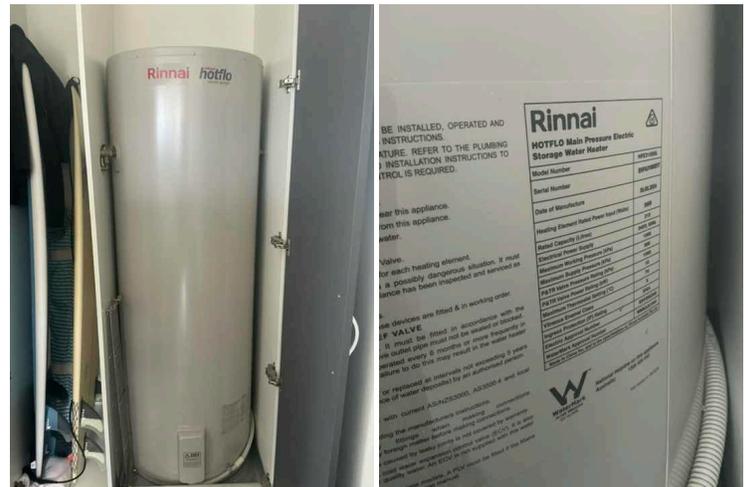
System Make

The make of the hot water unit is rinnai.

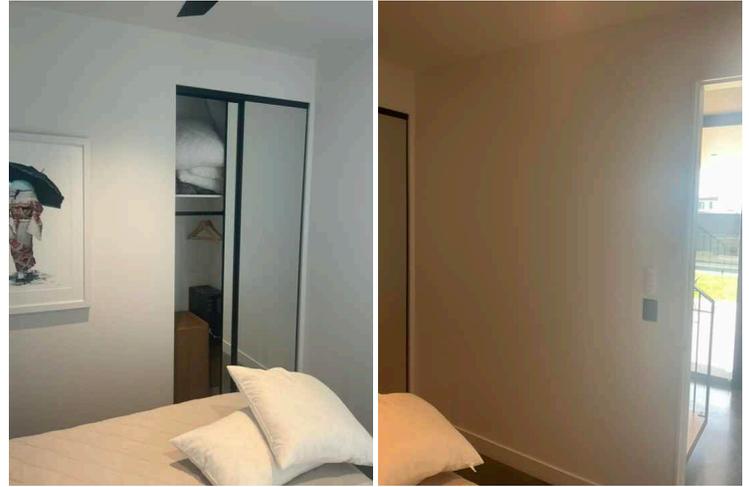
Bedroom 2

From the visible and accessible areas, this bedroom appears to be in a serviceable condition for the age of the property with no notable structural defects sighted.

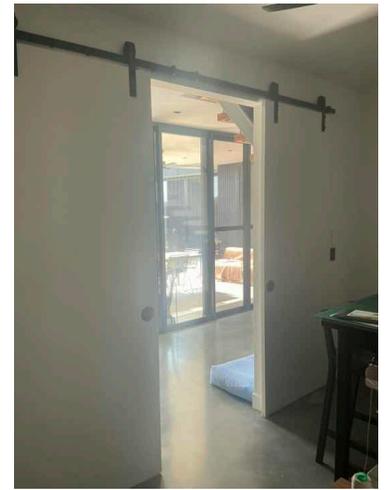
Bedroom 3

From the visible and accessible areas, this bedroom appears to be in a serviceable condition for the age of the property with no notable structural defects sighted.
