# Building and Pest Report

## 48 Surf Avenue Lennox Head

| Inspection Date: | 06 Nov 2025 |

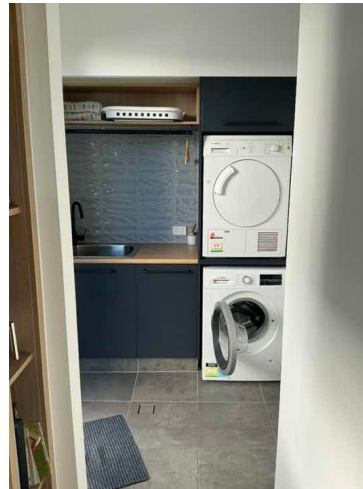
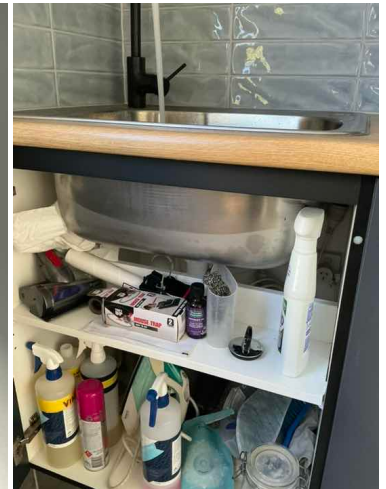
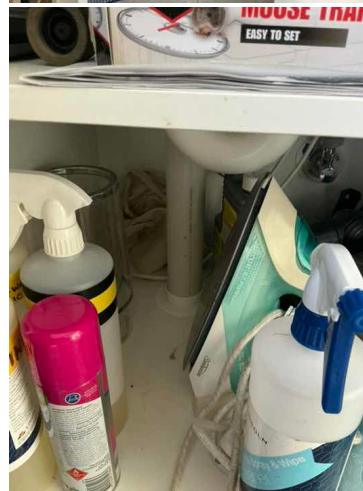
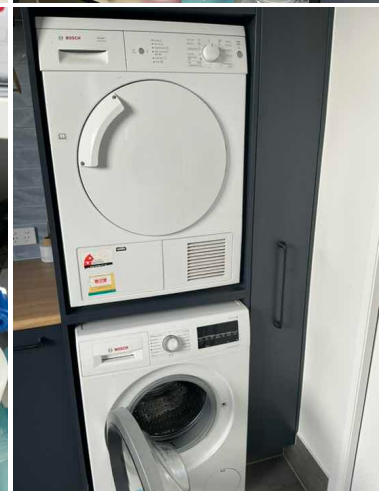
Appliances and the like restricted a full visual inspection.

Of the visible areas, the general condition of the laundry is serviceable or in reasonable condition for age of dwelling.

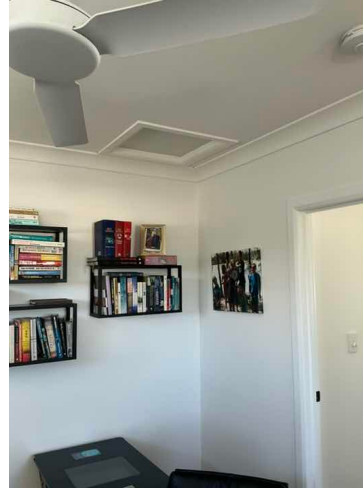
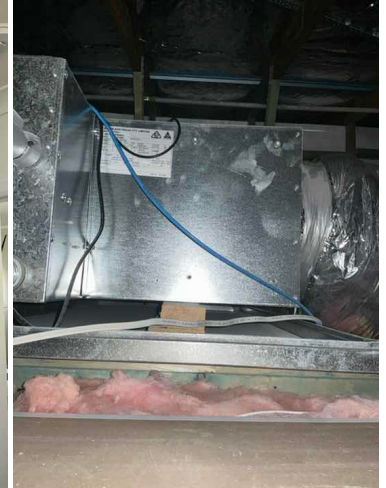
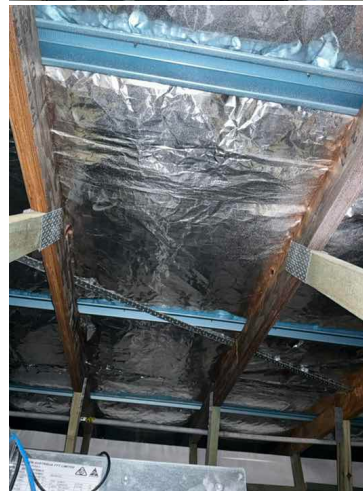
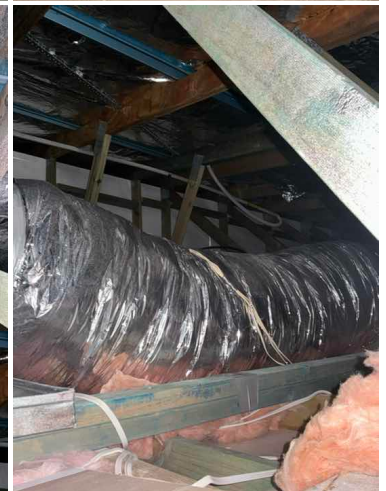
There is heating and/or cooling ducting present in the roof space. This is preventing a full inspection from being undertaken. It is strongly recommended that full access be gained as it could be harbouring timber pest activity, damage or defects.

There is insulation present in the roof space/void. This is preventing a full inspection of ceiling joists from being undertaken. It is strongly recommended that full access be gained as it could be harbouring timber pest activity, damage or defects.

There is low clearance in areas throughout the roof void which is preventing a full/thorough visual inspection taking place. It is strongly recommended that full access be granted to enable a thorough inspection to take place as it could be harbouring timber pest activity, damage or defects.

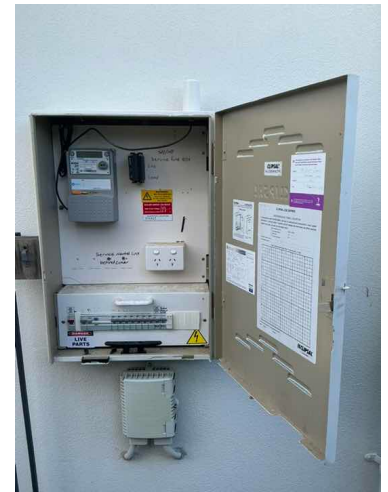
No, a durable notice was not found during the inspection.

This firm can give no assurances with regard to work that may have been previously performed by other firms. You should obtain copies of all paperwork and make your own inquiries as to the quality of the treatment, when it was carried out and warranty information. In most cases you should arrange for a treatment in accord with Australian Standard 3660 be carried out to reduce the risk of further attack.
