Building and Pest Report

12 Bentwing Place Tintenbar

Inspection Report

12 Bentwing Place, Tintenbar , NSW , 2478

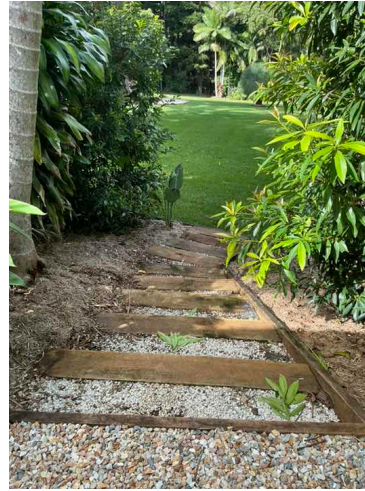
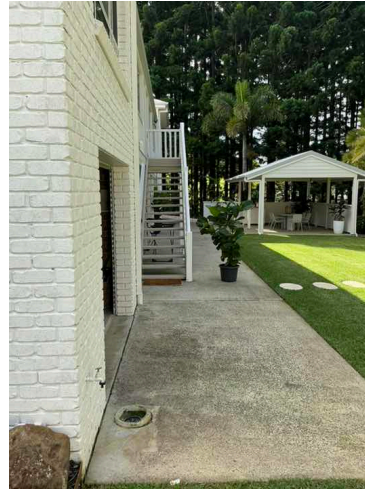
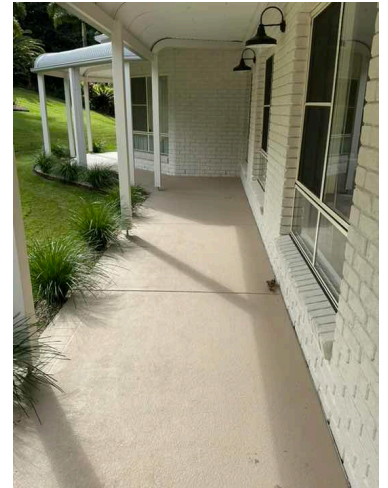
Pathways Condition

The paths around the home are in a serviceable condition for the age of this dwelling with no major defects visible.

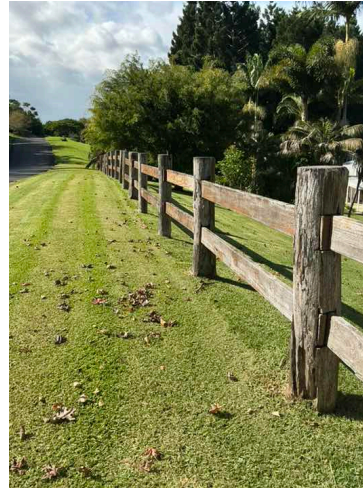
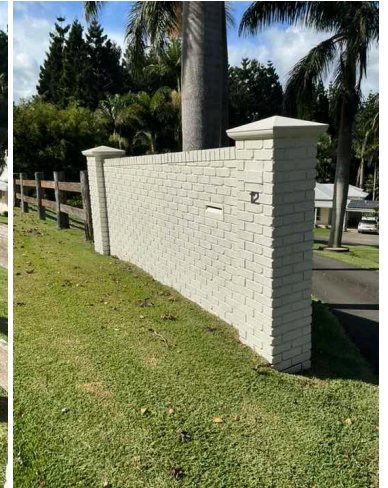
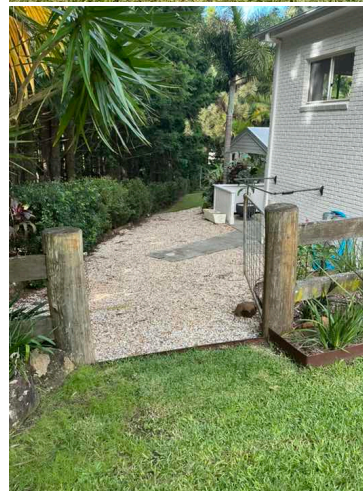
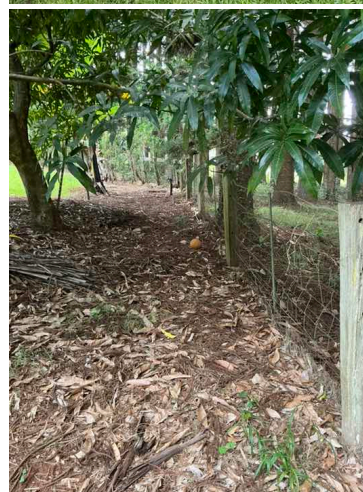
Fences & Gates

Of the visible areas, the general condition of the fences and gates is serviceable for the age of dwelling.

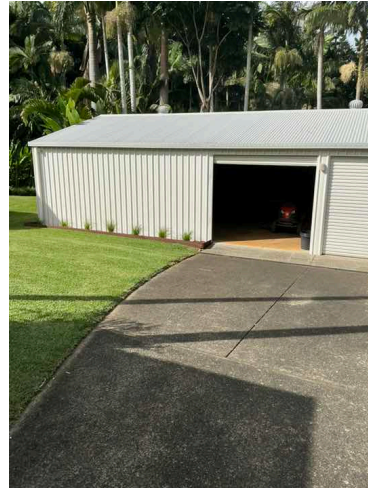
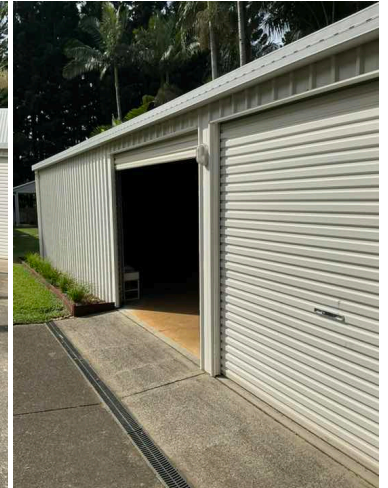
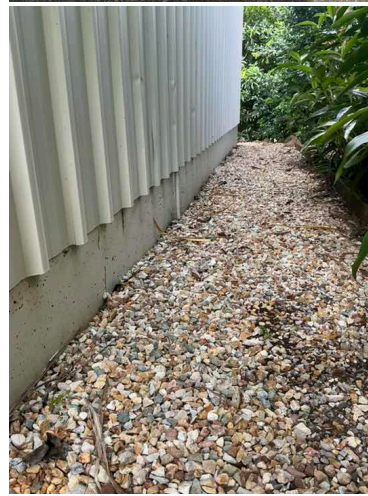
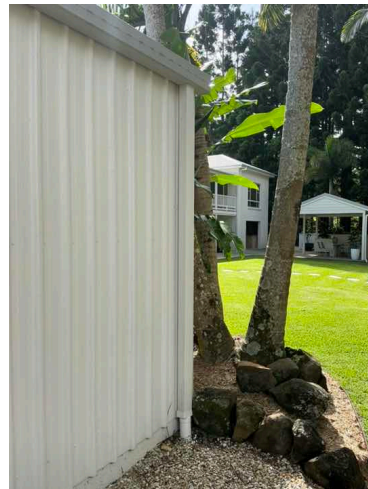
Shed Condition

The shed is in fair usable condition.

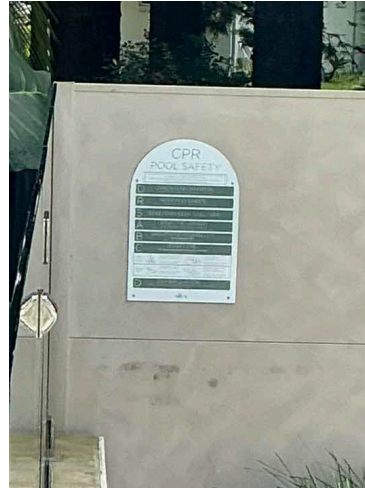
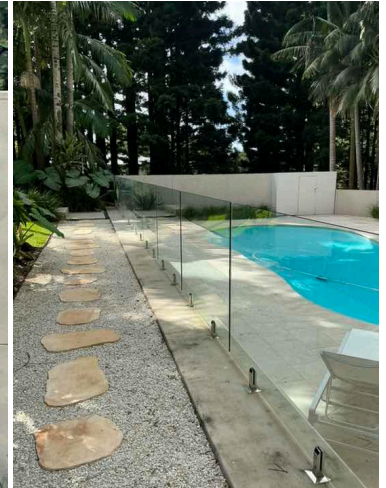
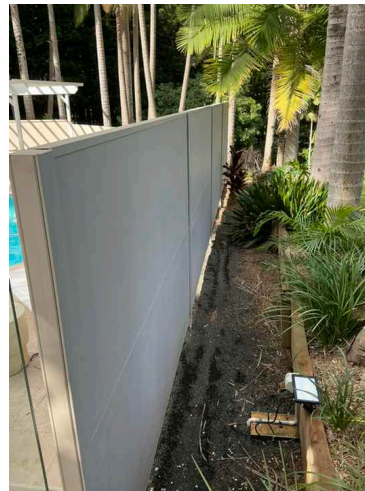
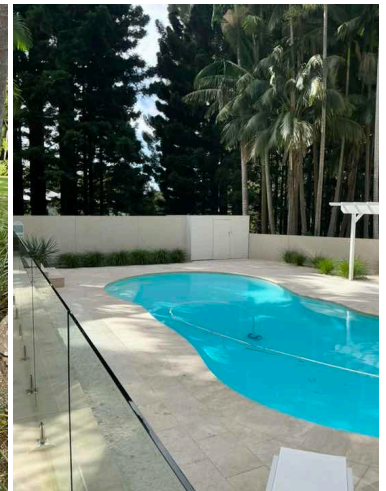
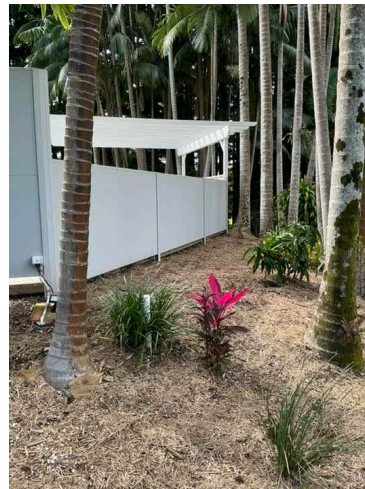
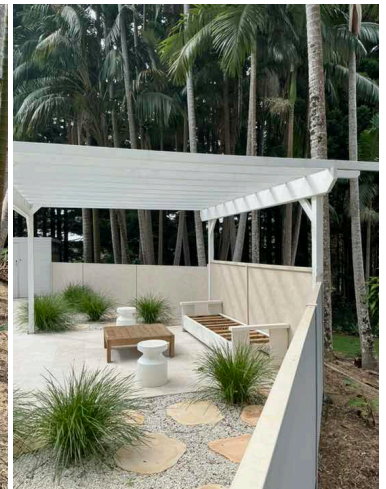
Pool Fence & Signs

Pool fence and signage were sighted.

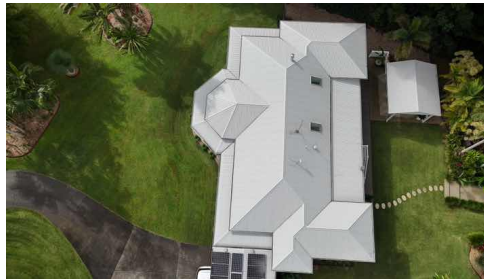
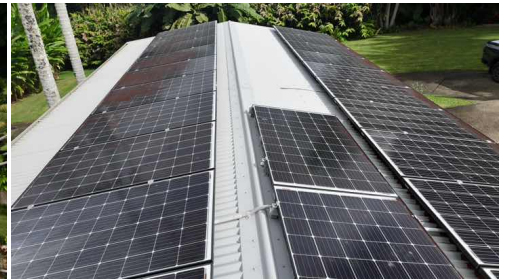
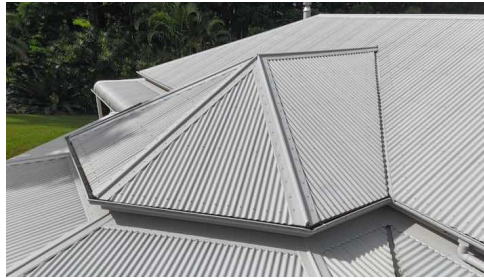
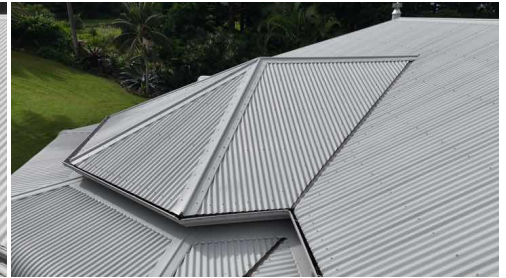
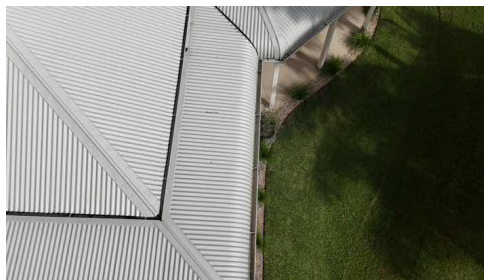
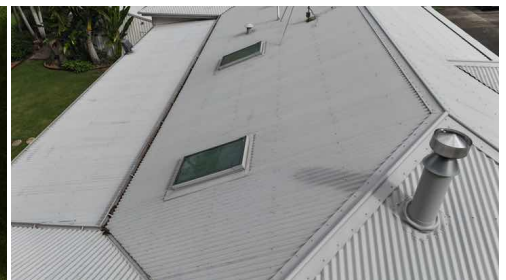
Overall Condition

Of the visible areas, the general condition of the roof is in serviceable condition for the age.

Note: In the absence of rainfall there is no guarantee that the roof won't leak.

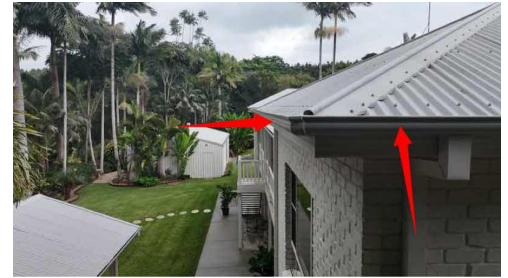
Guttering

All visible and accessible of the physical nature of the guttering system appears to be in a serviceable condition with no apparent defects at the time of inspection. In the absence of prolonged rain fall efficiency of the guttering can not be assessed and you may find that further investigation or repairs maybe required. Note: Periodic maintenance checks should be carried out for rust penetrations and leaks.

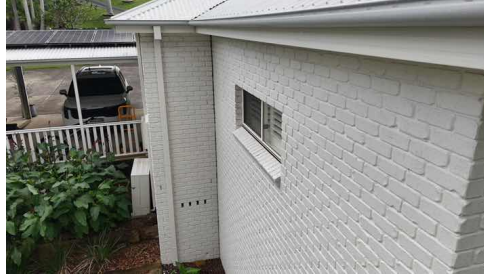
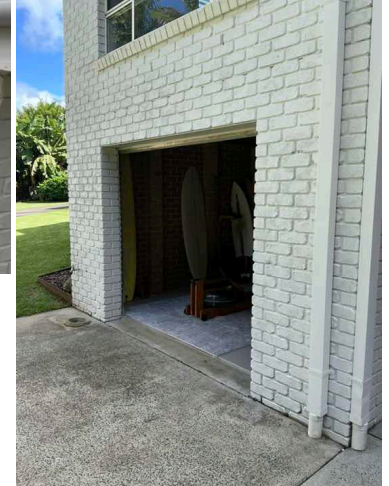
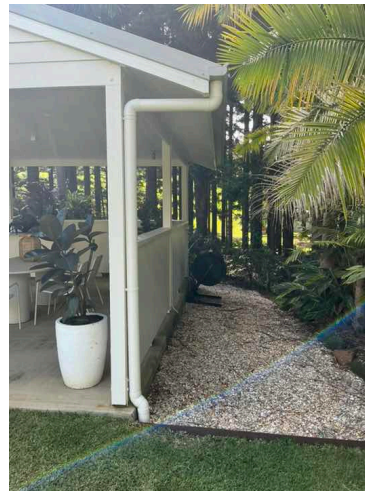
Downpipes

On visual inspection no apparent defects were noted to the down pipes and are considered serviceable, however no comment can be made with regard to blockages or connections to stormwater or functionality in the absence of rain. Note: Periodic maintenance checks should be carried out for rust penetrations and leaks.

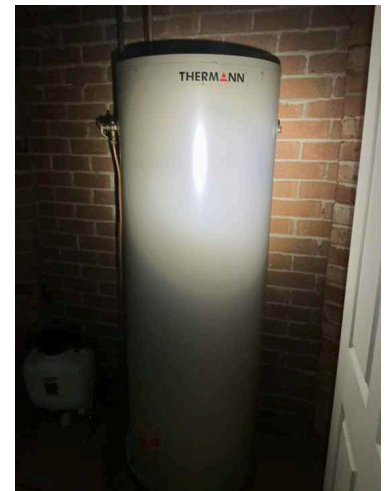
System Make

The hot water system appears to be in a serviceable condition. No specific tests other than running the hot water from a tap was carried out. No determination has been made as to the suitability or adequacy of the hot water system in relation to capacity or otherwise.

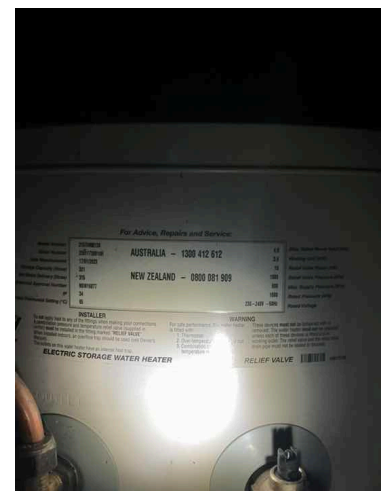
Hot water unit system capacity is 315 litre.

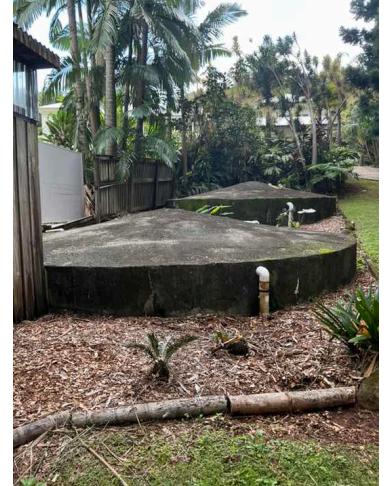
On Visual Inspection the water tank appears serviceable, but should be checked by a qualified plumber.

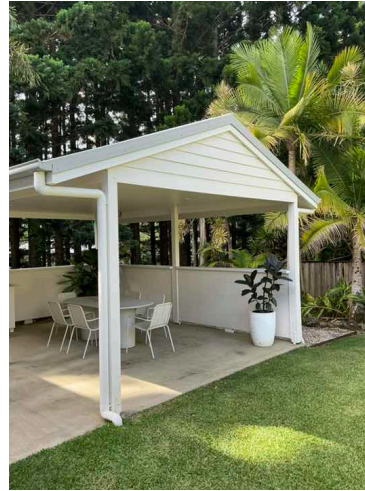
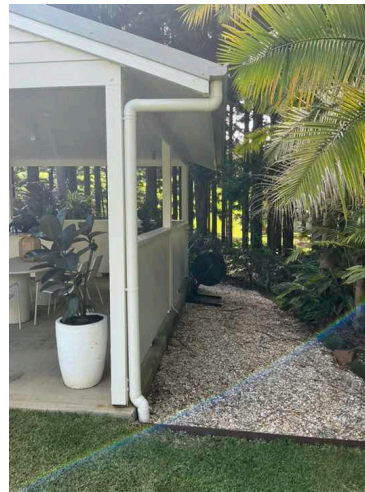
Visible sections of the Alfresco area are serviceable or in reasonable or condition for the age of this dwelling.

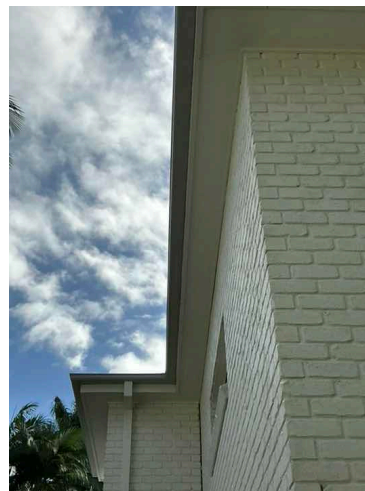
The soffit lining (eaves) are in a serviceable condition with no notable defects.

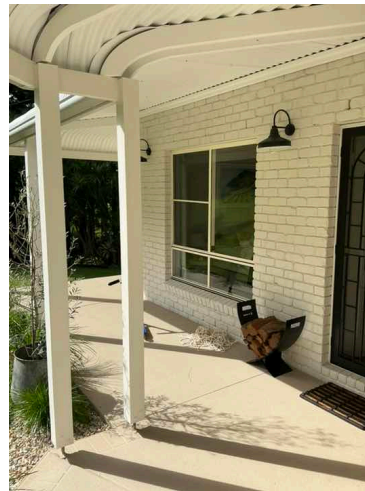
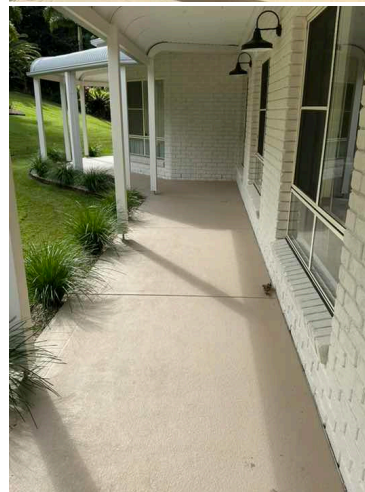
The entry porch serviceable or in reasonable or condition for the age of this dwelling.

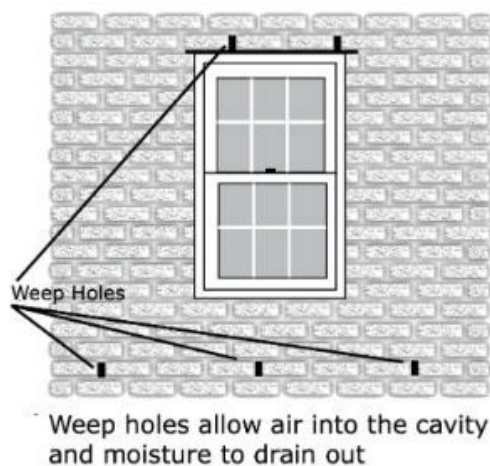
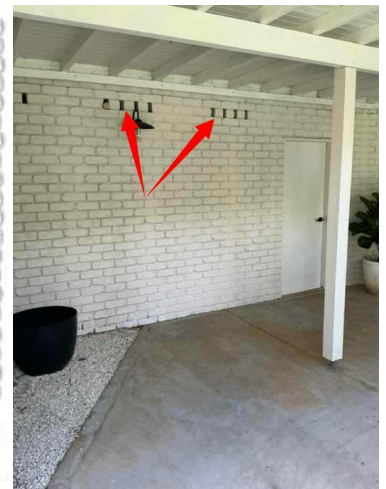
The weep holes are unobstructed .

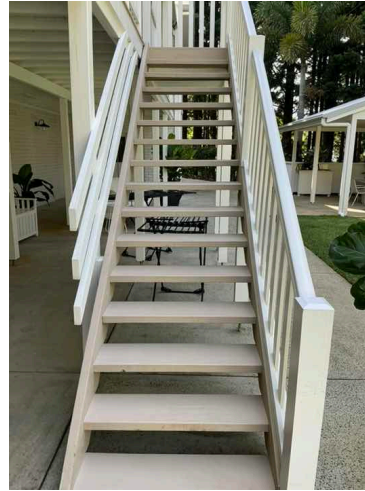
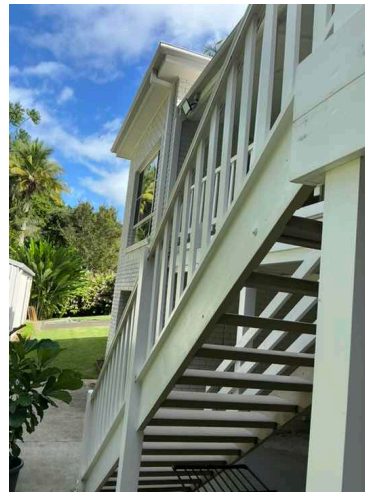
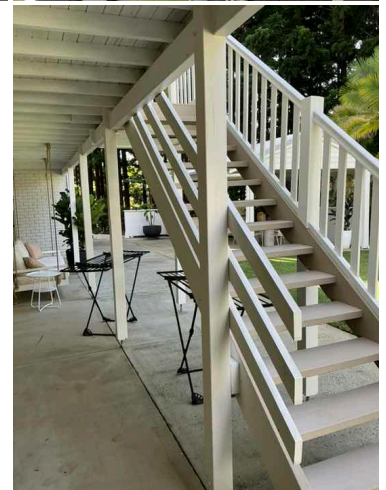
The stairs/steps appear to be serviceable with no notable defects.

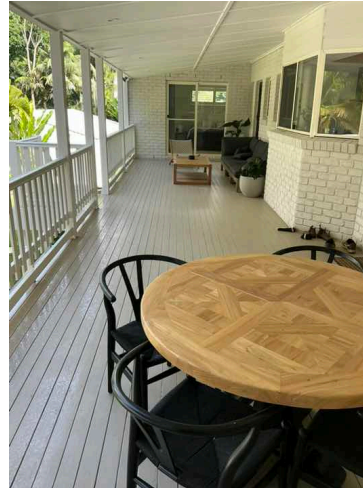
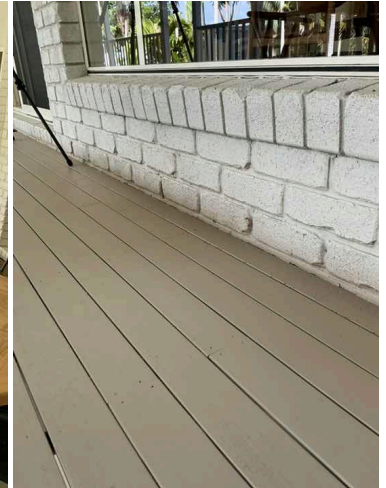
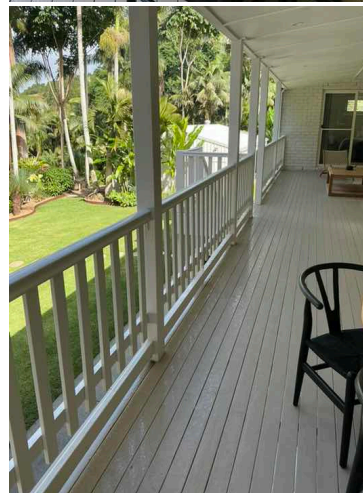
Though we are not structural engineers the balcony/s appear to be in a serviceable condition.

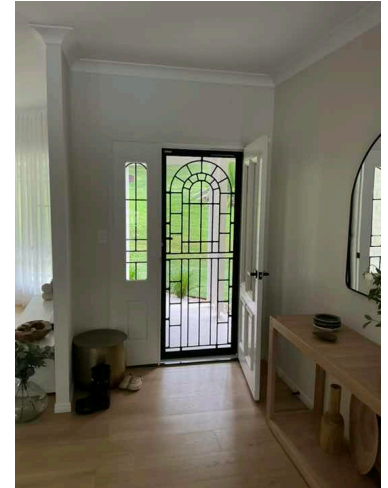
From the visible and accessible areas, this area appears to be in a serviceable condition for the age of the property with no notable structural defects sighted.

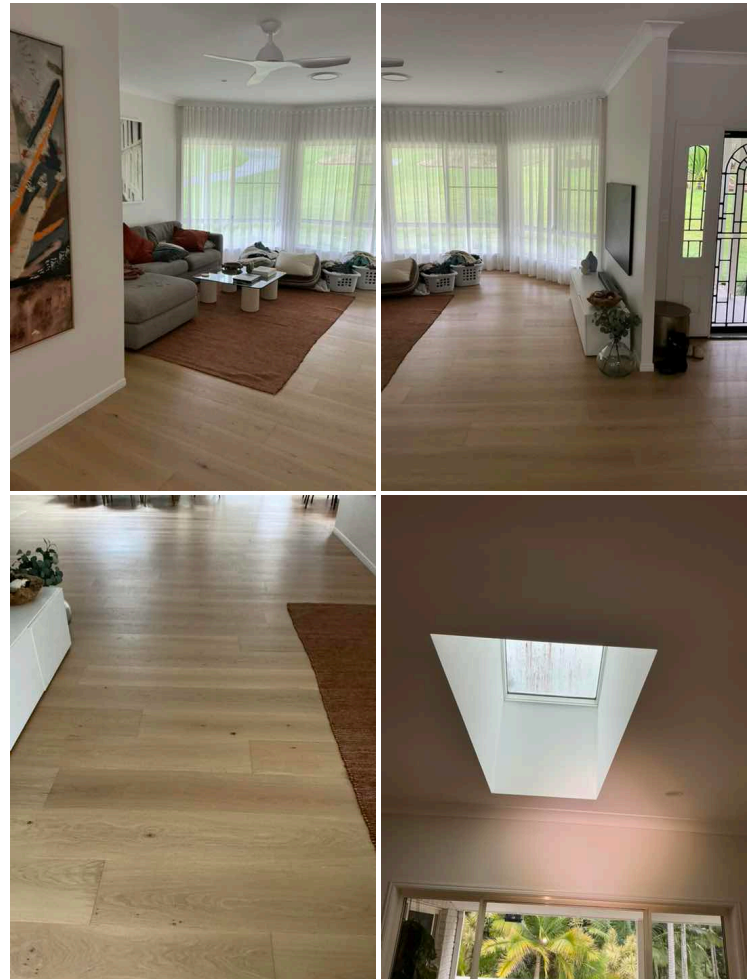
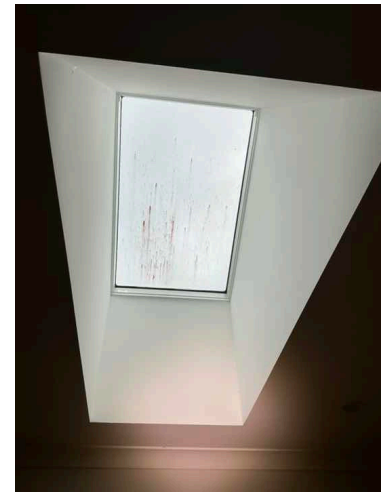
Living Room

From the visible and accessible areas, this room appears to be in a serviceable condition for the age of the property with no notable structural defects sighted.

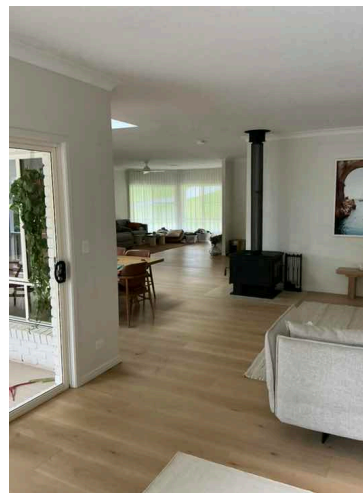
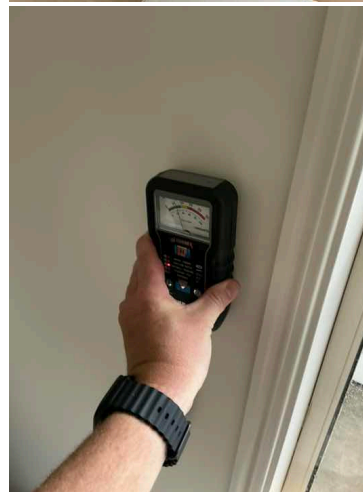
Combined Living & Dining

From the visible and accessible areas, this room appears to be in a serviceable condition for the age of the property with no notable structural defects sighted.

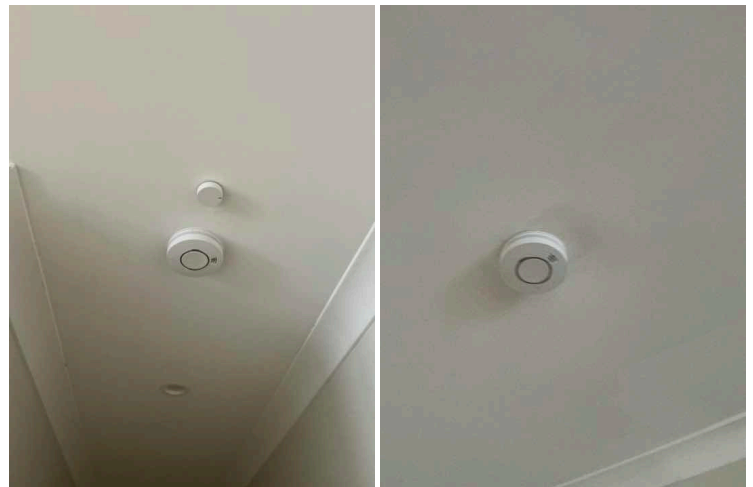
Yes 3 smoke alarms were sighted but not tested.

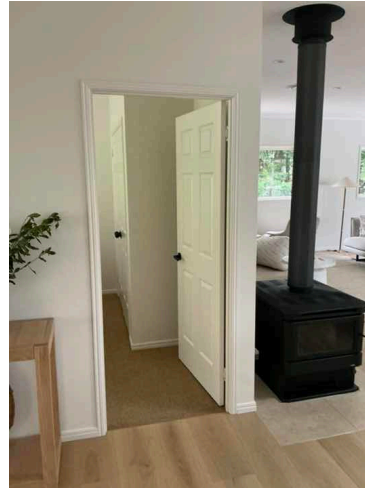
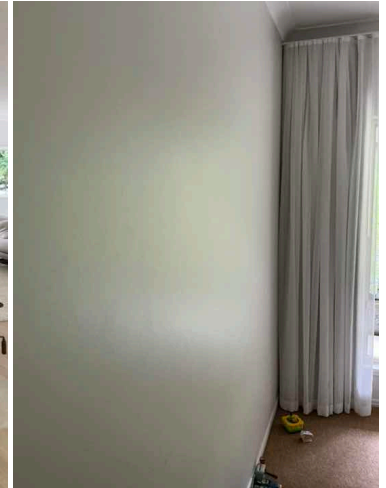
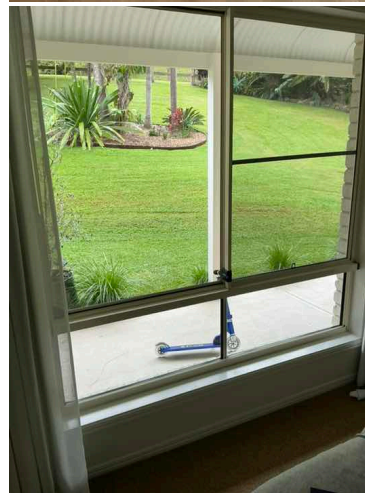
Bedroom 1

From the visible and accessible areas, this bedroom appears to be in a serviceable condition for the age of the property with no notable structural defects sighted.

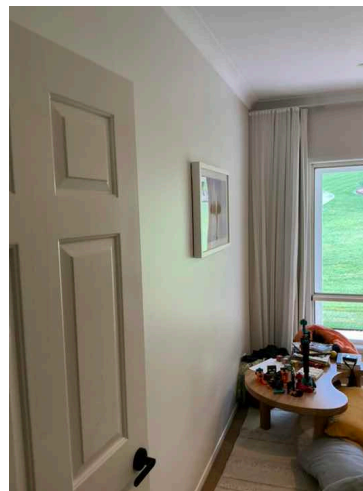
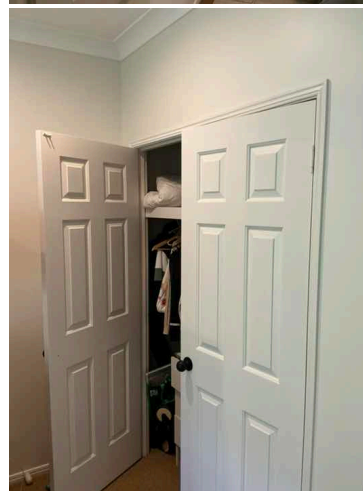
From the visible and accessible areas, this bedroom appears to be in a serviceable condition for the age of the property with no notable structural defects sighted.

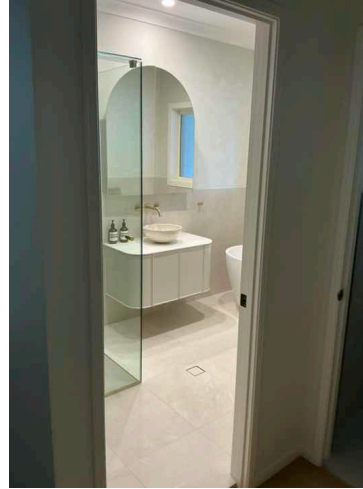
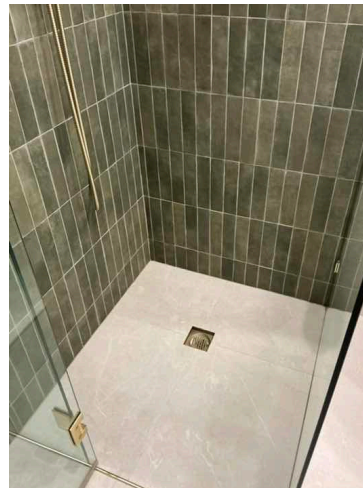
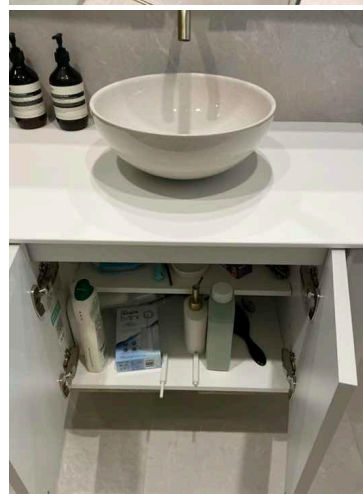
Of the visible areas, the general condition of this bathroom is serviceable or in reasonable condition for age of dwelling.

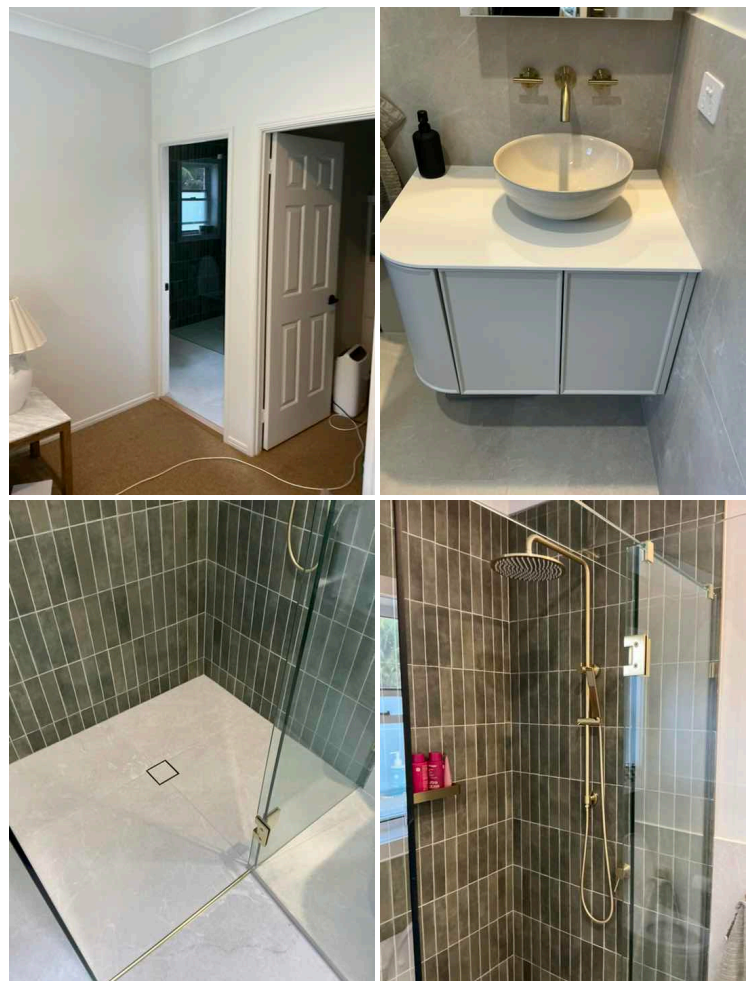
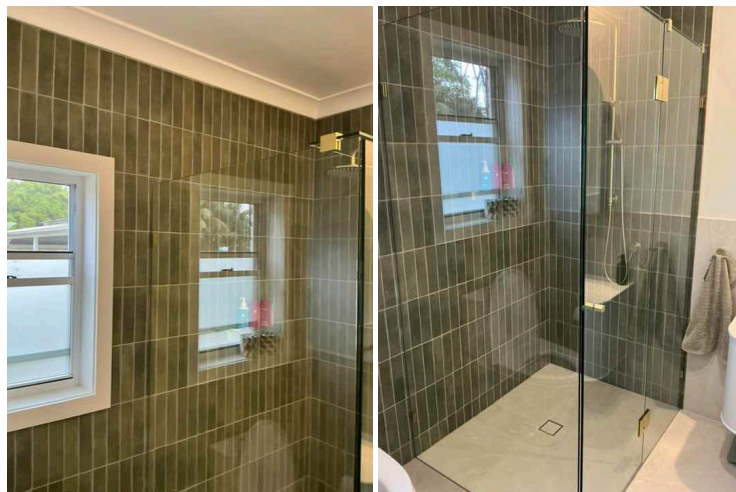
Of the visible areas, the general condition of this bathroom is serviceable or in reasonable condition for age of dwelling.

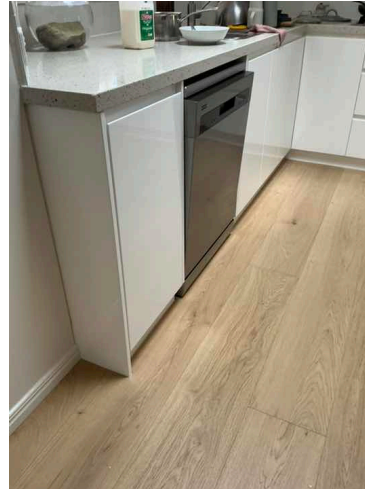
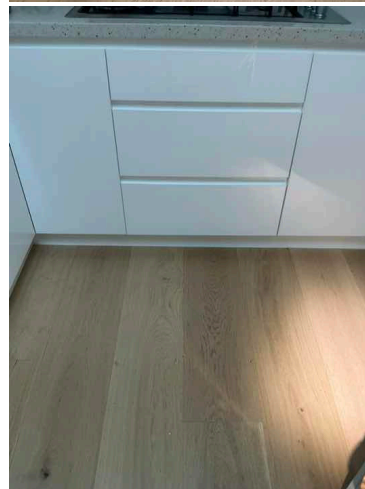
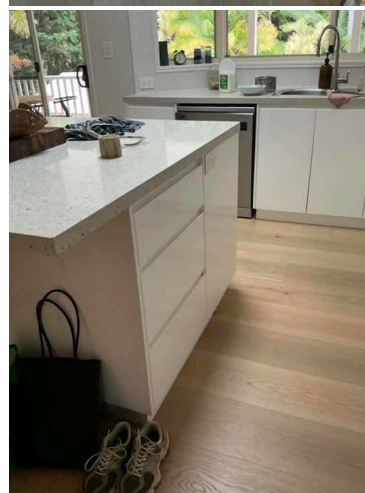
Of the visible areas, the general condition of the kitchen and pantry is serviceable or in reasonable condition for age of dwelling.

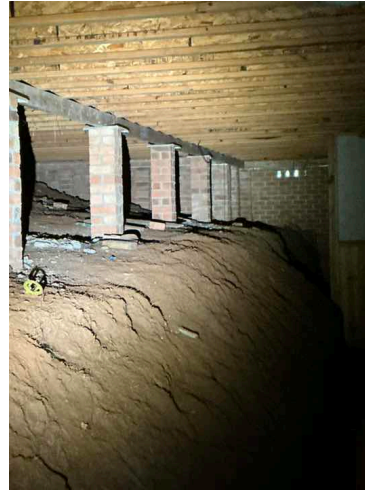
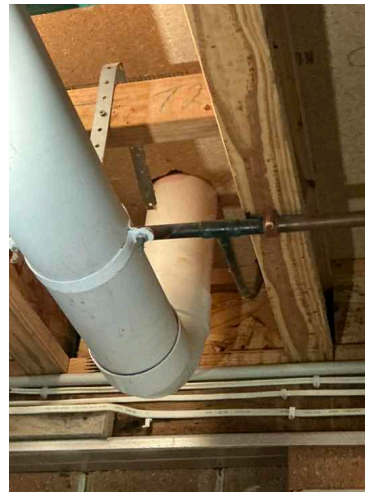
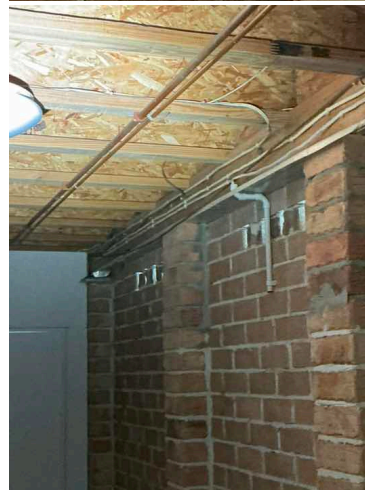
Of areas accessible and visible, the subfloor and components appeared to be in a serviceable condition.

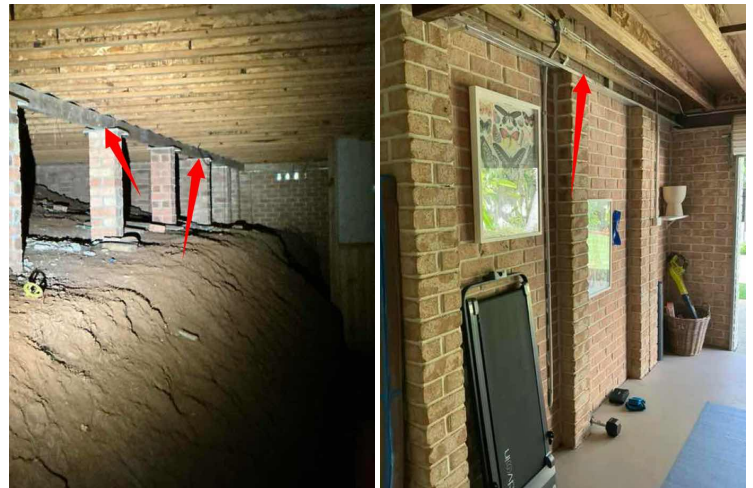
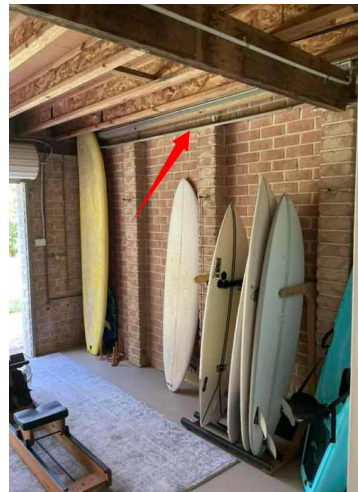
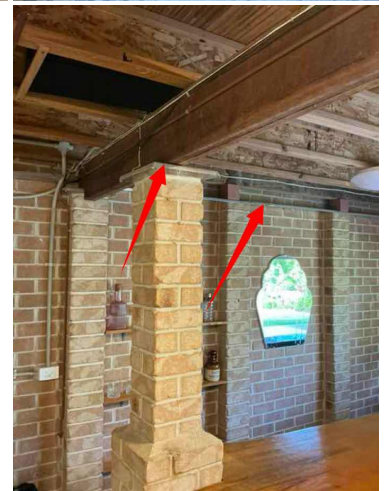
The ant capping is generally considered adequate.
