Building and Pest Report

8 Stonehenge Pl Lennox Head

Report/Agreement #	250225125443260
Inspection Date:	25 Feb 2025
Inspection Time:	12:54 pm

Pest And Building Inspection

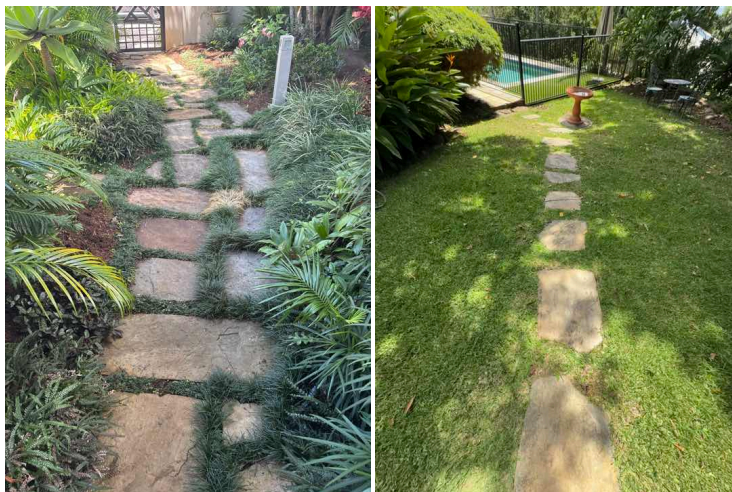
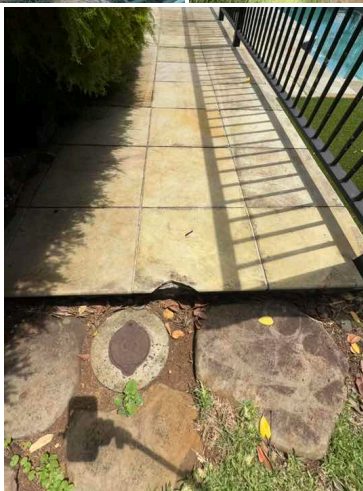
Pathways Condition

The paths around the home are in a serviceable condition for the age of this dwelling with no major defects visible.

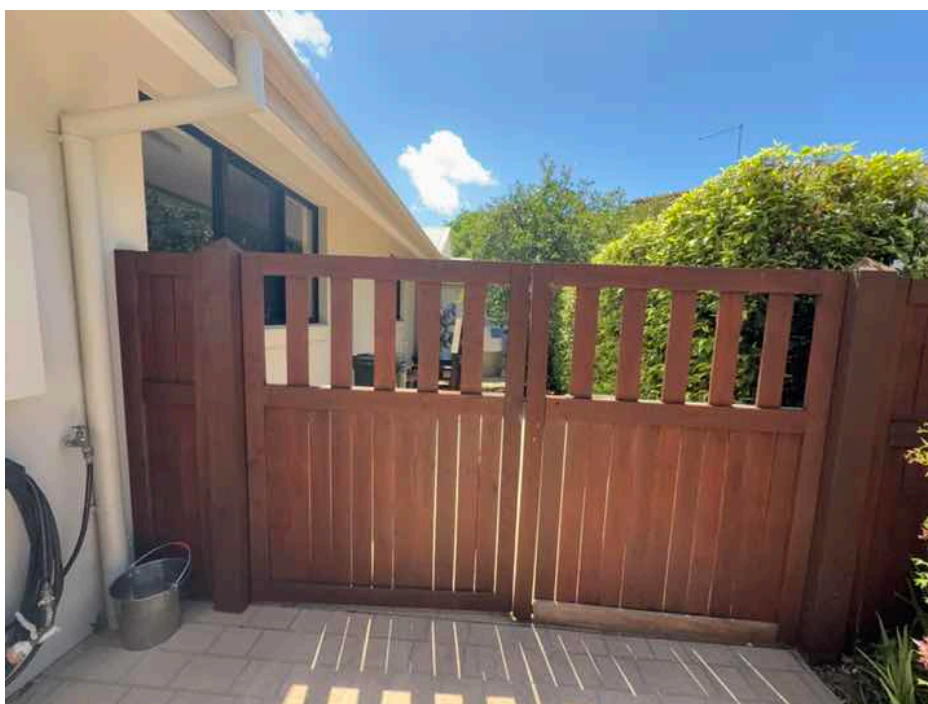
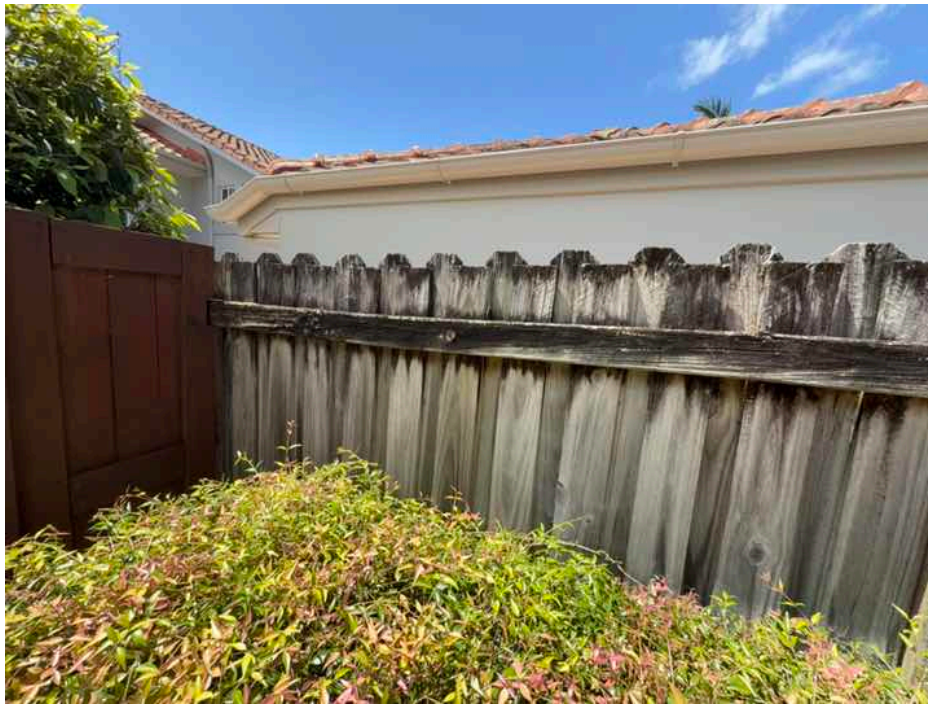
Fences & Gates

Of the visible areas, the general condition of the fences and gates is serviceable for the age of dwelling.

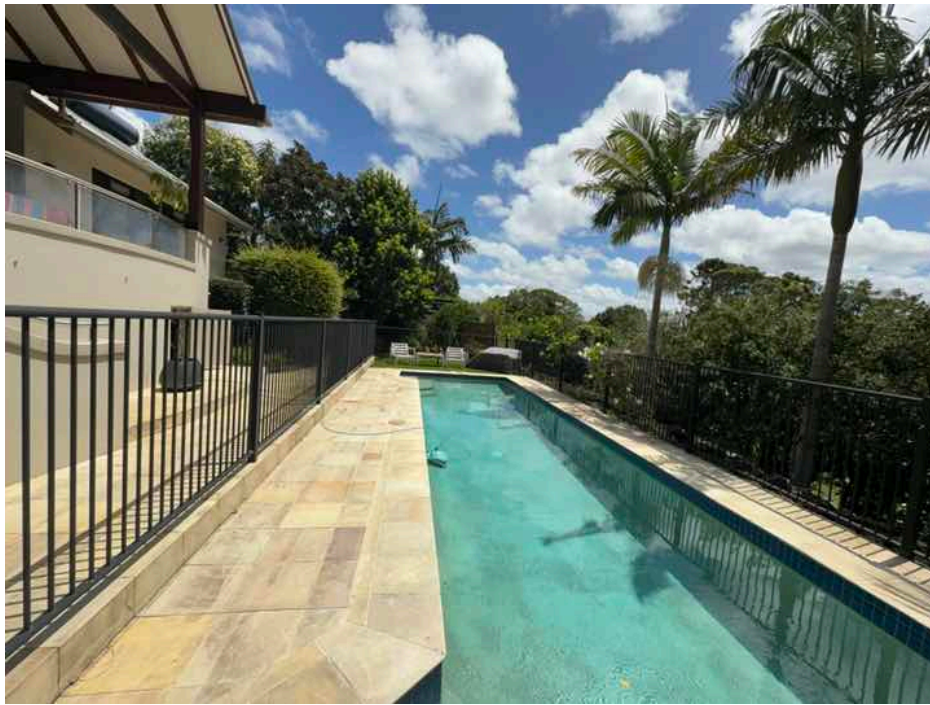
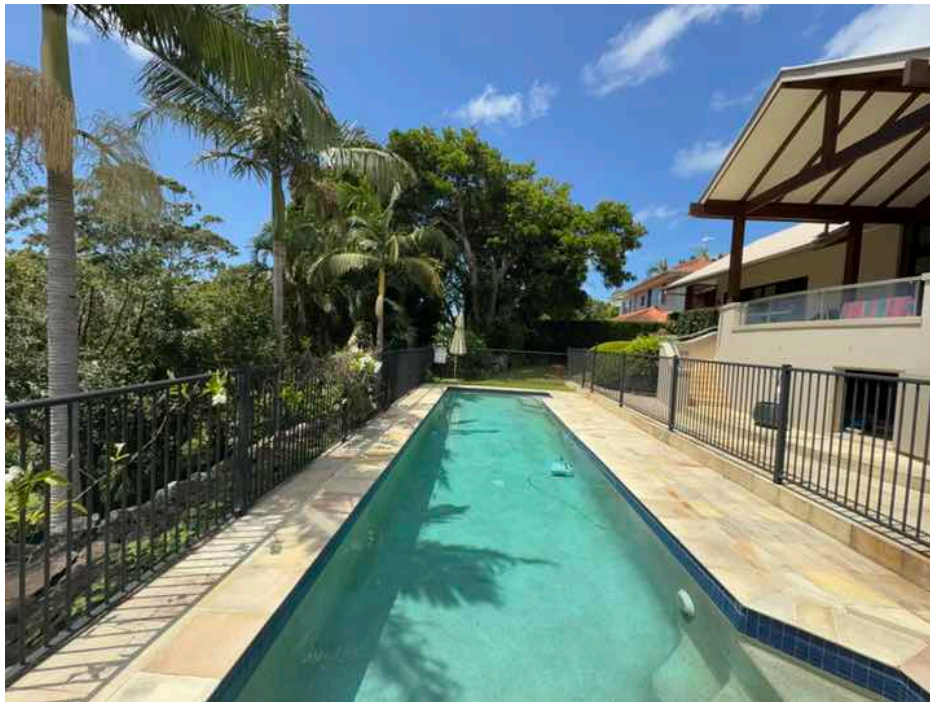
Pool Fence

Pool fence and signage were sighted.

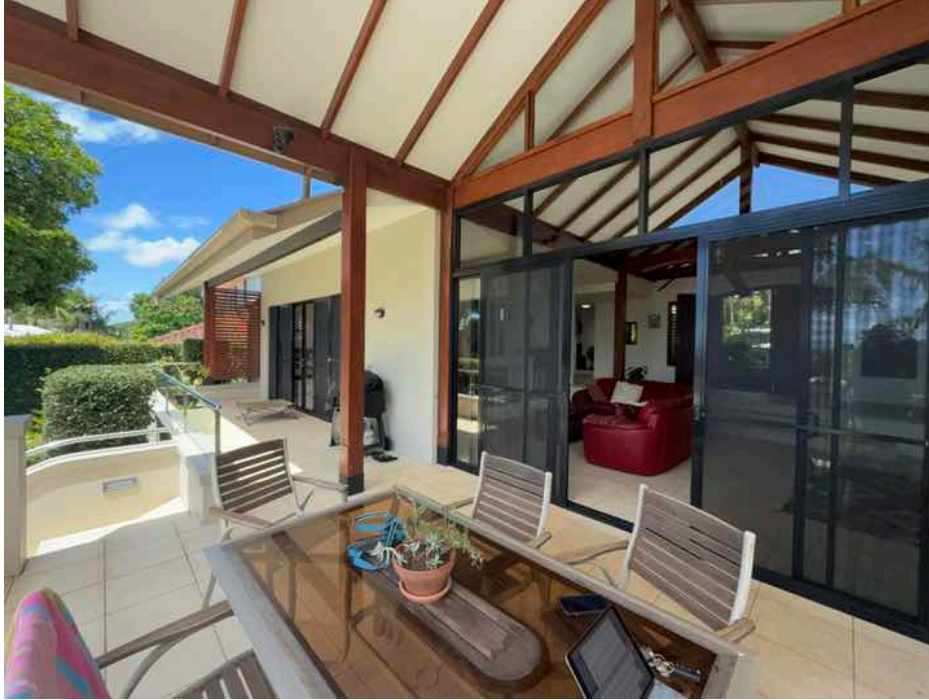
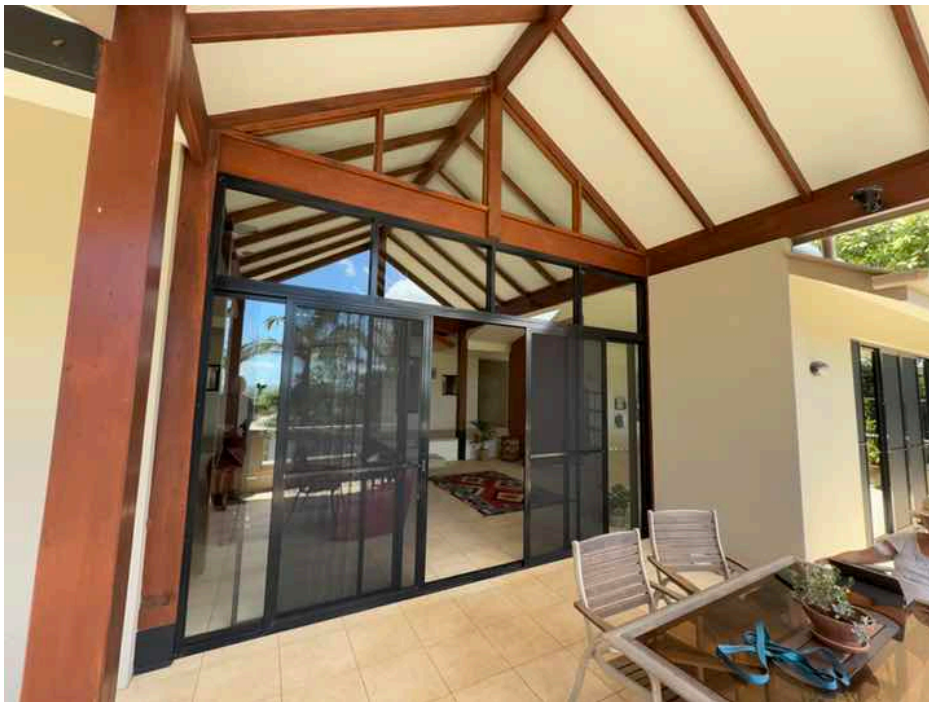
Visible sections of the Alfresco area are serviceable or in reasonable or condition for the age of this dwelling.

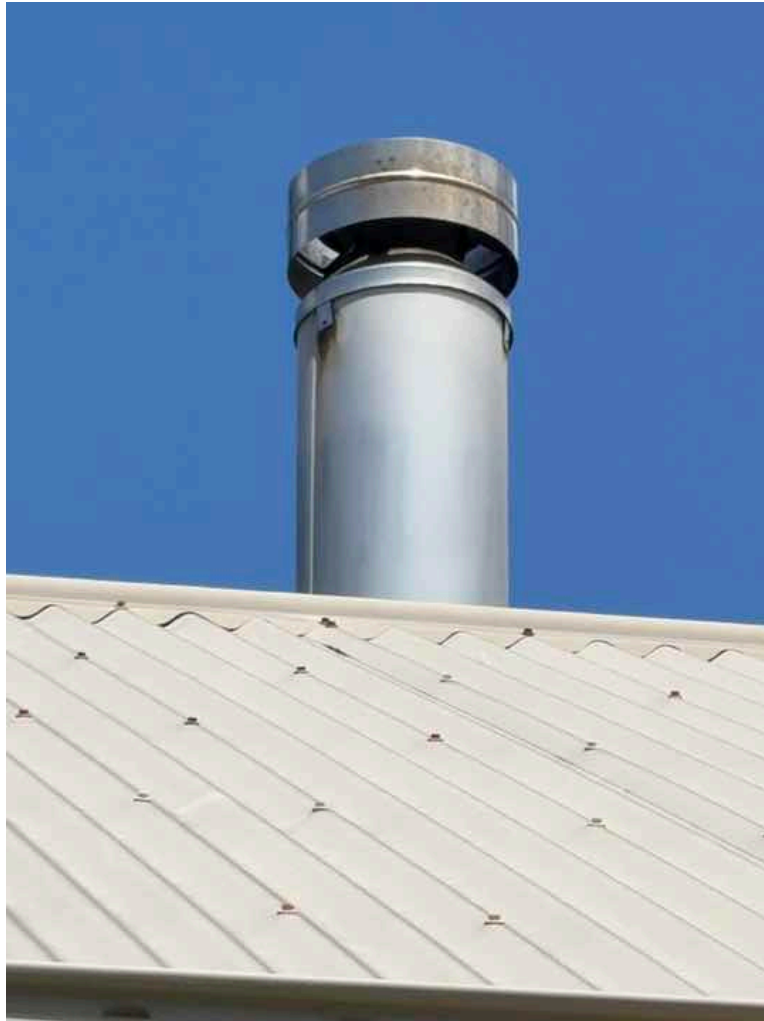
Chimney

On visual inspection, the general condition of the chimney walls is serviceable for the age.

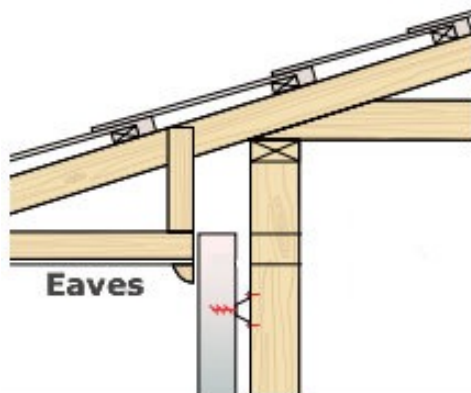
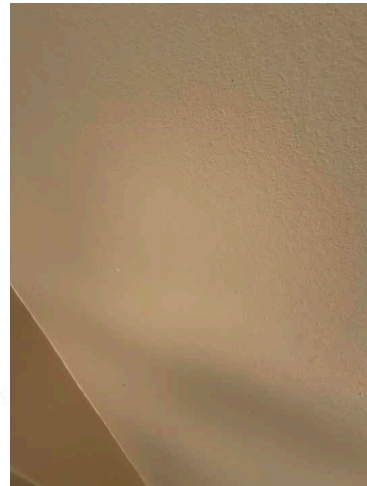
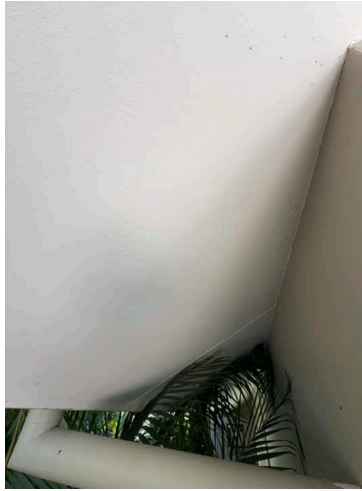
Eaves

The soffit lining (eaves) are in a serviceable condition with no notable defects.

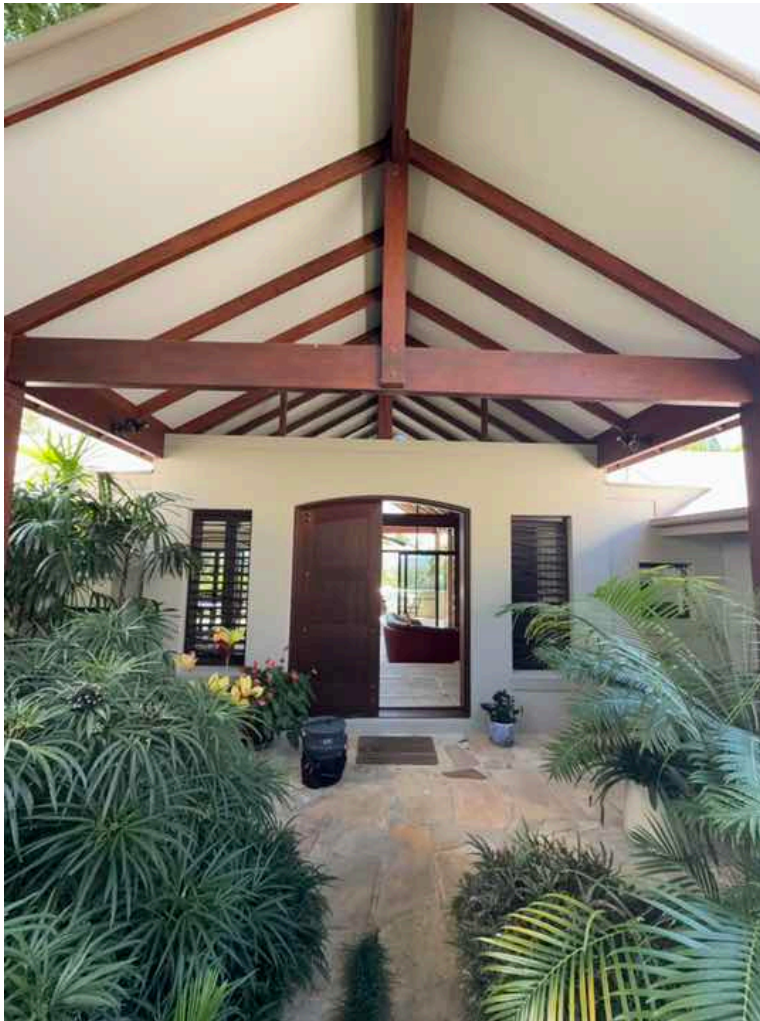
Entry Porch Area

The entry porch serviceable or in reasonable or condition for the age of this dwelling.

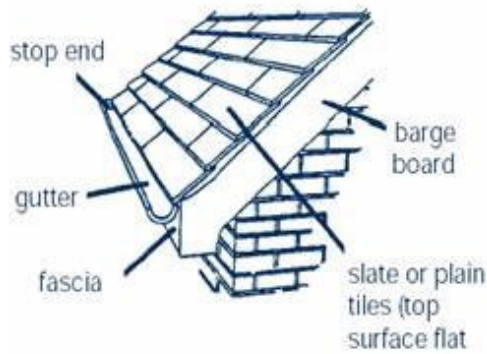
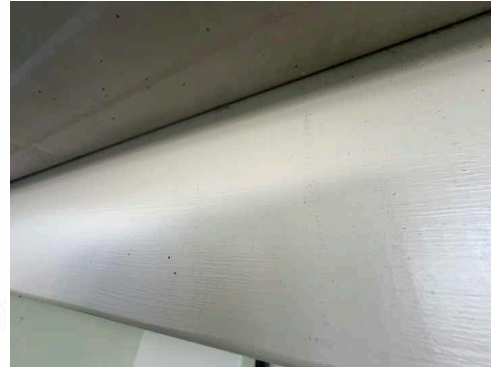
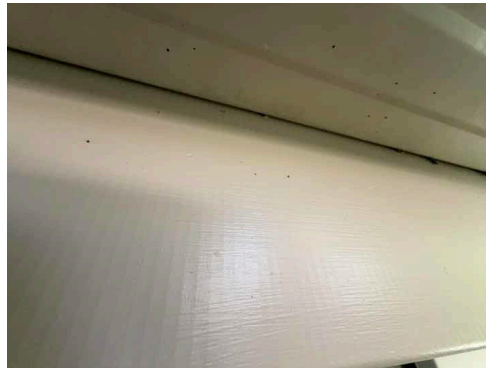
On visual inspection, the general condition of the fascia/barge boards is serviceable.

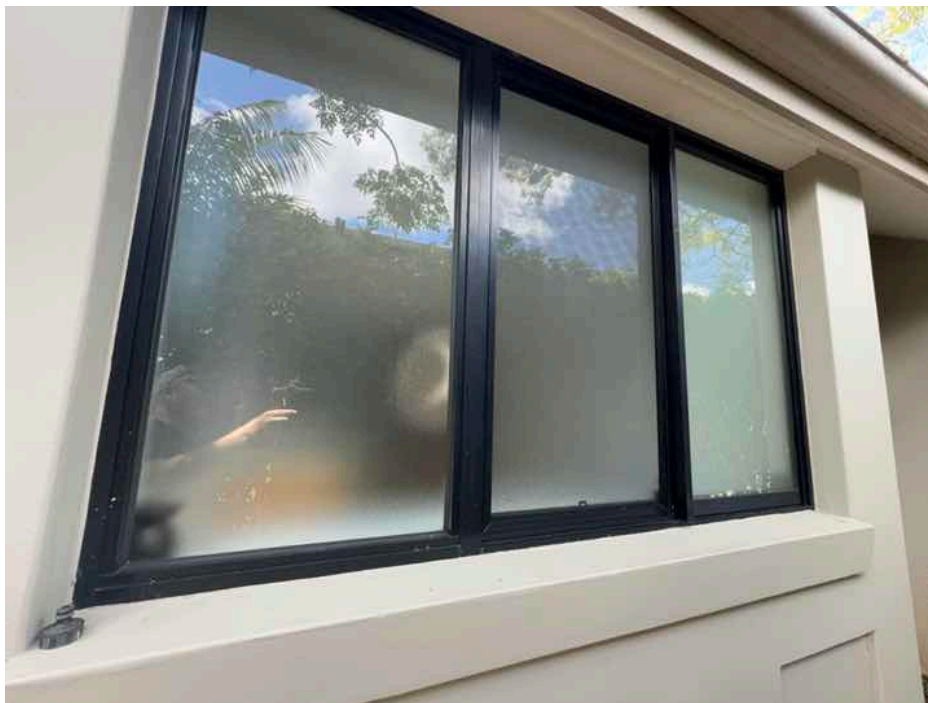
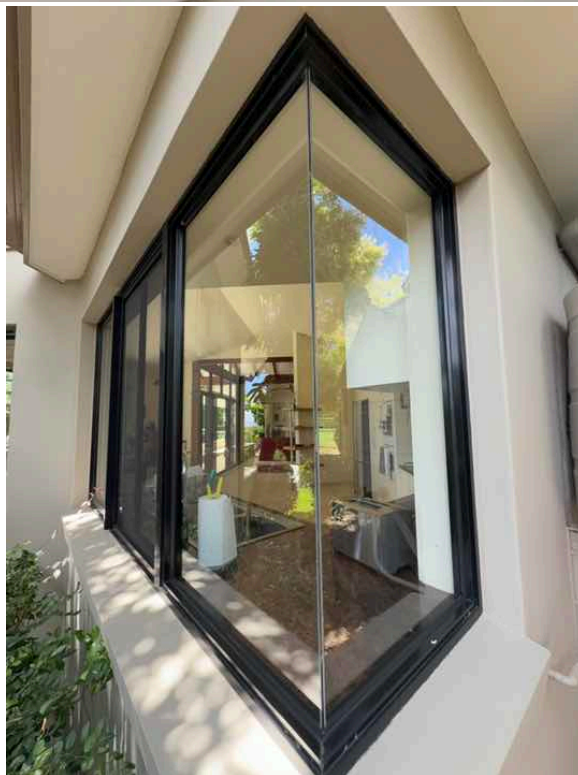
On visual inspection, the general condition of the windows is serviceable for the age.

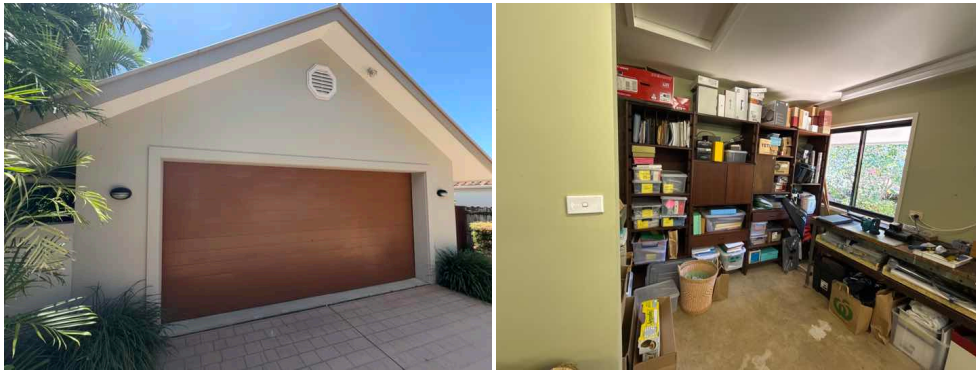
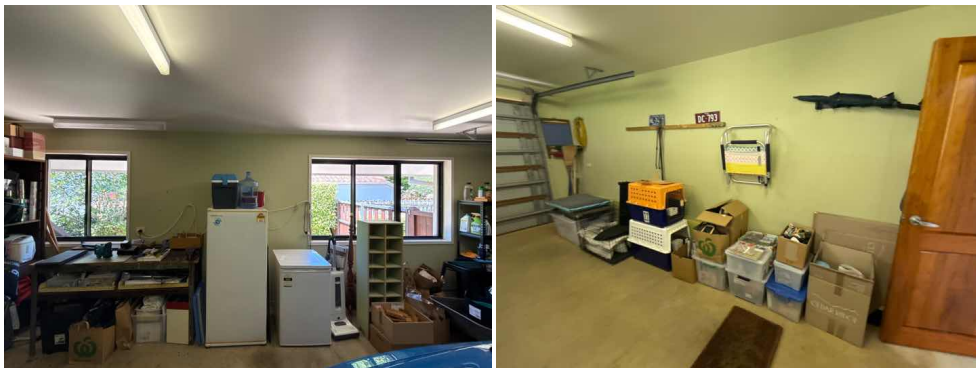
From the visible and accessible areas, the garage appears to be in a serviceable condition for the age of the property with no notable structural defects sighted.

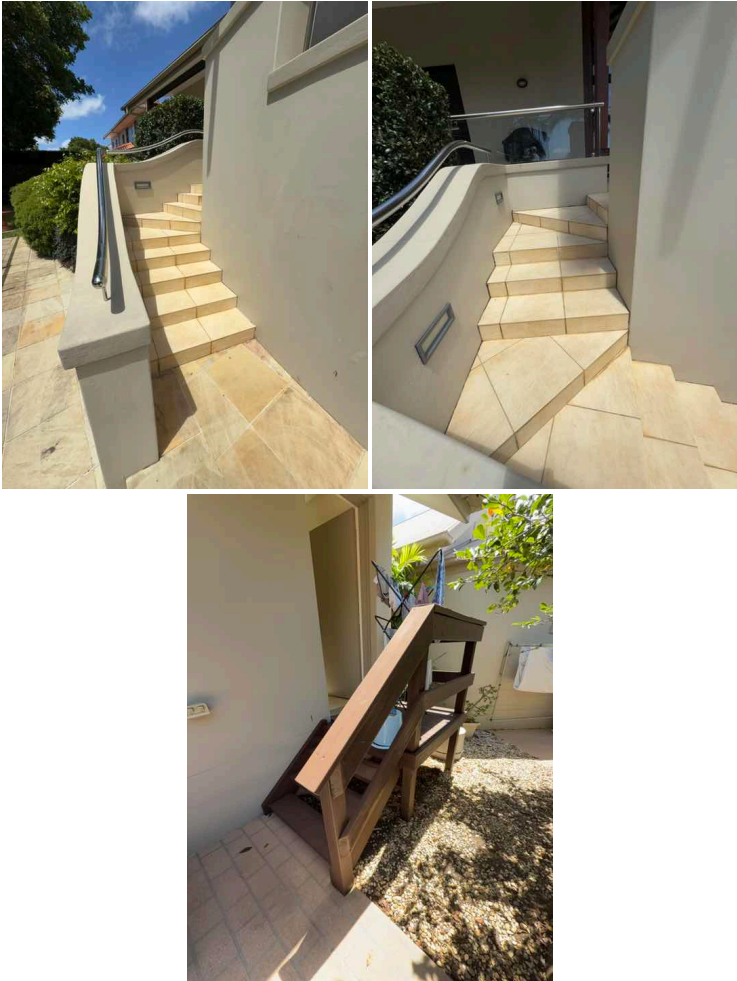
The stairs/steps appear to be serviceable with no notable defects.

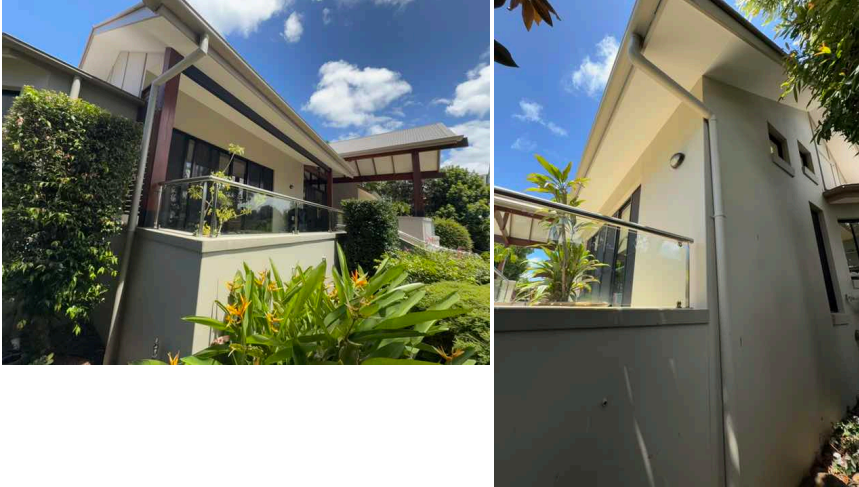
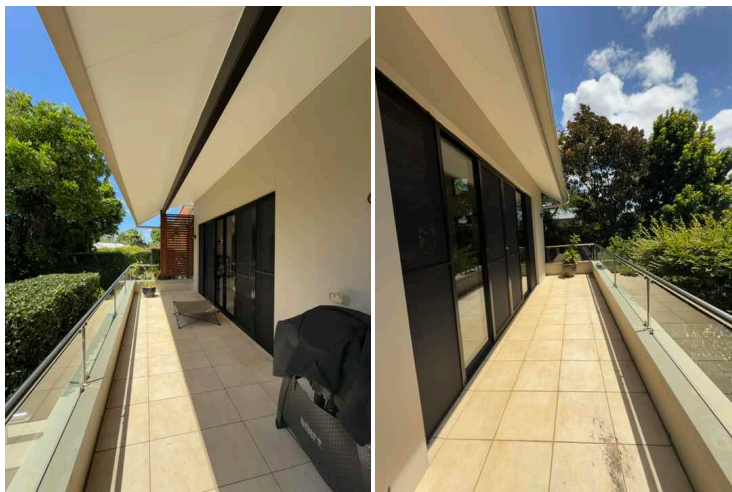
Balcony Findings

Though we are not structural engineers the balcony/s appear to be in a serviceable condition.

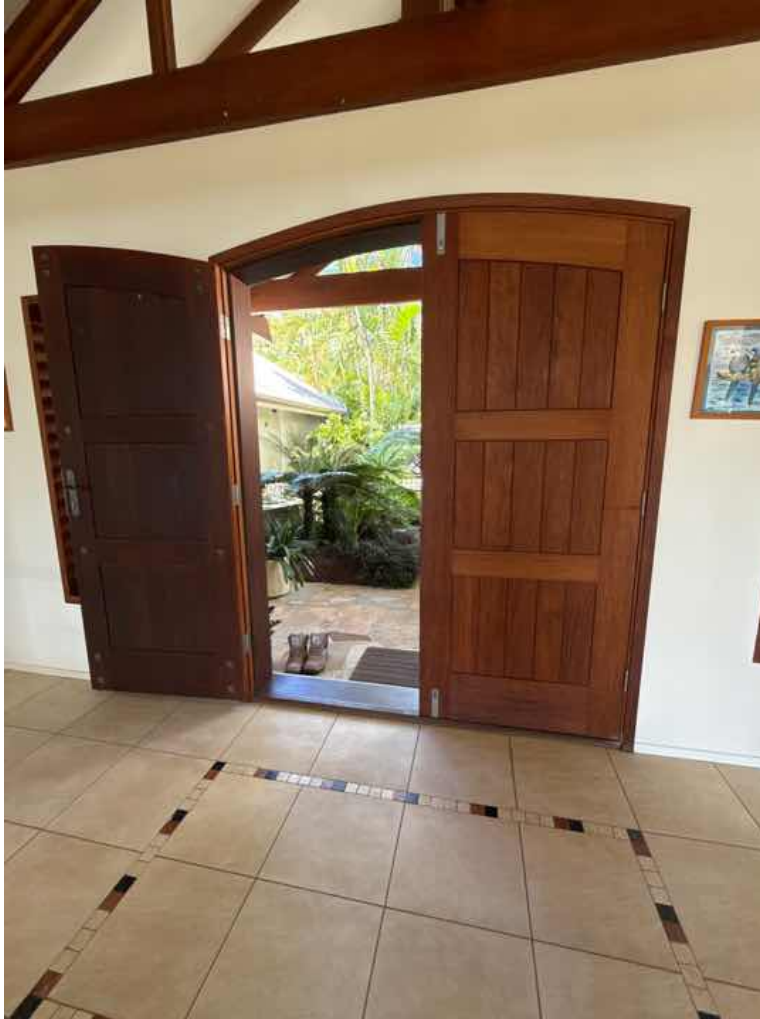
Front Entry Doors

The doors are in serviceable condition with no notable defects observed.

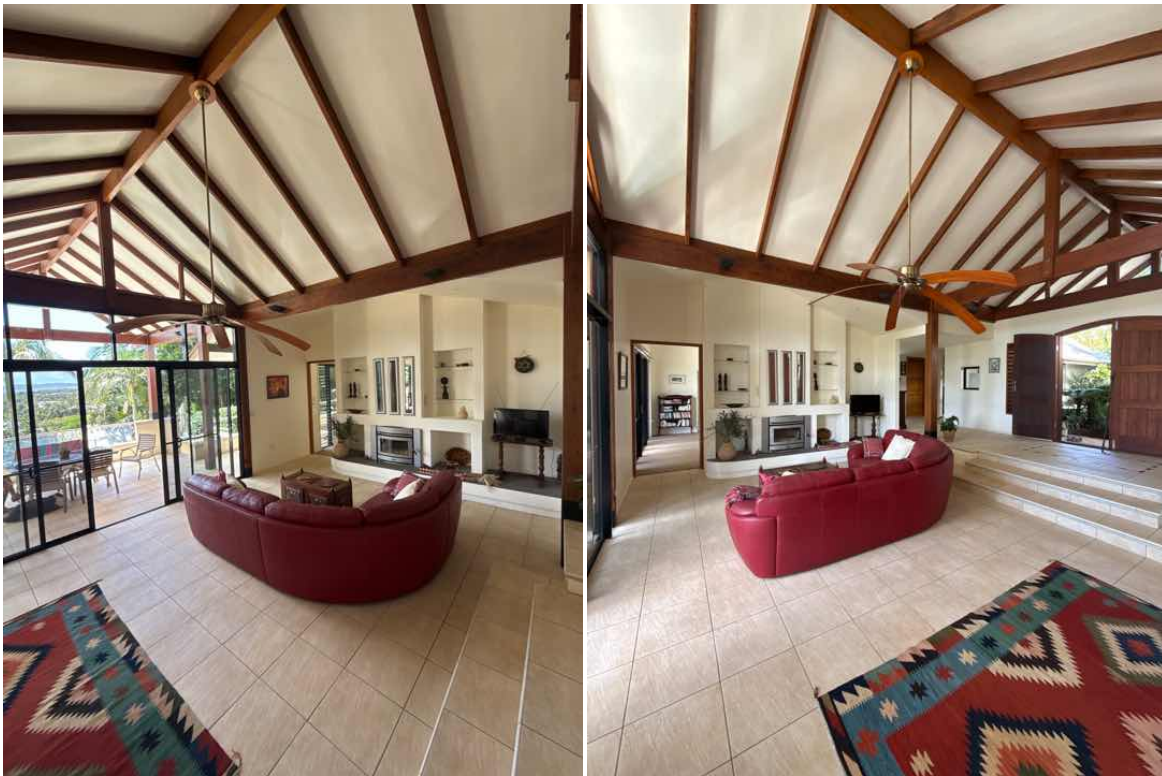
From the visible and accessible areas, this room appears to be in a serviceable condition for the age of the property with no notable structural defects sighted.

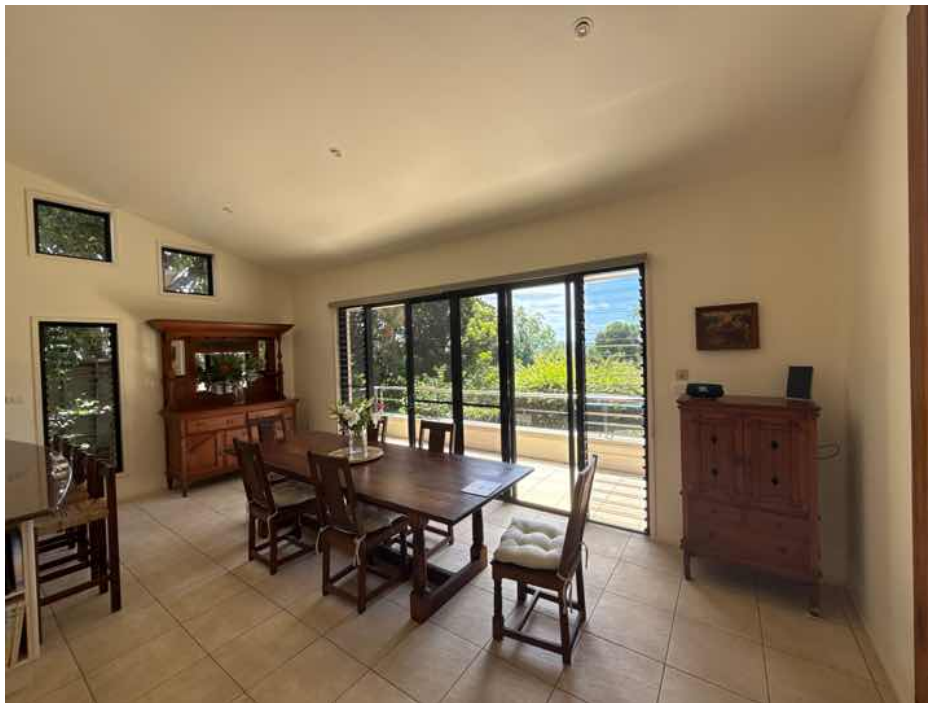
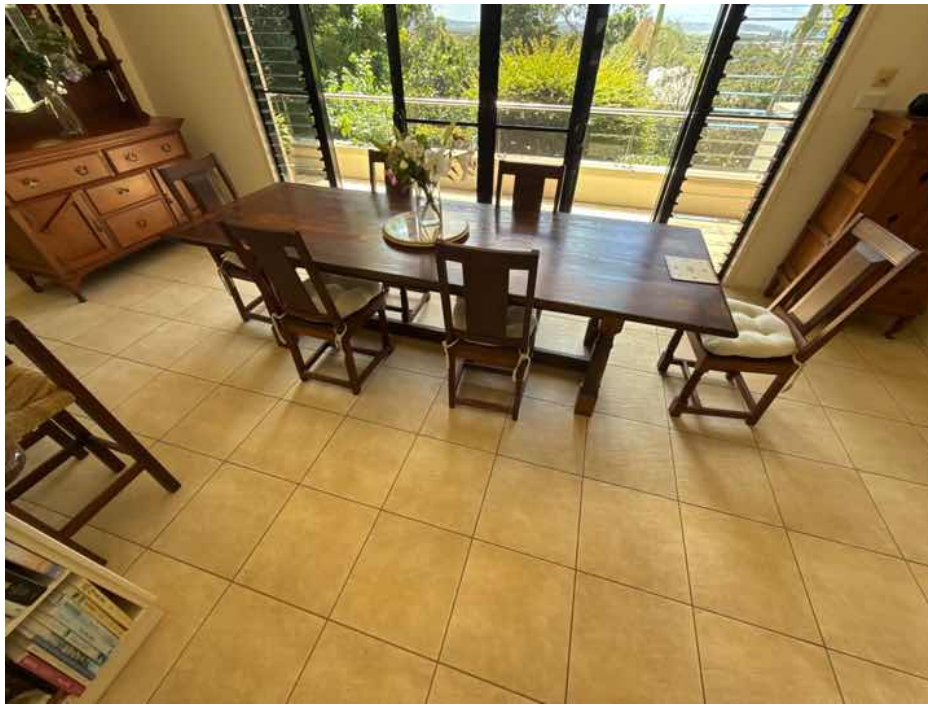
Dining Room

From the visible and accessible areas, this room appears to be in a serviceable condition for the age of the property with no notable structural defects sighted.

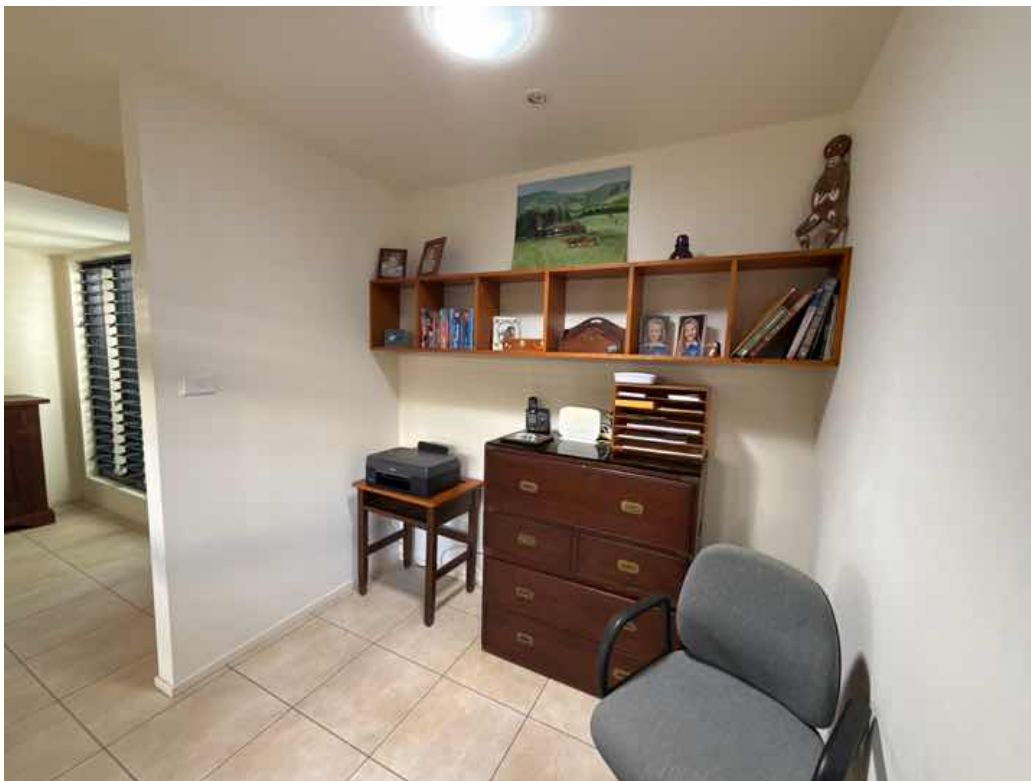
Study

From the visible and accessible areas, this room appears to be in a serviceable condition for the age of the property with no notable structural defects sighted.

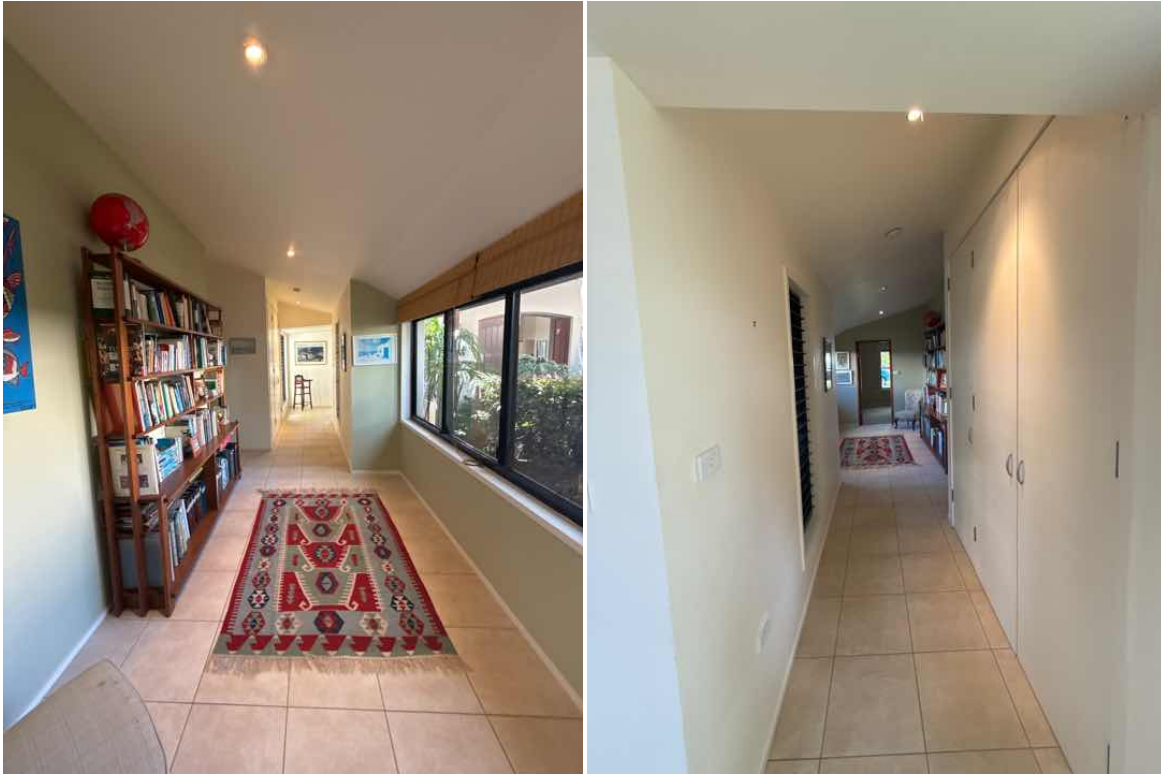
Hallway/s

From the visible and accessible areas, the hallway/ appears to be in a serviceable condition for the age of the property with no notable structural defects sighted.

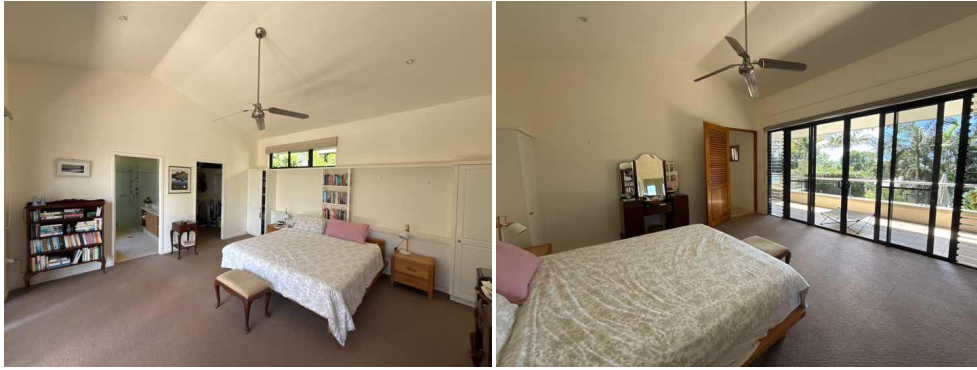
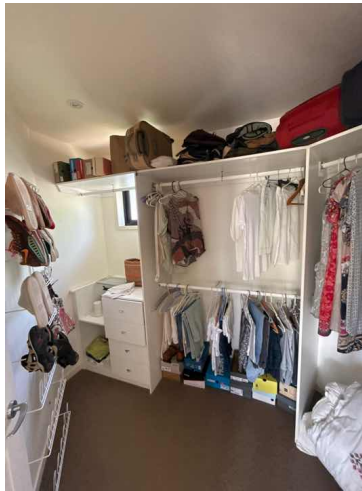
From the visible and accessible areas, this bedroom appears to be in a serviceable condition for the age of the property with no notable structural defects sighted.

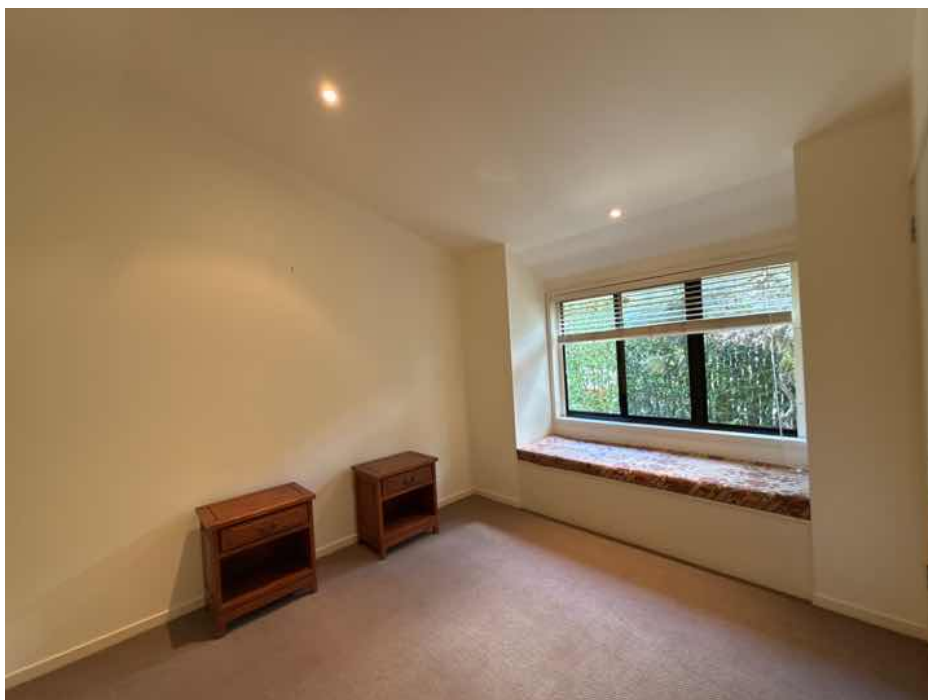
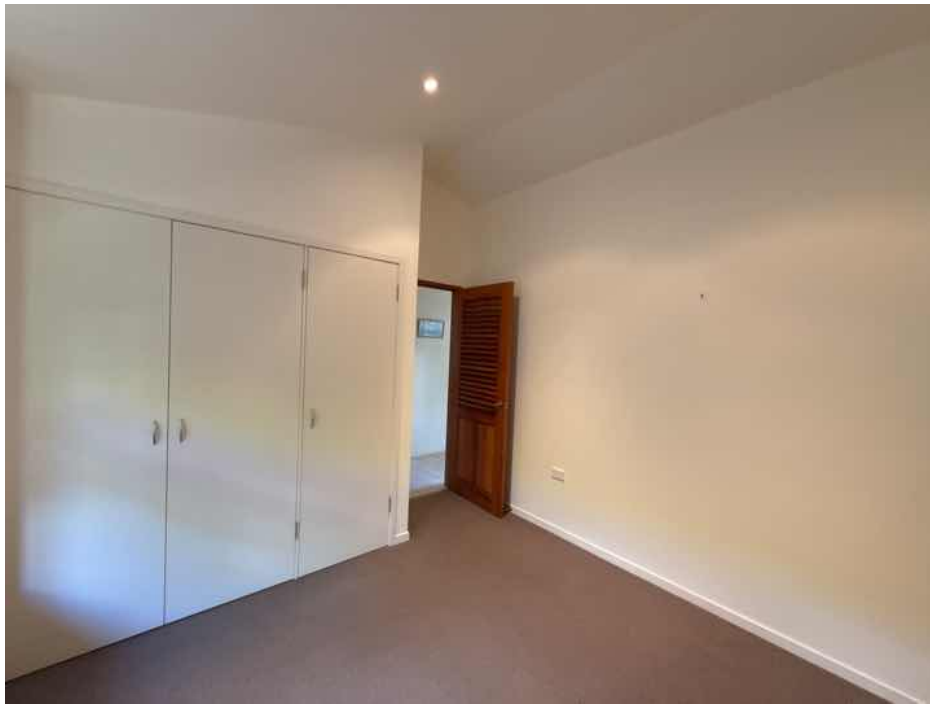
Bedroom 2

From the visible and accessible areas, this bedroom appears to be in a serviceable condition for the age of the property with no notable structural defects sighted.

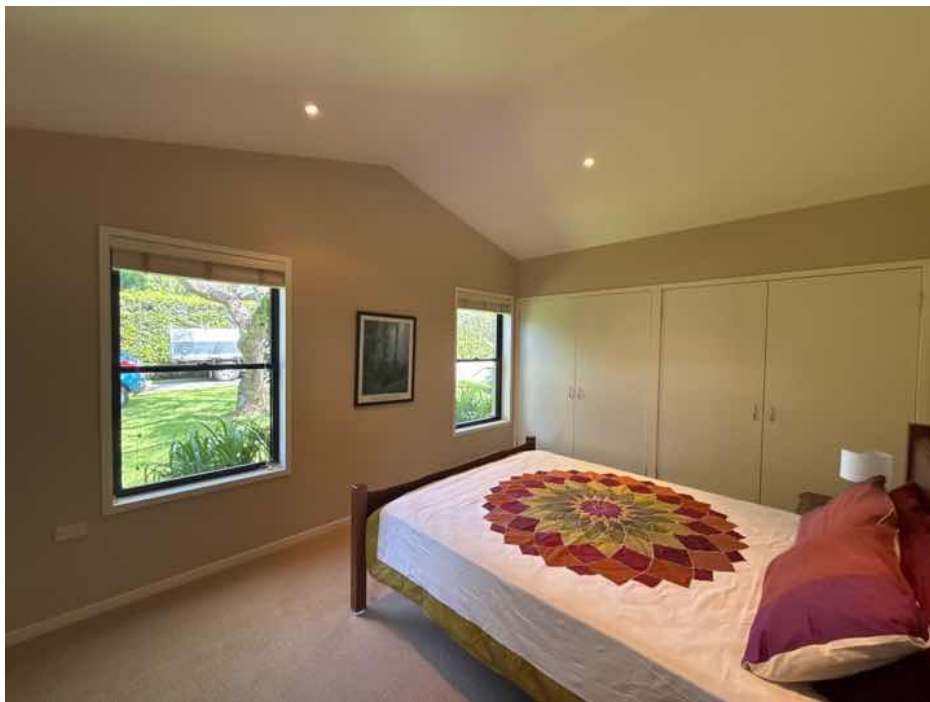
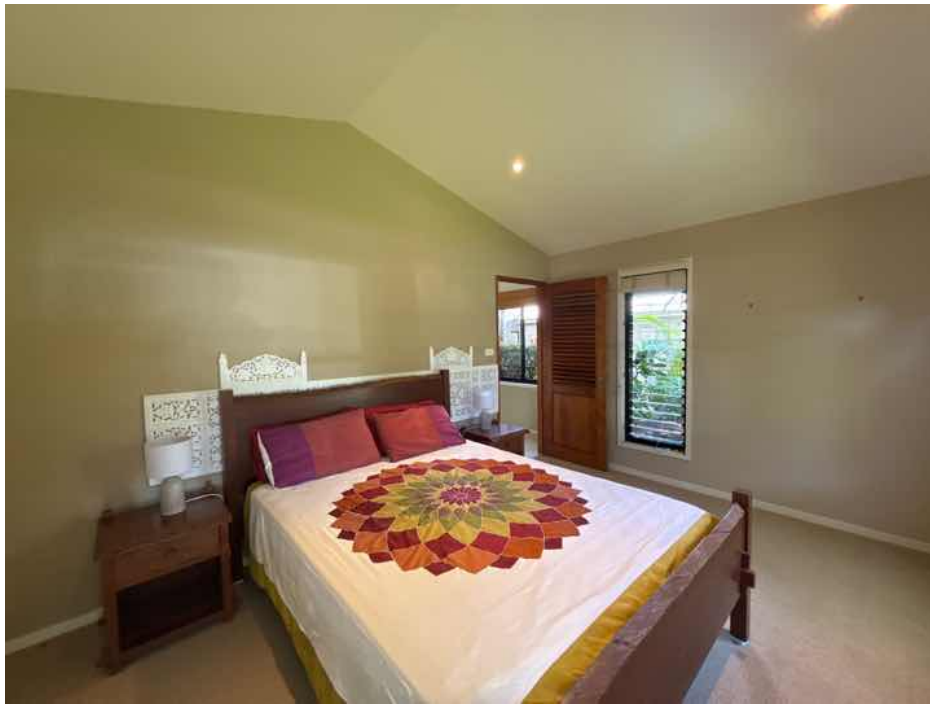
Bedroom 3

From the visible and accessible areas, this bedroom appears to be in a serviceable condition for the age of the property with no notable structural defects sighted.

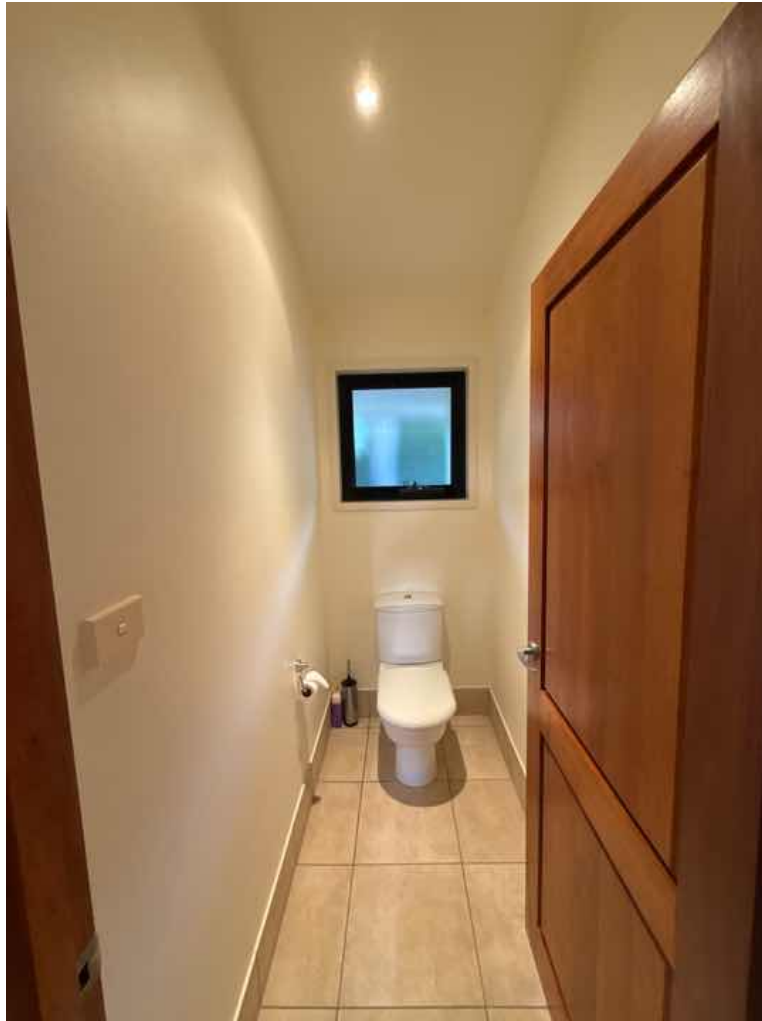
Of the visible areas, the general condition of this bathroom is serviceable or in reasonable condition for age of dwelling.

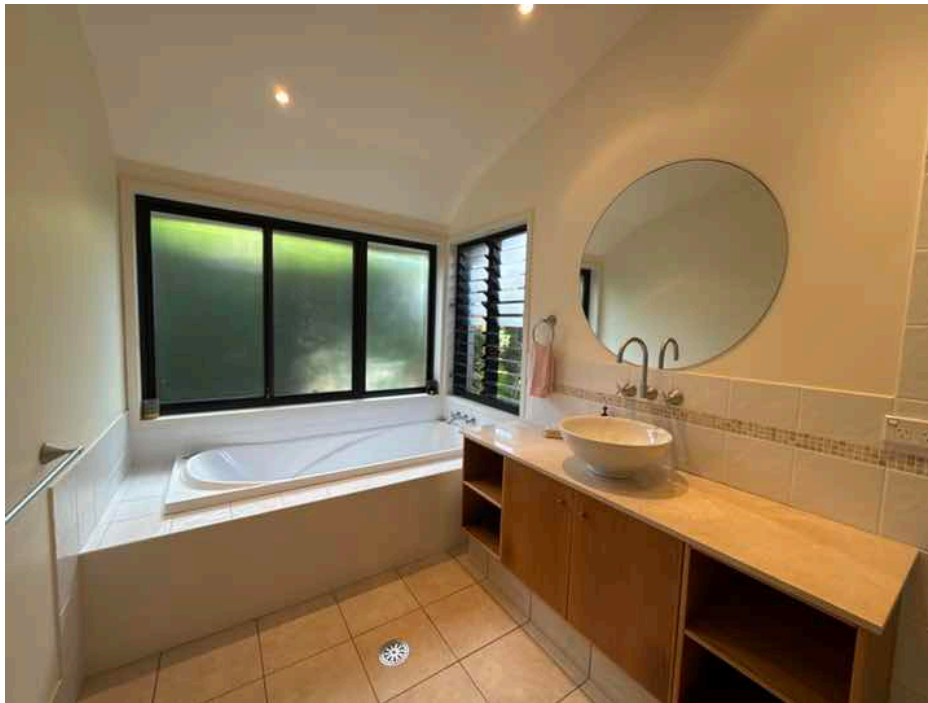
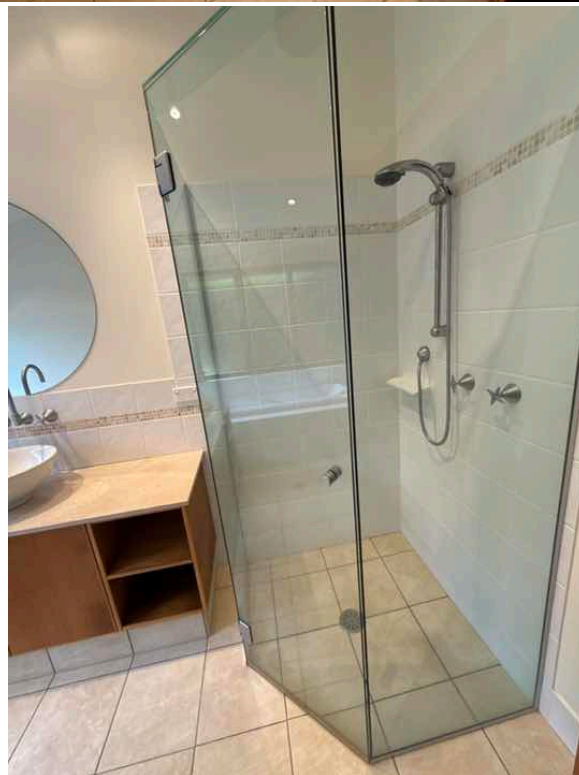
Of the visible areas, the general condition of this bathroom is serviceable or in reasonable condition for age of dwelling.

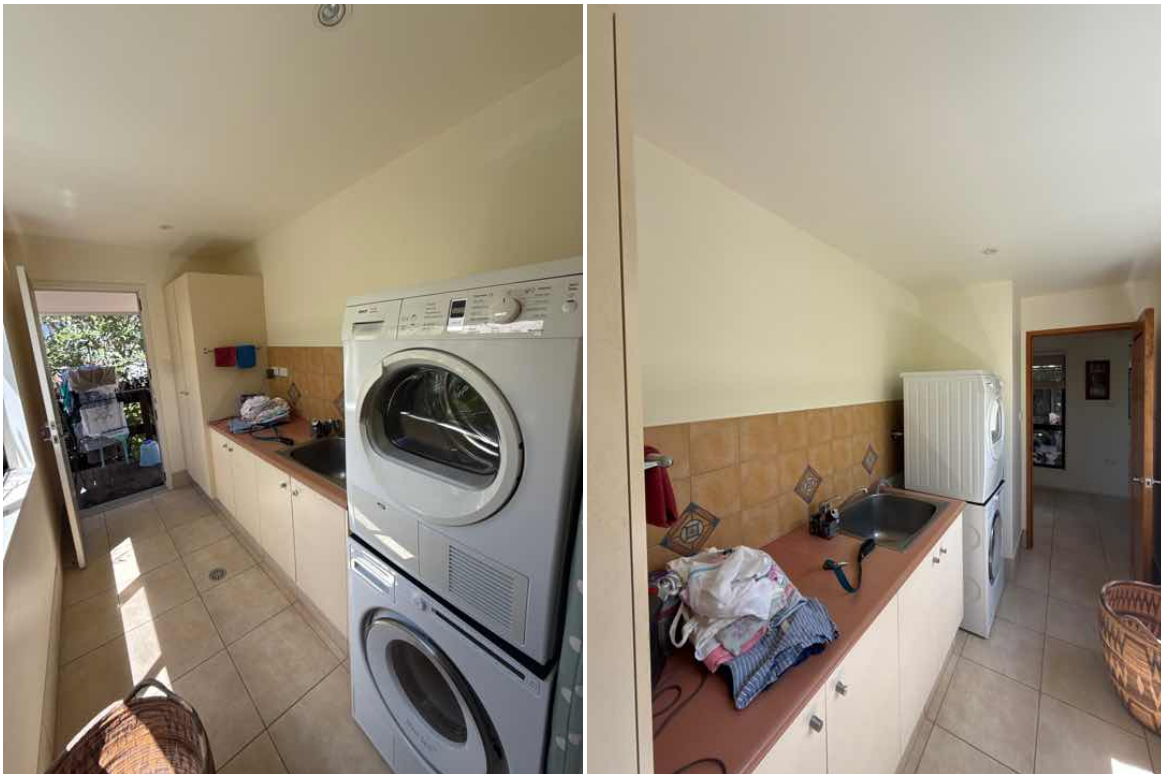
Of the visible areas, the general condition of the laundry is serviceable or in reasonable condition for age of dwelling.

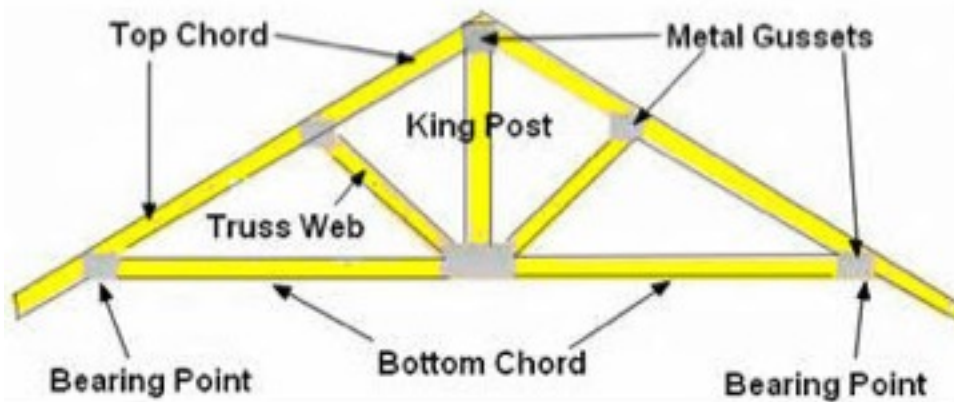
Common Roof Truss

Cathedral/Raked Design - There is no crawl space in this ceiling design.
