Building and Pest Report

8 Stonehenge Pl Lennox Head

Report/Agreement #	250225125443260
Inspection Date:	25 Feb 2025
Inspection Time:	12:54 pm

Pest And Building Inspection

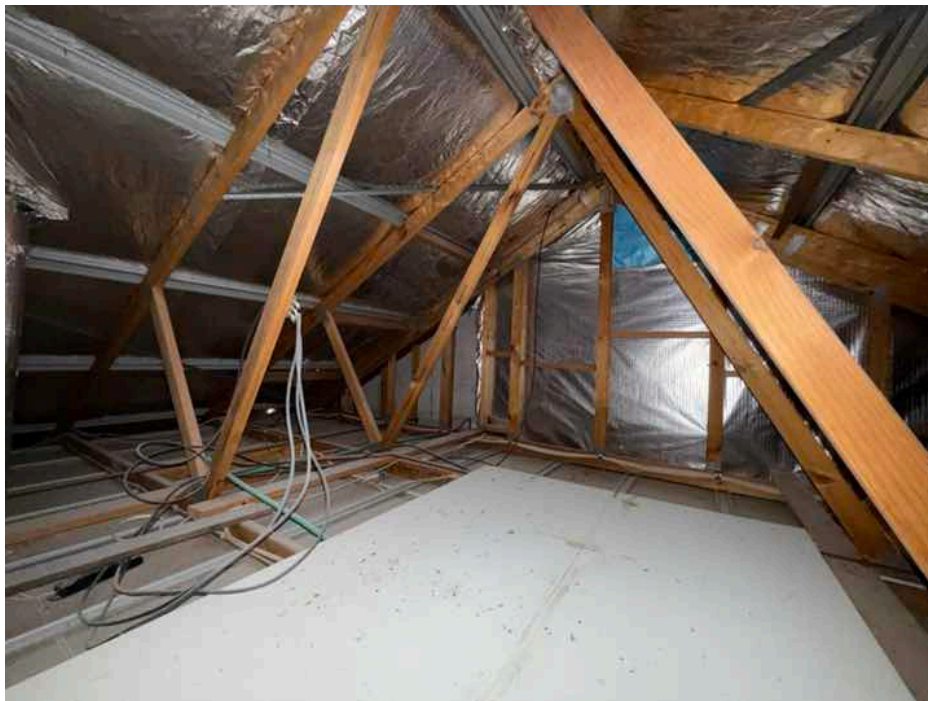
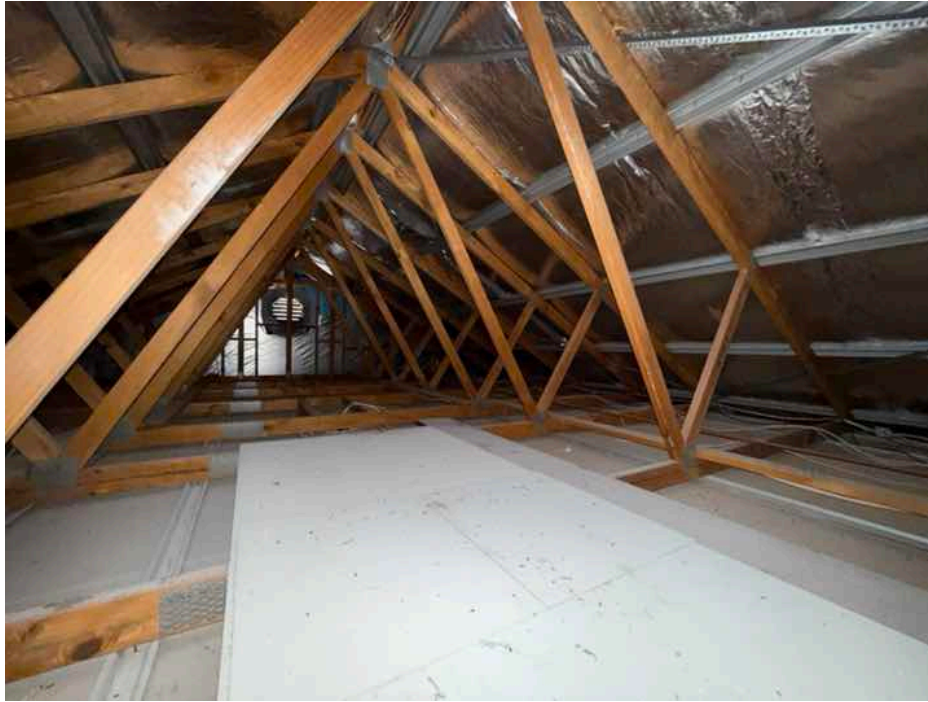
Visible sections of the roof void is in a serviceable condition for age of this dwelling.

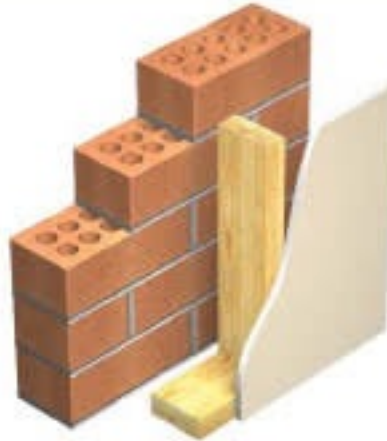
BRICK VENEER WALL

Rendered masonry.
