Building and Pest Report

9 Sand Street Skennars Head

Inspection Report

9 Sand St, Skennars Head, NSW, 2378

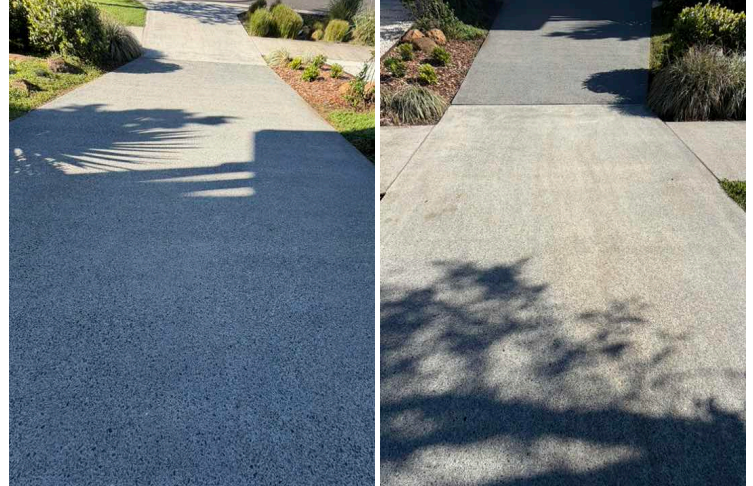
Driveway Condition

On visual inspection, the general condition of the driveway is serviceable.

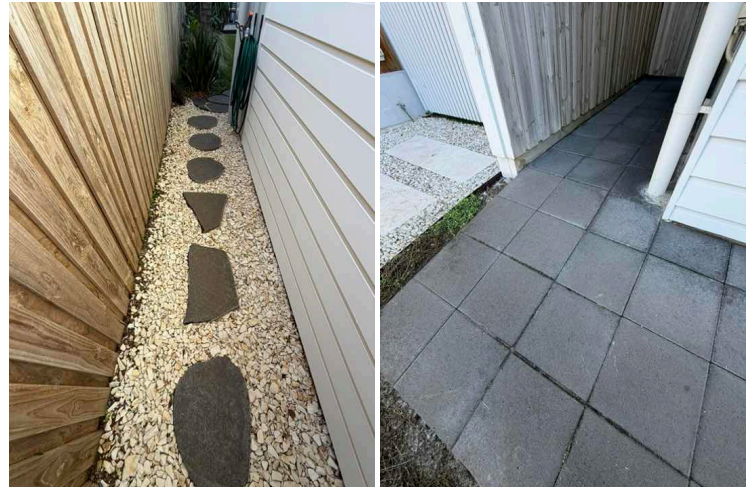
Pathways Condition

The paths around the home are in a serviceable condition for the age of this dwelling with no major defects visible.

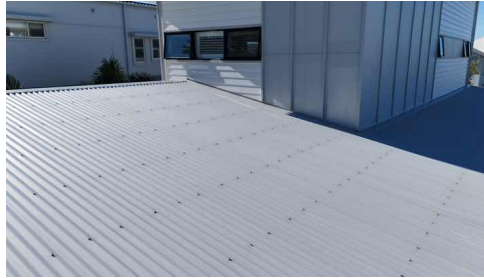
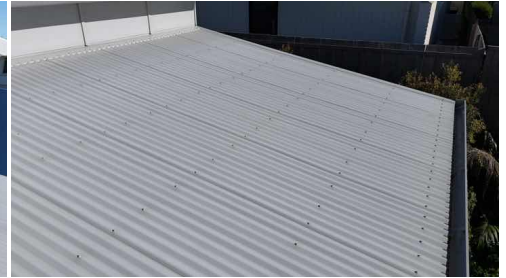
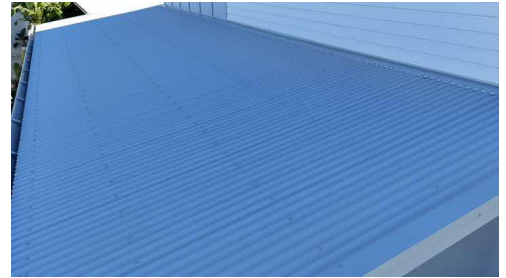
Overall Condition

Of the visible areas, the general condition of the roof is in serviceable condition for the age.

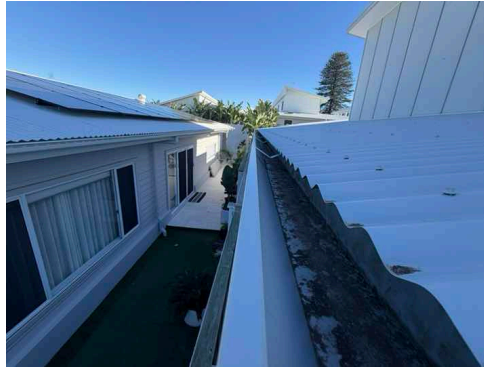
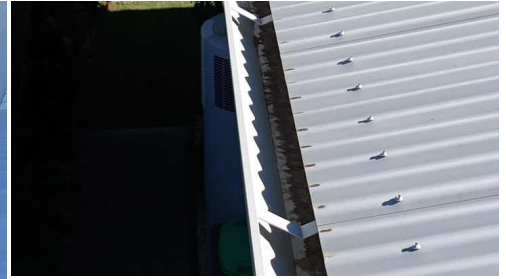
Gutter Findings

All visible and accessible of the physical nature of the guttering system appears to be in a serviceable condition with no apparent defects at the time of inspection. In the absence of prolonged rain fall efficiency of the guttering can not be assessed and you may find that further investigation or repairs maybe required. Note: Periodic maintenance checks should be carried out for rust penetrations and leaks.

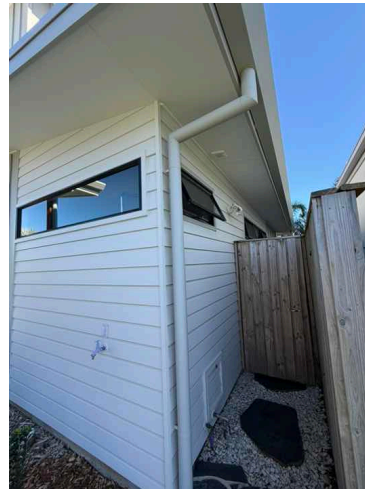
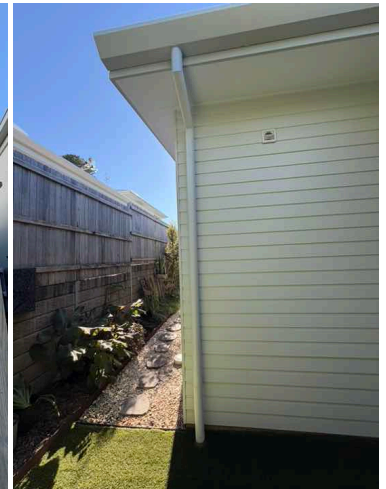
Downpipe Findings

On visual inspection no apparent defects were noted to the down pipes and are considered serviceable, however no comment can be made with regard to blockages or connections to stormwater or functionality in the absence of rain. Note: Periodic maintenance checks should be carried out for rust penetrations and leaks.

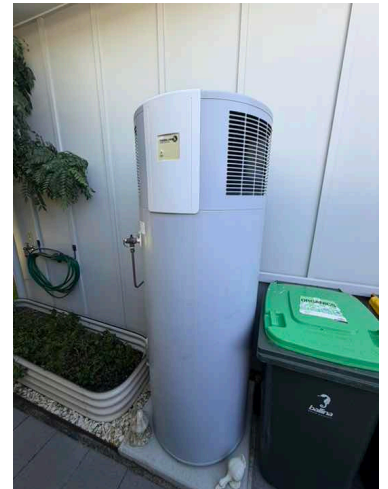
System Make

Leaking observed from hot water unit at time of inspection. Engage a licensed plumber to assess and rectify.

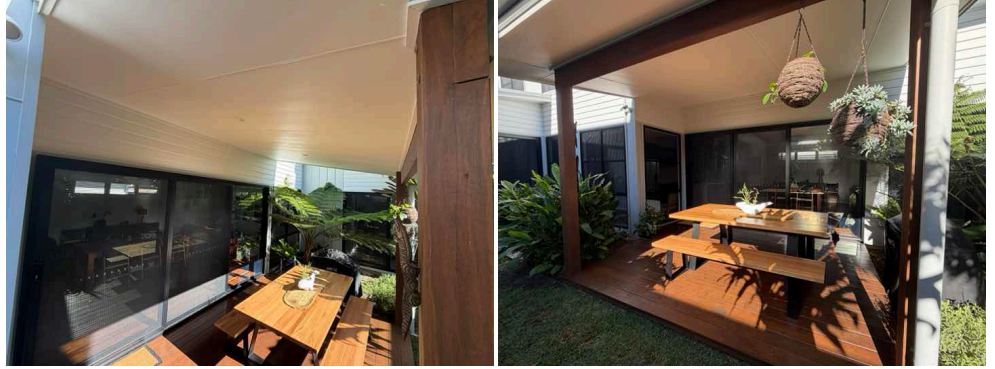
Overall Condition

Visible sections of the Alfresco area are serviceable or in reasonable or condition for the age of this dwelling.

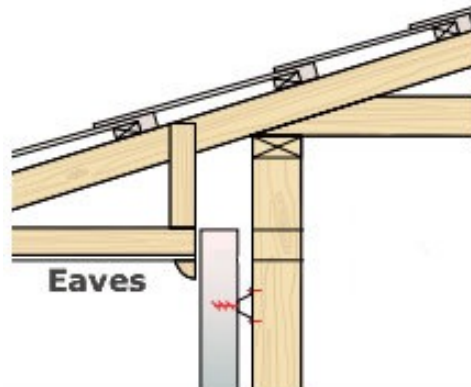
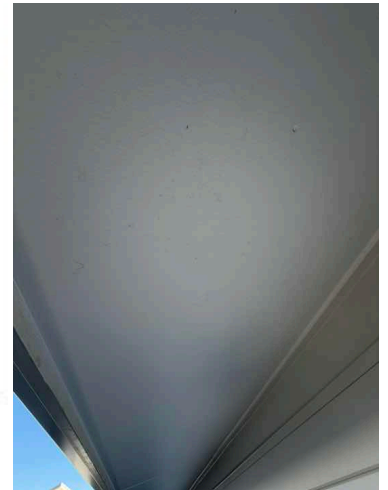
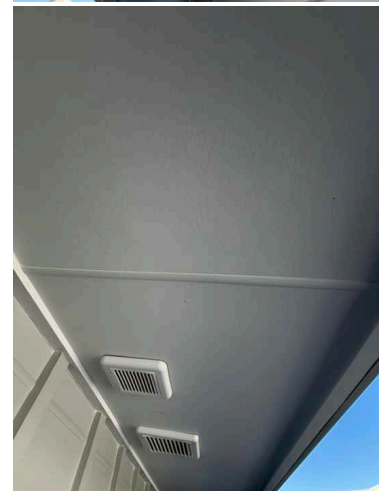
Eave Condition

The soffit lining (eaves) are in a serviceable condition with no notable defects.

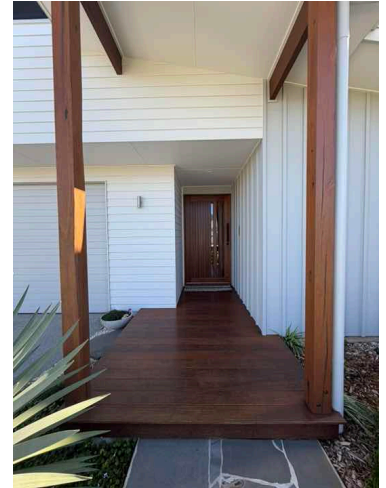
Overall Condition

The entry porch serviceable or in reasonable or condition for the age of this dwelling.

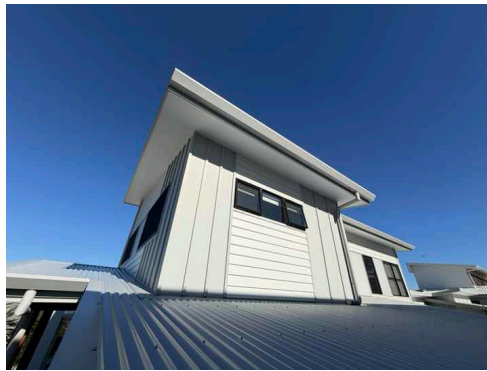
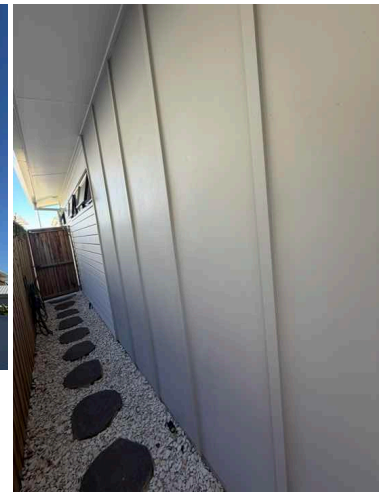
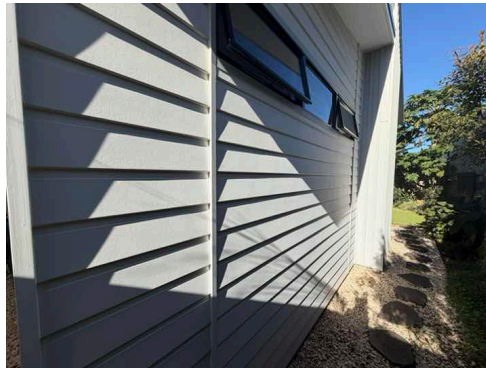
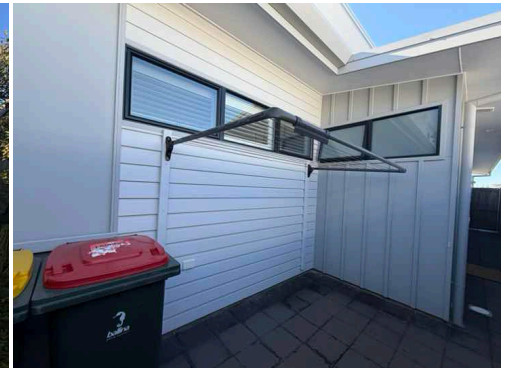
Condition

On visual inspection, the general condition of the exterior walls is serviceable for the age.

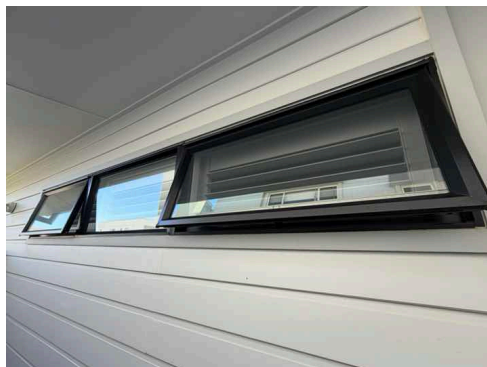
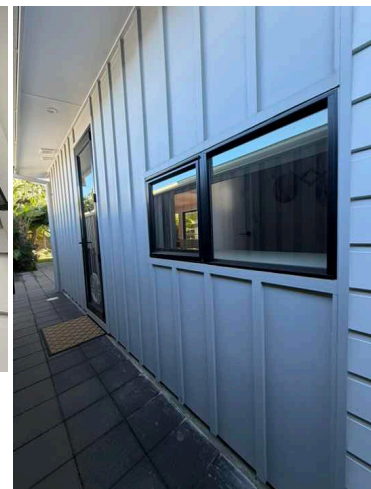
Overall Condition

On visual inspection, the general condition of the windows is serviceable for the age.

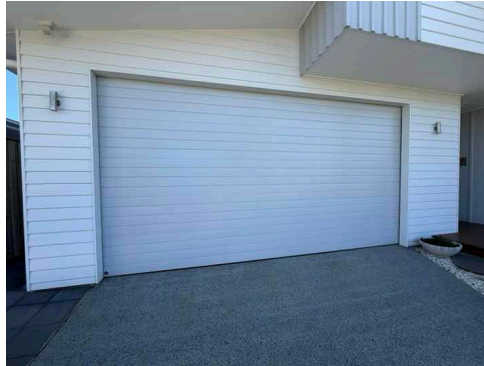
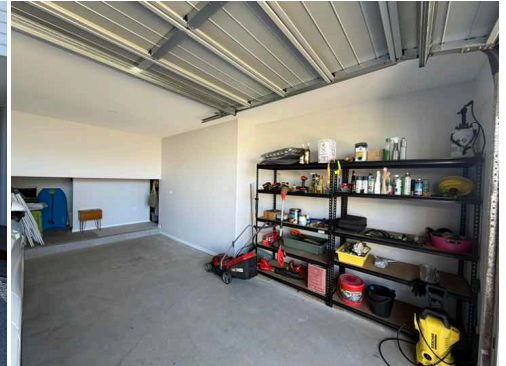
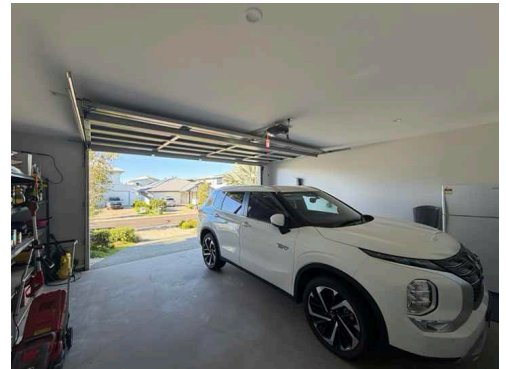
Overall Condition

From the visible and accessible areas, the garage appears to be in a serviceable condition for the age of the property with no notable structural defects sighted.

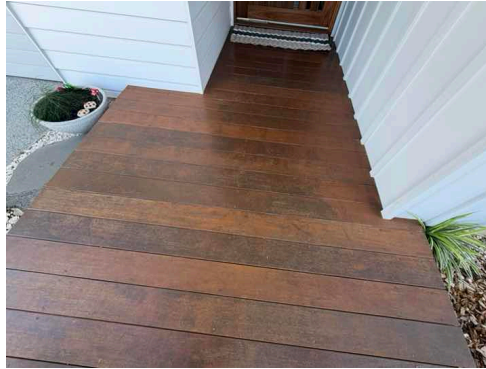
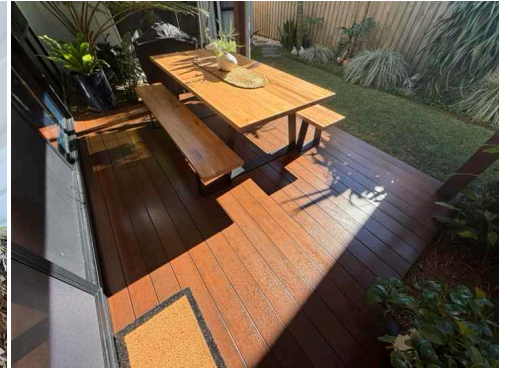
Overall Condition

Of areas visible, the decking appears to be in a serviceable condition.

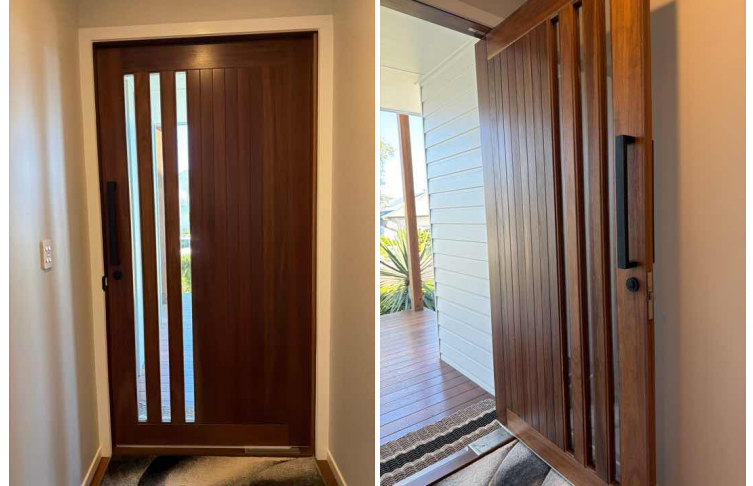
Front Entry Doors

The doors are in serviceable condition with no notable defects observed.

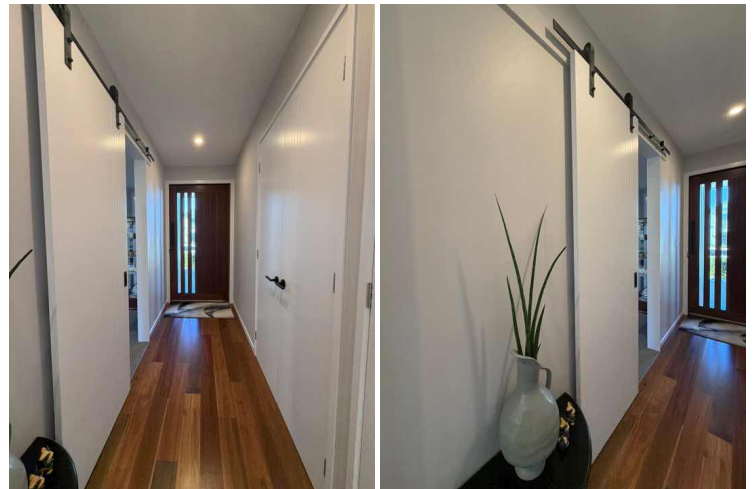
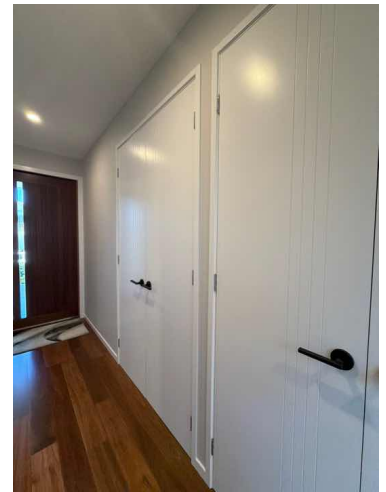
Overall Condition

From the visible and accessible areas, this area appears to be in a serviceable condition for the age of the property with no notable structural defects sighted.

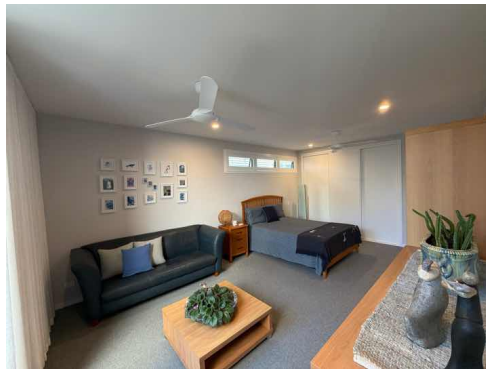
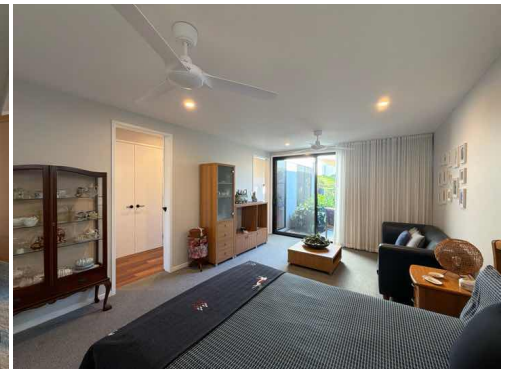
Living Room

From the visible and accessible areas, this room appears to be in a serviceable condition for the age of the property with no notable structural defects sighted.

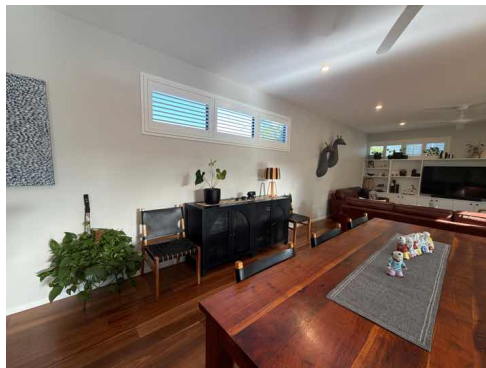
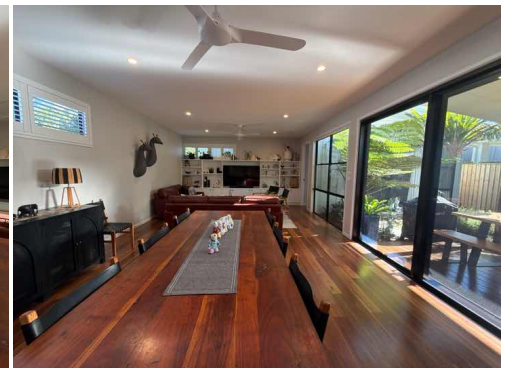
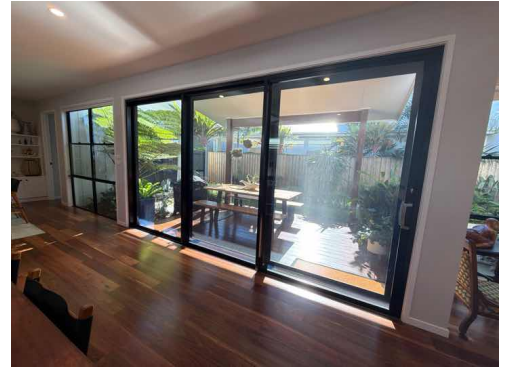
Combined Living & Dining

From the visible and accessible areas, this room appears to be in a serviceable condition for the age of the property with no notable structural defects sighted.

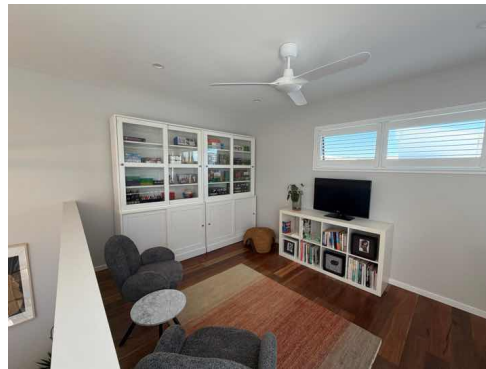
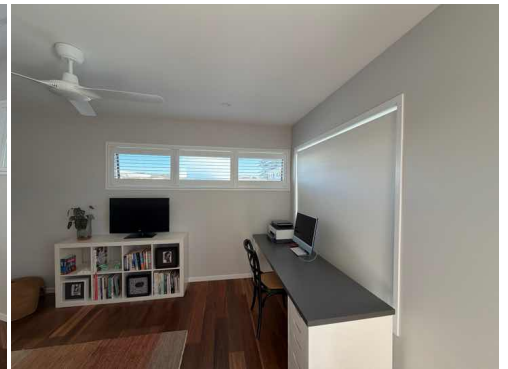
Study

From the visible and accessible areas, this room appears to be in a serviceable condition for the age of the property with no notable structural defects sighted.

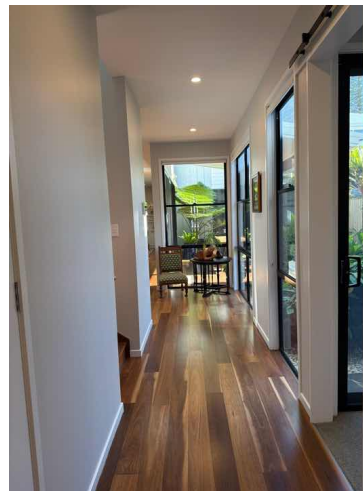
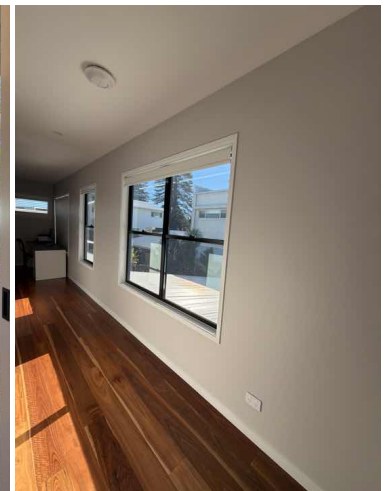
From the visible and accessible areas, the hallway/ appears to be in a serviceable condition for the age of the property with no notable structural defects sighted.

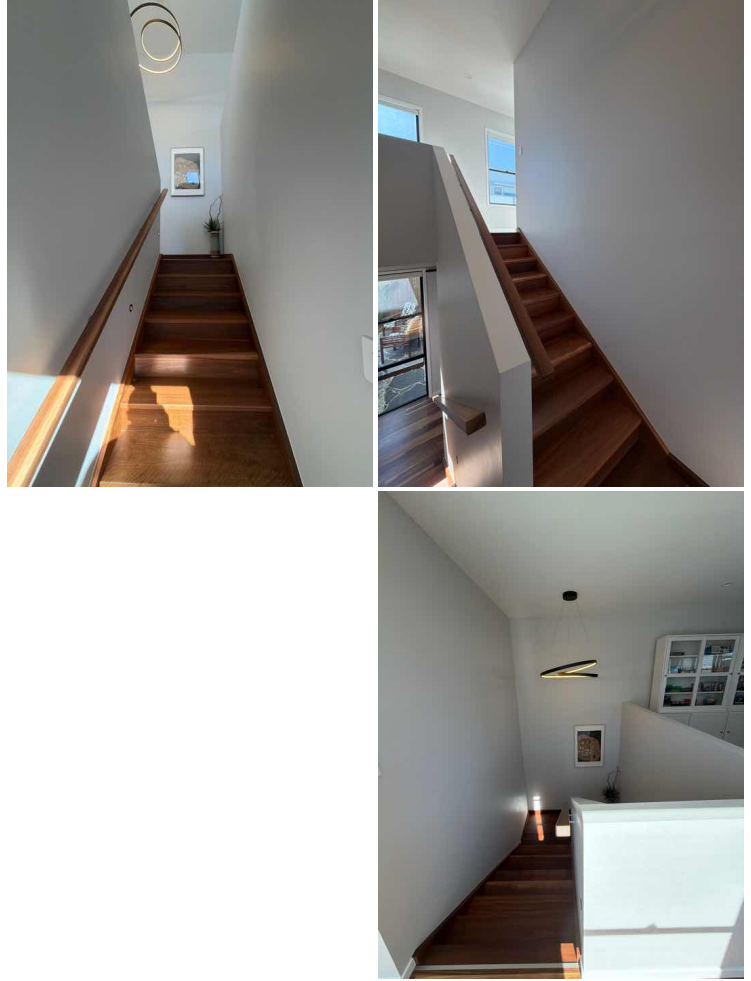
Internal Stair Case

The internal staircase and components appear to be in a serviceable condition for the age with no notable defects sighted.

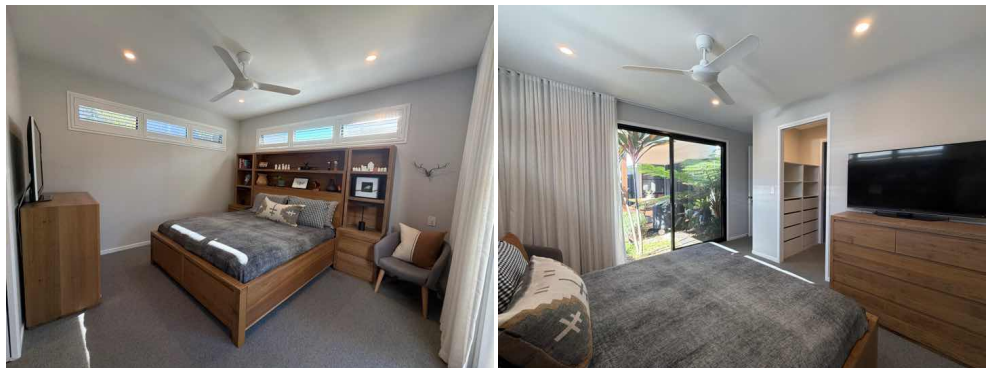
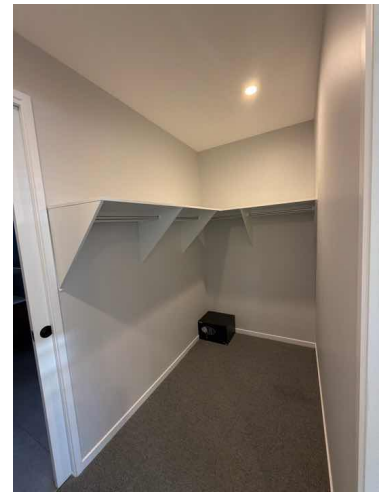
Bedroom 1

From the visible and accessible areas, this bedroom appears to be in a serviceable condition for the age of the property with no notable structural defects sighted.

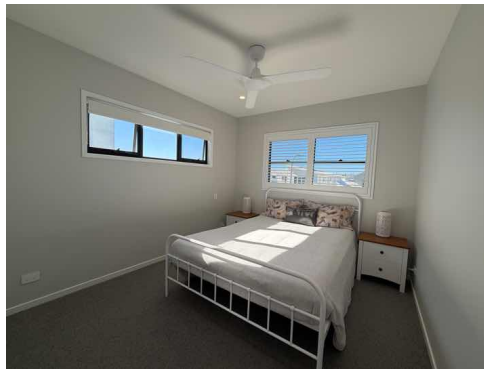
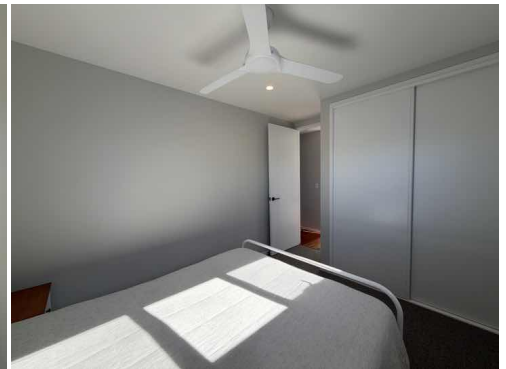
Bedroom 2

From the visible and accessible areas, this bedroom appears to be in a serviceable condition for the age of the property with no notable structural defects sighted.

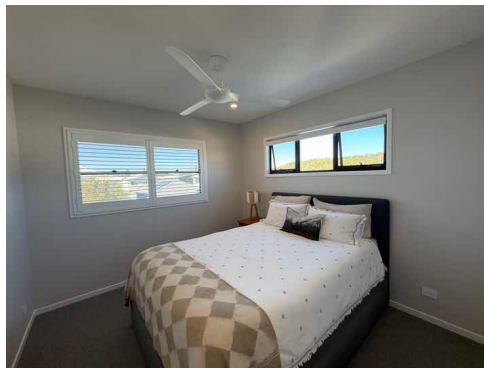
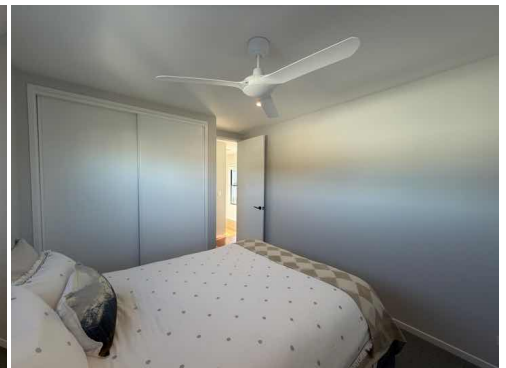
Bedroom 3

From the visible and accessible areas, this bedroom appears to be in a serviceable condition for the age of the property with no notable structural defects sighted.

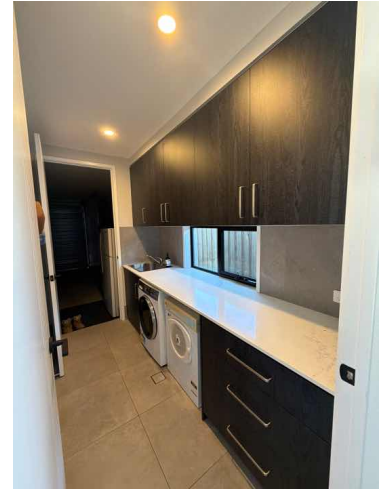
Of the visible areas, the general condition of the laundry is serviceable or in reasonable condition for age of dwelling.

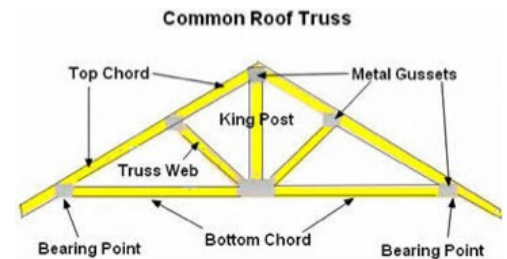
Roof Frame Type

The roof frame is a truss timber frame.

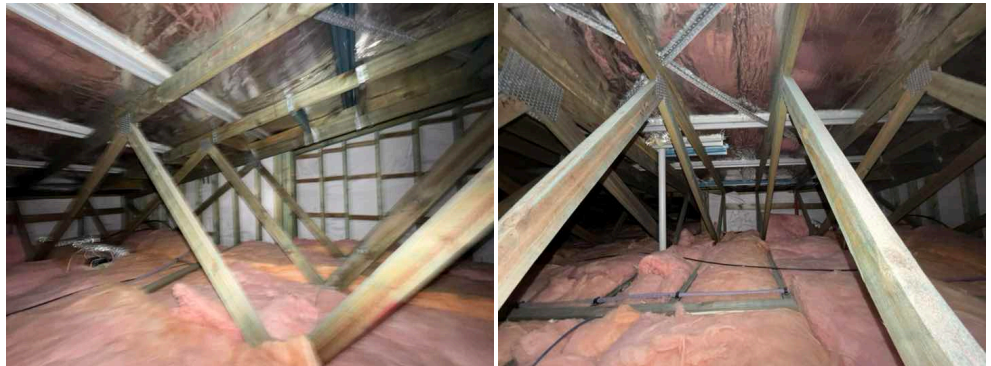
Visible sections of the roof void is in a serviceable condition for age of this dwelling.

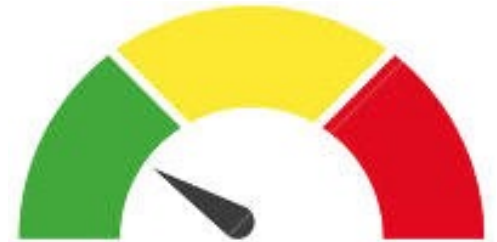
The overall condition of this residential dwelling in the context of its age, type and general expectations of similar properties is **ABOVE AVERAGE**

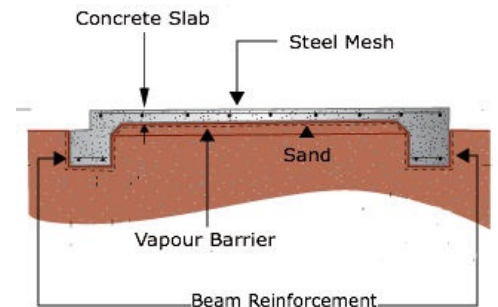
Footings Type

Slab on ground construction.
