PEST AND BUILDING PRE-PURCHASE REPORTS

Inspection Report

4 Seaside Av, Skennars Head, NSW, 2478

Pest And Building Inspection

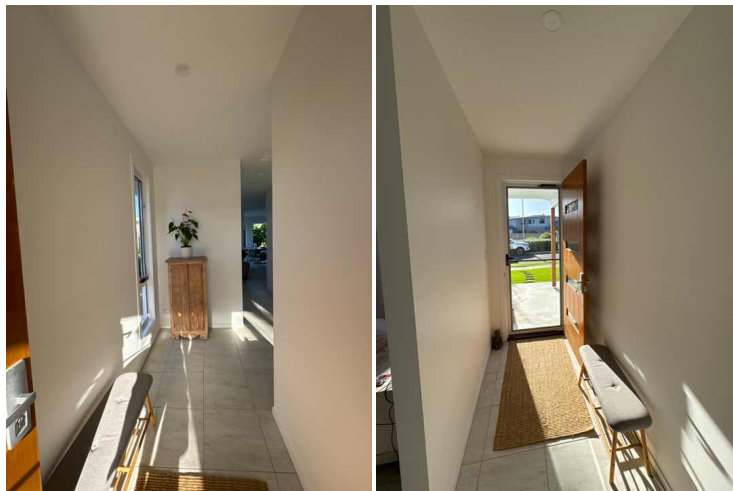
From the visible and accessible areas, this area appears to be in a serviceable condition for the age of the property with no notable structural defects sighted.

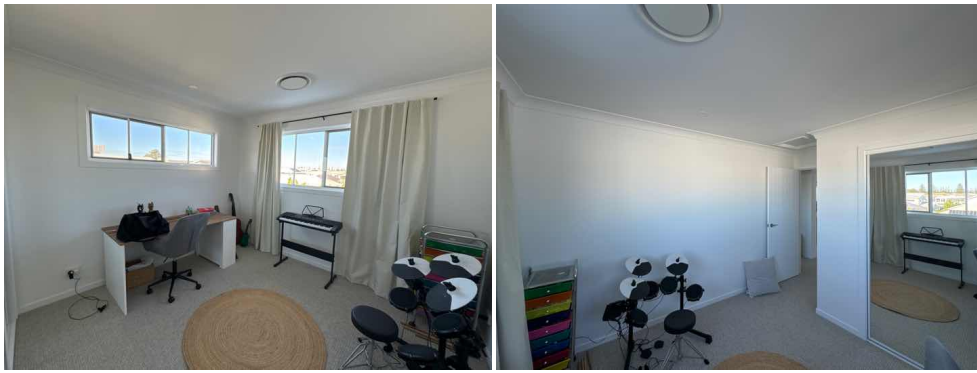
From the visible and accessible areas, this bedroom appears to be in a serviceable condition for the age of the property with no notable structural defects sighted.

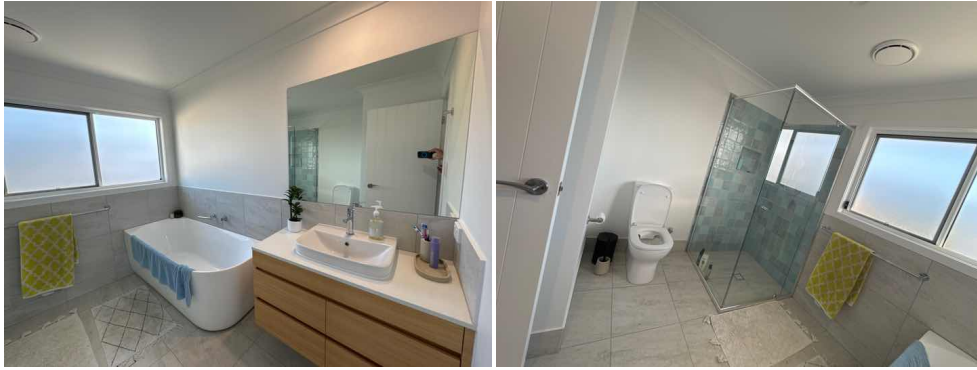
Of the visible areas, the general condition of this bathroom is serviceable or in reasonable condition for age of dwelling.

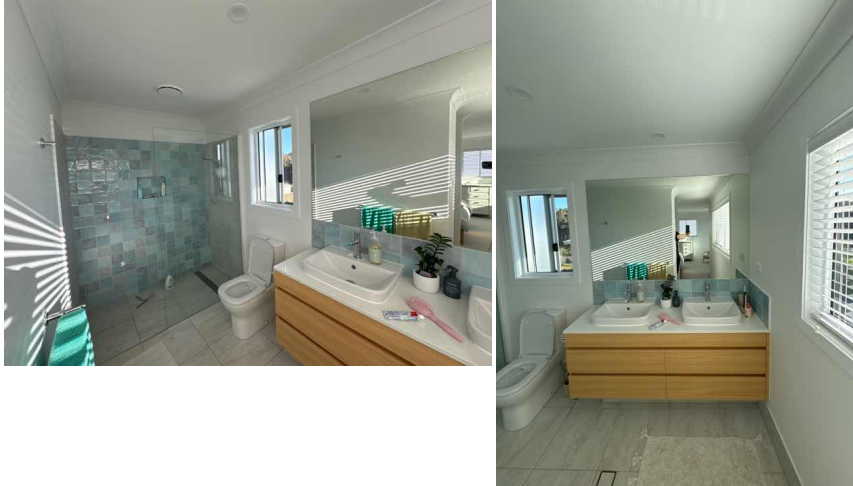
Of the visible areas, the general condition of this bathroom is serviceable or in reasonable condition for age of dwelling.

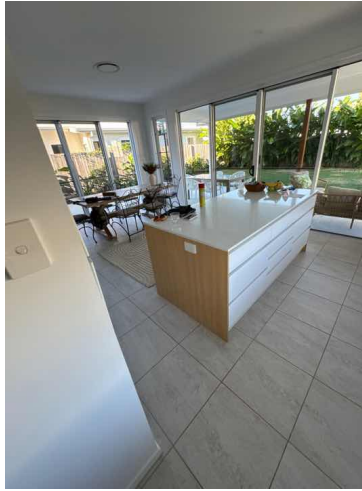
Cupboards And Bench Tops

These components appear to be in a serviceable condition
