# Building and Pest Report

1/1 Sunrise  
Crescent  
Lennox Head

### Pest And Building Inspection

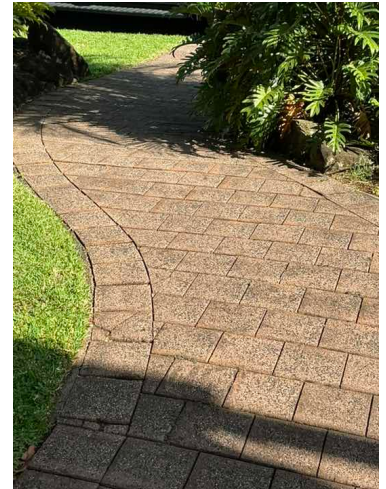
The paths around the home are in a serviceable condition for the age of this dwelling with no major defects visible.

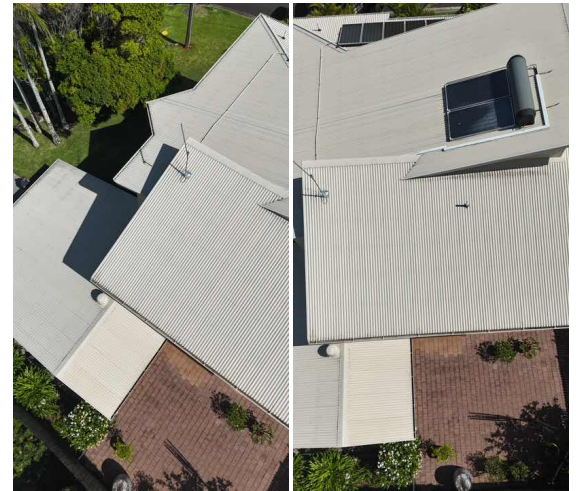
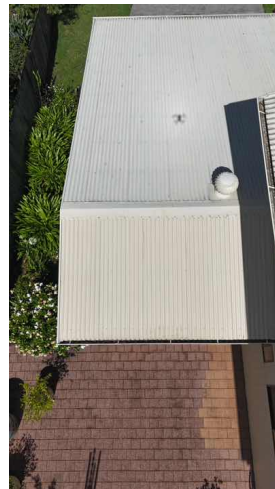
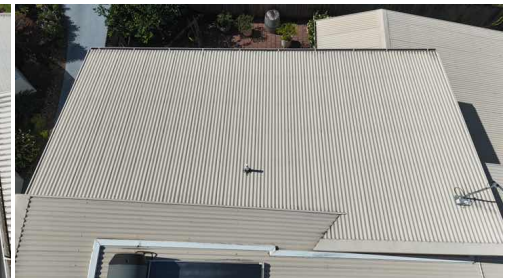
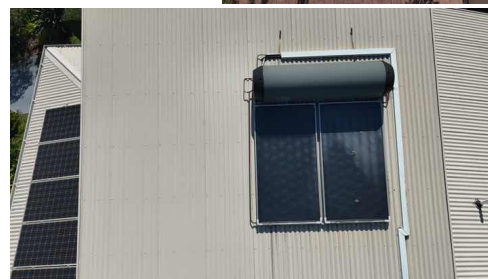
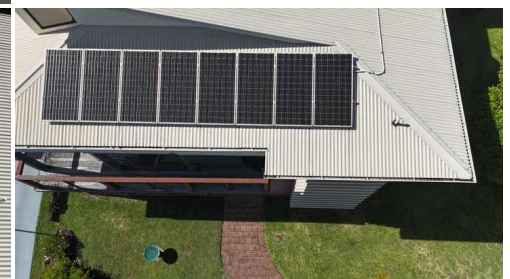
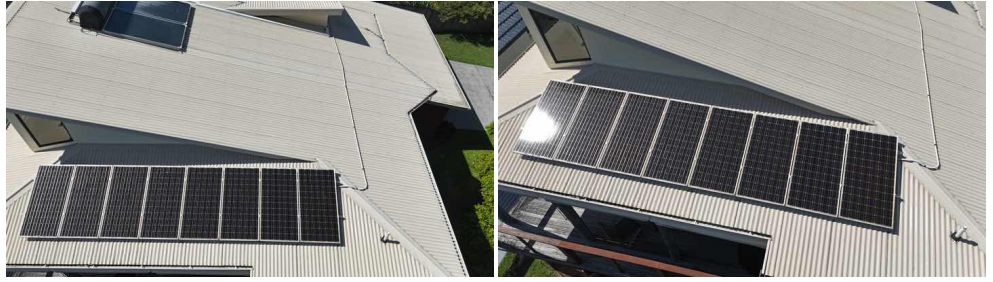
Of the visible areas, the general condition of the roof is in serviceable condition for the age.

Note: In the absence of rainfall there is no guarantee that the roof won't leak.

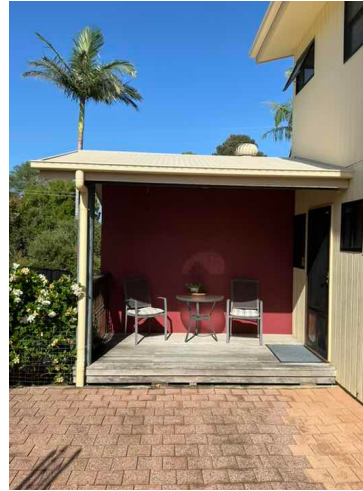
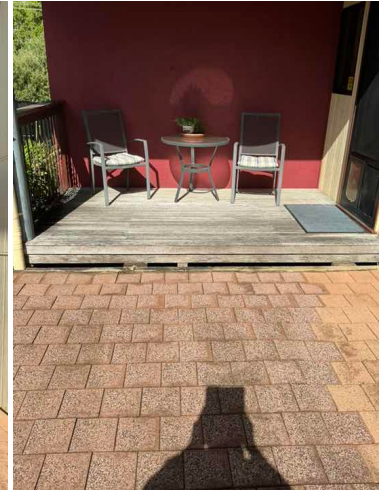
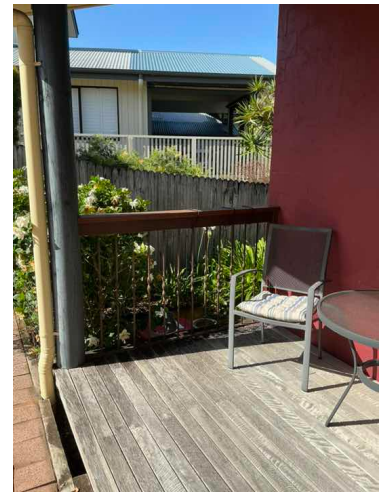
Visible sections of the Alfresco area are serviceable or in reasonable or condition for the age of this dwelling.

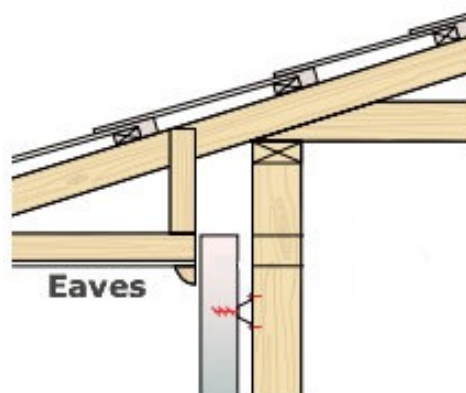
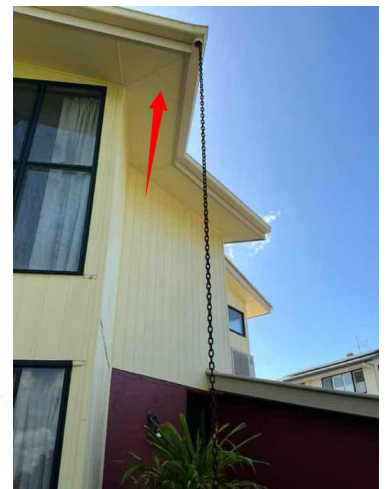
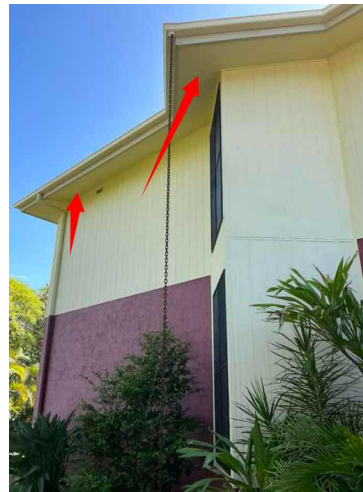
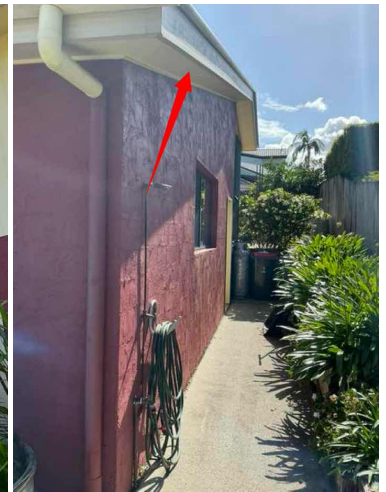
The soffit lining (eaves) are in a serviceable condition with no notable defects.

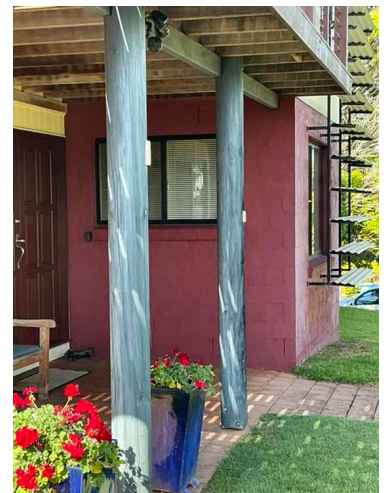
The entry porch serviceable or in reasonable or condition for the age of this dwelling.

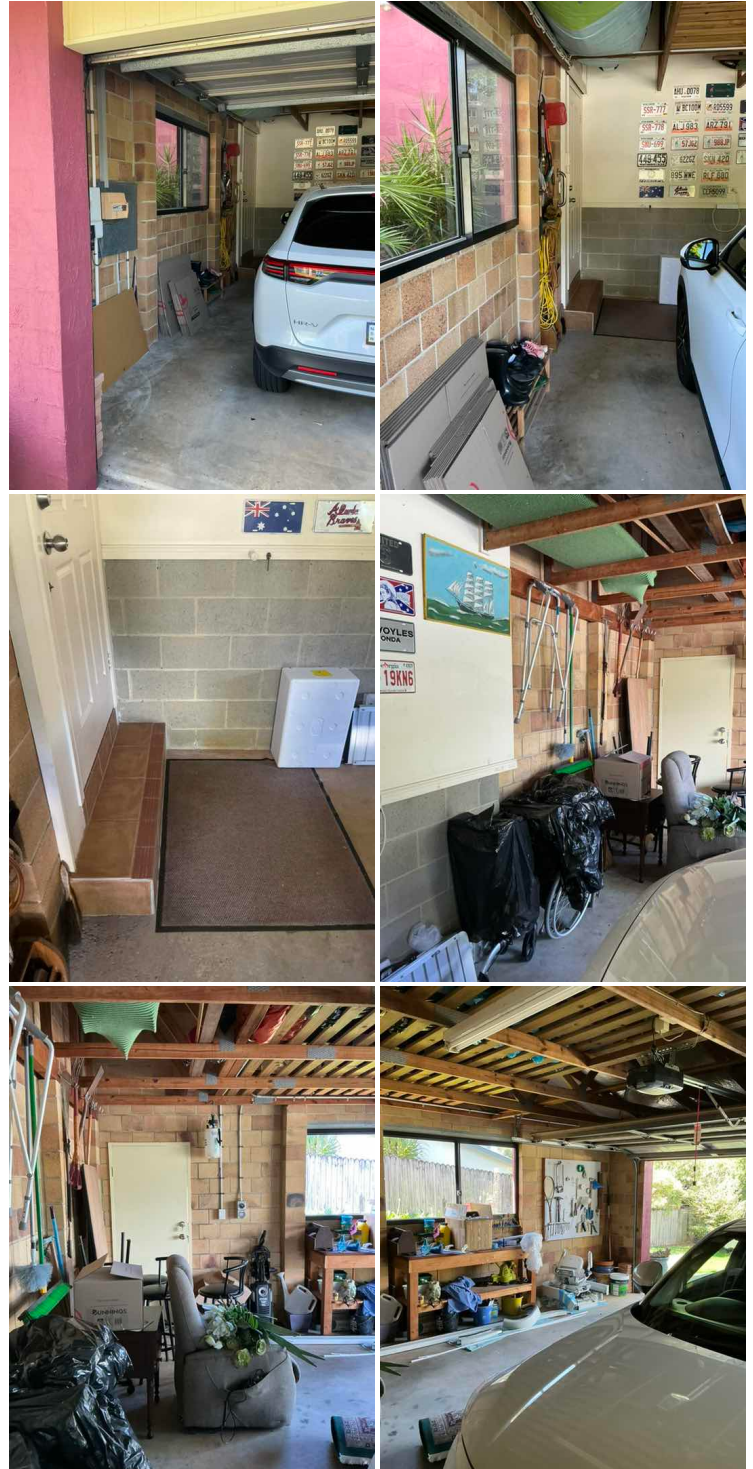
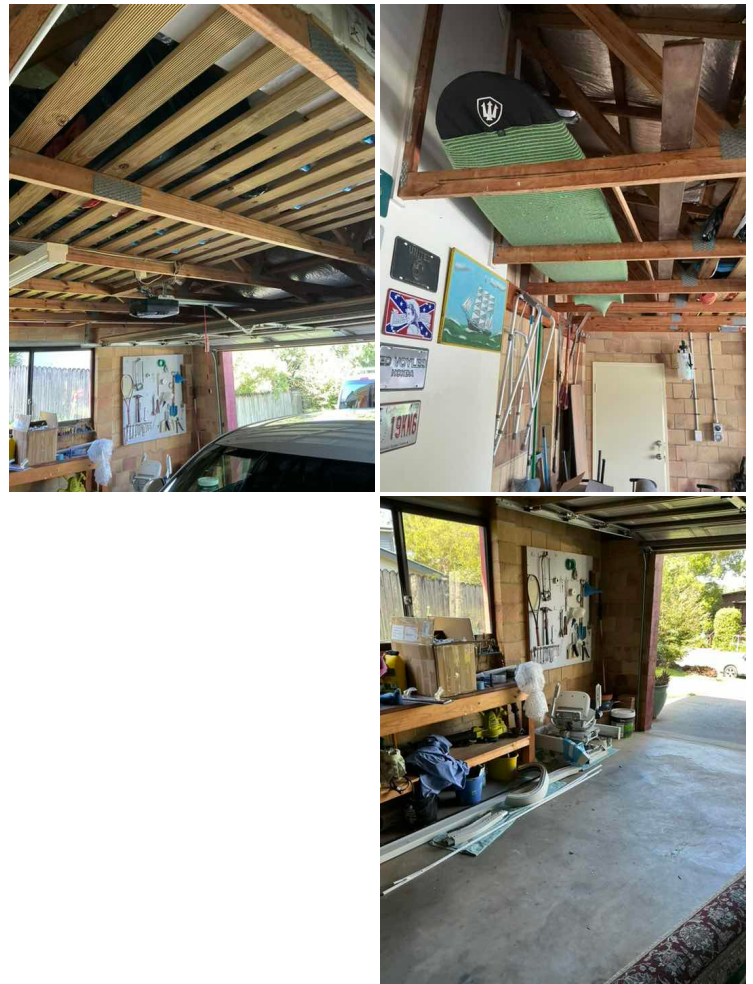
Stored items restricted a full and thorough inspection of this area. Defects may exist in the obstructed and inaccessible areas. It is strongly recommended that full access be granted to enable a thorough inspection as there may be timber pest activity, damage or defects. Note: Where vehicles and storage has restricted a full inspection it is advised that this area be cleared so a full and unobstructed inspection can be carried out.

From the visible and accessible areas, the garage appears to be in a serviceable condition for the age of the property with no notable structural defects sighted.

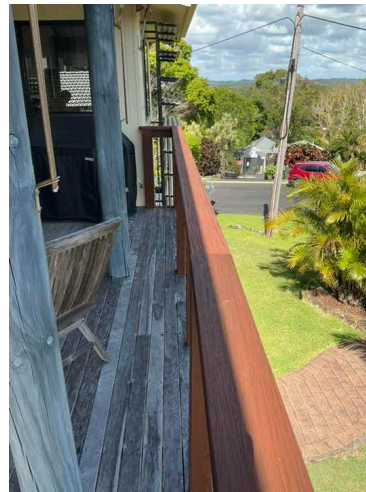
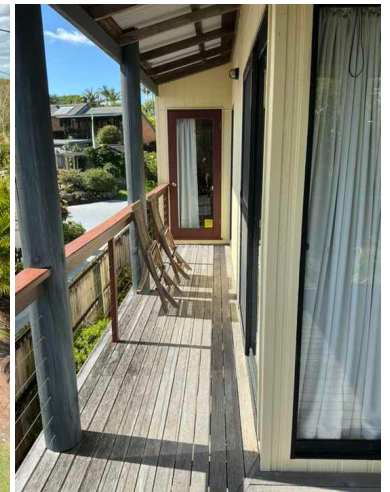
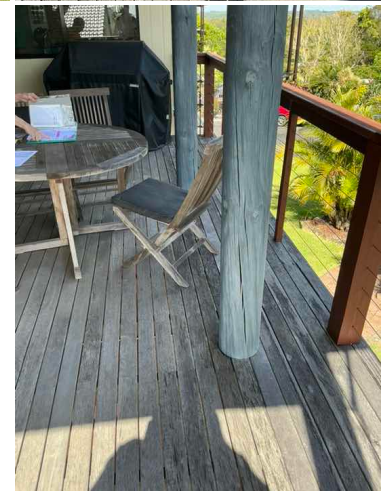
Upon visual inspection, the decking shows signs of weathering and potential wood deterioration. Recommend sanding and sealing the wood to prevent further damage. The railing appears secure, but regular checks are advised to ensure stability. Engage a licensed tradesperson for maintenance and repairs to prolong the deck's lifespan and ensure safety.

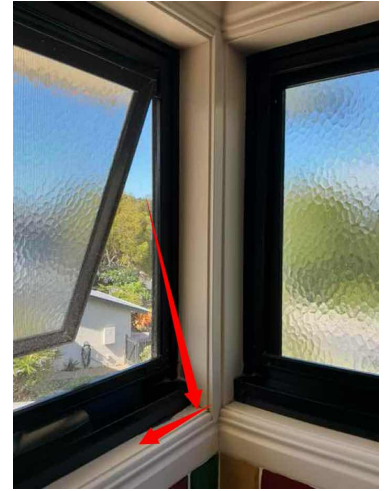
On inspection, defects were present that will require further assessing and recommendations by licensed and qualified trades persons, please read below for details.

#1. Some architraves are water damaged and require replacement. Contact a qualified fixout carpenter.

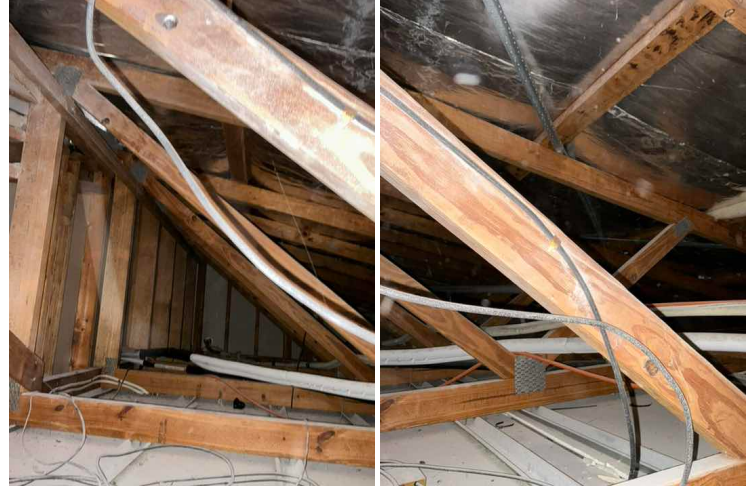
Visible sections of the roof void is in a serviceable condition for age of this dwelling.
