# Building and Pest Report

## 1 Lennox Street Lennox Head

### Pest And Building Inspection

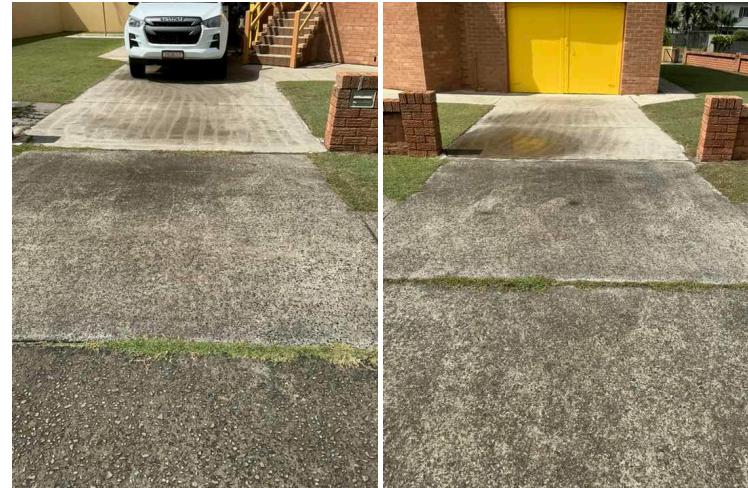
On visual inspection, the general condition of the driveway is serviceable.

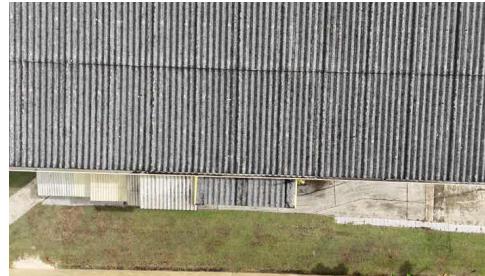
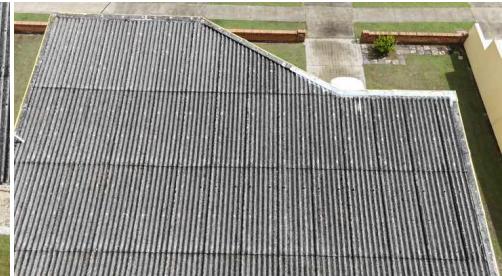
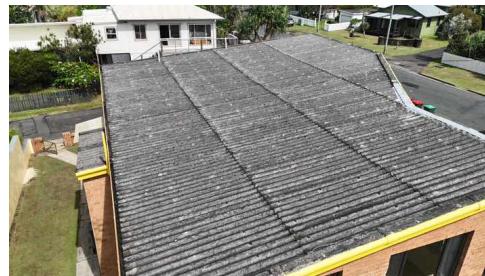
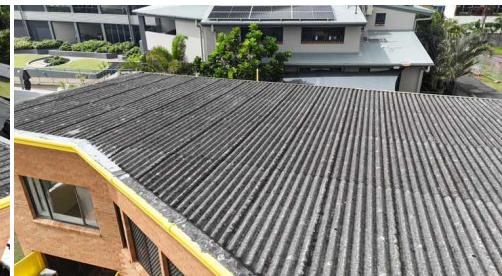
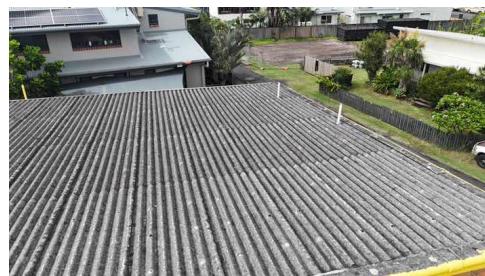
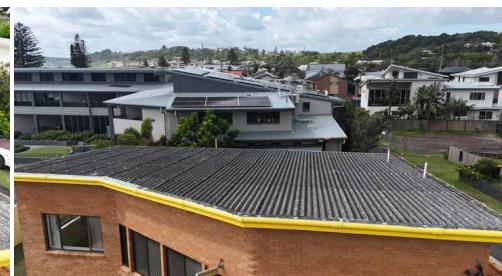
Asbestos roof lining. We strongly recommend obtain a asbestos inspection.

Of the visible areas, the general condition of the roof is in serviceable condition for the age.

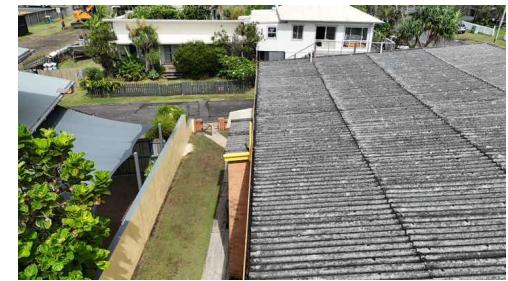
All visible and accessible of the physical nature of the guttering system appears to be in a serviceable condition with no apparent defects at the time of inspection. In the absence of prolonged rain fall efficiency of the guttering can not be assessed and you may find that further investigation or repairs maybe required. Note: Periodic maintenance checks should be carried out for rust penetrations and leaks.

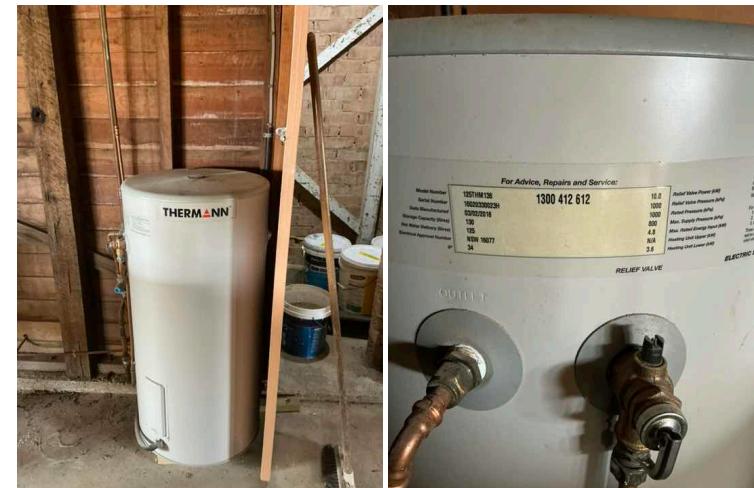
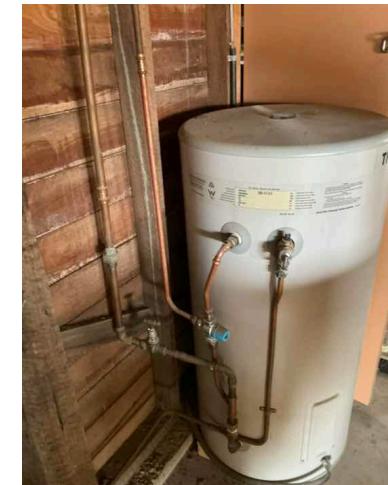
Thermann

Hot water unit system capacity is 130 litre.

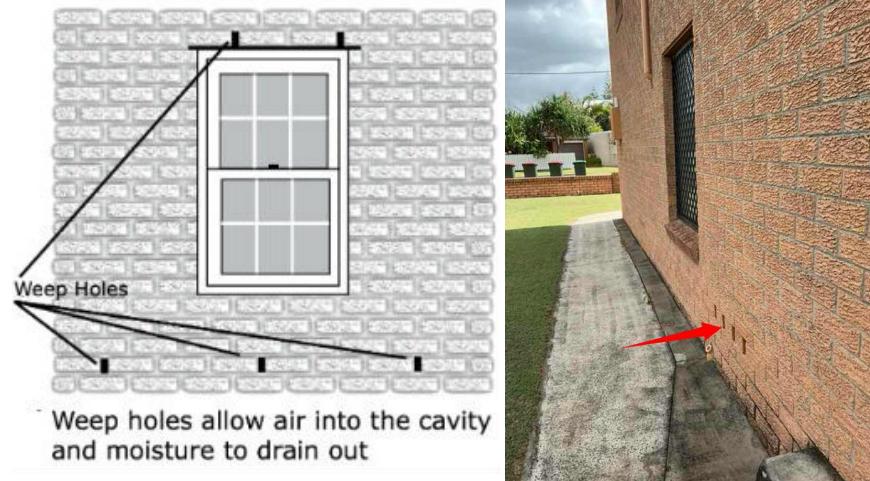
The weep holes are unobstructed .

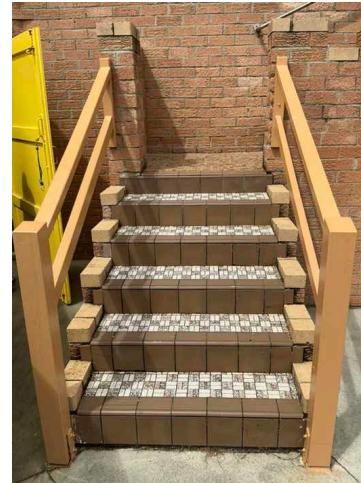
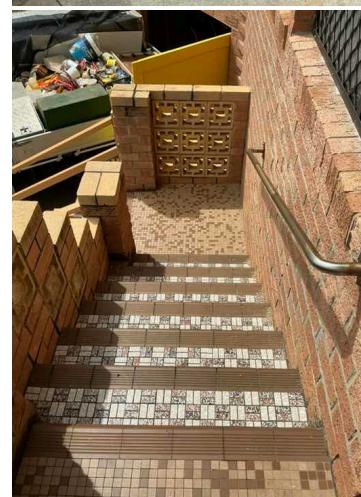
Upon visual inspection, there are signs of structural deterioration in the brickwork and concrete. Cracks and gaps suggest potential instability. Recommend engaging a licensed mason or structural engineer to assess and repair the compromised areas to ensure safety and integrity.

#2. Settlement/movement cracking. A qualified concreter should be engaged for advice and recommendations.

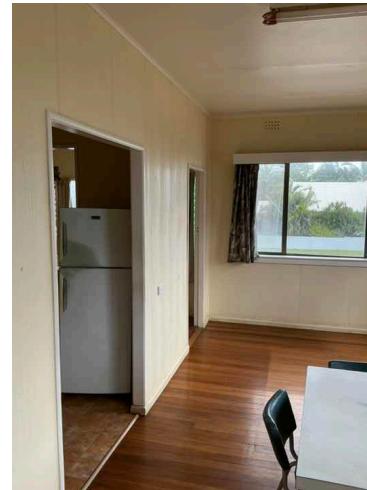
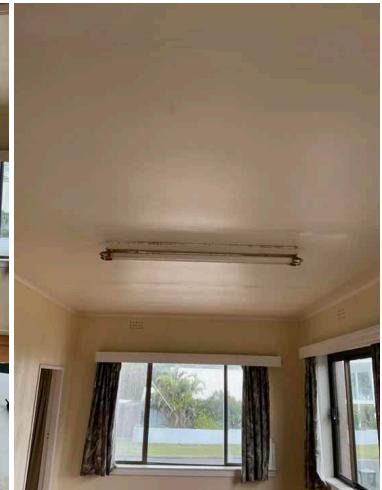
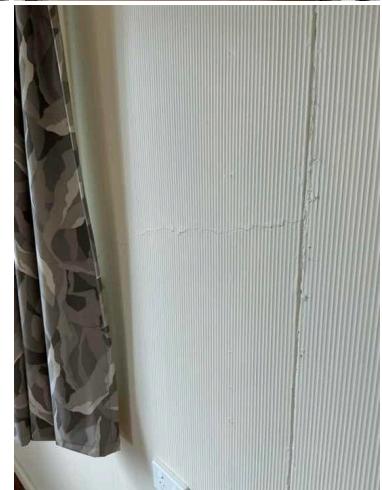
Upon visual inspection, there are visible cracks along the wall joints. It is recommended to engage a licensed plasterer to assess and repair the cracks to prevent further deterioration. Ensure proper sealing and repainting to maintain the wall's integrity and appearance.

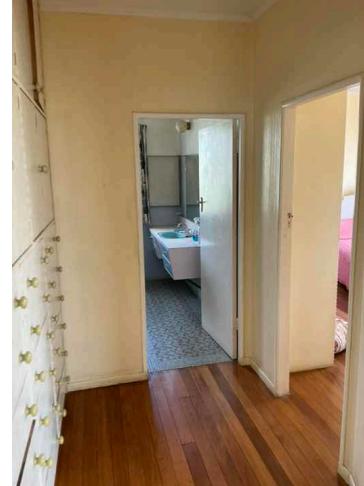
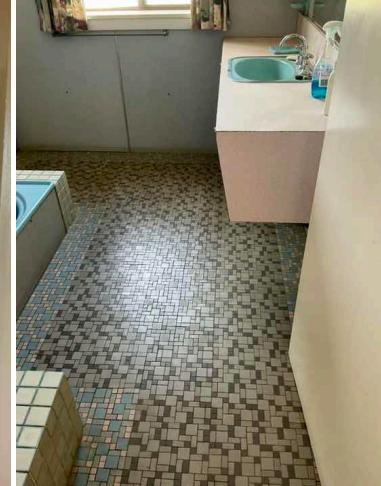
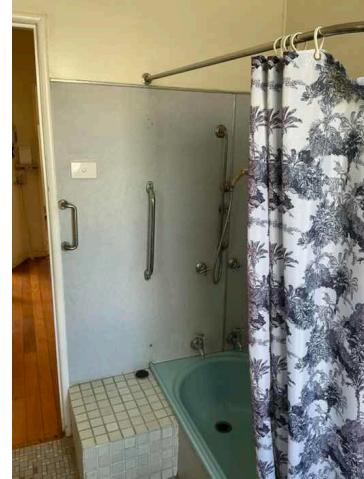
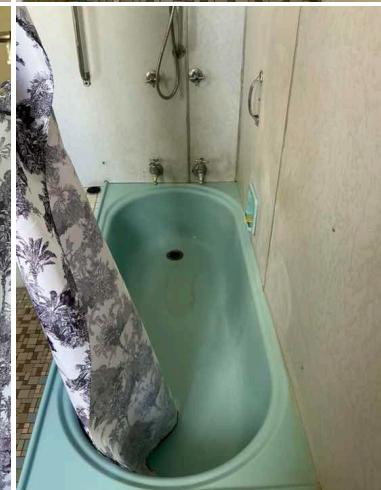
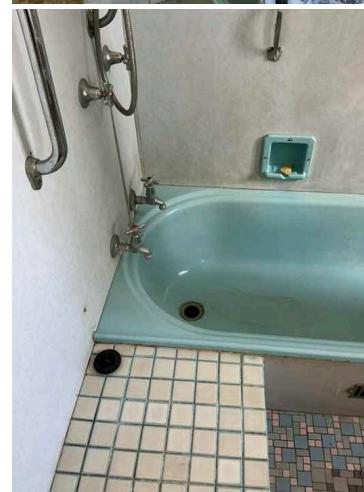
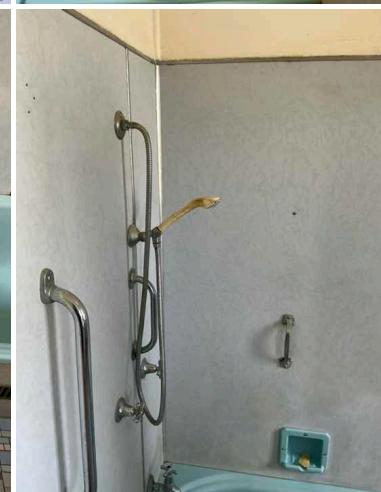
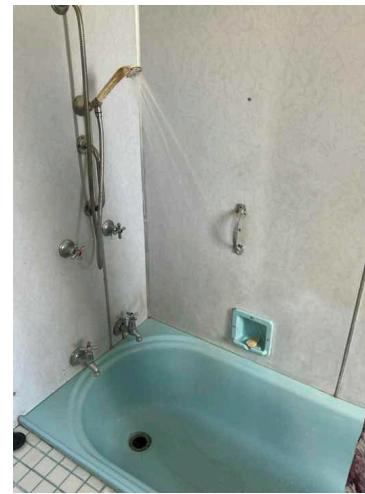
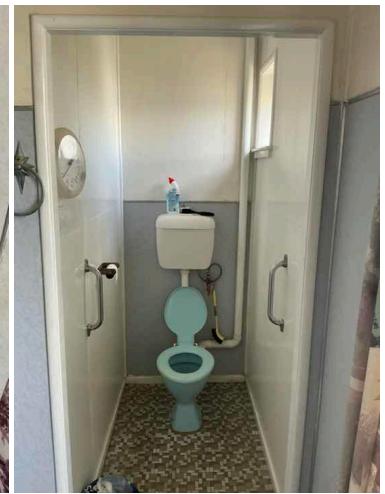
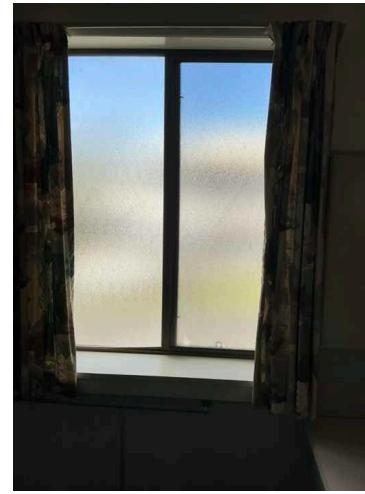
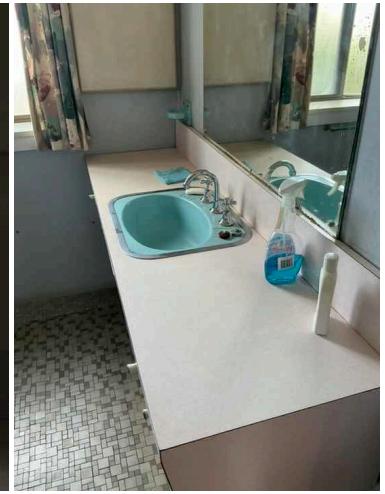
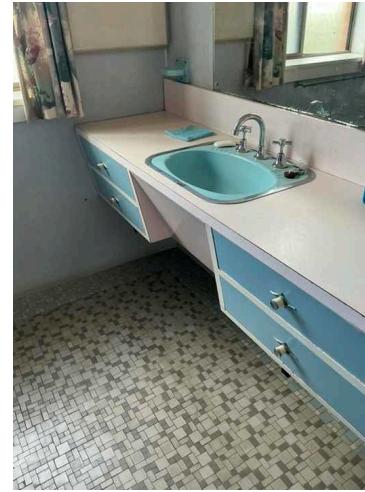
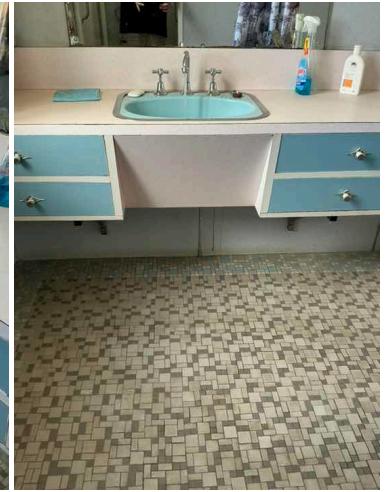
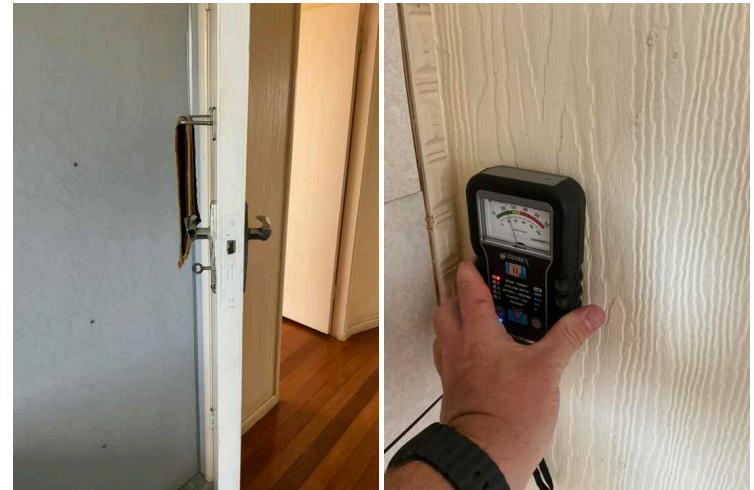
Of the visible areas, the general condition of this bathroom is serviceable or in reasonable condition for age of dwelling.

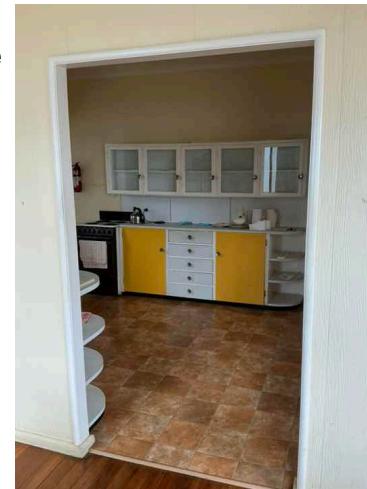
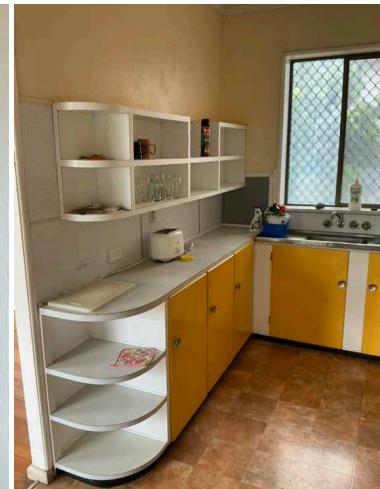
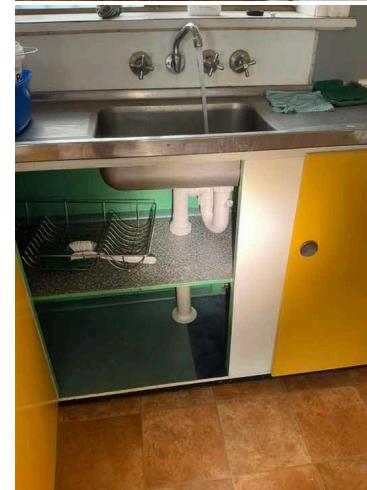
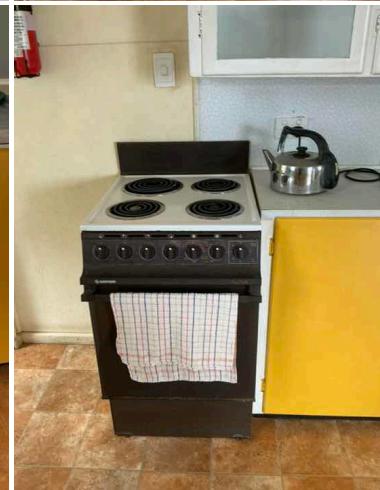
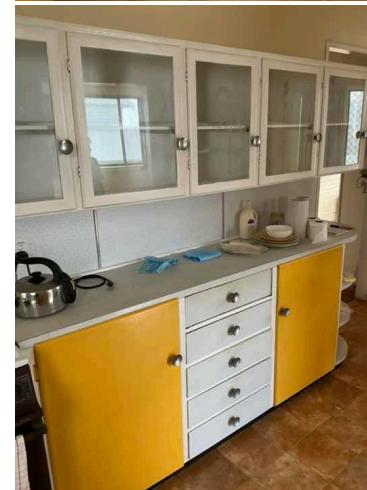
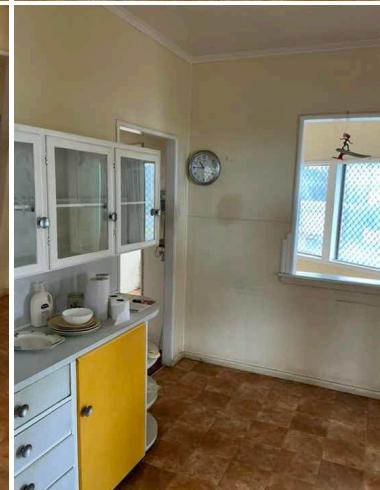
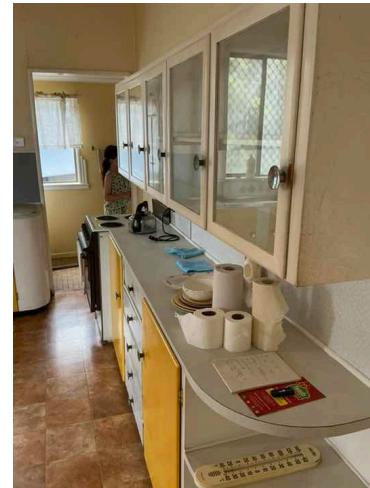
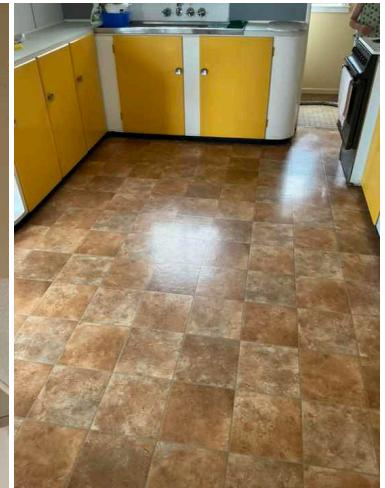
Of the visible areas, the general condition of the kitchen is serviceable or in reasonable condition for age of dwelling.

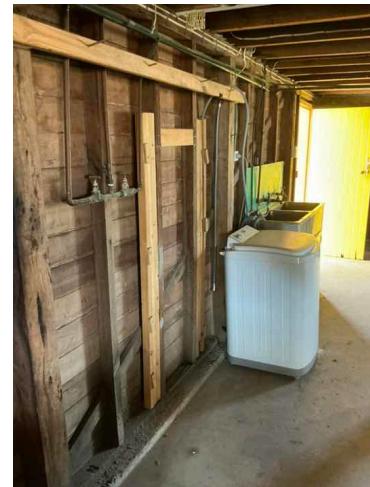
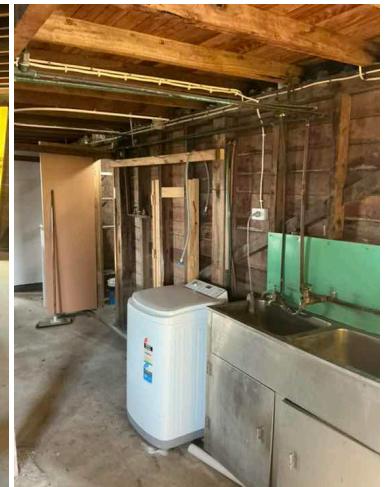
Of the visible areas, the general condition of the laundry is serviceable or in reasonable condition for age of dwelling.

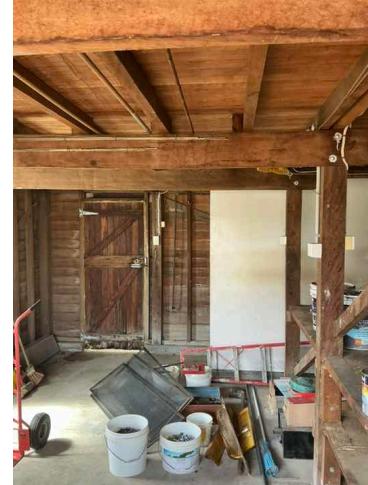
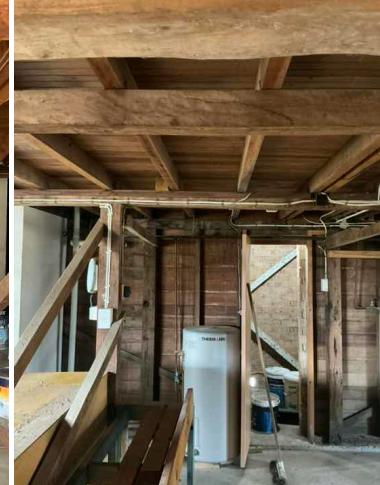
Of areas accessible and visible, the subfloor and components appeared to be in a serviceable condition.

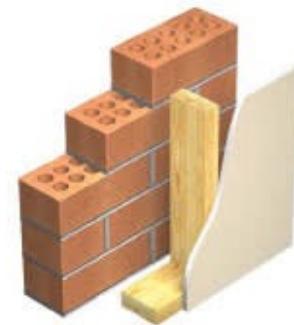
**BRICK VENEER WALL**

The structure is of brick veneer construction.

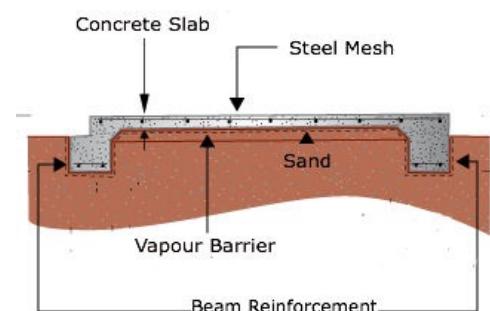
Slab on ground construction.
